**FINAL - INTERIM REMEDIAL ACTION REPORT
FORMER TEXACO SERVICE STATION NO. 21-1556
101 Mulford Road
Toledo, Washington**

April 14, 2011

**Prepared by:
SAIC Energy, Environment & Infrastructure, LLC
18912 North Creek Parkway, Suite 101
Bothell, Washington 98011**

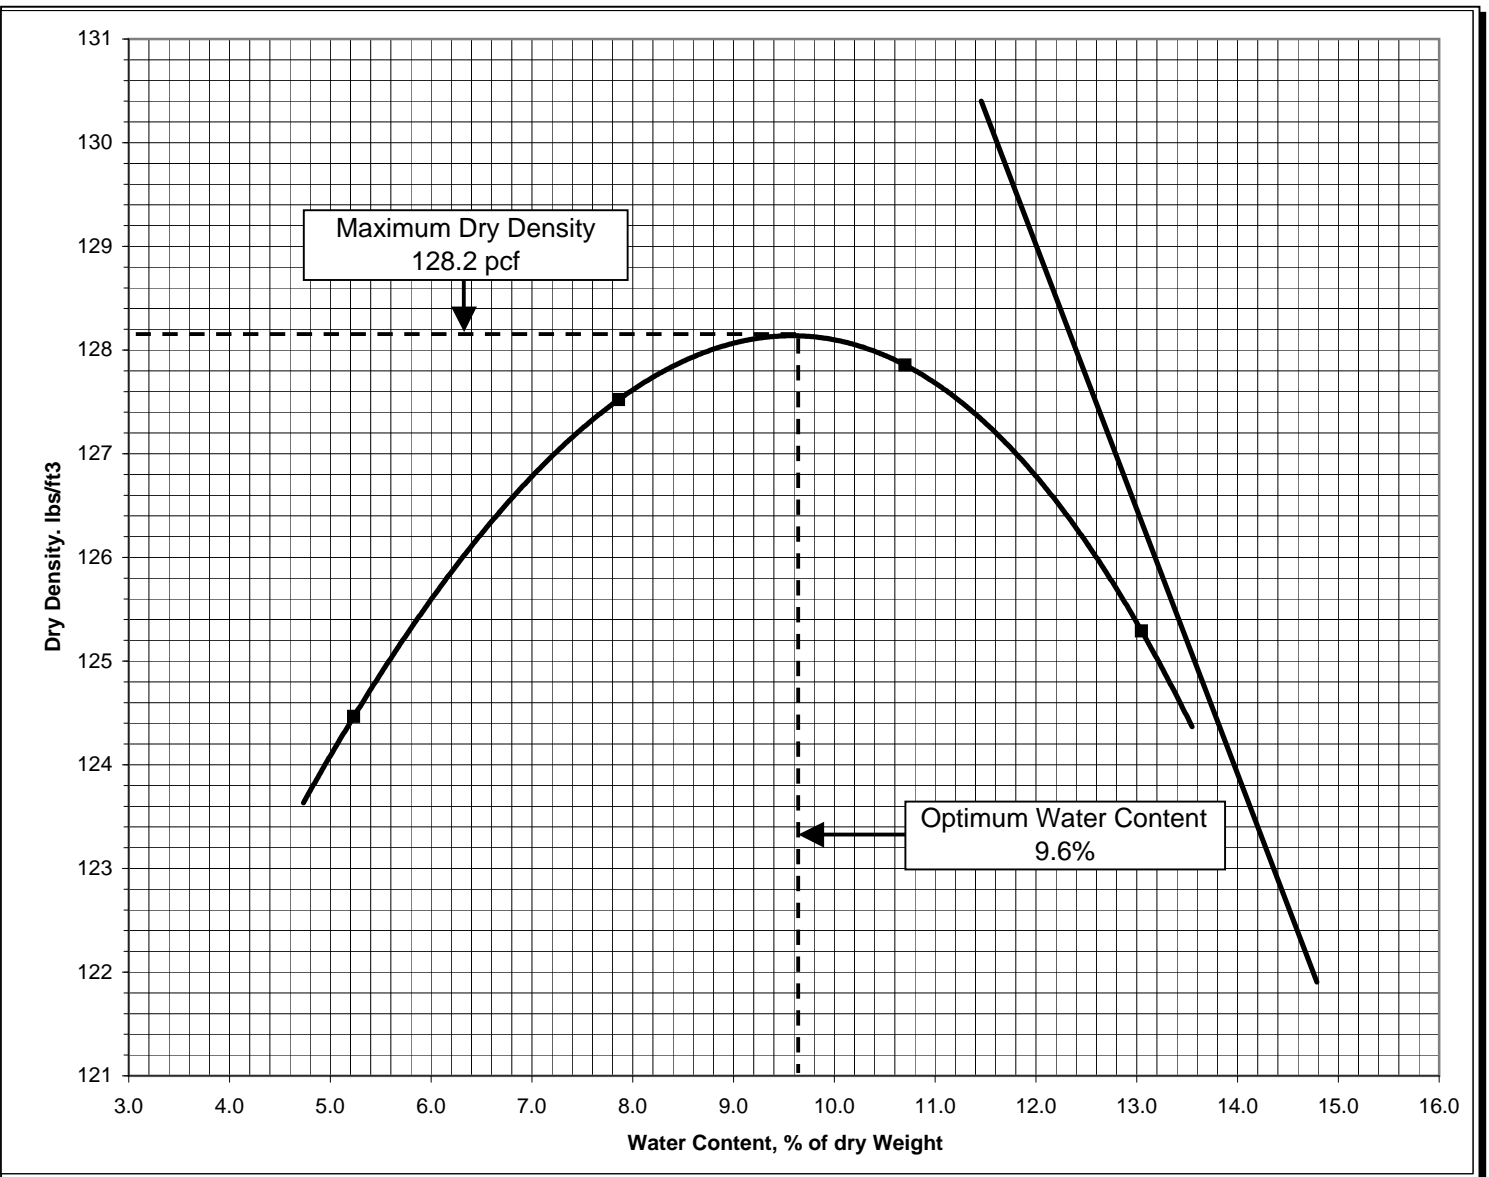
Moisture Density Relationship Test

Test Results	
Optimum Water Content %	9.6
Max Dry Density Corr. lbs/ft ³	128.2

Sieve Analysis	
Sieve Size	Percent Retained
3/4	10%
3/8	35%
#4	48%

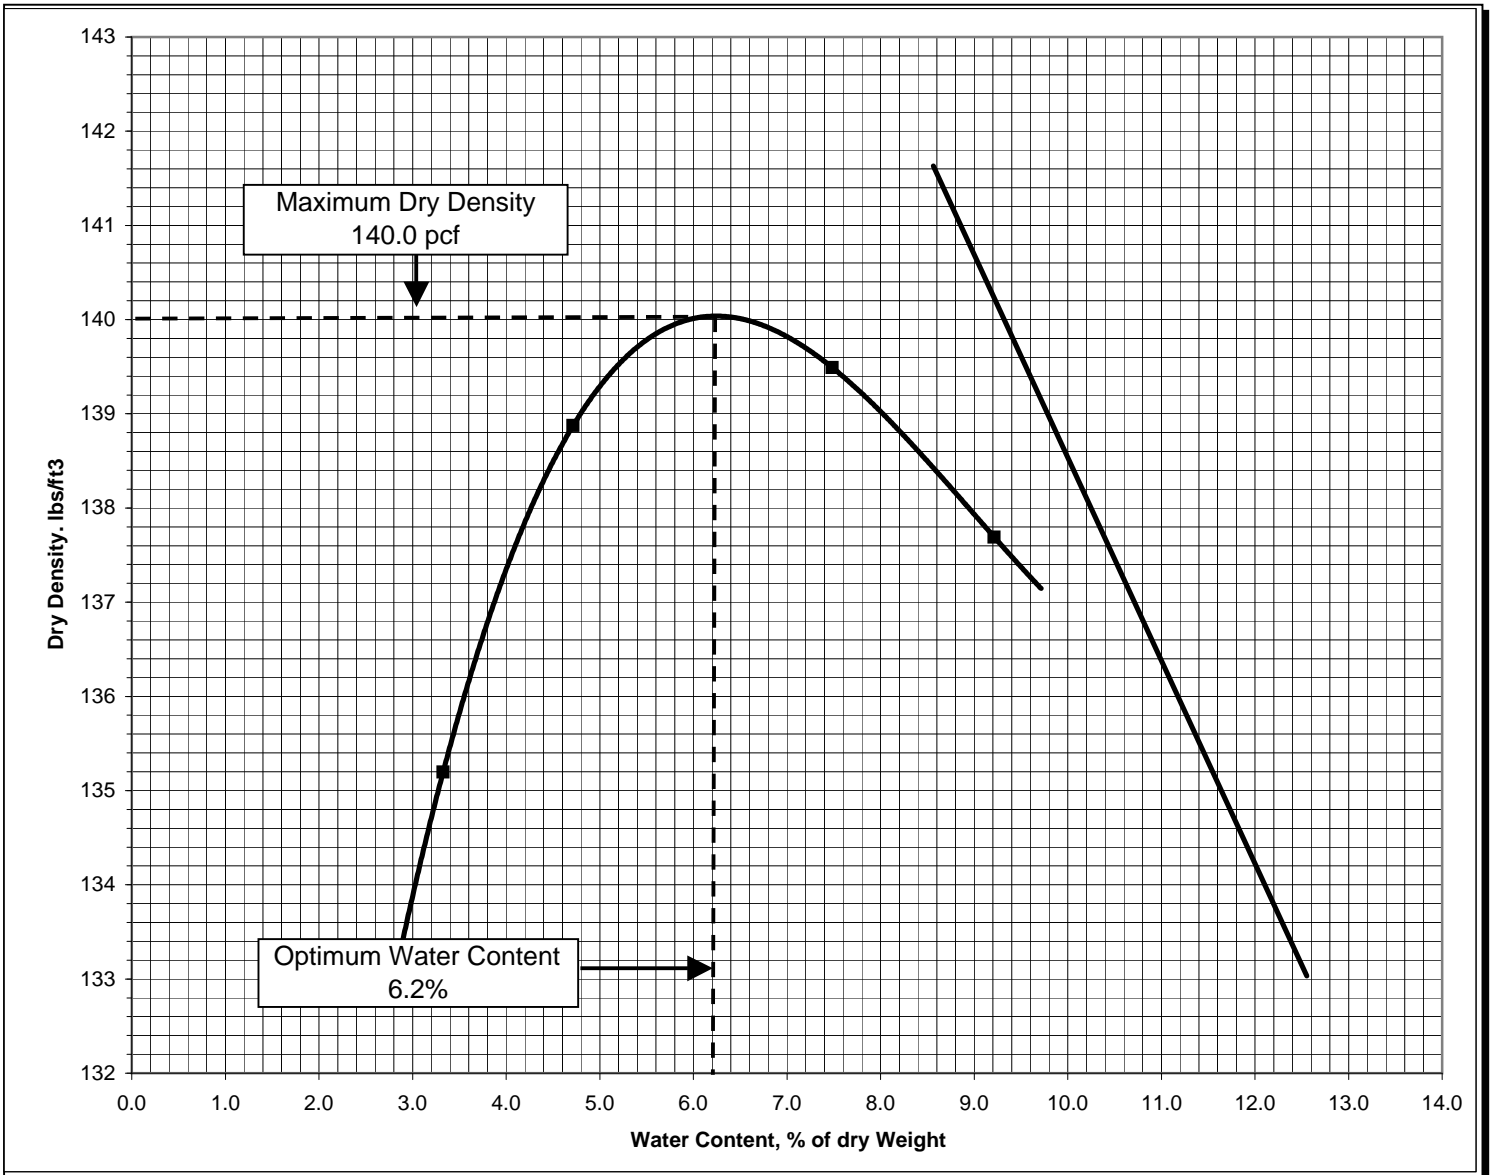
Moisture Density Relationship Test

Sieve Analysis	
Sieve Size	Percent Retained
3/4	29%
3/8	52%
#4	64%

Zero Void line plotted at SpG: 2.65
 Max. Density Uncorrected: 132.4

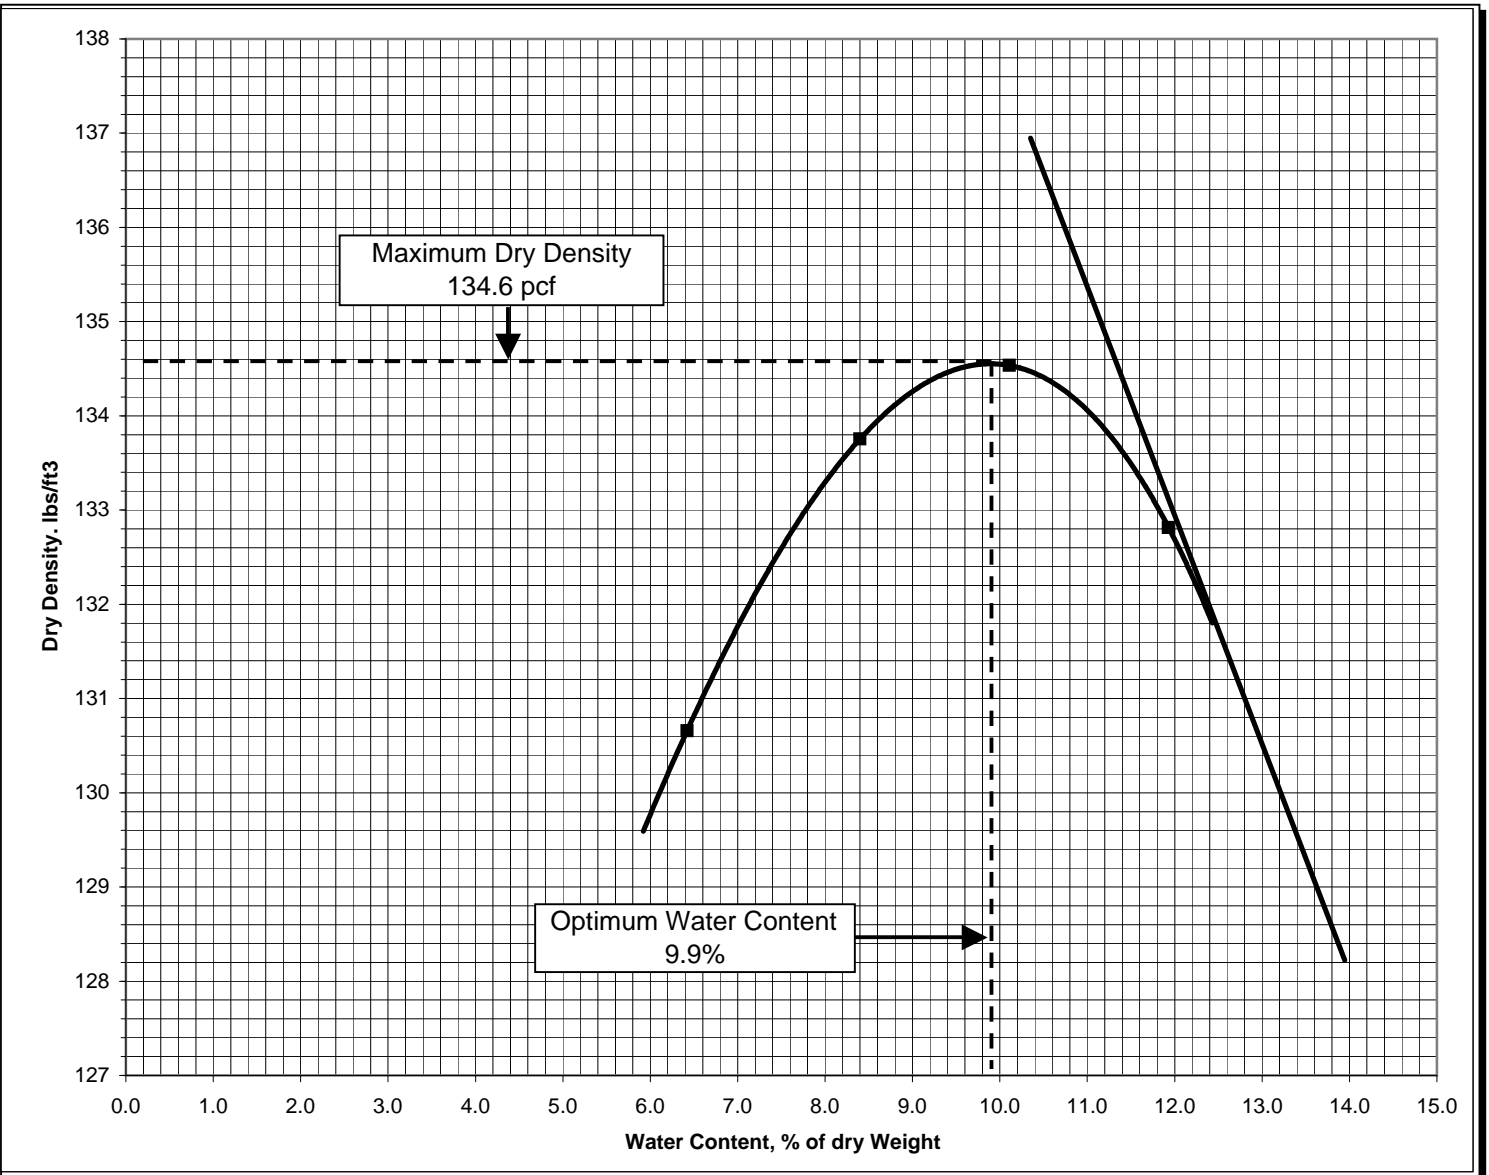
Moisture Density Relationship Test

Test Results	
Optimum Water Content %	9.9
Max Dry Density Corr. lbs/ft ³	134.6

Sieve Analysis	
Sieve Size	Percent Retained
3/4	14%
3/8	54%
#4	74%
