## TECHNICAL MEMORANDUM

**RE: INTERIM ACTION COMPLETION REPORT  
EMERGENCY BULKHEAD REPAIR  
BLAINE MARINA INC SITE  
BLAINE, WASHINGTON**

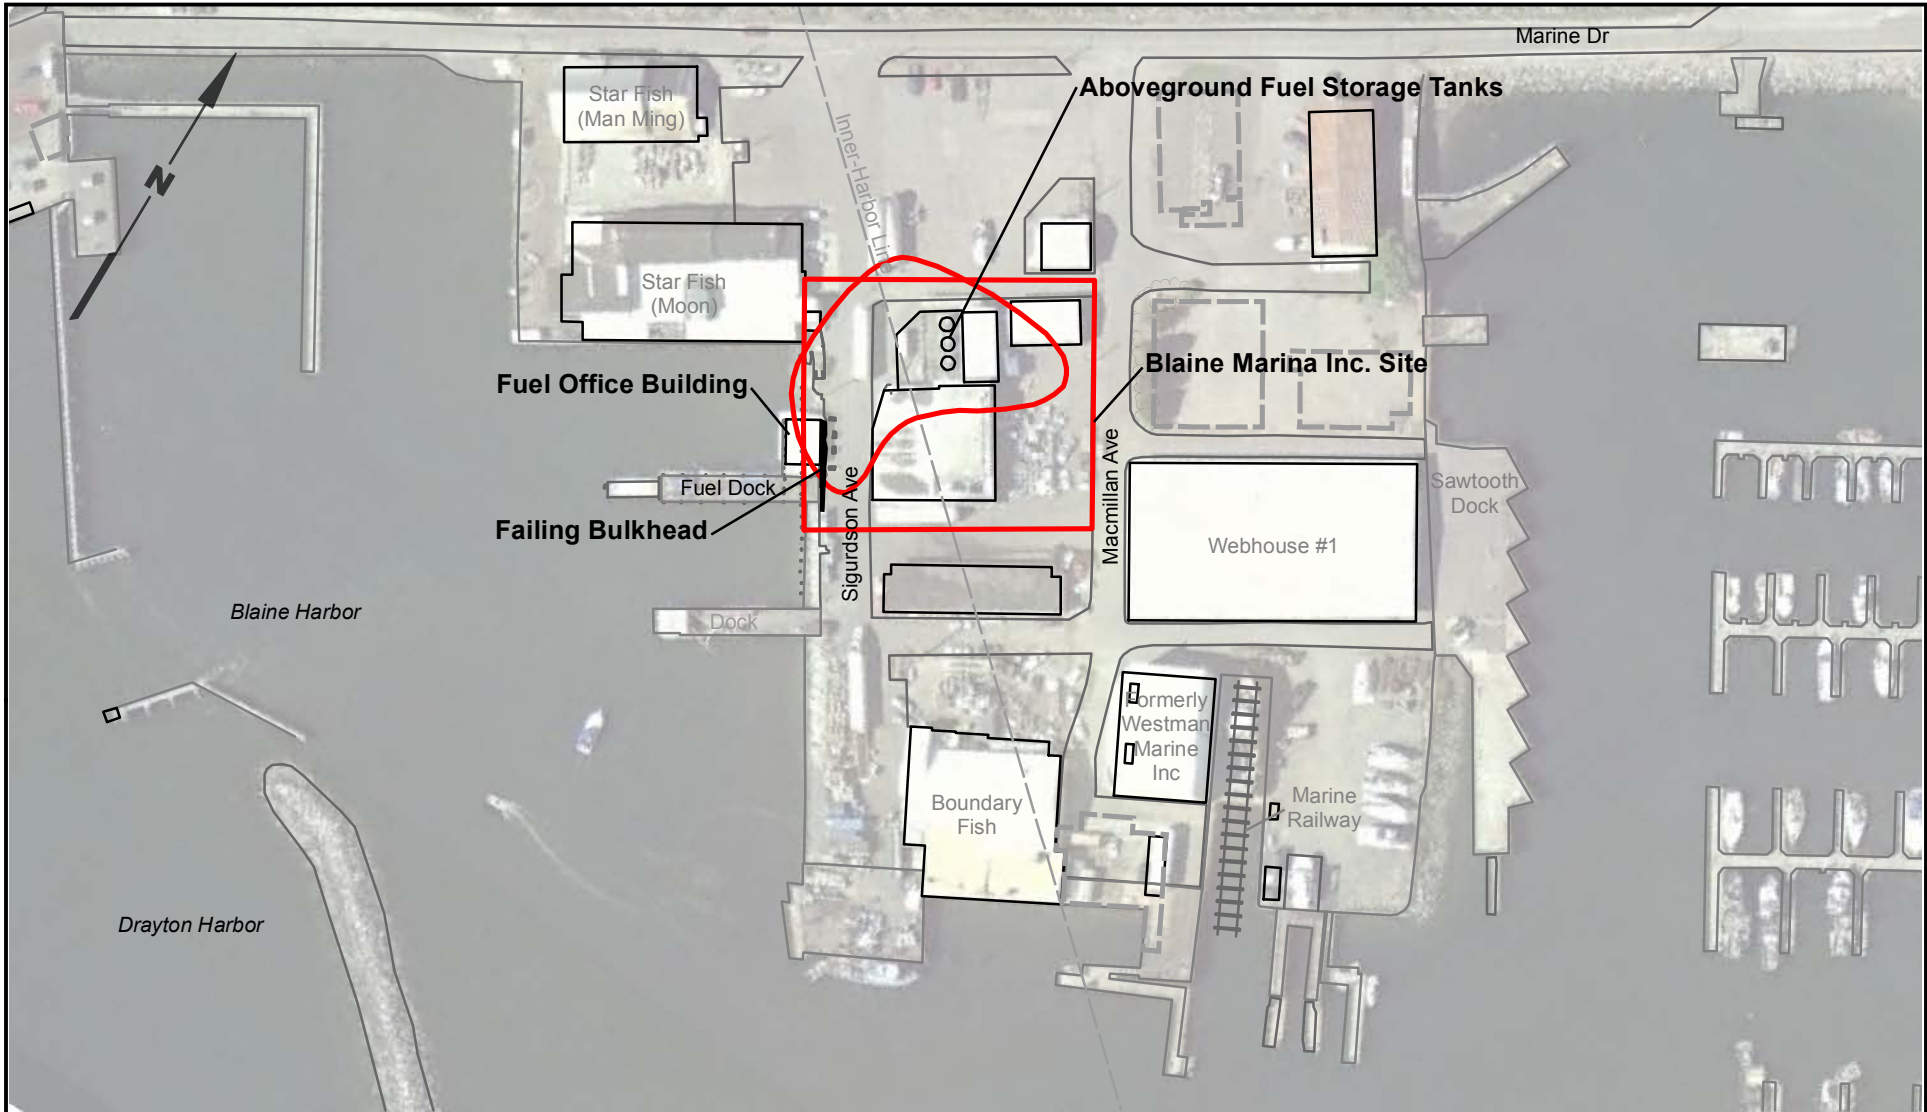
Blaine Marina Inc. Blaine Harbor Blaine, Washington	<b>Blaine Marina Inc.</b> <b>Site Plan</b>	Figure <span style="font-size: 2em; font-weight: bold;">2</span>
---	---	---

The interim action addressed an approximately 60-foot section of failing bulkhead located along the alignment shown on Figure 2. The details of the interim action were described in the Interim Action Plan (Landau Associates 2012<sup>1</sup>), and compared with two other alternatives for repairing the bulkhead. The selection of the preferred alternative was reviewed and approved by Ecology. The fuel office building was deconstructed to the finished floor level by the tenant in advance of the interim action. The interim action was implemented between August 20, 2012 and October 16, 2012 without any significant deviations from the interim action plan. Photographs taken during construction of the interim action are provided on Figures 3 through 5. The photographs show the trench excavated along the bulkhead, installation of the bulkhead sheetpiles, construction of the pile cap, and the completed repair.

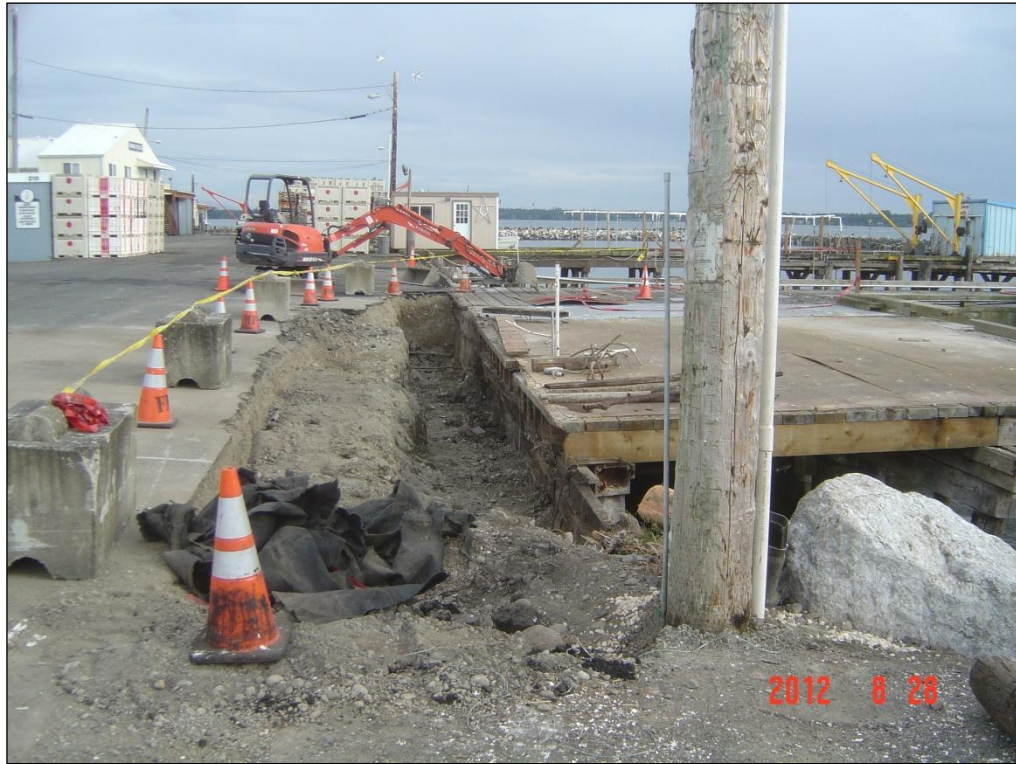
1. Construction trench for bulkhead installation.

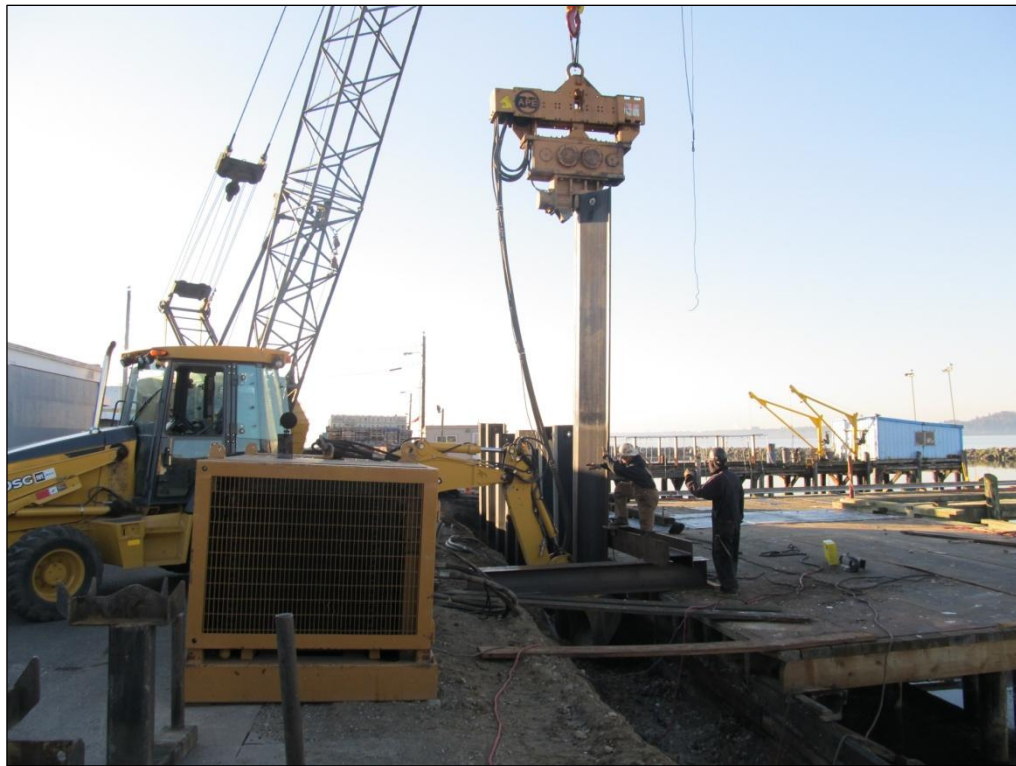
2. Installation of bulkhead sheetpiles.

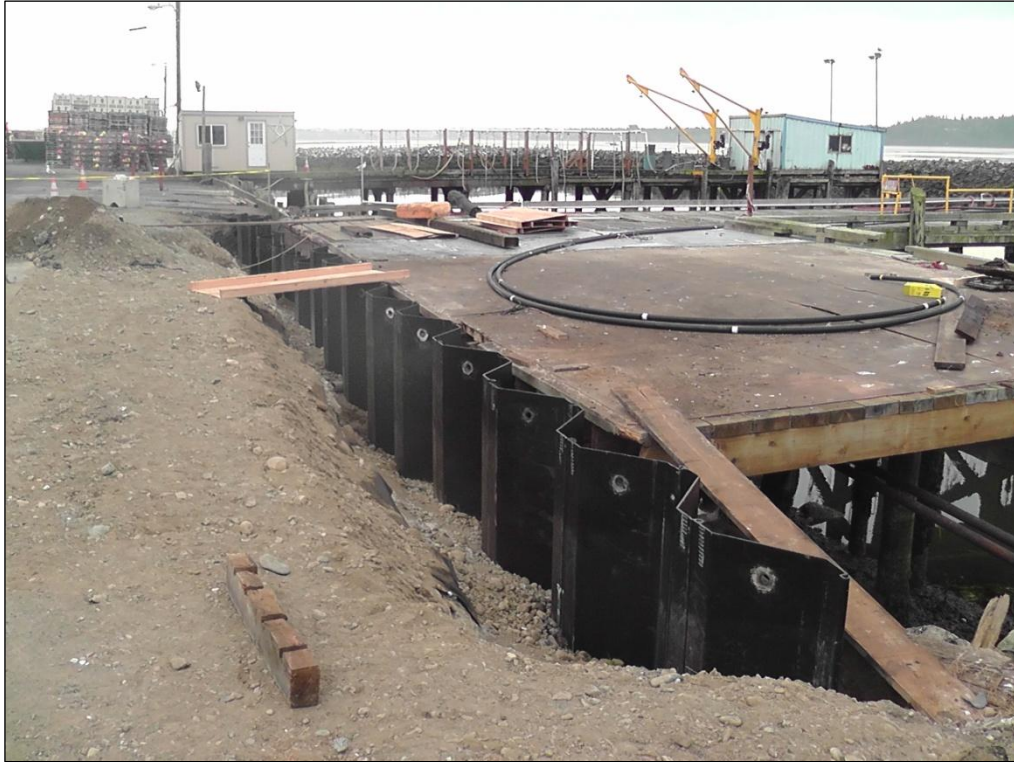
3. Installed bulkhead.

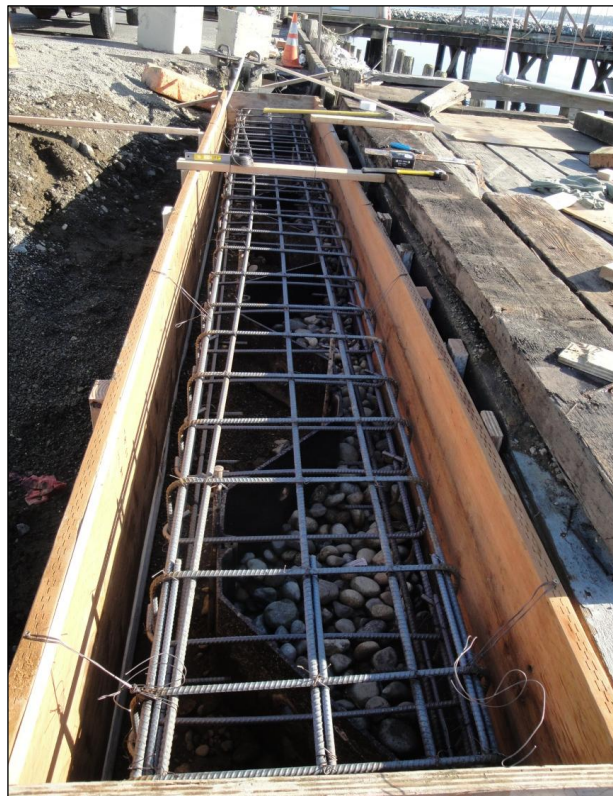
4. Pile cap form in front of fuel dock.

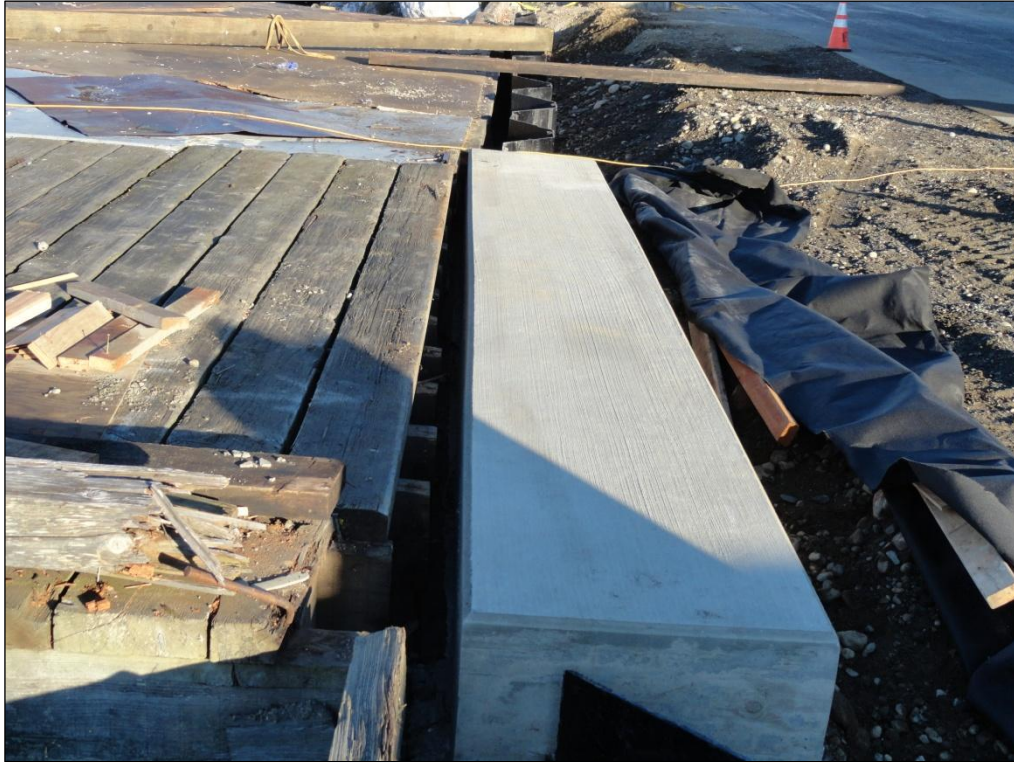
5. Completed pile cap.

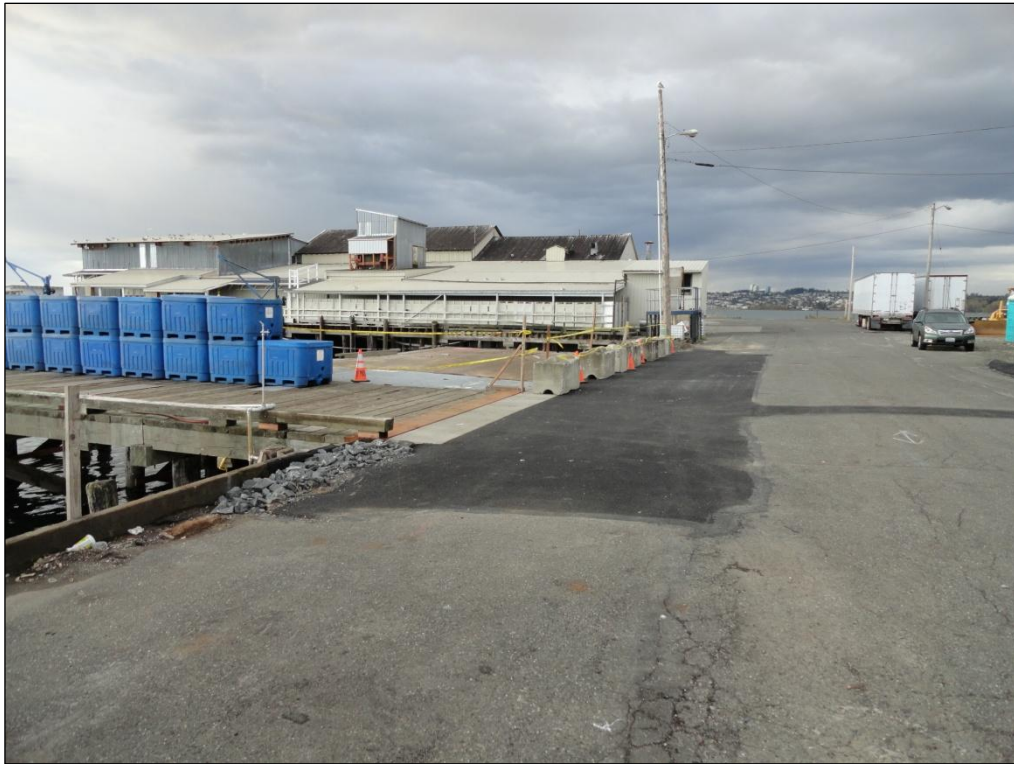
6. Completed construction.
