**UNDERGROUND STORAGE TANK SITE ASSESSMENT
BOISE CASCADE CORPORATION,
YAKIMA, WASHINGTON**

UNDERGROUND STORAGE TANK SITE ASSESSMENT
Boise Cascade Corporation, Yakima, Washington

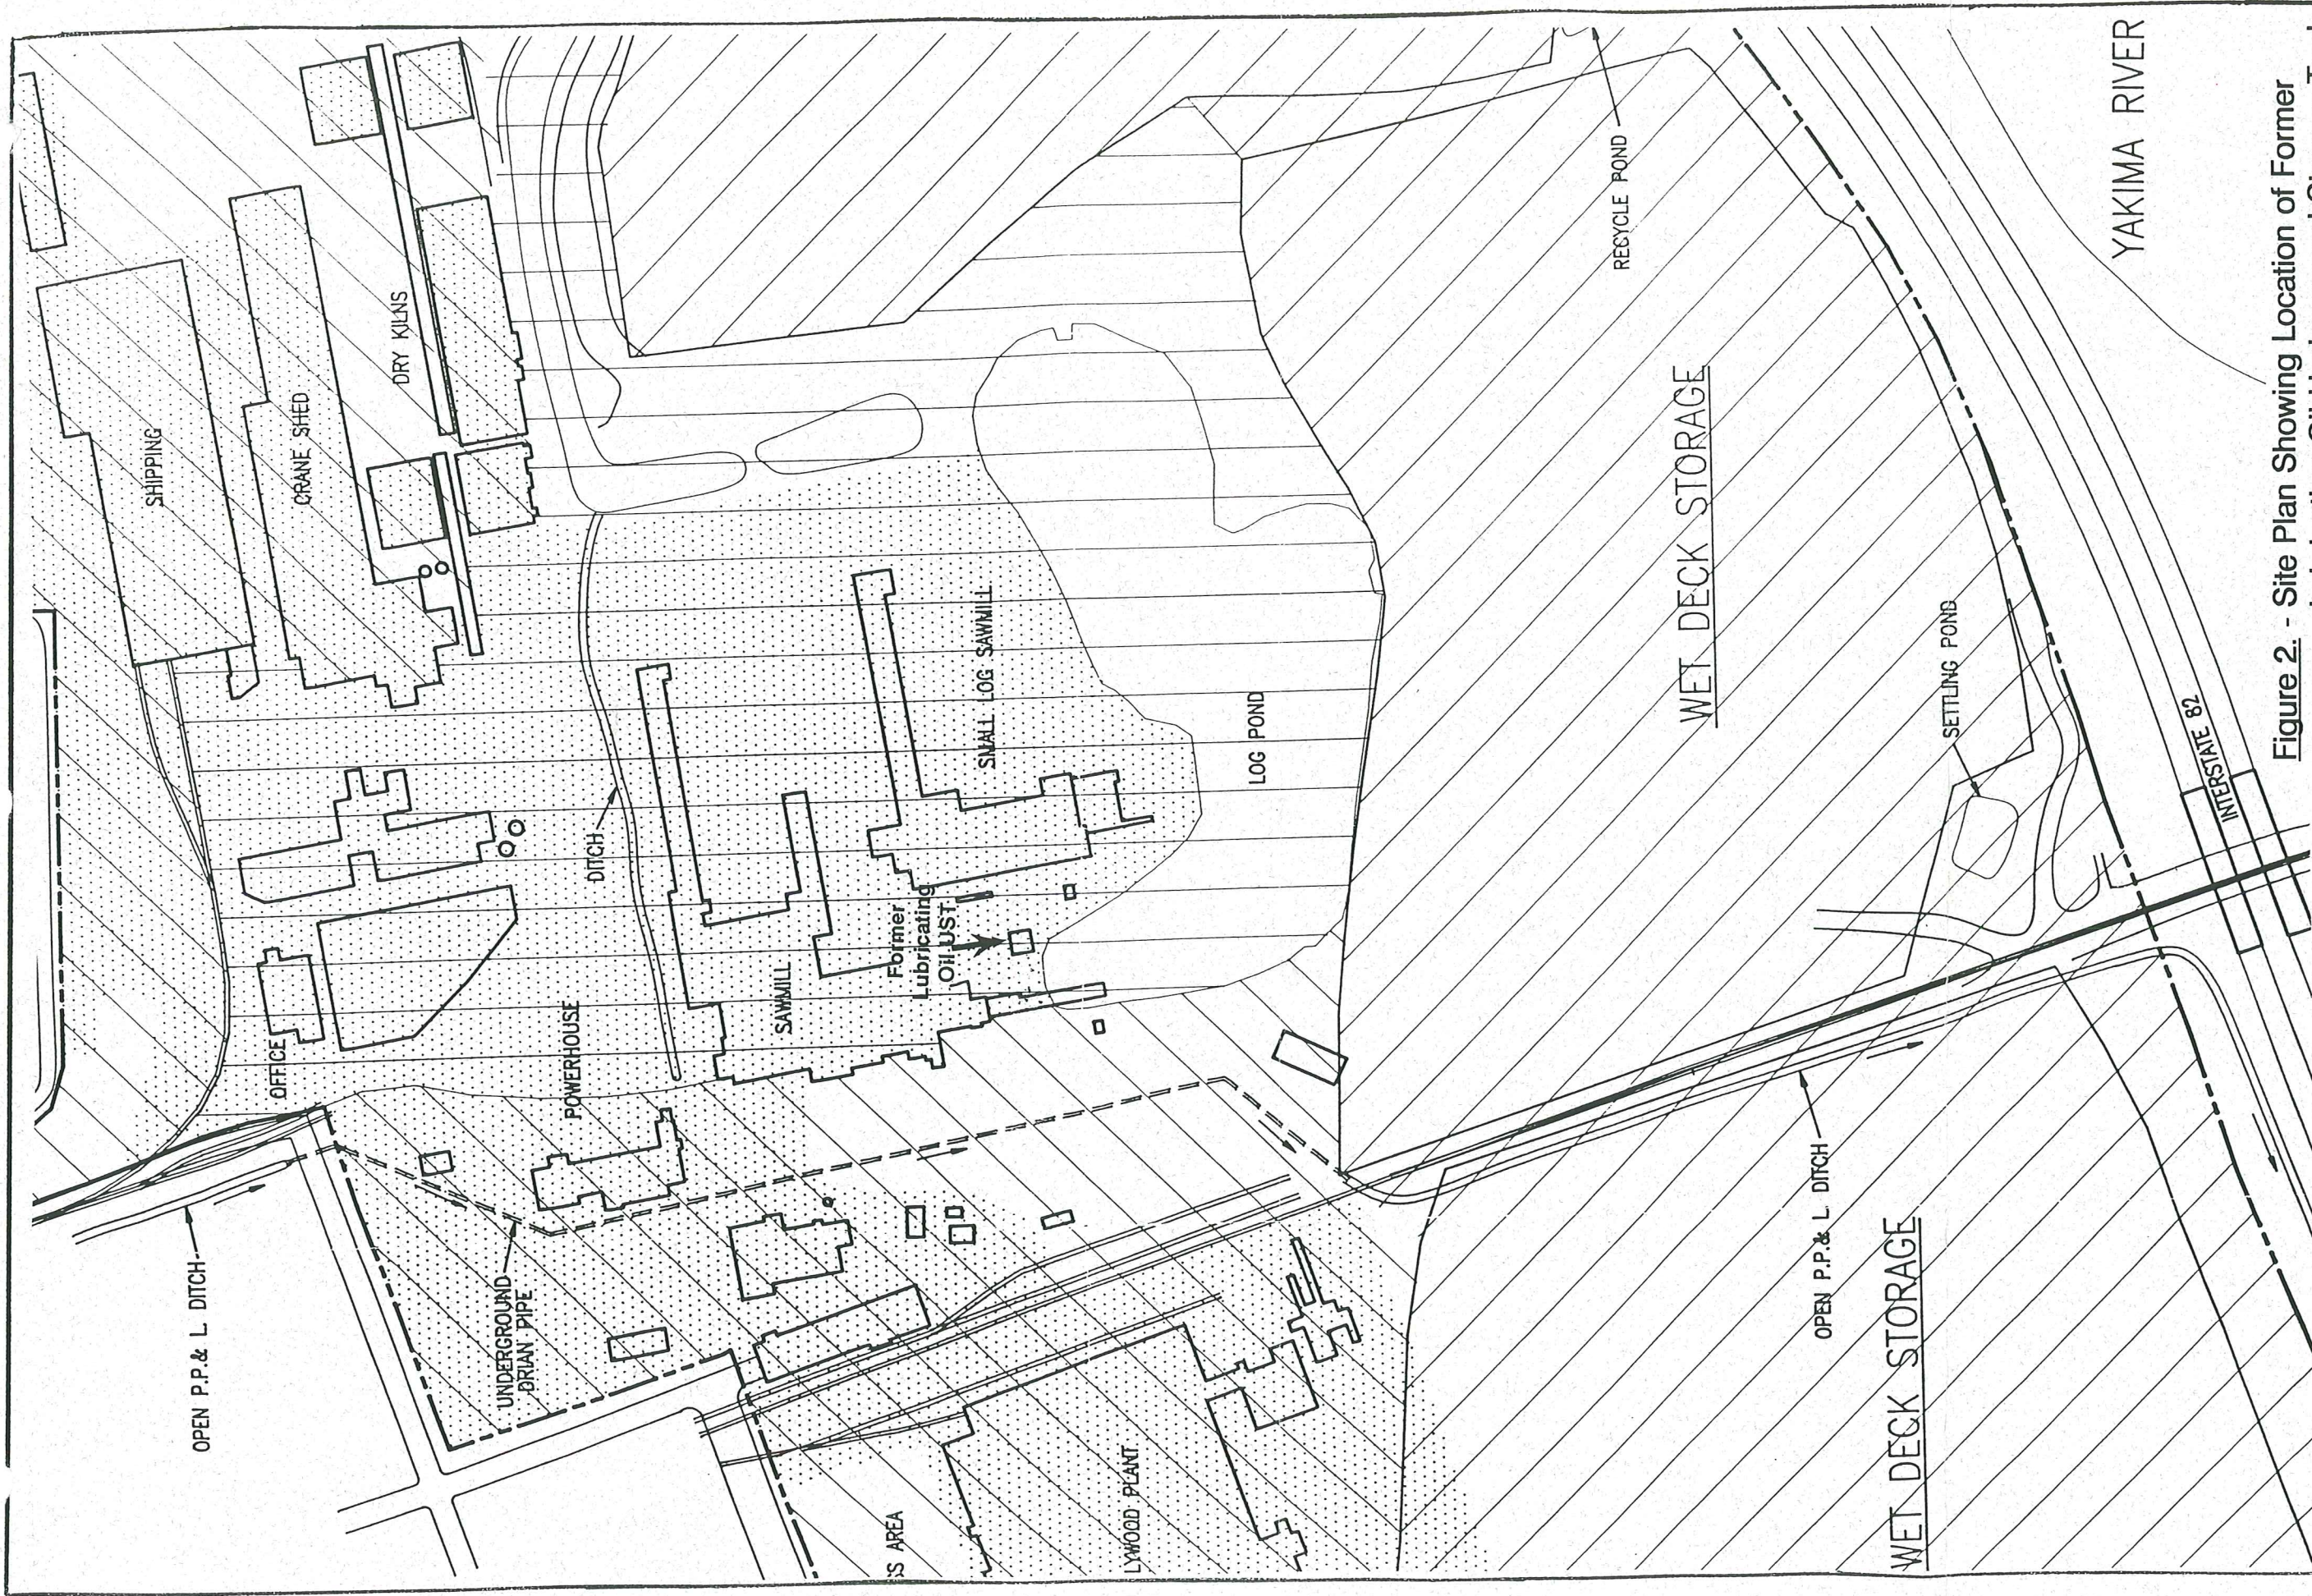
Figure 2. - Site Plan Showing Location of Former Lubricating Oil Underground Storage Tank

Figure 3 documents the specific location of the former lubricating oil underground storage tank. The tank was located adjacent to a small building that houses a heat exchanger for the small log mill. Pavement had to be cut away to remove the tank. In the area of the heat exchanger building and the small log mill, the Site is mostly paved.

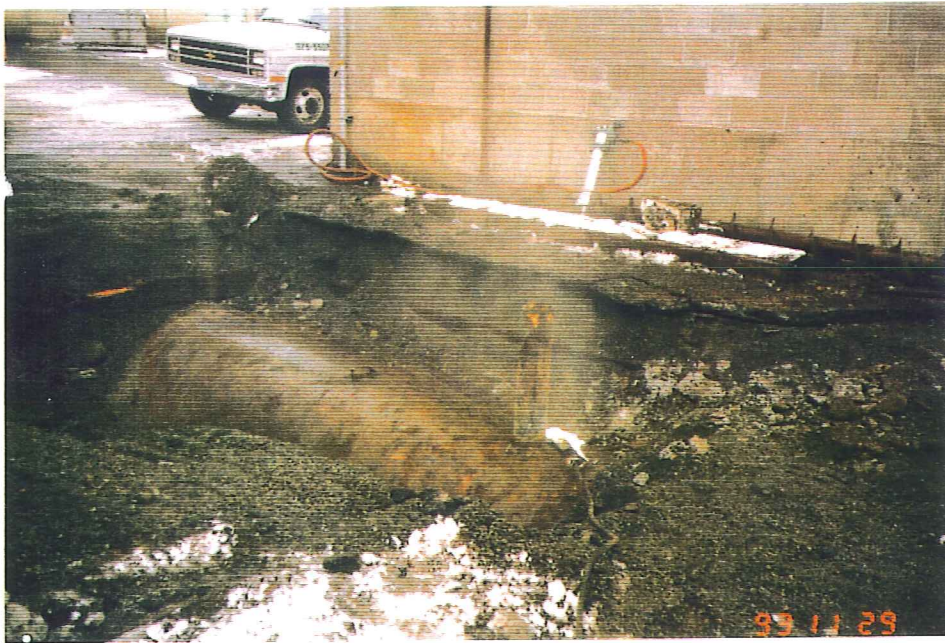
One (1) 2000 gallon steel underground storage tank was decommissioned at the Site (Figures 1, 2 and 3; and Photo 1) on November 29, 1993. Photographs in Appendix D document tank decommissioning activities.

Photo 1. Site underground storage tank. Small building housing heat exchanger in background.

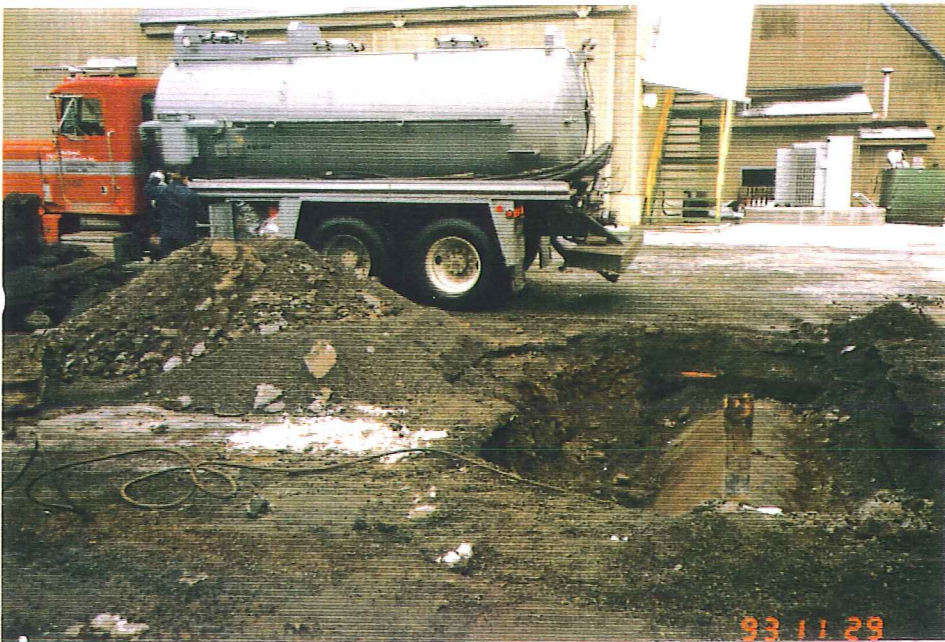
Photo 2 shows the tank being inerted. This was completed by Sound Testing, Inc., Seattle, Washington. Photo 3 shows residual sludge (about 4 to 6 inches) and tank materials being pumped from the tank for disposal. This was completed by Northwest EnviroService, Seattle, Washington. Photo 4 shows the tank being lifted from the tank pit. Excavation work was completed by Ken Leingang Excavating, Inc., Yakima, Washington. Photo 5 shows the empty tank pit. Groundwater was encountered in the bottom of the test pit at about 8 feet below ground surface. Groundwater did not display a sheen indicating possible contamination and free product was not observed on its surface. Photo 6 shows the removed tank.

Photo 2. The tank was inerted by Sound Testing, Inc., Seattle, Washington. Line in foreground connects to purging equipment.

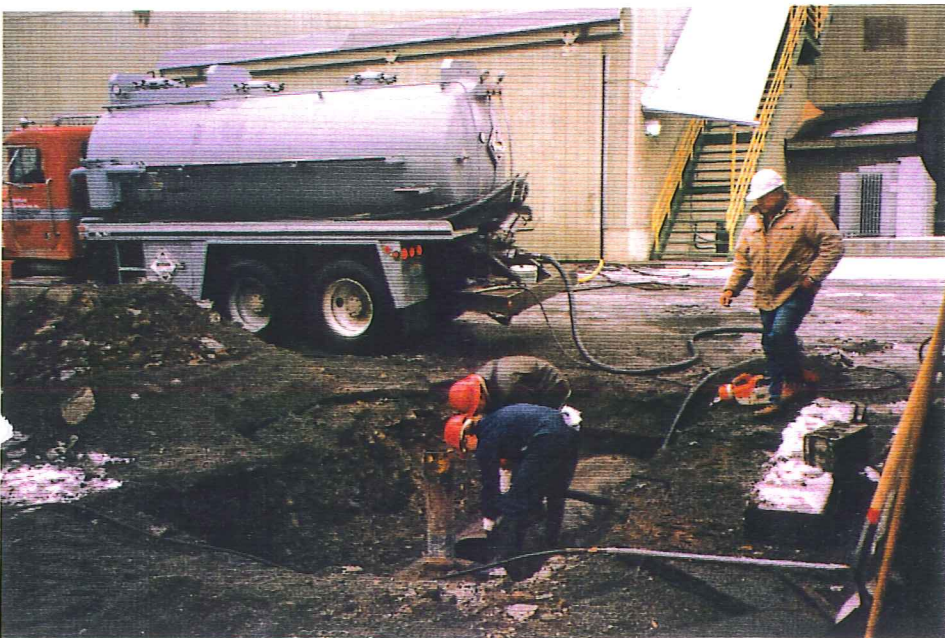
Photo 3. The tank was cleaned by Northwest EnviroService, Seattle, Washington.

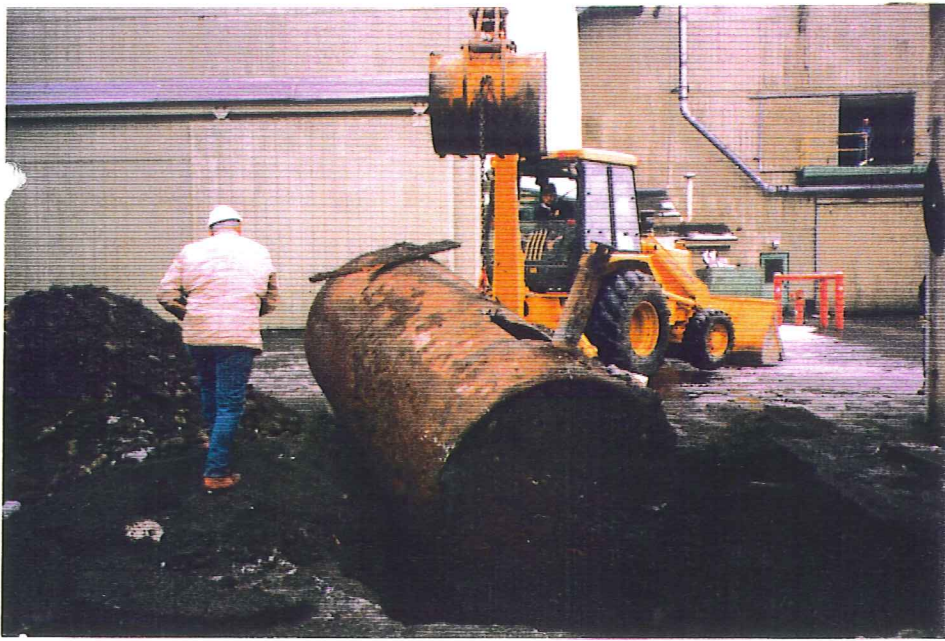
Photo 4. Tank being lifted from pit.

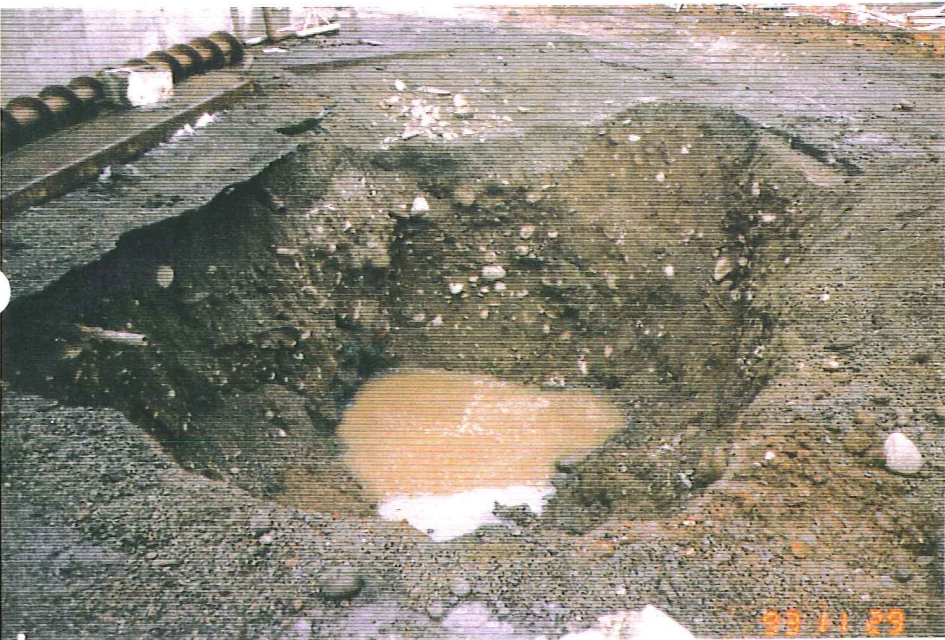
Les Tipton of CES collected soil samples at the Site. Tank pit soils did not appear contaminated. Groundwater was present in the tank pit. However, as for soils, it did not appear contaminated. Free product was not observed on its surface.

Photo 5. Empty tank pit.

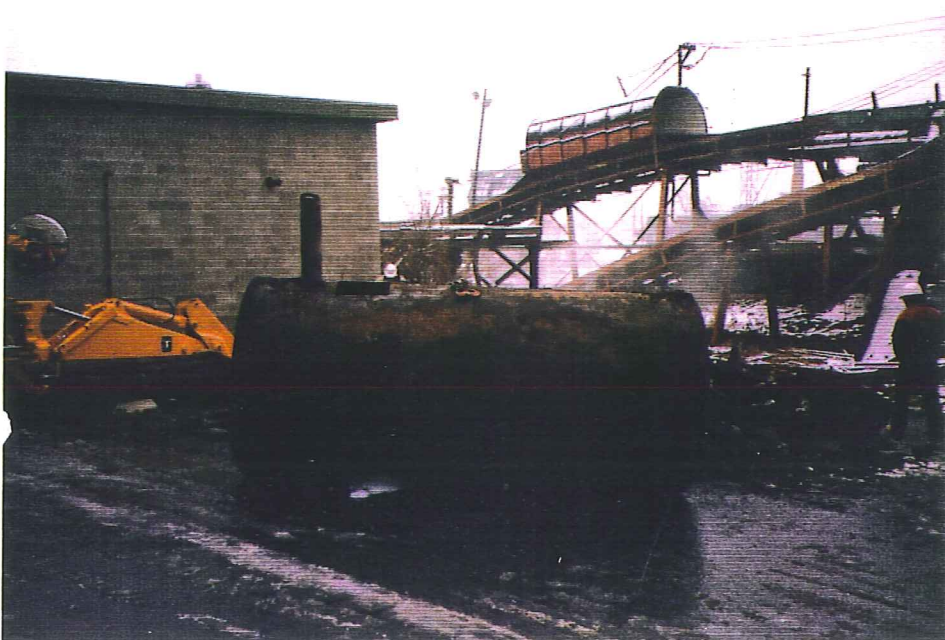
Inspection of the excavated tank did not reveal obvious holes. The tank was rusty in spots, but appeared sound throughout.

Photo 6. Removed tank.

The tank will be rendered unusable by BCC, and recycled at Yakima Steel Fabricators, Yakima, Washington.
