RADIOLOGICAL REMEDIAL INVESTIGATION REPORT
Former Naval Station Puget Sound
Seattle, Washington

Contract No. N62470-08-D-1007
Task Order FZN4
Shaw Project No. 137165

May 2011

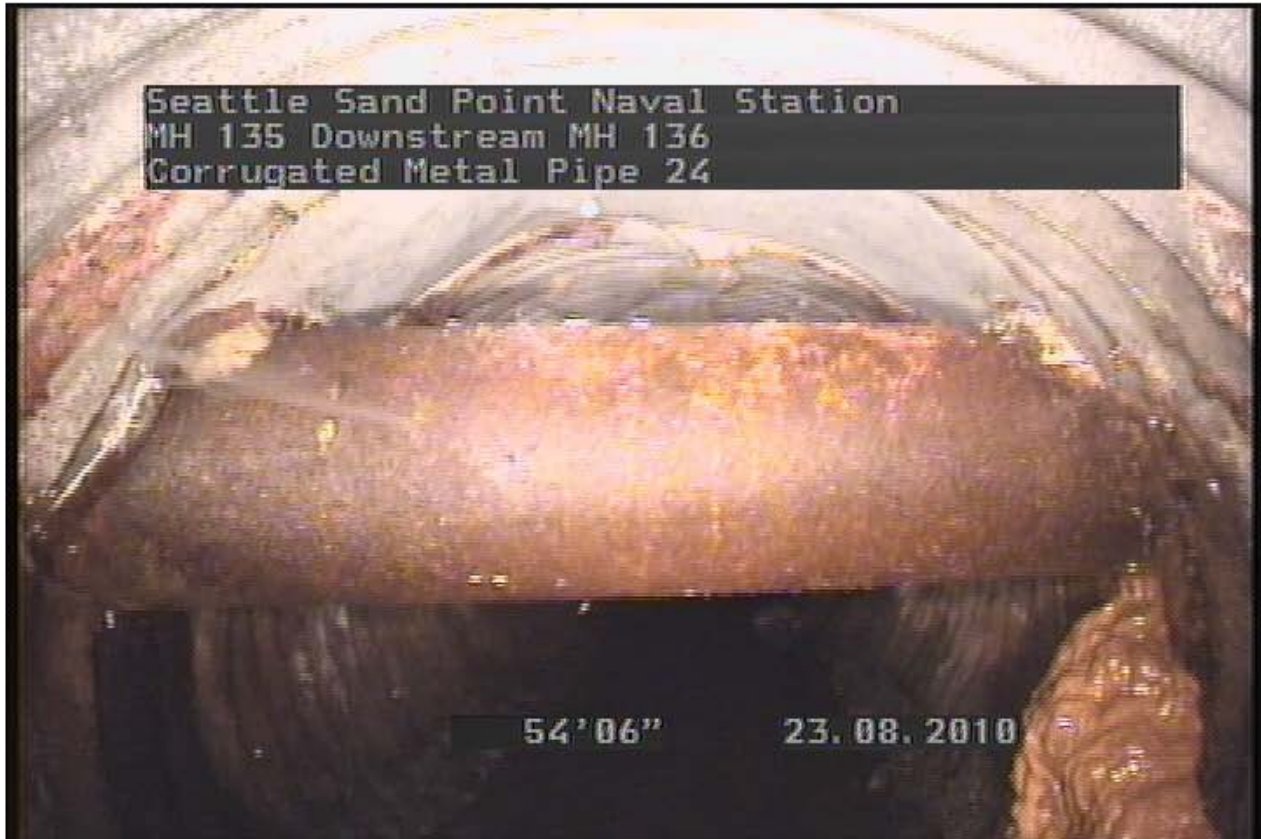
Figure 27
24 Inch Storm Sewer Line Obstruction near Catch Basin CB-1

No elevated readings were detected with the exception of catch basin CB-1 (RSS-093) (Appendix B). Elevated beta/gamma readings were identified in the 3 to 4 inch clay pipe that connected the catch basin to the 24-inch storm drain line to the east (Figure 7).

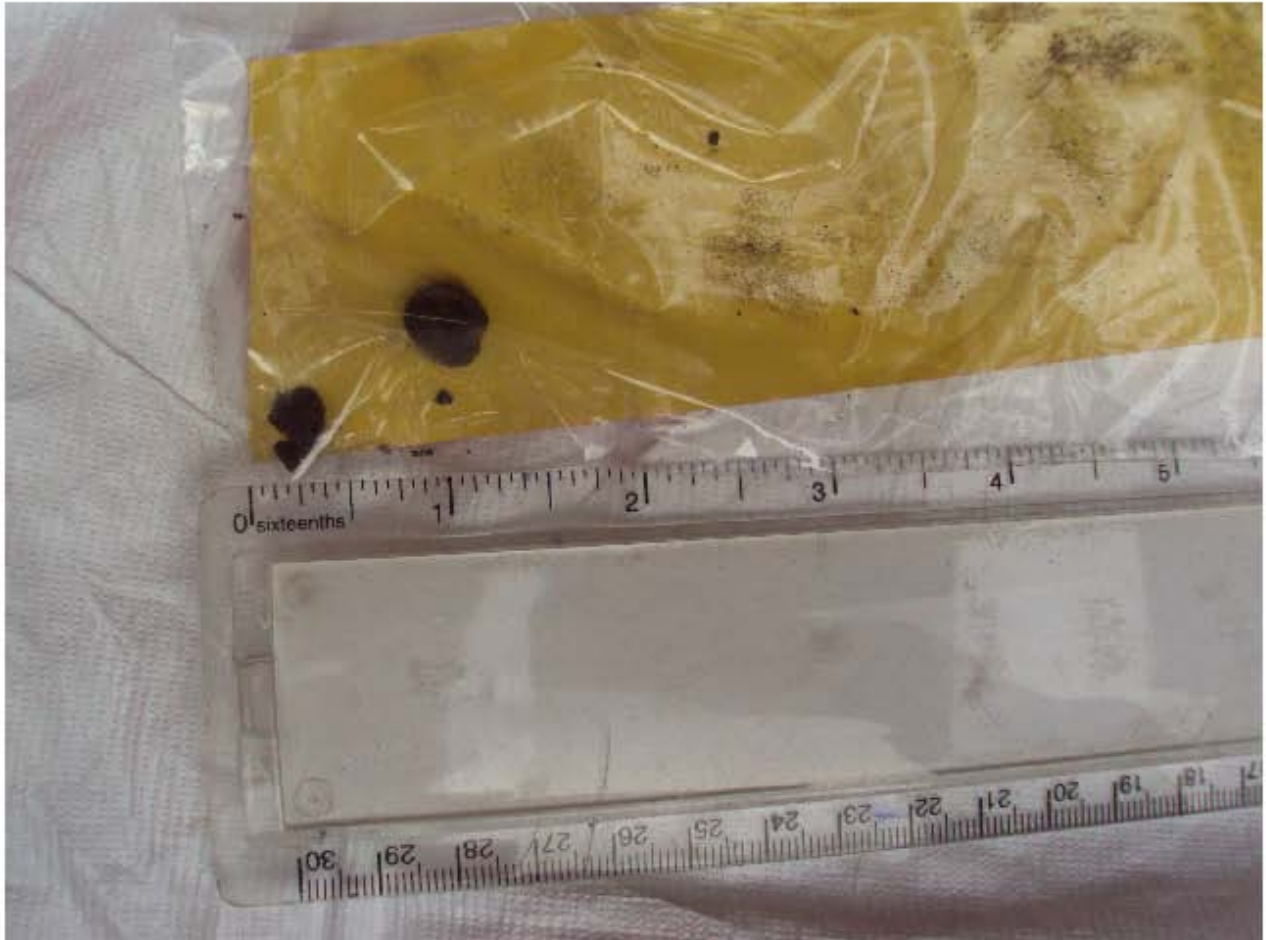
Figure 37
Object Recovered from Boring Number 60

could possibly be similar in nature to the object found at boring B-60 (Figure 37, “Object Recovered from Boring Number 60”) and with some deterioration could also contribute to some limited distributed contamination in the surrounding soils.

On the southwest corner of Building 2, a small isolated hotspot was located within inches of the building wall. Boring B-60 was drilled at this location. The top 6 inches of soil was the only interval with elevated activity. Upon closer investigation of the soil, a small article (possibly a piece of aircraft instrumentation [Figure 37]) was discovered and removed (RSS-509) (Appendix B). A dose rate at 30 centimeters from the object was 10 microRoentgen per hour above background. The object was labeled as radioactive material and stored in the locked Radioactive Material Storage Area located on the first floor of Building 27. The top 6 inch interval was analyzed and exceeded the project cleanup criteria at 64.6 pCi/g Ra-226. After sampling, a scan of the borehole indicated that the soil exhibited background gamma levels. A sample from the 1.5 to 2 foot interval had a Ra-226 concentration below the project cleanup criteria.
