PHASE II ENVIRONMENTAL SITE ASSESSMENT **Yakima Valley Transportation Company** 3rd Avenue South & West Pine Street Yakima, Washington HWA Project No. 2006-116-22

PHASE II ENVIRONMENTAL SITE ASSESSMENT

Yakima Valley Transportation Co. Trolley Repair Barn & Substation

Parcel No. 18132444465 Yakima, Washington

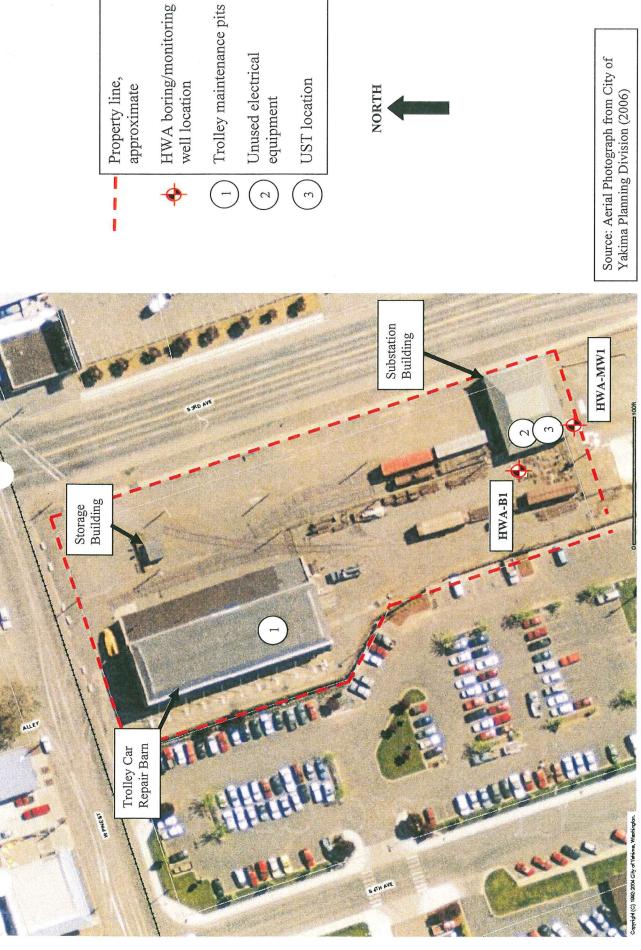
SITE MAP

Figure 1 presents a regional perspective of the subject property location. Figure 2 shows the site boundaries and general features and is based on an aerial photograph of the vicinity of the subject property taken in 2003. Figures 3 and 4 show sampling locations.

Source: Aerial Photograph from City of Yakima Planning Division (2006)

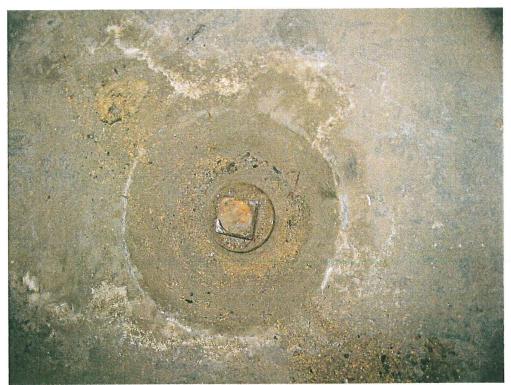
- An apparent UST fill port was observed in the floor of the Substation Building. The cap could not be removed during our site visit for inspection of tank contents.

UST fill port, Substation building.

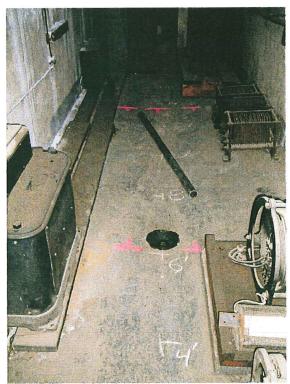
The GPR was used to delineate the ends and approximate depth of the UST beneath the floor slab of the building. The UST was found to be approximately four to six feet below the floor slab, and was approximately seven to eight feet in length. A copy of the geophysical investigation report is included as Appendix C.

The UST located beneath the Substation Building was found, using geophysical techniques, to be approximately four feet below the floor slab, and between seven and eight feet long. HWA attempted to access the UST through the fill port for measurements and to determine the nature of the contents, but was unable to remove the fill port cap after multiple attempts.

UST in Substation building with location/length marked based on GPR survey.

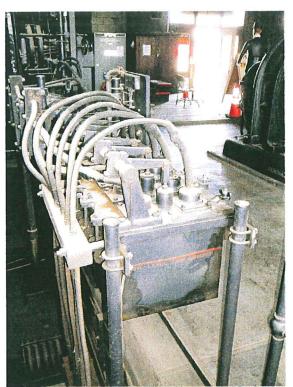
The two oil samples collected from unused electrical equipment did not contain PCBs above laboratory reporting limits.

'Switch 1' sample collected from unused electrical equipment in foreground.

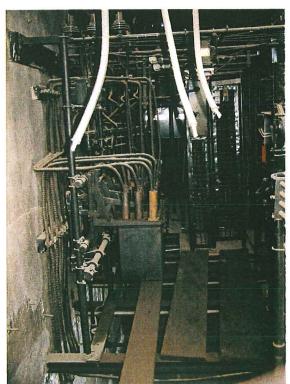
'Switch 2' sample collected from unused electrical equipment in foreground.

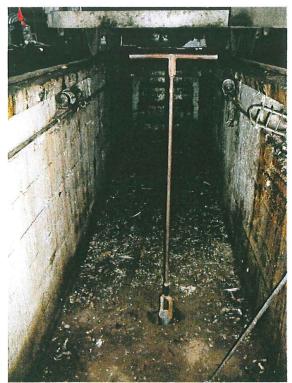
HWA completed three hand auger soil borings through two drain holes and one sump observed in the floors of maintenance pits located in the Trolley Barn (Figure 3). Two borings, 'Pit-1-N' and 'Pit-1-S' were completed in the west maintenance pit, and one boring 'Pit-2' was completed in the east maintenance pit. HWA sampled the three borings to 0.5 feet below grade. The boring depths were limited by dense site soils and limited access within the maintenance pits.

'Pit-1-S' sample location in west maintenance pit, Trolley Barn.

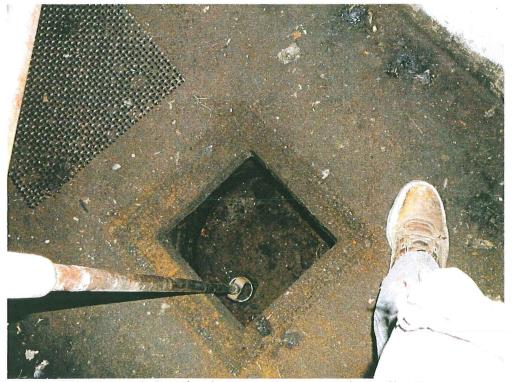
'Pit-2' sample location in east maintenance pit, Trolley Barn.

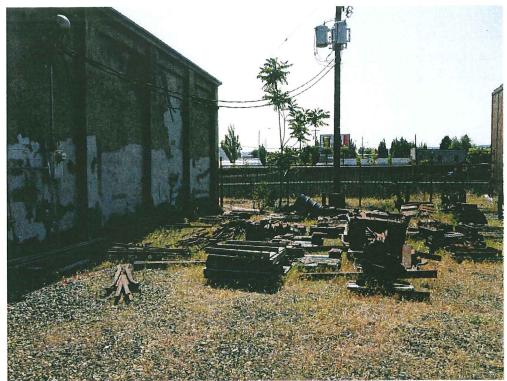
Rail yard and west side of Substation building. HWA-B1 location in foreground.

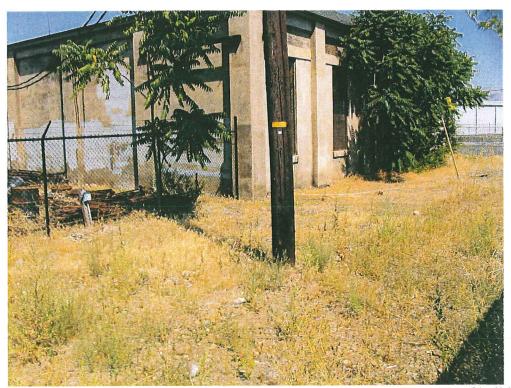
Southwest corner of Substation building. HWA-MW1 location near corner of building.
