***Abandoned Mine Lands  
Initial Investigation Report  
Advance Mine  
Northport, Washington***

***Prepared for  
Washington State  
Department of Ecology***

***December 28, 2006  
17274-00(AV)***

Prepared by  
**Hart Crowser, Inc.**

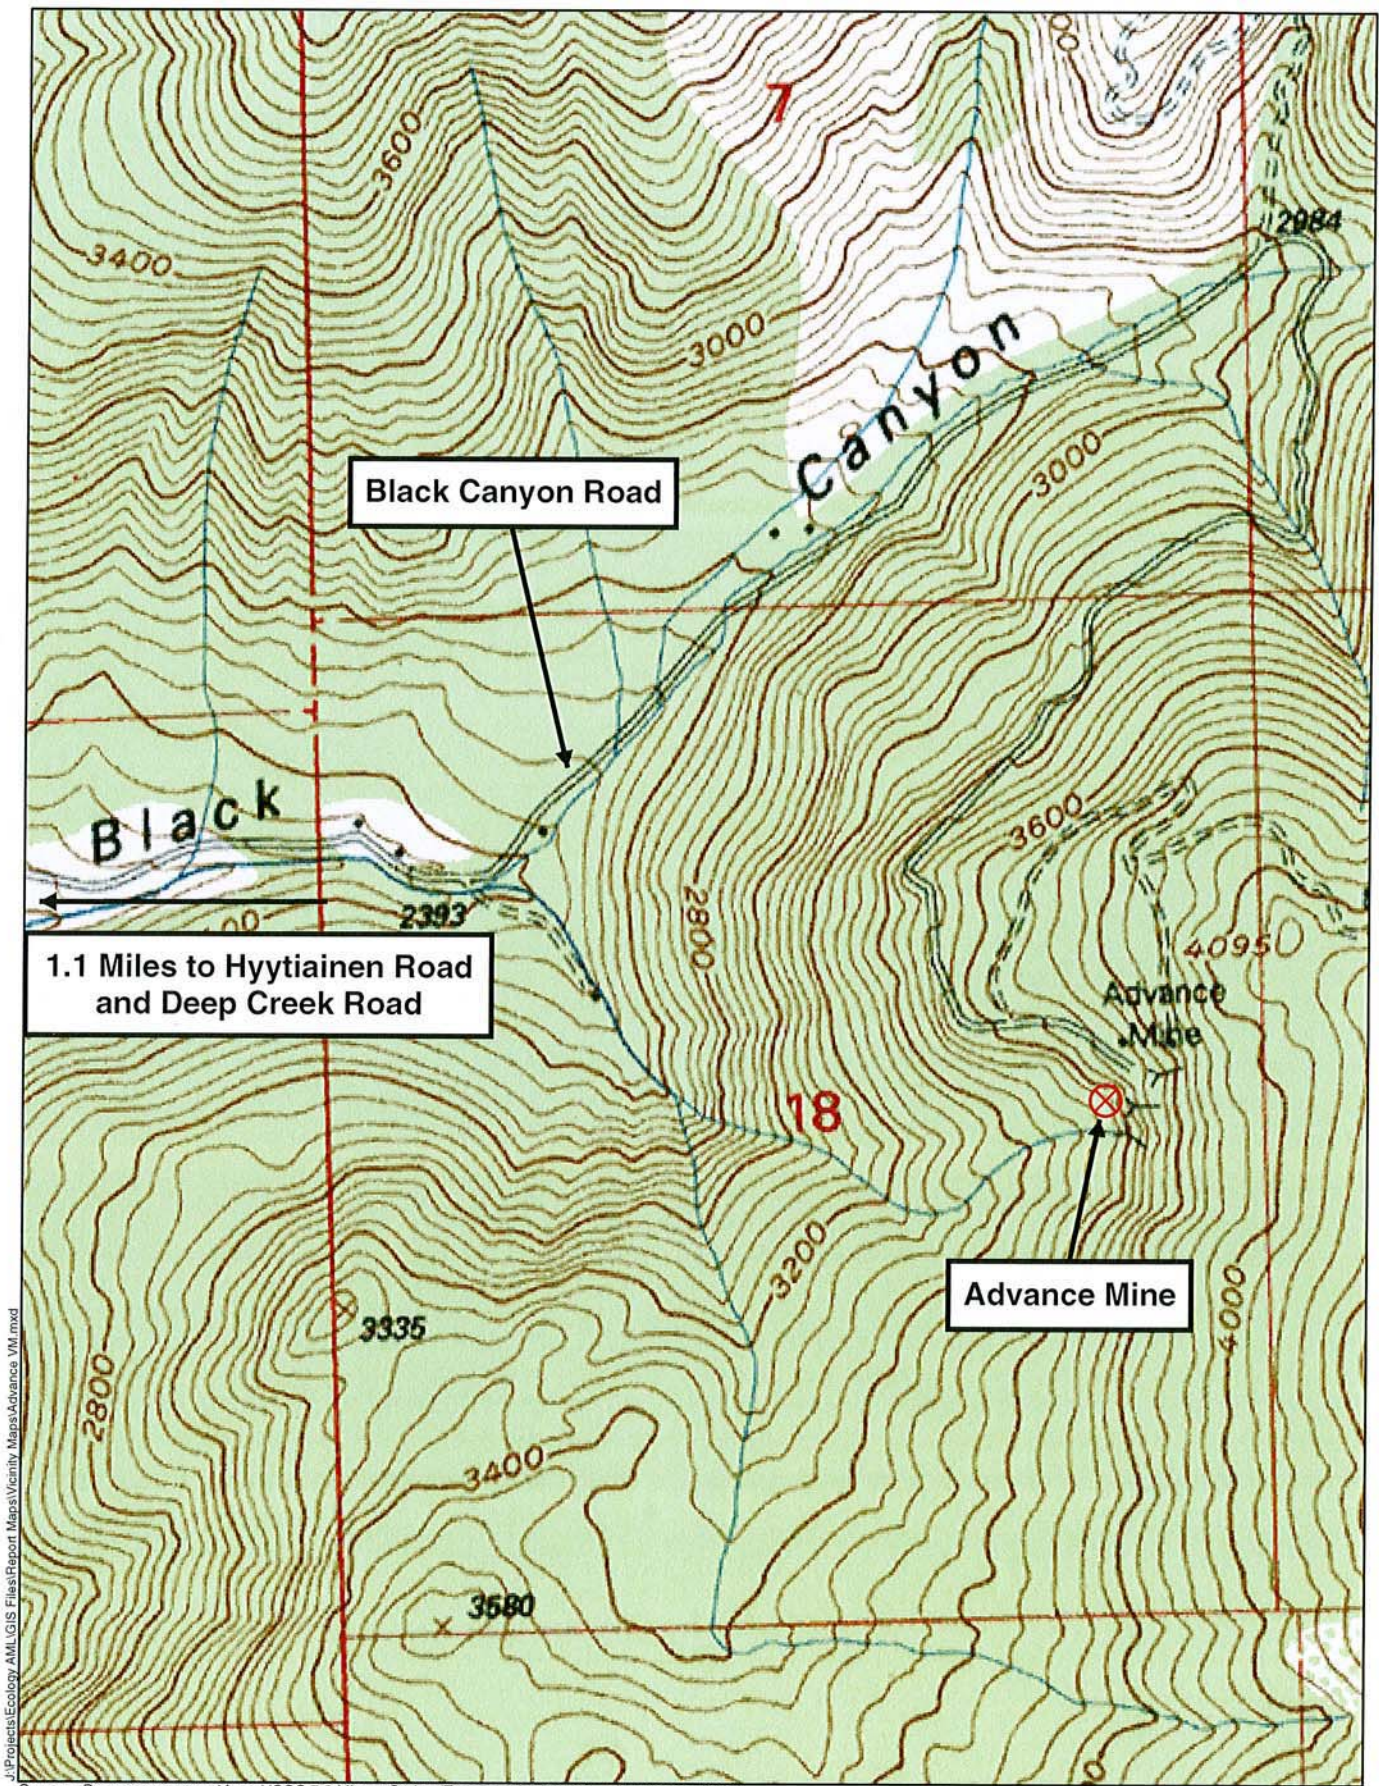
### Vicinity Map Advance Mine

No surface water, creeks, or streams were observed on the site or nearby although a small stream was indicated on USGS maps (Figure 2)

Mine Location Visited in Field

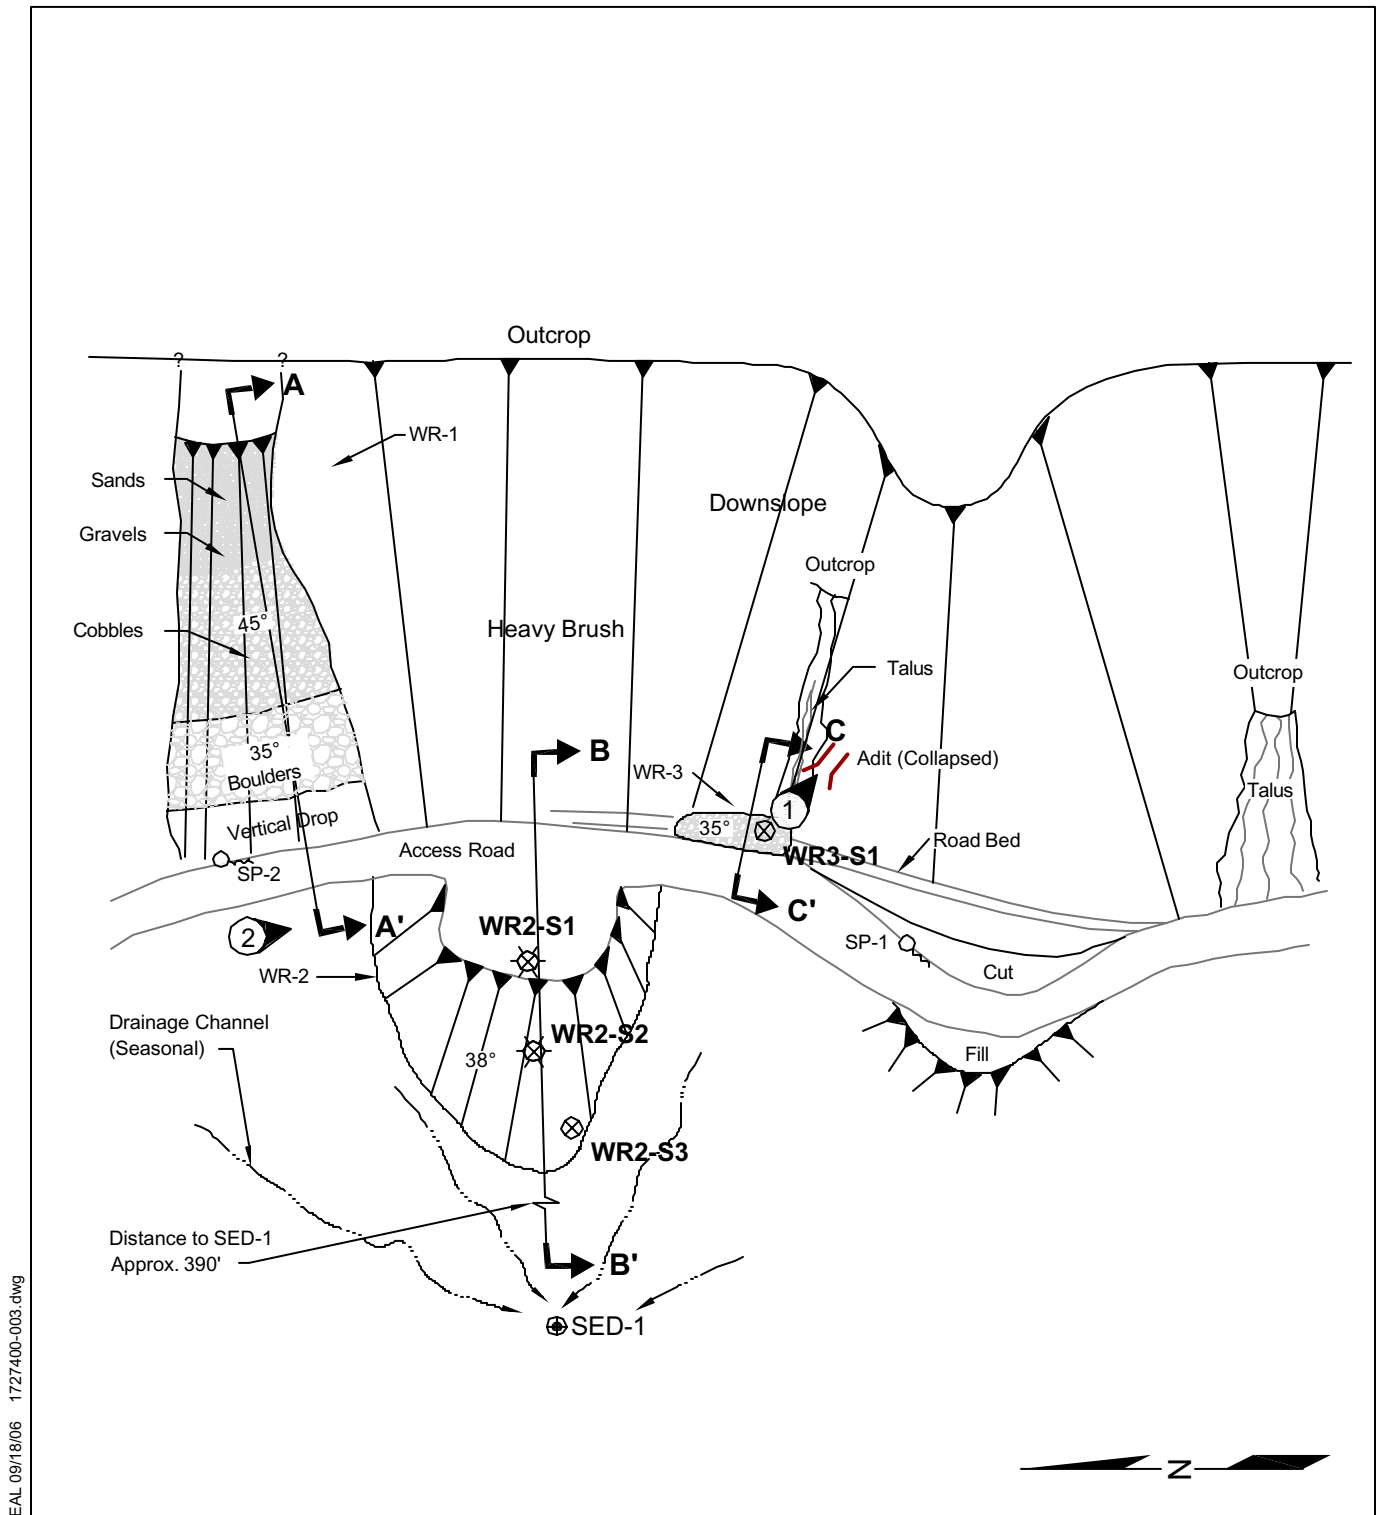
# **Site Plan** **Advance Mine**

Three waste piles were observed on site (Figure 3), which consisted of a wet, gray-black, gravelly Sand, with cobbles and boulders. Cross sections used to estimate waste rock volumes are indicated on Figure 4. WR-1 lies at the north end of the site, is upslope (east) of the access road, and is approximately 1,200 cubic yards in volume. Coarser materials, such as cobbles and boulders, are evident at the bottom of WR-1. Rail ties, cans, and other metal debris were observed at the bottom of WR-1. Finer materials suitable for sampling, such as sands and gravels, remain at the top of the slope. One or more adits may exist above WR-1, but were inaccessible due to unstable slopes on the waste rock pile and impediments around the pile such as steep slopes, heavy brush, and a near-vertical rock face.

An initial site investigation was conducted on June 14, 2006. Photographs were taken, and GPS coordinates and waste rock and sediment samples were collected. Mine features, photograph locations and directions, GPS waypoints, sample locations, and the direction of surface water flows are shown on Figure 3.

Two seeps were observed at the time of sampling, but flow was not great enough to sample. The seeps appear to drain to the south, away from the waste rock piles (Figure 3). Other drainage channels that were dry at the time of sampling were also observed. The channels converge below the toe of WR-2, and the sediment sample was collected at this location.

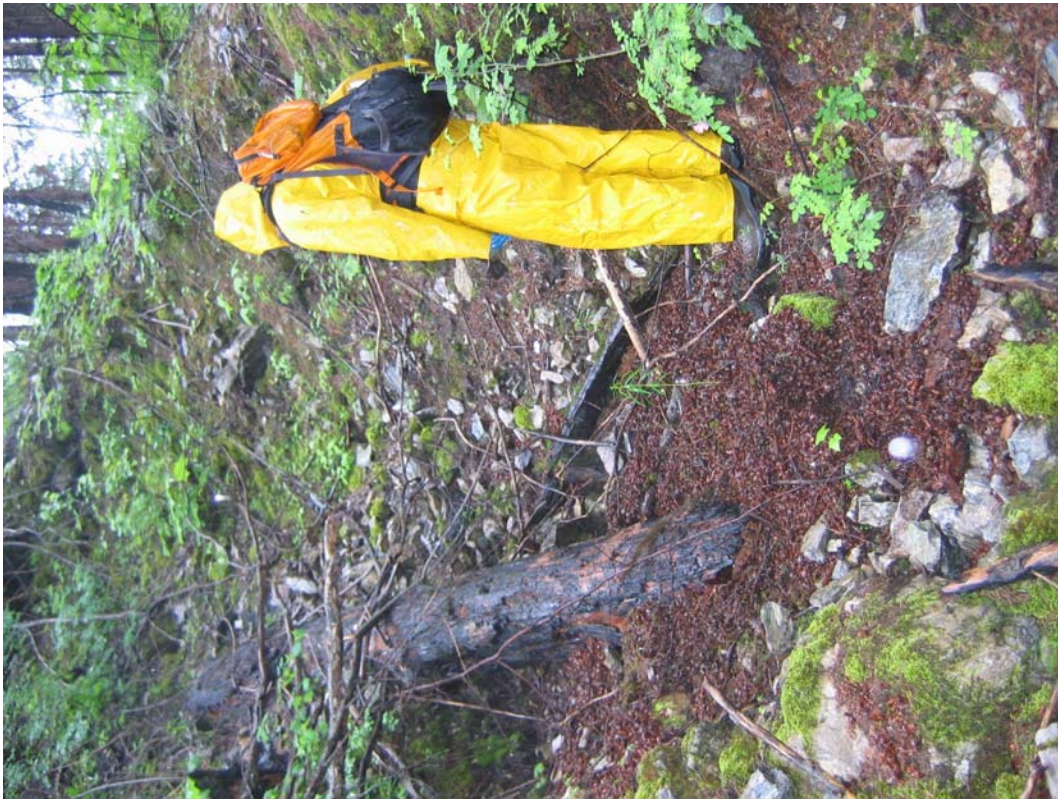
To the south of WR-1 and also upslope (east) of the access road is a smaller waste pile, WR-3, that is estimated to be about 200 cubic yards in volume. A collapsed adit (Photograph 1) is located upslope of WR-3 and is behind a thick stand of maples that appear to be healthier than the surrounding vegetation. The health of the maples may be the result of a more constant water supply from mine drainage exiting the adit. No flow was observed coming from the adit at the time of our visit. An overgrown road grade leading south from WR-3 connects the adit with the main access road. Talus slopes composed of native material similar in appearance to the waste rock are present above WR-3 and farther south from the site.

Photograph 1 - View of Adit 1. ←Up

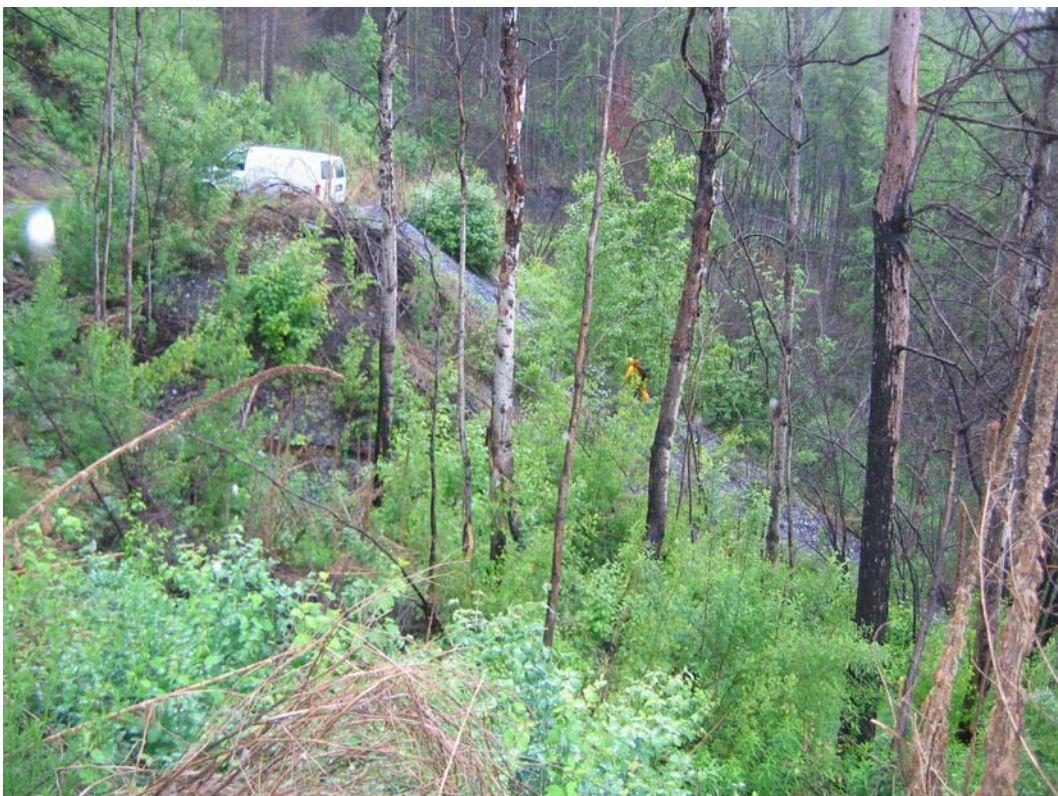
WR-2 lies downslope (west) of the access road, below WR-1 and is approximately 1,300 cubic yards in volume (Photograph 2). The natural grade drops off steeply below the road for approximately 100 feet and then becomes a gentler grade. The drainage channels surrounding WR-2 converge about 1,000 feet below the road, which is below the toe of WR-2. No flowing water was observed in the drainages at the time of our visit. There were boulders and large rocks in the drainage, both mine waste and natural talus.

Photograph 2 - View of Waste Rock Pile 2 (WR-2).
