**Abandoned Mine Lands Initial Investigation Report
Alpine-Gold Dollar-Insurgent-Mammoth Claims
Republic, Washington**

**Prepared for
Washington State
Department of Ecology
Rick Roeder, Project Manager**

**December 28, 2006
17274-00(AP, GD, IN, MM)**

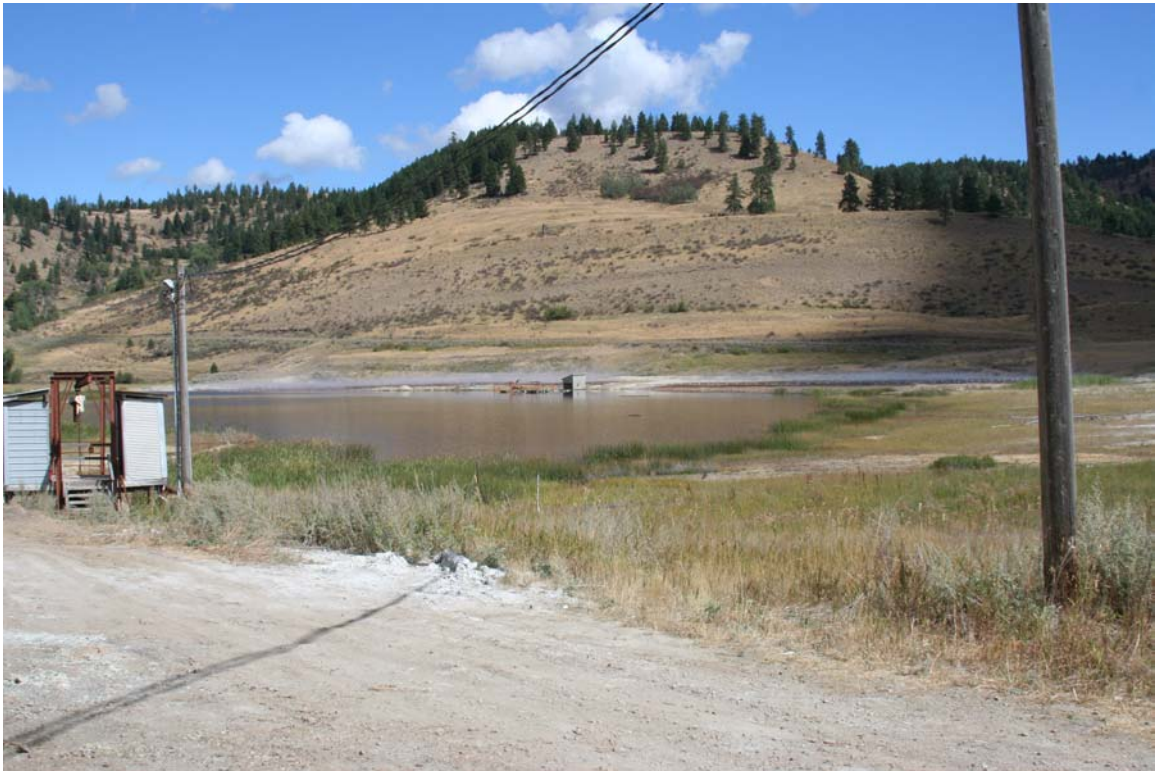
Photograph 1 - View of tailings pond that partially lies on the Alpine Claim.

The Alpine Claim includes the southern portion of the tailings pond (probably associated with the former Knob Hill Mine, see Photograph 1), the foundations of a building that may be a wash house (Photograph 2), and several small buildings on the slope below the crest of the hill. The slope faces southeast. There was no evidence of mining (adits, pits, trenches) on the claim. The land is undeveloped, covered with grasses, herbs, and a few pine trees. The drainages follow the slope contours; all the drainages were dry. The buildings on the southern portion of the claim are part of the Knob Hill Mine operation; they were not included in the scope of our work.

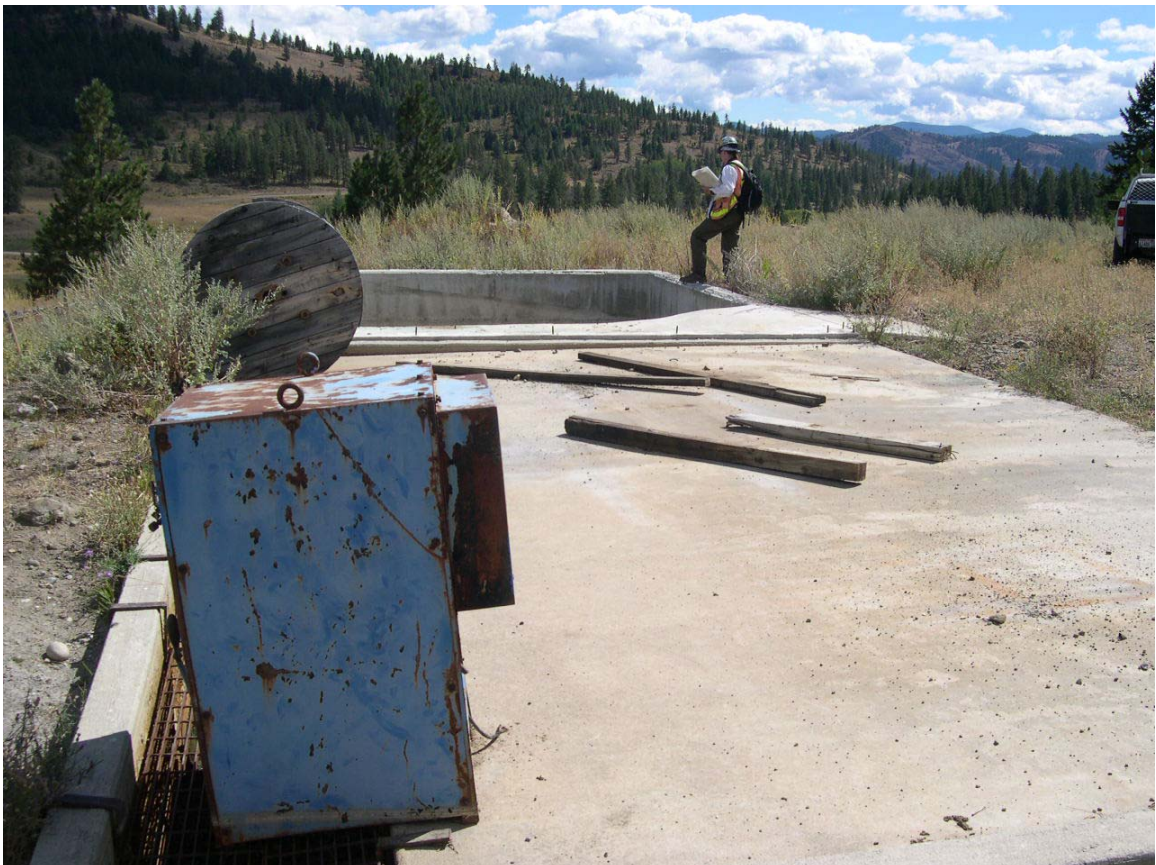
Photograph 2 - View of possible wash house on the Alpine Claim.

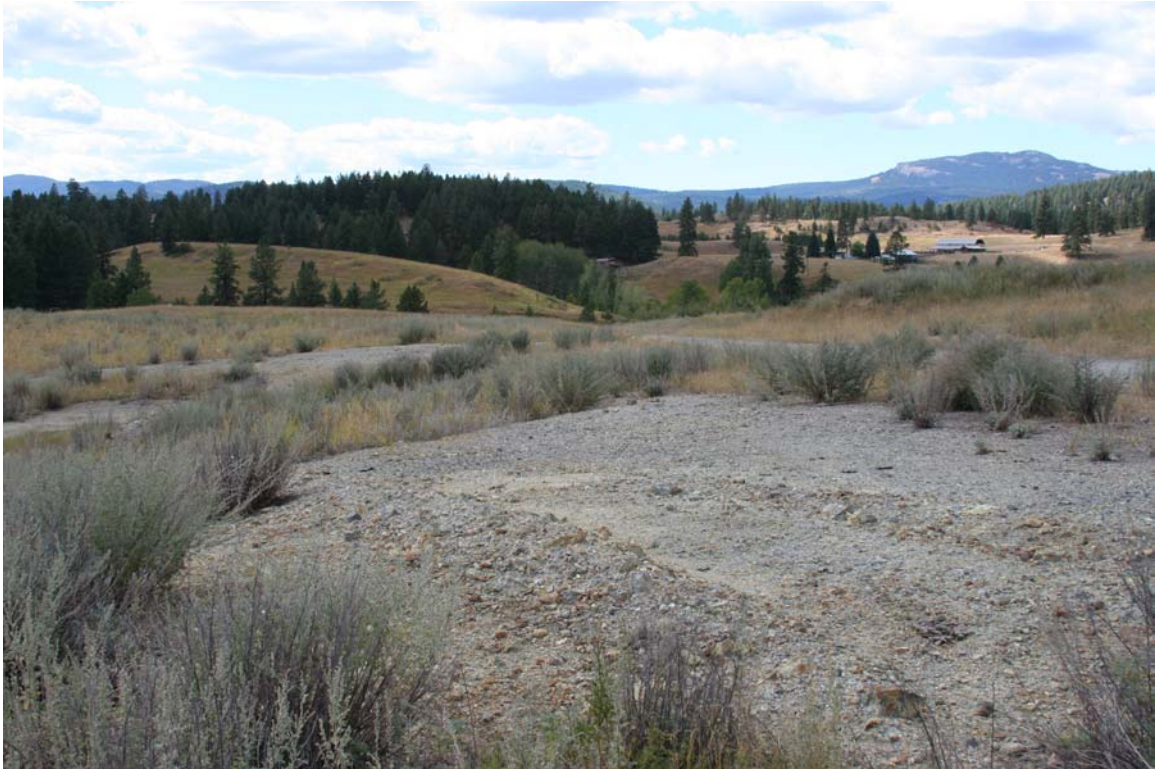
The northern portion of the Gold Dollar Claim, south of the access road, contains several shallow areas of waste rock from an unknown source (Photograph 3). A sample, GD-WR1-S1, was collected of the waste rock material. There was no evidence of mining (adits, pits, trenches) on the claim. The land is undeveloped, covered with grasses, herbs, and a few shrubs. There is evidence of grading associated with several access roads (Figure 2). The upper part of the claim is a gently sloping terrace, bisected by a shallow, wide ravine in the center, and another terrace below. There is a well on the south end of the claim, adjacent to the intersection of the road to the lower Knob Hill Mine and a road that goes north to the Trade Dollar Mine (Figure 2). The well is in a small wooden manhole under a galvanized metal lid (Photograph 4). No other structures were observed on the claim.

One sample of waste rock was obtained on the north end of the Gold Dollar Claim. The source is unknown. The waste rock appears to be a thin (less than 2 feet) mantling of the ground surface in an area of approximately 30 by 30 feet. Total waste rock volume is estimated at 67 cubic yards.

Photograph 3- View of waste rock on the Gold Dollar Claim.

The Gold Dollar Claim contains one waste rock pile with an approximate volume of 67 cubic yards. The waste rock sample contains metals at concentrations above MTCA Method A, MTCA Method B, or ecological screening criteria. The main contaminants of concern are antimony, arsenic, mercury, selenium, silver, and thallium. Arsenic concentrations have the potential to fail TCLP criteria for dangerous waste. Additional sampling and TCLP analysis are recommended to determine whether the waste rock would be classified as dangerous waste.

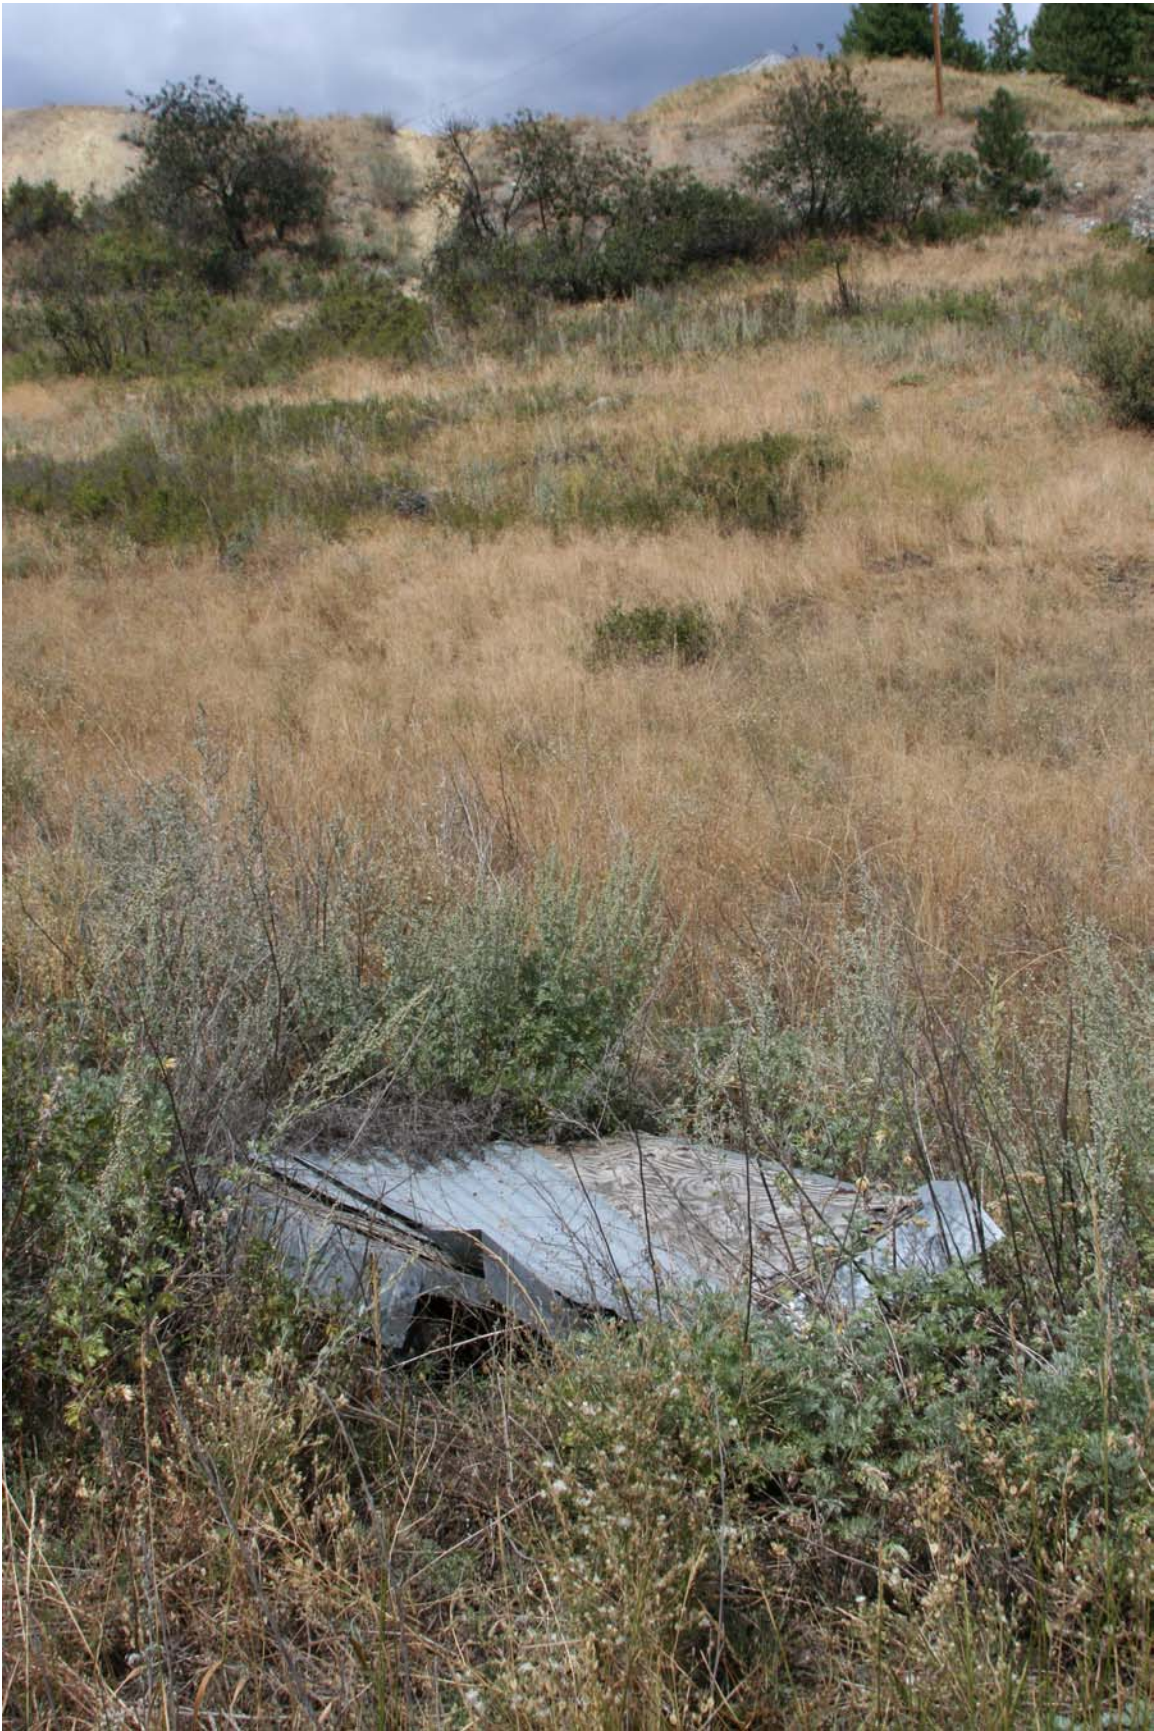
Photograph 4- View of covered well on the Gold Dollar Claim.

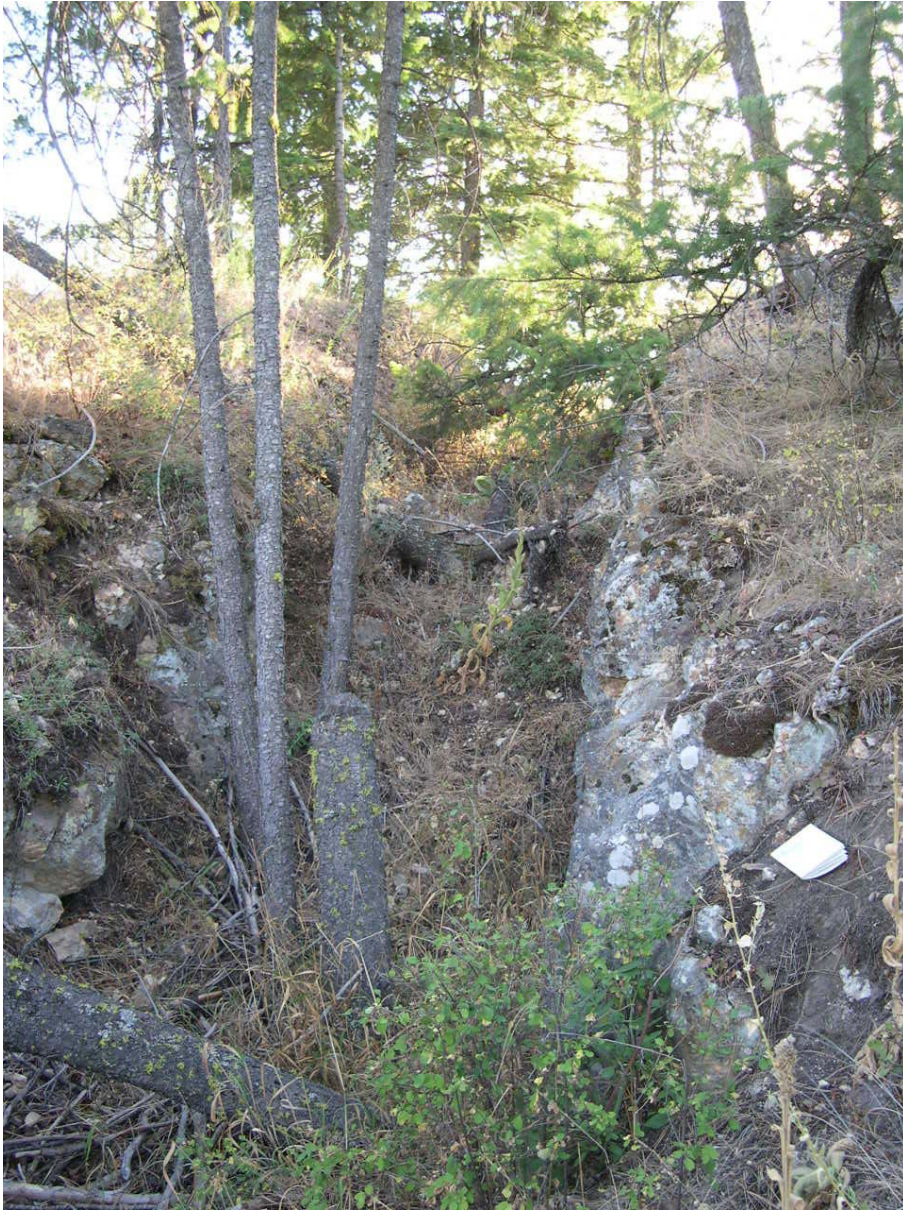
What appears to be a trench prospect on the claim was observed at the top of the ridge to the south of the road (Photograph 5). The trench prospect measured approximately 80 feet long by 4 feet wide by 4 feet deep. A thin cover of gravel, cobbles, and soil approximately 14 cubic yards in volume was observed adjacent to the trench prospect. This material appeared to be a mix of soil and country rock (i.e., non-mineralized, native rock), not waste rock.

Photograph 5- View of trench prospect on the Mammoth Claim.
