***Abandoned Mine Lands  
Initial Investigation Report  
Butte and Boston Mine  
Republic, Washington***

***Prepared for  
Washington State  
Department of Ecology***

***December 28, 2006  
17274-00(B&B)***

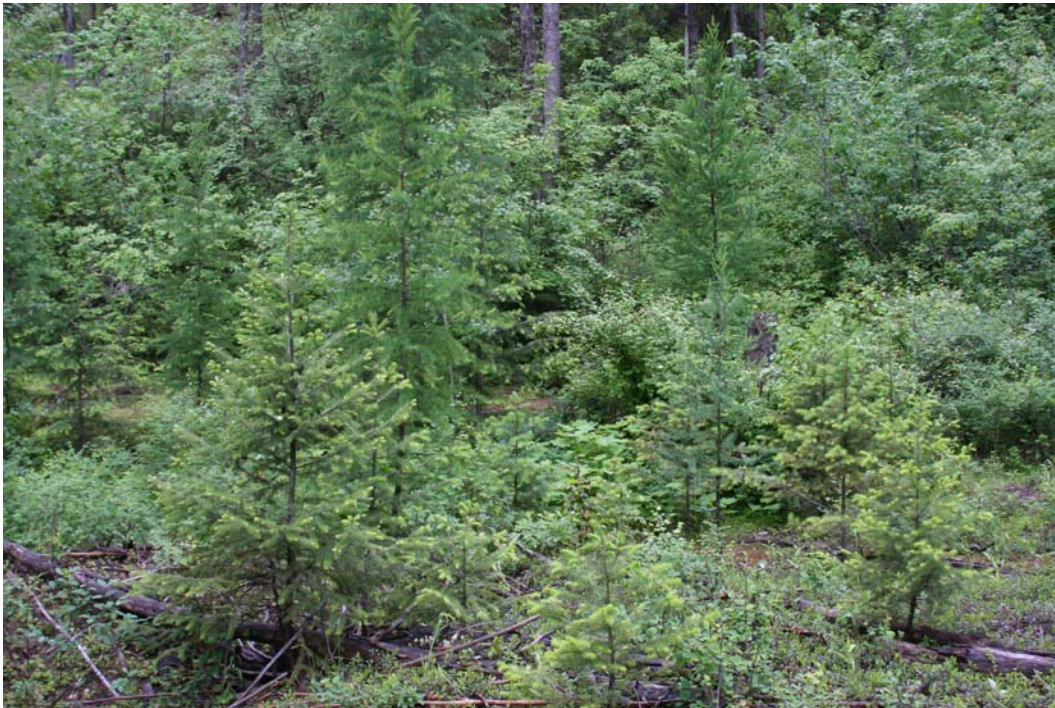
An L-shaped waste rock pile, WR-1, of approximately 950 cubic yards lies east of an adit at the foot of a steep hill (Figure 3, Photographs 1 and 2). WR-1 varies in thickness from 5 to 8 feet and contains moist, orange-red, silty, gravelly Sand. Short strands of barbed wire are scattered throughout the pile.

Photograph 1 - View of Butte and Boston Mine waste rock (WR-1).

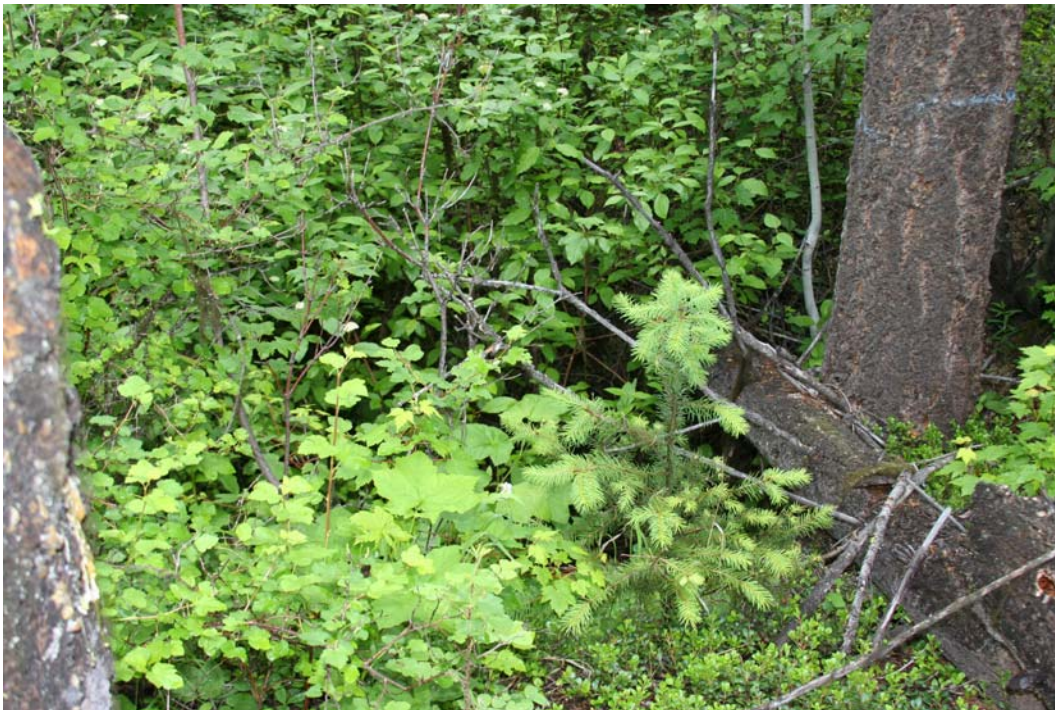
Several adits are present in the vicinity, but only one is believed to be a part of the Butte and Boston claim. This adit is on the west side of the waste rock pile and is partially collapsed. We did not observe any drainage seeping from the adit.

Photograph 2 - View of Butte and Boston Mine adit.

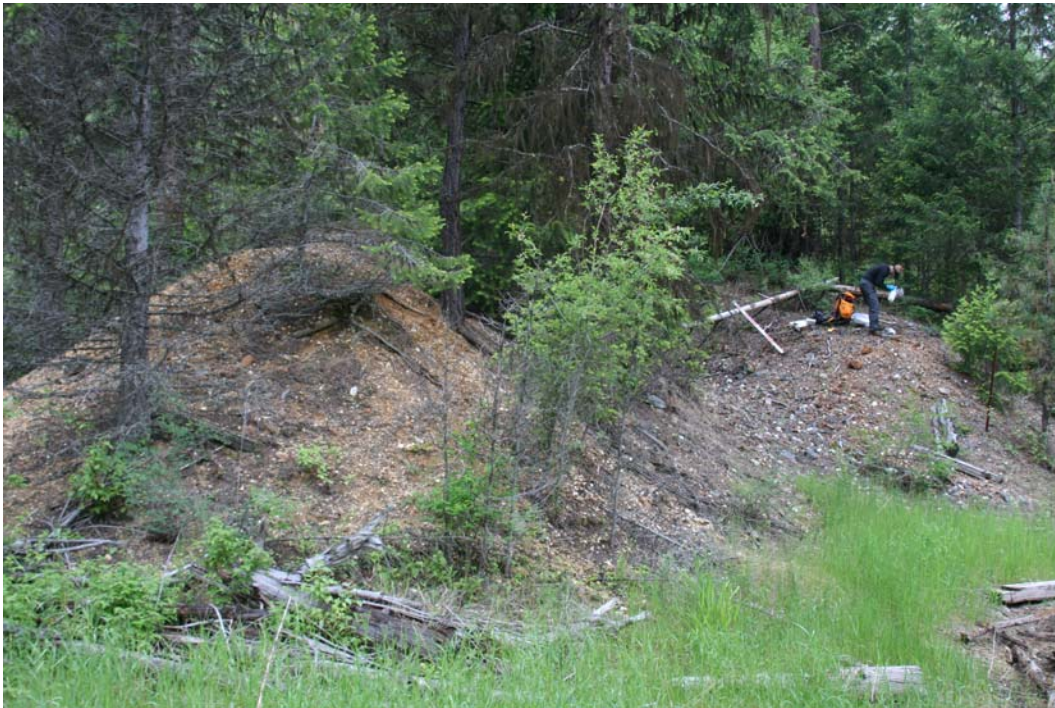
Photograph 3 - View of Chico Mine Waste Rock (WR-1).

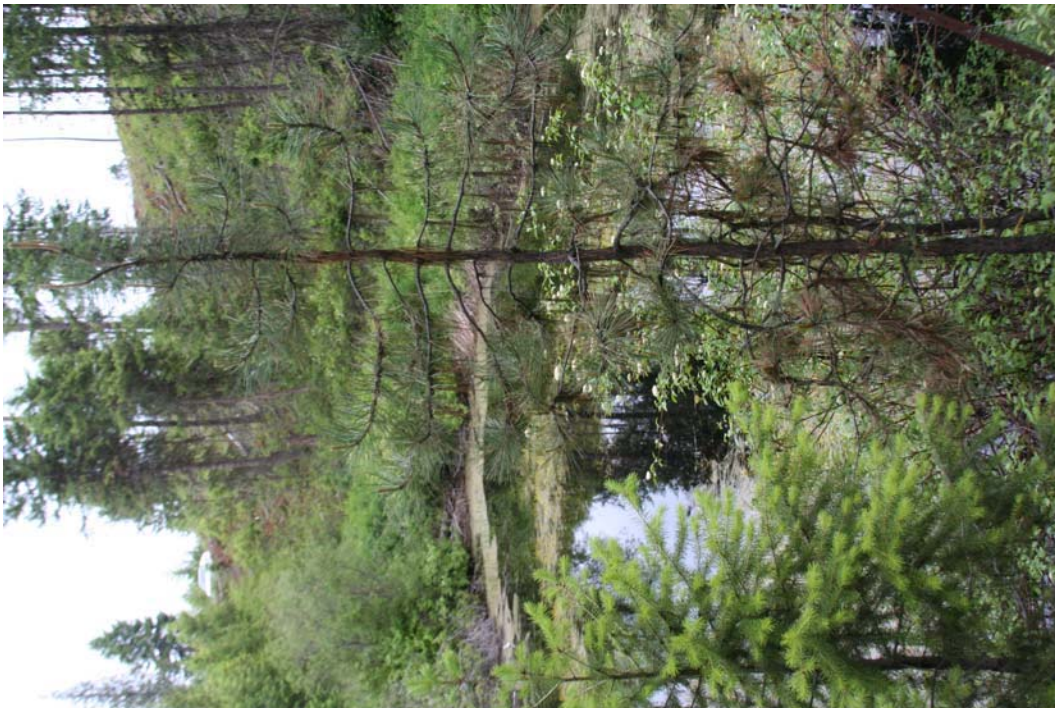
Photograph 4 - View of stagnant pond near Chico Mine site. ←Up
