JOHN'S AUTO WRECKING
411 93RD AVENUE SOUTHEAST
OLYMPIA, WASHINGTON
FACILITY/SITE NO. 57665495
VCP PROJECT NO. SW1127
REMEDIAL INVESTIGATION

JULY 2013

JOHN'S AUTO WRECKING
411 93rd Avenue Southeast, Olympia, Washington
Facility/Site No. 57665495; VCP Project No. SW1127
Remedial Investigation
July 2013

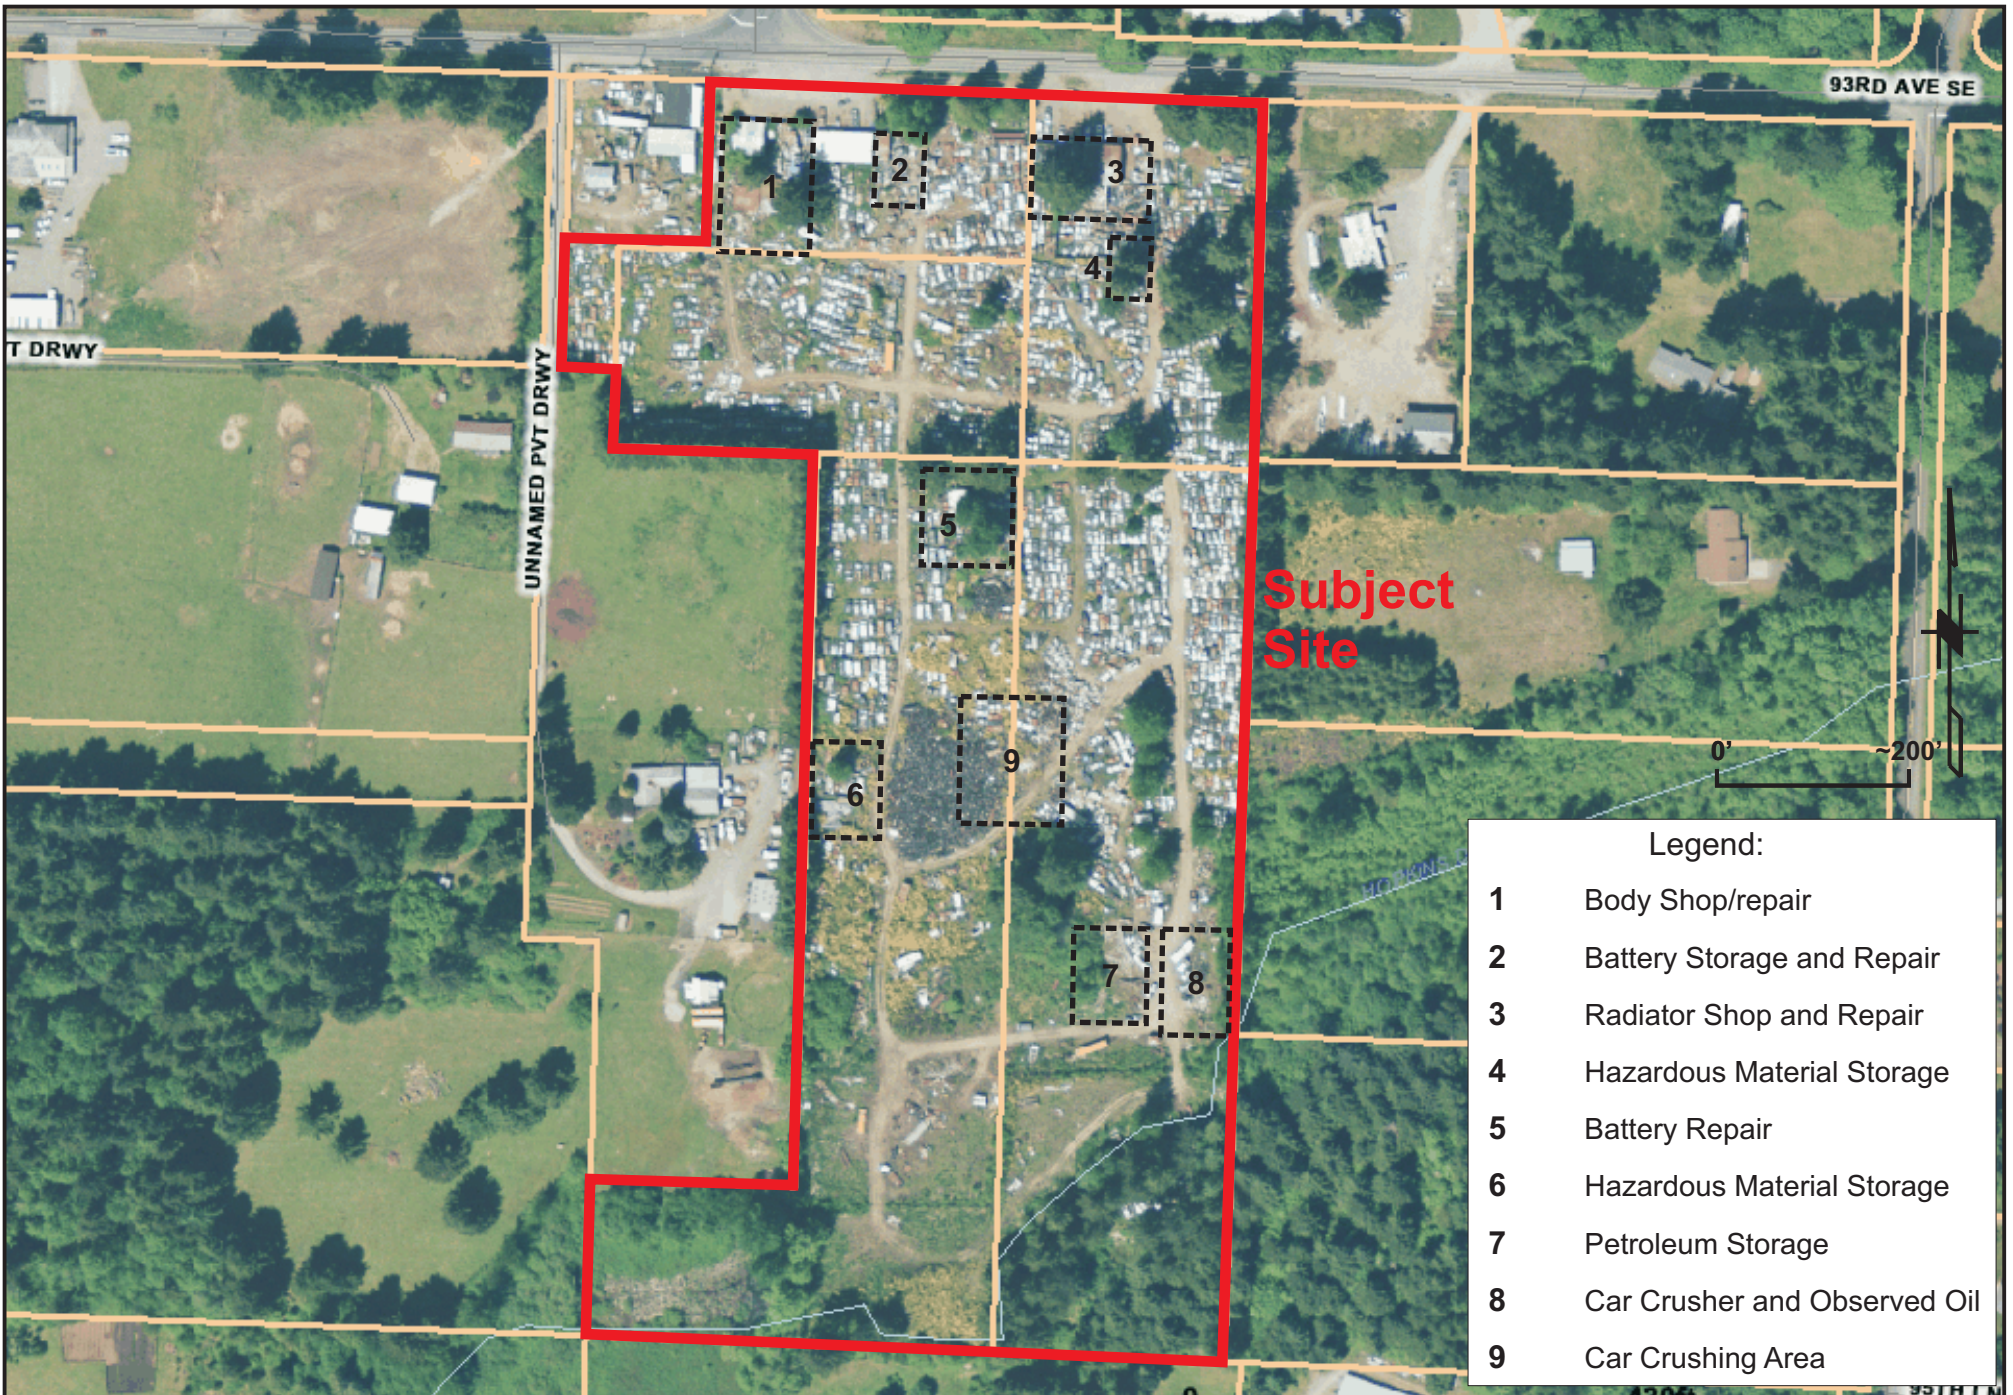
1	Body Shop/repair
2	Battery Storage and Repair
3	Radiator Shop and Repair
4	Hazardous Material Storage
5	Battery Repair
6	Hazardous Material Storage
7	Petroleum Storage
8	Car Crusher and Observed Oil
9	Car Crushing Area
