**PHASE II ENVIRONMENTAL
SITE ASSESSMENT REPORT
SNOQUALMIE PASS PROPERTY GROUP
FOREST ROAD AND INTERSTATE 90
SNOQUALMIE PASS, WASHINGTON**

December 13, 2007
ECI Project No. E-13008-3

Prepared for
Evo Properties
P.O. Box 31879
Seattle, Washington 98103

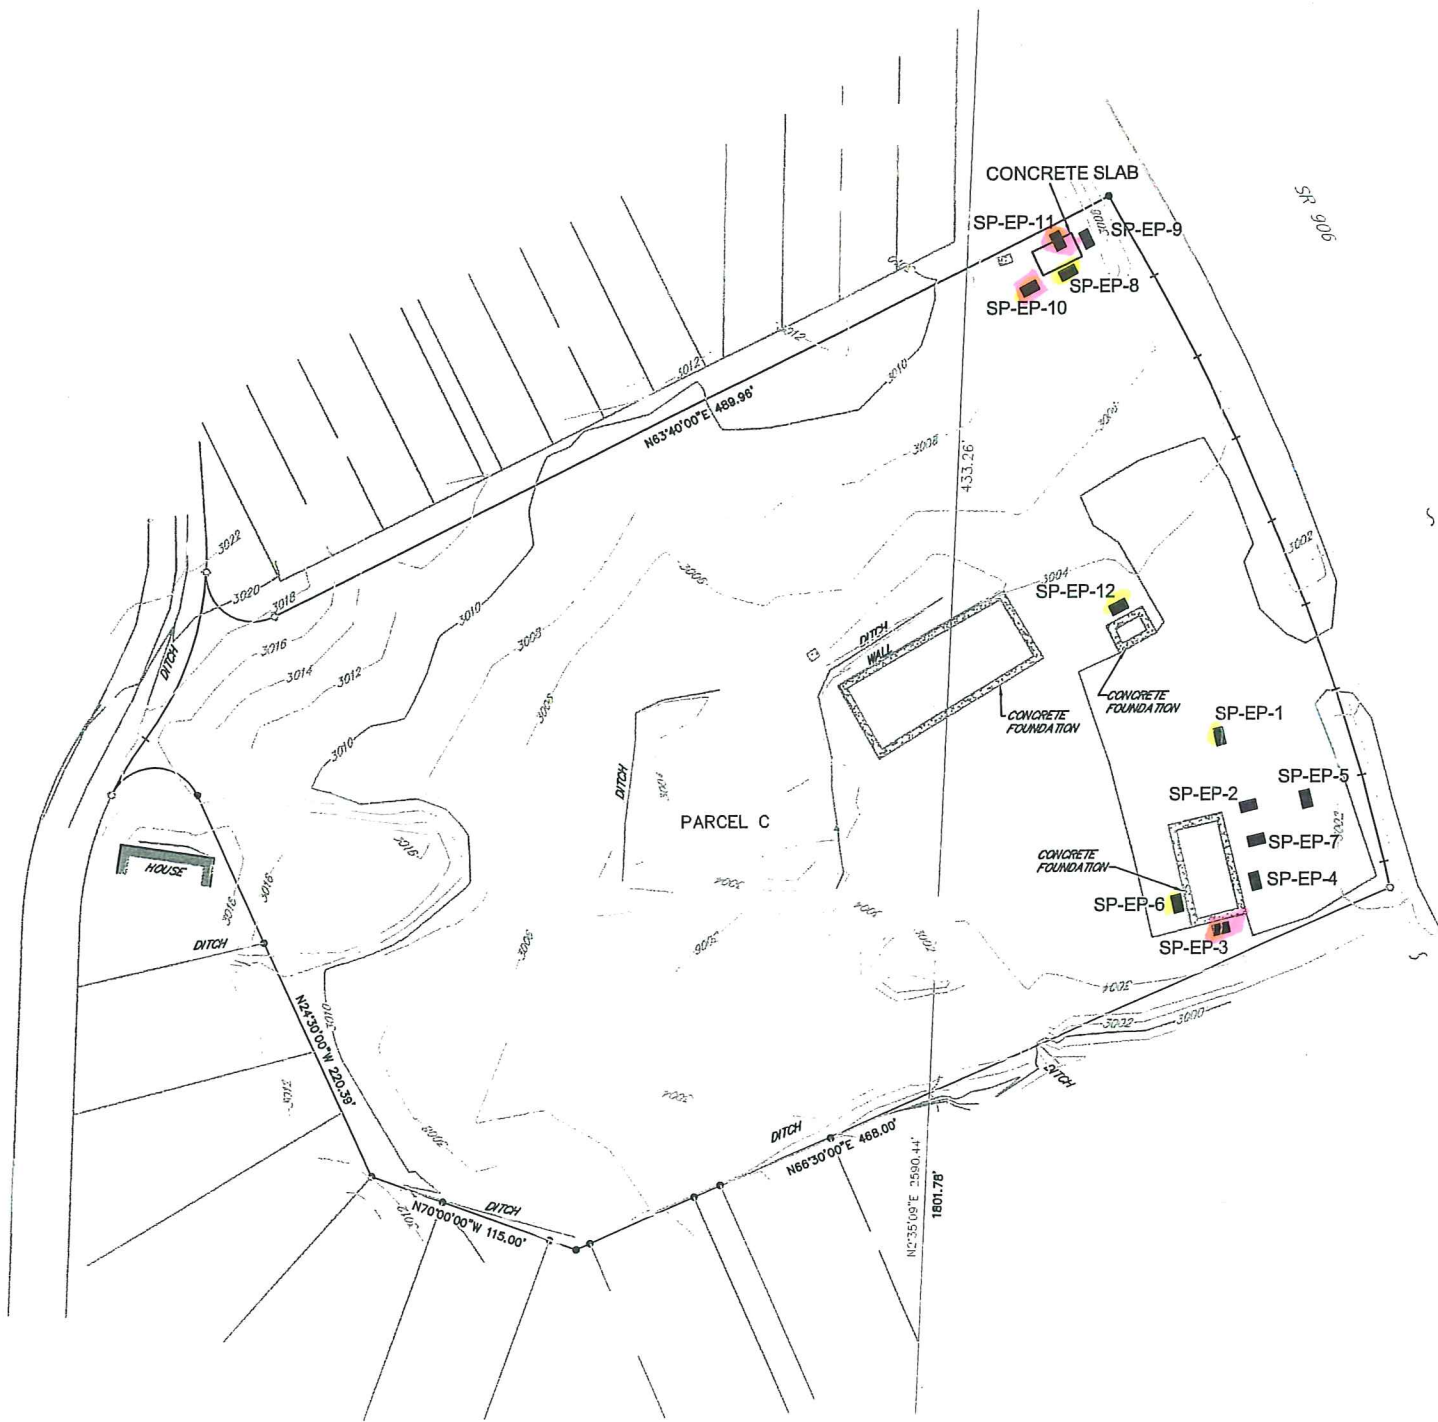
DRWN. DNM		PROJ. NO. 13008-3
CHKD. RNS	DATE 11/28/07	PLATE 2

ECI observed and documented the excavation of 12 test pits on the Kittitas County parcel in the vicinity of what appeared to be two former building slabs and subsurface geophysical anomalies. Soil samples were collected from soils exhibiting field evidence of petroleum hydrocarbons and analyzed for diesel-range petroleum hydrocarbons (DRPHs) and heavy oil-range petroleum hydrocarbons (ORPHs) by Method NWTPH-Dx. Soil samples were collected and field screened by sheen testing (adding water to a sample retained in a sampling spoon and checking for the presence of a visible oily sheen). The locations of the exploration test pits and site assessment samples are shown on "Exploration Pit Location Plan: Kittitas County Parcel," Plate 2.

EXPLORATION PIT LOCATION PLAN
KITITAS COUNTY PARCEL
SNOQUALMIE PASS, WASHINGTON

Analytical results for site assessment samples collected at a depth interval of 4 to 7 feet below grade from exploration test pit SP-EP-3 near the southern portion of the former gasoline station foundation exhibited environmentally significant levels of ORPHs and GRPHs, including benzene. The mixture of the two hydrocarbons suggests the presence of a waste oil tank (or former tank that was removed). There may also have been a sump in the general area of the former service bay that received waste fluids. Test pits dug to the east (SP-EP-6) and west (SP-EP-4) of Test Pit SP-EP-3 did not exhibit evidence of significant accumulation of petroleum hydrocarbons, indicating that the area of petroleum hydrocarbon impacted soil appears to be somewhat limited in lateral extent. The soil contamination in Test Pit SP-EP-3 does not appear to extend deeper than 8 feet; the depth at which groundwater was encountered. However, since contaminated soil is in contact with groundwater, additional characterization of the site will be required to determine dissolved chemicals possibly present in the groundwater associated with the release along with groundwater flow direction and gradient. This can be accomplished by the installation of groundwater monitoring wells (preferably after contaminated soil has been removed).

Several areas near the former foundation were checked for the presence of buried tanks, piping and soil contamination following up on geophysical anomalies. No tanks were found, however, extensive runs of the former fuel distribution system were exposed. Test pits SP-EP-1, SP-EP-2, SP-EP-4, SP-EP-5 and SP-EP-7 were excavated in the vicinity of the suspected tank system and piping runs, however, no environmentally significant levels of GRPHs or DRPHs were encountered based on field observations and laboratory analytical results.

Analytical results for soil samples collected adjacent to and beneath a concrete slab located near the northeast corner of the Kittitas parcel indicate that significant petroleum hydrocarbon impact exists, along with lead in the soil sample from Test Pit SP-EP11 collected at 3.5 fbg that exceeds the Model Toxics Control Act Method A cleanup level of 250 ppm. Based on observations from this area, the contamination appears to be related to past vehicle servicing in this area, evidenced by car parts and ORPH-impacted soil and debris at a depth interval of approximately 2 to 6 feet below grade. Based on the suspected presence of waste oil, the contamination was tested for PCBs to check if the waste may be hazardous. PCBs were not detected in sample SP-EP-11-3.5. The contamination in this area also appeared to be somewhat limited in lateral extent.

Petroleum hydrocarbon impact has been confirmed on the Kittitas County parcel in at least two locations (near the northeastern and southeastern corners of the subject property). ECI recommends excavation and removal of all petroleum hydrocarbon-impacted soil in the two areas identified during exploration activities (south of the exposed service station foundation near the south boundary of the site and in the vicinity of the concrete slab near the northeastern corner of the subject property). In addition, all former piping runs and possible hydraulic lifts and associated concrete slabs should be removed from both areas. Although no tanks were found during the site assessment phase of this project, there may be some tanks remaining. Tracing the extensions of the piping systems during removal will be useful in the final determination of whether or not the suspect tanks have been removed. ECI recommends that an environmental scientist be present to document the independent cleanup action on the site and to collect cleanup confirmation samples. Model Toxics Control Act Method A cleanup regulations require reporting of the contamination within 90 days of discovery.

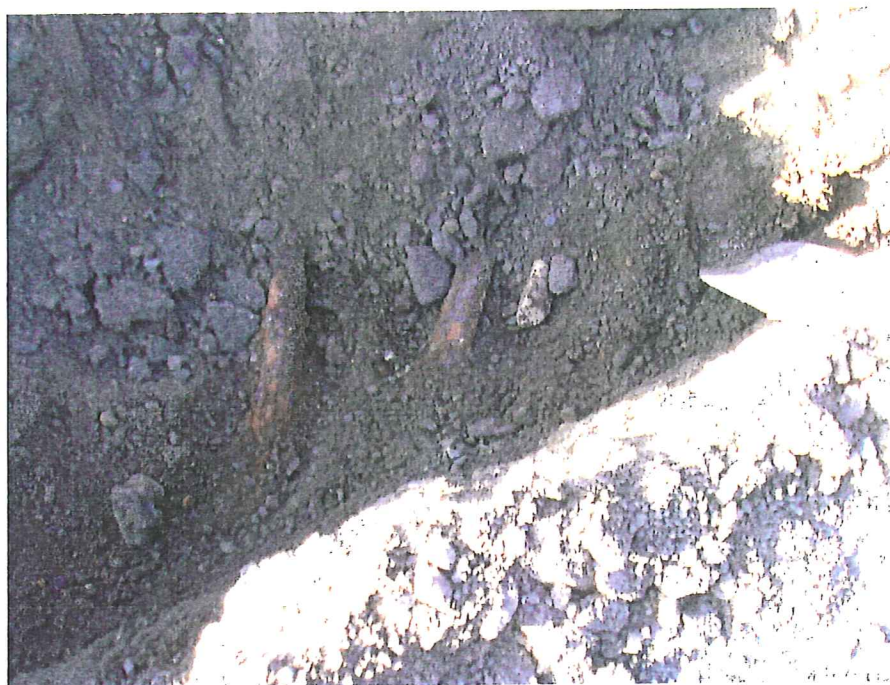
Photograph 1: ECI followed up on the geophysical anomalies by excavating test pits and exposing piping that was part of the former tank system on the Kittitas parcel. No tanks were found, however ECI cannot rule out that buried tanks remain on the subject property

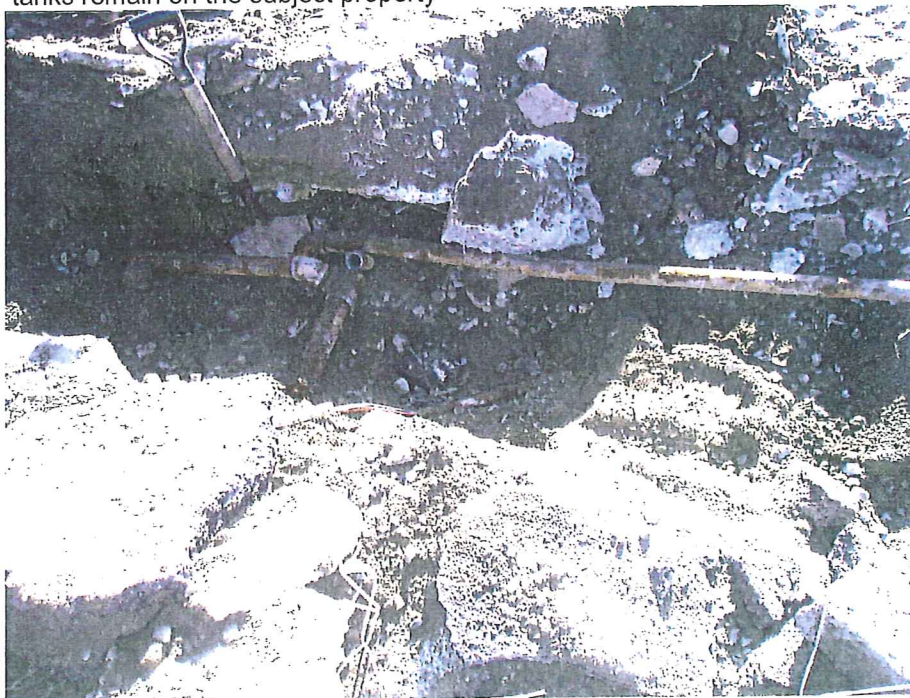
Photograph 2: The piping runs were followed in an attempt to find tanks or contamination associated with possible piping leaks.

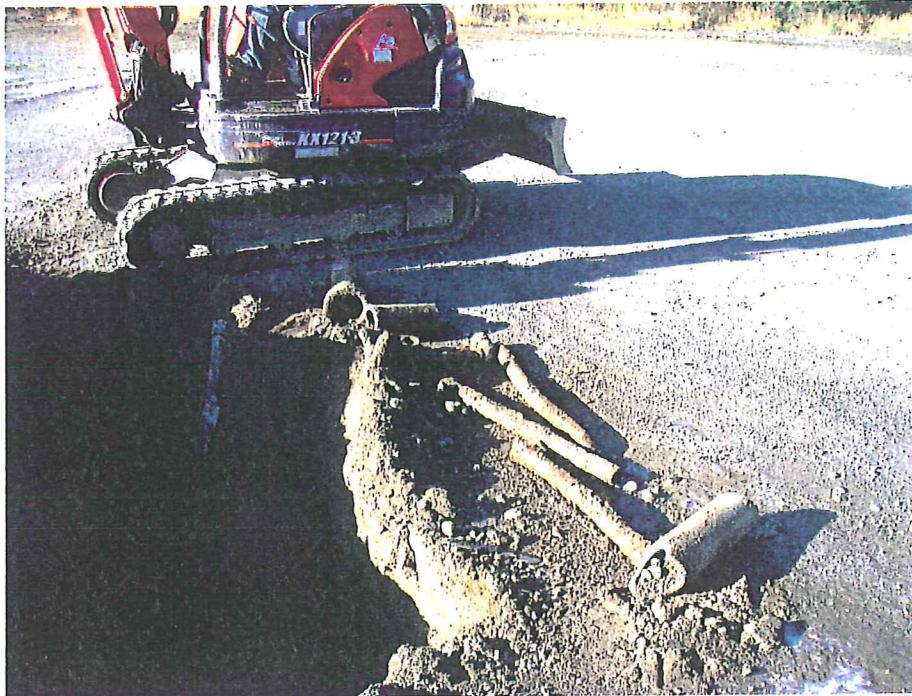
Photograph 3: Several of the geophysical anomalies were attributed to the buried product piping found on the Kittitas parcel. Soil below the piping runs did not exhibit significant quantities of petroleum hydrocarbons.

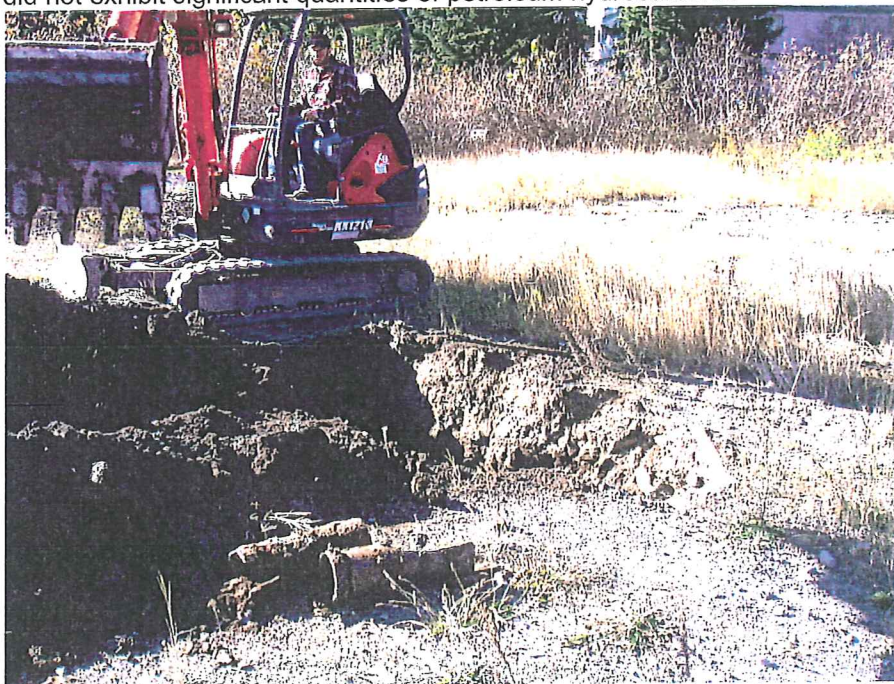
Photograph 4: Trenching allowed lateral exploration of buried anomalies. The trench was deepened whenever contamination was detected.

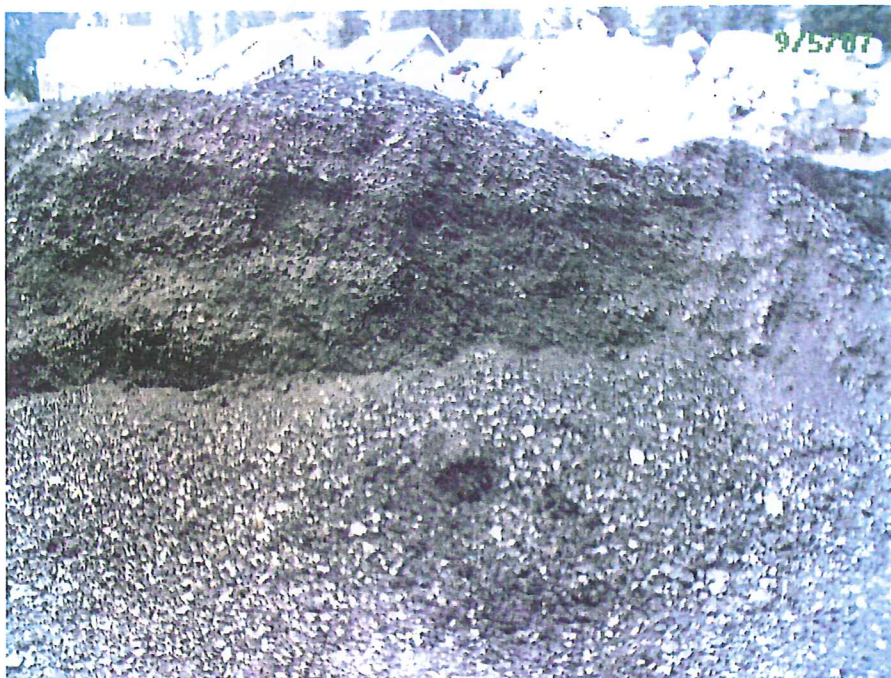
Photograph 5: Piles of ground asphalt contain up to 60,000 ppm of heavy oil range petroleum hydrocarbons, and should be removed from the site either as petroleum contaminated soil or used as road base under asphalt paving.

foot below grade) does exhibit environmentally significant levels of heavy oil-range petroleum hydrocarbons. ECI recommends removal of this asphaltic fill material including the area near the existing AST. cPAHs do not appear to be present at environmentally significant levels in the asphaltic material stockpiled on site. ECI recommends that an environmental scientist be present during the final stages of soil removal to collect confirmational samples. Once all fill material has been removed and the site has been graded, ECI recommends the installation of a groundwater monitoring well along the southern portion of the parcel to check for possible GRPH impact from the adjacent gasoline station.

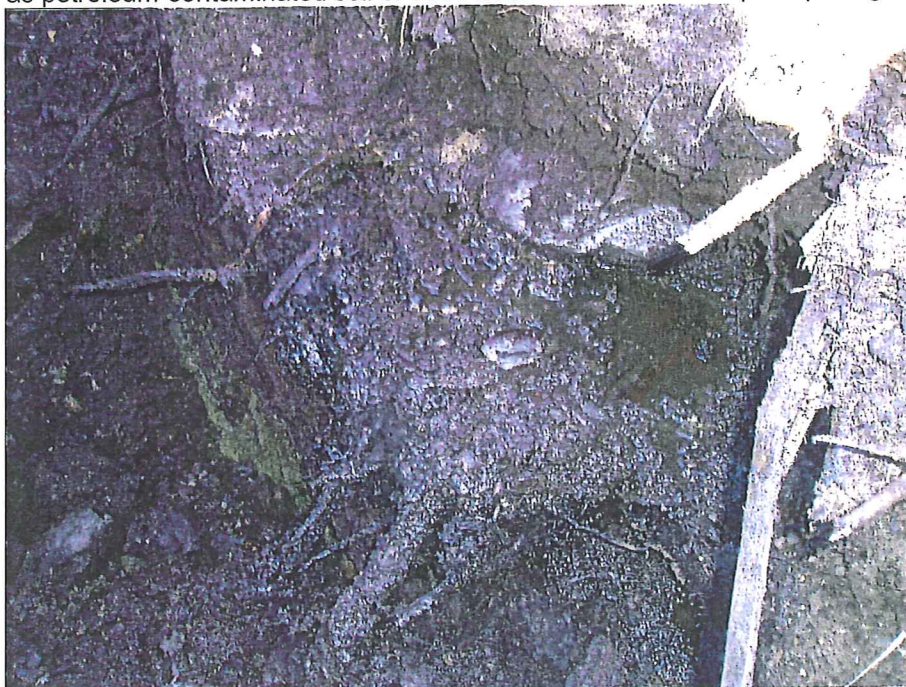
Photograph 6: View of the contamination exposed near the northeast corner of the subject property. The contaminated horizon contains automotive debris.

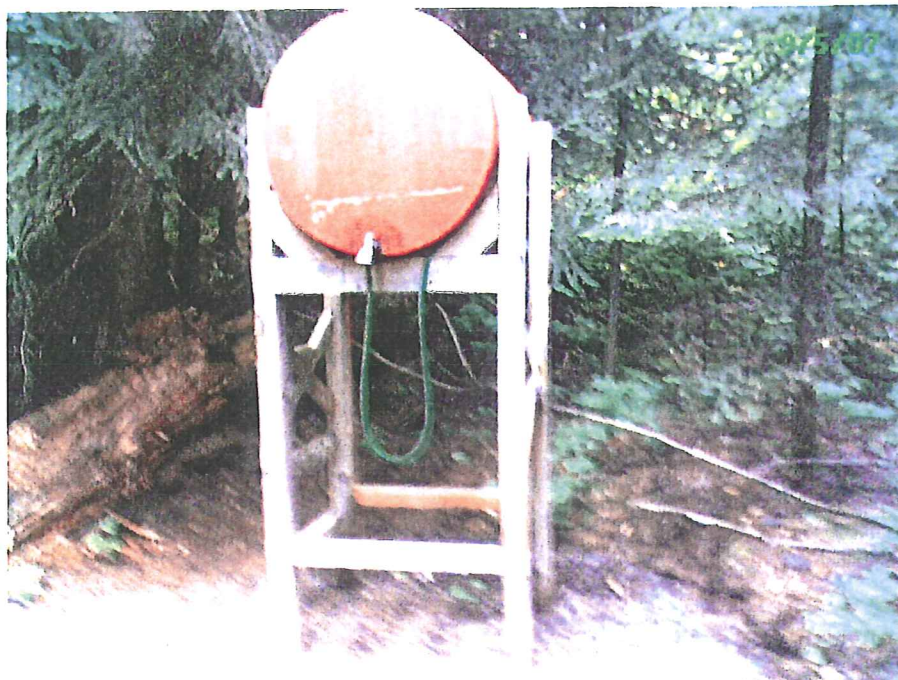
Photograph 7: A soil sample collected near the base of the above ground tank exhibited diesel range petroleum hydrocarbons above MTCA cleanup levels.

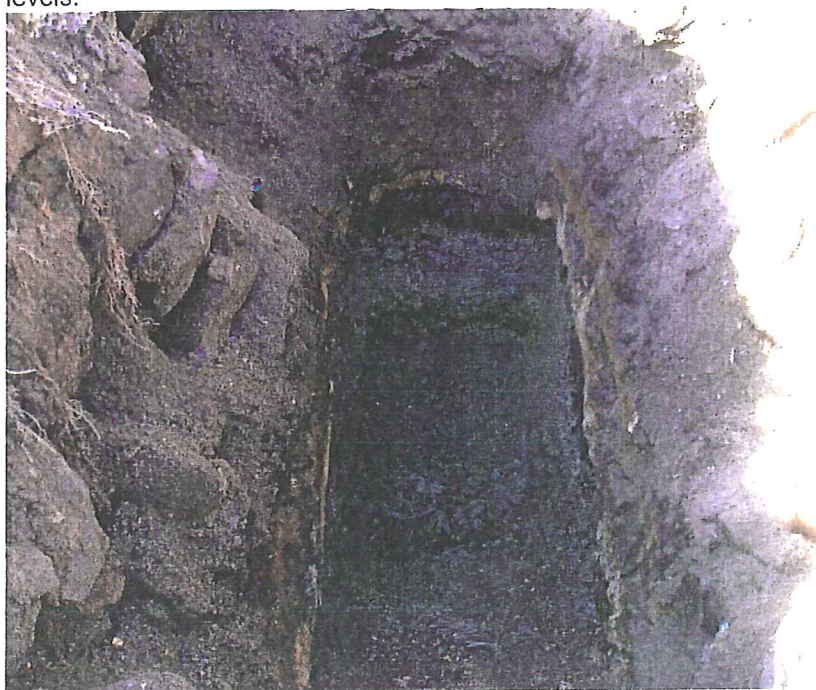
Photograph 8: View of soil contamination exhibiting bluish gray discoloration which is typical of petroleum hydrocarbon impacted soil. The buried concrete debris seen in the sidewall made use of a drill rig impractical.
