# FIELD RECONNAISSANCE AND SEDIMENT SAMPLING REPORT

Upper Columbia River Site Washington

August 2007
Washington Department of Ecology
Toxics Cleanup Program
Eastern Regional Office
Spokane, WA

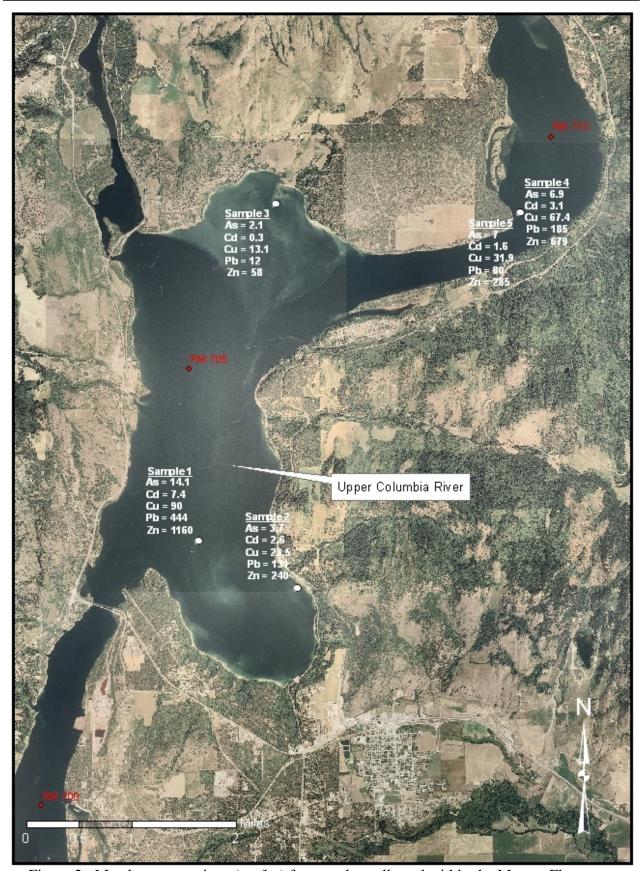
Figure 2: Metal concentrations (mg/kg) for samples collected within the Marcus Flats area.

Laboratory analytical results for the <2 mm size fraction are presented in Table 1 and graphically overlaid on an aerial photographs in Figures 2 and 3. Detailed descriptions of the sampling locations and sediment descriptions are provided in Appendix C. Visual observations of Samples 6, 8, and 10 showed the presence of black, sand-sized material recognized as slag.

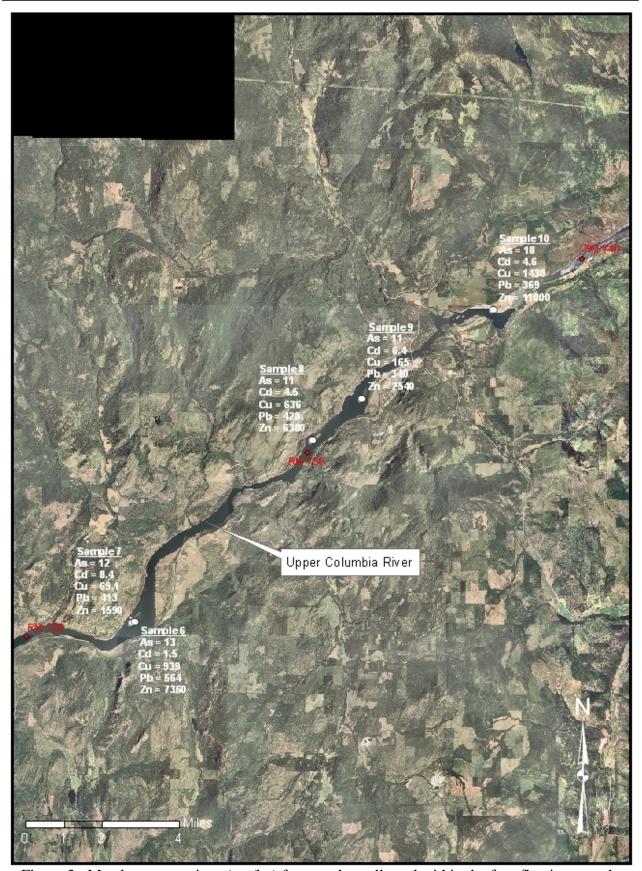
Figure 3: Metal concentrations (mg/kg) for samples collected within the free-flowing stretch.

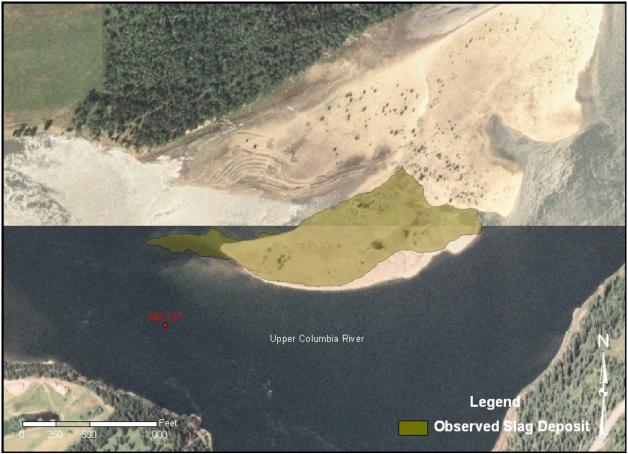
Figure 4: Survey area of observed slag deposit totaling approximately 20 acres in size.

Sample 10 from the vicinity of Deadman's Eddy – approximately RM 737.5 – contained the highest apparent percentage of slag. The area from which Sample 10 was collected appeared to contain a variable slag content ranging from roughly 10% to 65%. Vertical variations in apparent slag content were noted when excavating the shallow pits used to obtain composite sub samples. A GPS-based reconnaissance was conducted to estimate the approximate areal extent of the side bank/point bar deposit (associated with Sample 10) covered by slag material. Based on the shape and perimeter coordinates of this sediment deposit, the slag-enriched zone covers an area of approximately 20 acres. The area depicted on Figure 4 likely does not represent the full extent of the Deadman's Eddy side bank/point bar area where slag-enriched sediment is present; adjacent areas not directly traversed on foot, also appeared to contain observable quantities of slag based on color and geomorphologic attributes of sediment deposition that were generally similar to the Sample 10 area.

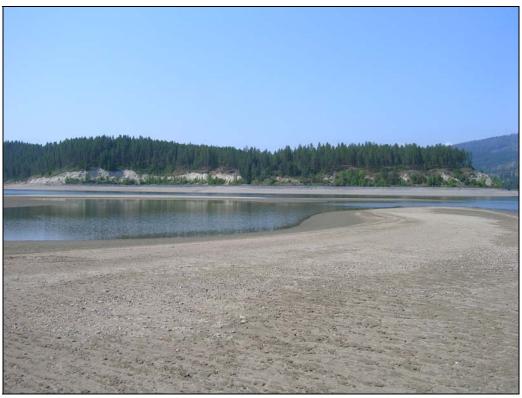
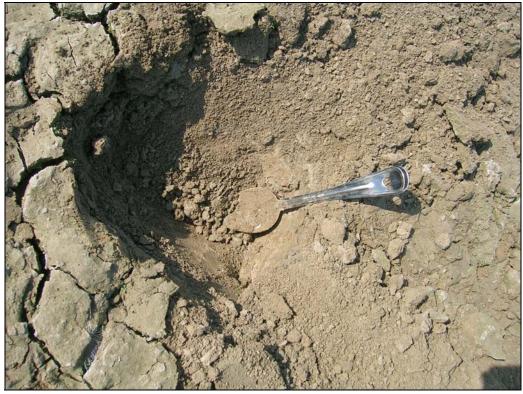
Sample 1

Sample Location 1: View looking to the south.

<u>Sample 1</u> – Collected near center of island. Composition: Silty clay to clayey silt, reddish mottling observed

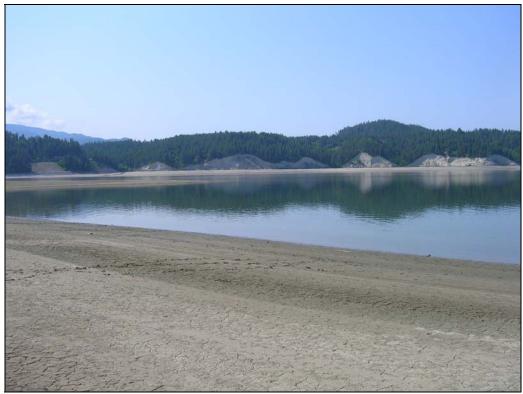
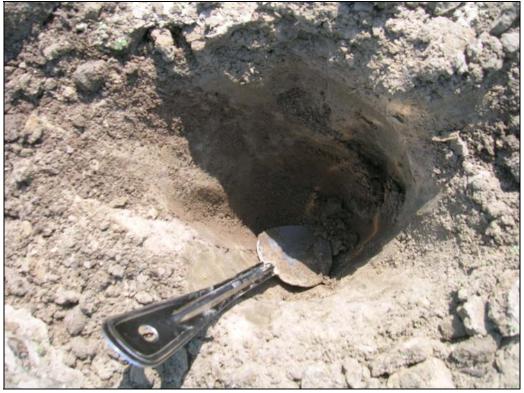
Sample 2

Sample Location 2: View looking to the southwest.

Marcus area - exposed shoreline sloping area located in large embayment on river left near Hwy 25. No eroding bluffs noted in the immediate proximity. Composition: sandy silty clay or clayey silt, minor reddish mottling. Occasional mussel shells (*A. oregonensis*) noted in the immediate area.

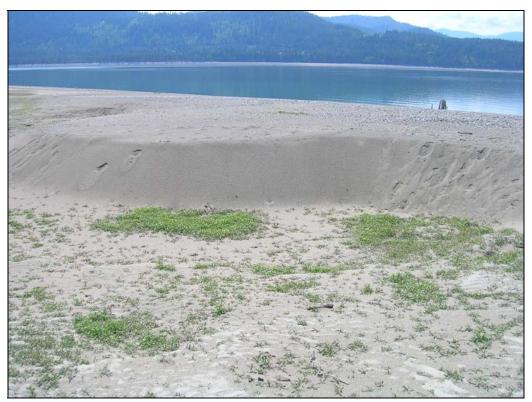
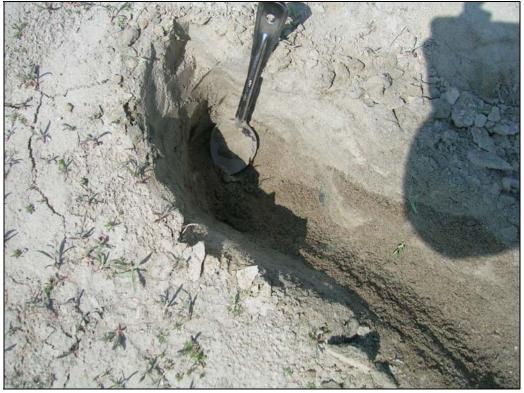
Sample 3

Sample Location 3: View looking to the southeast.

<u>Sample 3</u> – Composite sample collected to evaluate surface-only sediment (0 to 3 inches) within a small depression situated on the lee side of a migrating sandy bedform wedge. Composition: sandy clayey silt. Shallow excavated hole showed 3 inches of the silt overlying medium sand. Top 3 inches were sampled.

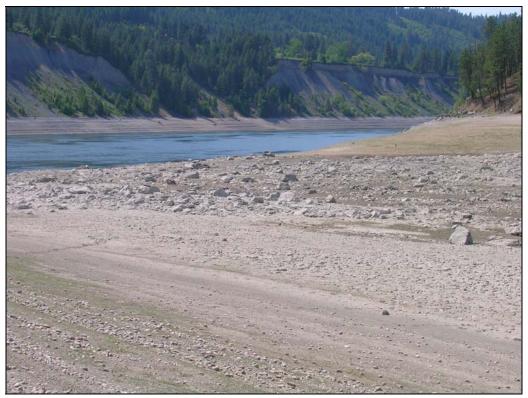
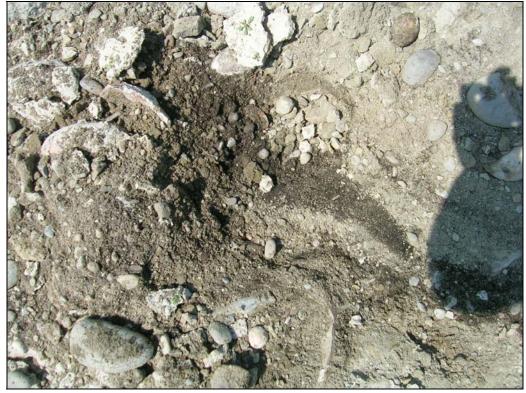
Samples 4 and 5

Sample Locations 4 and 5: View looking to the southwest.

<u>Sample 4</u> – Collected in dry channel feature. Location marked by a shrinkage-cracked sandy silt (0 to 3 inches) over a cobbly, sandy silty gravel transitioning to a dark brownish mix of gravel sand & silt that appeared organic rich [soil horizon?]. The Sample 4 composite was collected from the 0 to 4 inches, above the dark brownish horizon.

<u>Sample 5</u> – Sample of the dark brownish layer, approximately 4 to 6 inches in depth.

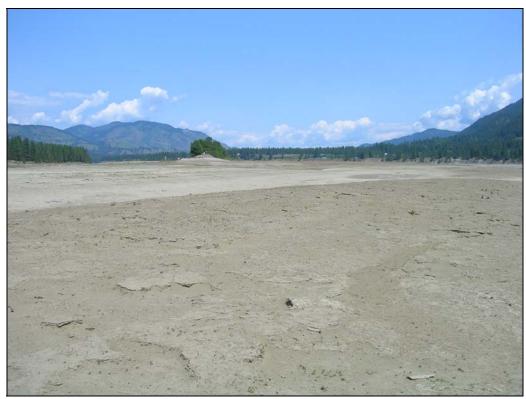
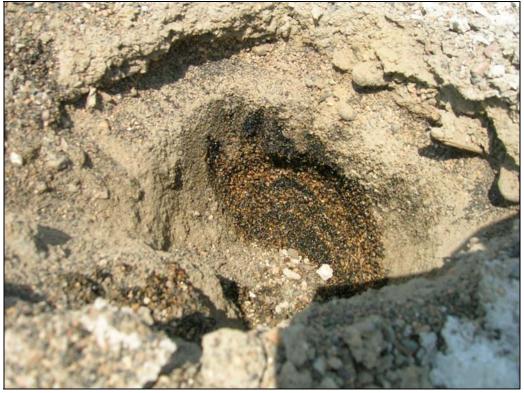
Sample 6

Sample Location 6: View looking to the northeast.

<u>Sample 6</u> – Just down stream of the treed island, on the side nearest the active channel, are a series of discontinuous sand bars that appear to contain significant slag. Slag increases with depth where evaluated. A sample was collected from one of the sand/slag deposits and was situated several feet above the active river/reservoir level. Collected sample contained minor very fine gravel. The composite sample was collected from 2 to 6 inches in depth, after removing a thin layer of organic flotsam and mixed materials locally distributed at the surface.

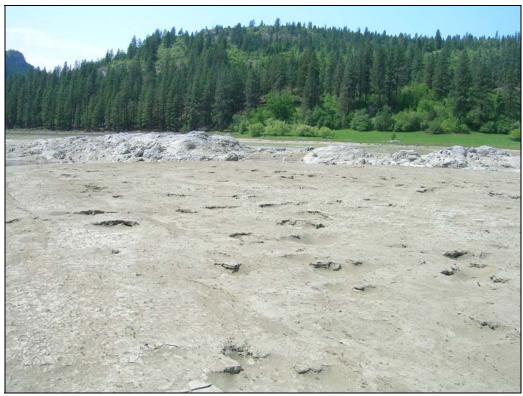
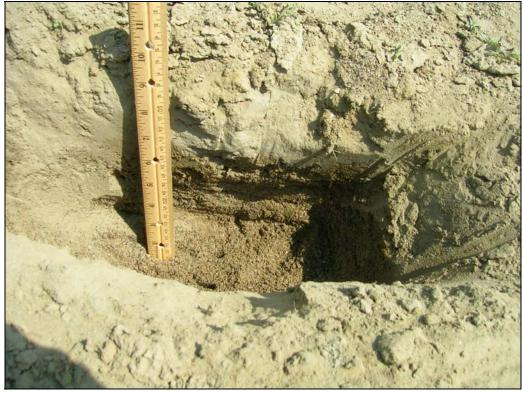
Sample 7

Sample Location 7: View looking west just upstream of Sample 7.

<u>Sample 7</u> – Near the down-stream end of the treed island a silt layer was composite sampled from 0 to 4 inch in depth collection points. The sampled silt overlaid sand that appeared to contain slag.

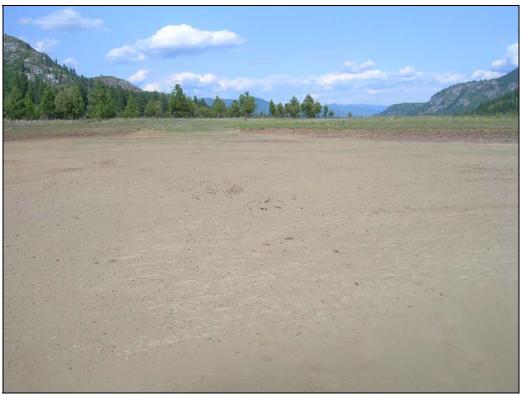
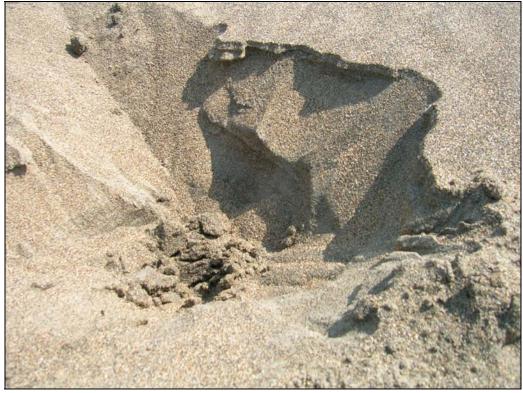
Sample 8

Sample Location 8: View looking to the north.

Sand bar down stream of island feature, located at approximately RM 730.5 on river right. Sand bar looks to be roughly about 100 ft long, 50 ft wide, and 4 ft in height. Slag present.

<u>Sample 8</u> – Sampled slag-bearing sand.

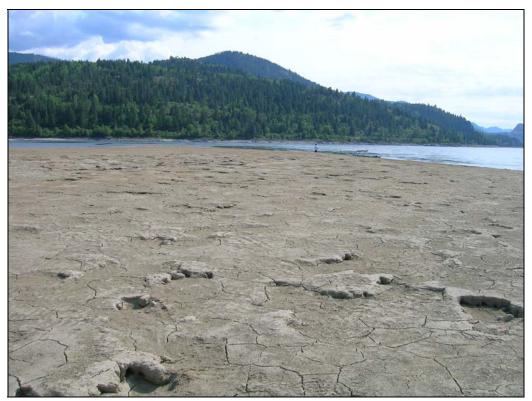
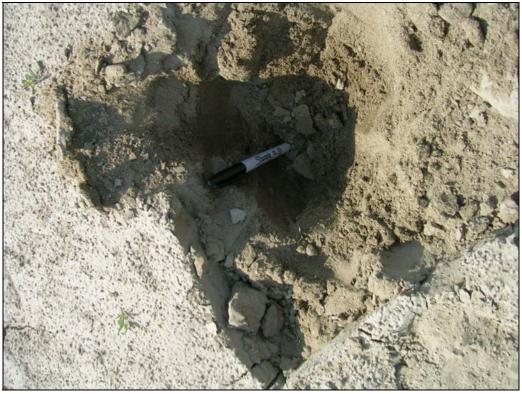
Sample 9

Sample Location 9: View looking to the east.

<u>Sample 9</u> – Composite sample collected (0 to 6 inches) from a mudflat area close to the river. Composition: sandy silt grading to sand. No indication of slag at this location.

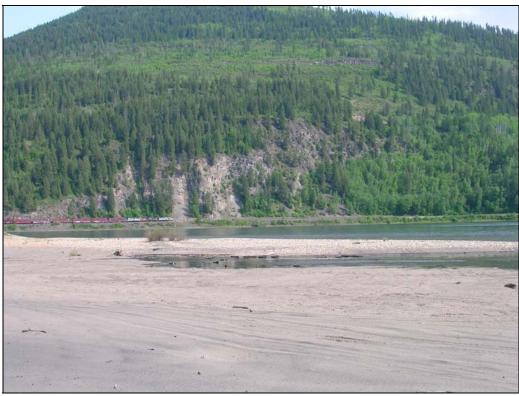
Sample Location 10: View looking to the east.

<u>Sample 10</u> – Slag-bearing sand located near the down stream end of the sandbar deposit. Slag content (roughly estimated to be at least 10 to 30%) is below the maximum observed in this area. Composite sampling conducted over 0 to 6-inch depth intervals. Sand characteristics were similar at each station.

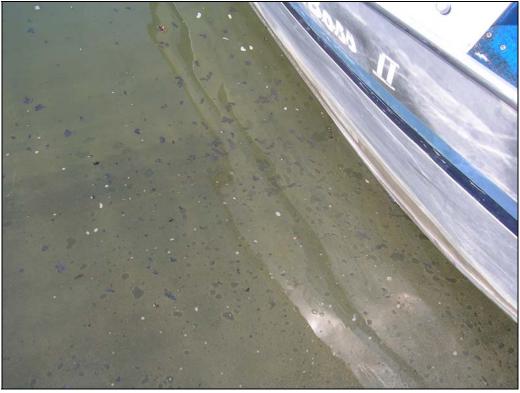
Sample Location 10: Observed floating slag.

This is a broad floodway and island area along river right at approximately RM 737.5. Area is known as "dead man eddy". The exposed area covers tens of acres and is marked by high energy cobble deposits on the up-stream end, transitioning to mostly sand on the downstream side. The downstream end of the area contains substantial slag mixed with sand. Slag percentages in the sand were roughly estimated to range from 10% to 65+%, with some areas examined below the surface to be potentially higher. Some parts of the overall area are higher in elevation and have well established trees; these higher points appear to have cleaner sand, less impacted by the slag. A preliminary survey of the impacted sands using the GPS unit indicates the area to be approximately 20 acres in size with adjacent areas that were not surveyed to also be impacted by slag. The thickness of the sands looks to reach at least 8 to 10 feet in some areas. Floating slag observed in quite water areas.
