**Ecology Draft Final Remedial
Investigation/Feasibility Study Report**

Former Reliable Steel Site
1218 West Bay Drive NW
Olympia, Washington
Ecology Agreed Order No. DE-08TCPSR-5223

**Former Reliable Steel Site
Olympia, Washington
Ecology Agreed Order
No. DE-08TCPSR-5223**

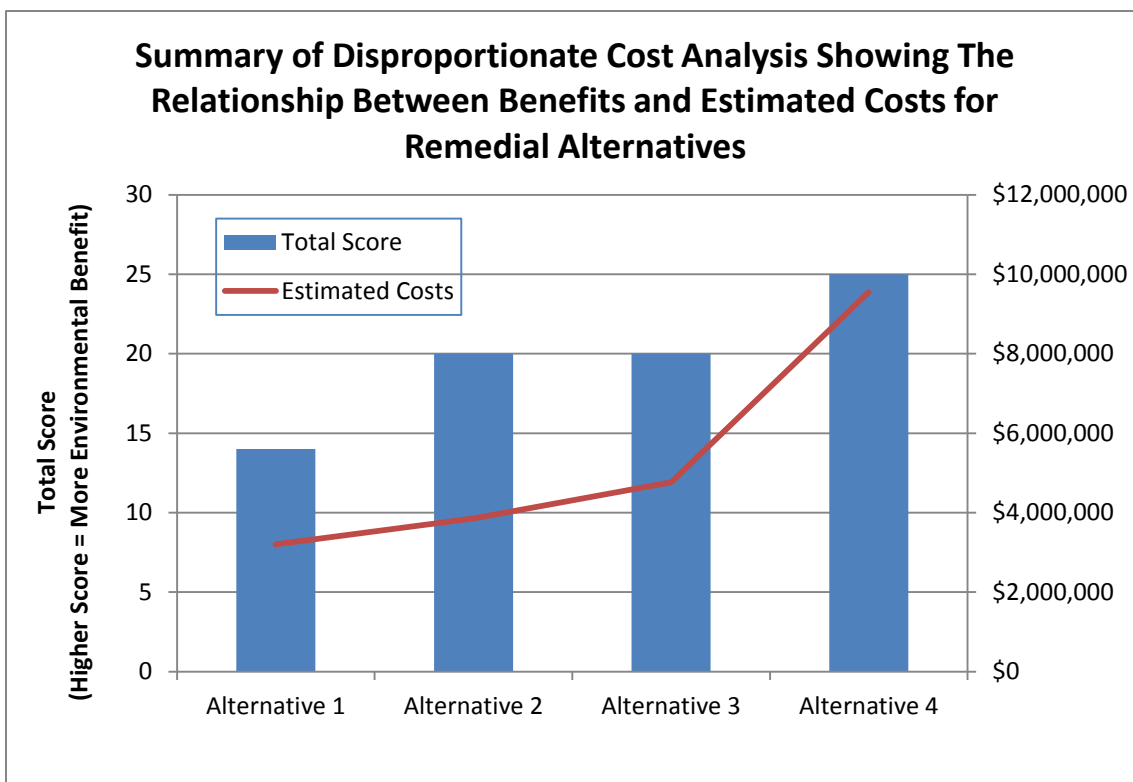
As discussed in Section 8.7.2.1, the MTCA analysis of disproportionate costs is used to determine which remedial alternative that otherwise meets threshold requirements is permanent to the maximum extent practicable through comparison of the costs and benefits of the alternatives. Remedial Alternatives 1 through 4 meet MTCA threshold requirements, and thus were evaluated based on the relative benefits ranking factors of the DCA. The evaluation of the level of achievement for how each individual criterion applies to each alternative, using a numeric scoring scale of 1 (lowest) to 5 (highest) and the methodology described above in Section 9.7.2.1, is presented in Table 31. Table 36 presents the analysis of these results, including the summation of the resulting scores for each alternative and the determination of disproportionate cost. The conclusions of this evaluation are summarized in the following sections and the graph below.

Vertical bars represent scoring for environmental benefit for each alternative.
