CORNET BAY MARINA MITIGATION PLAN MODEL TOXIC CONTROL ACT (MTCA) CLEANUP

PREPARED BY:

GRETTE ASSOCIATES^{LLC}

JULY 1, 2013

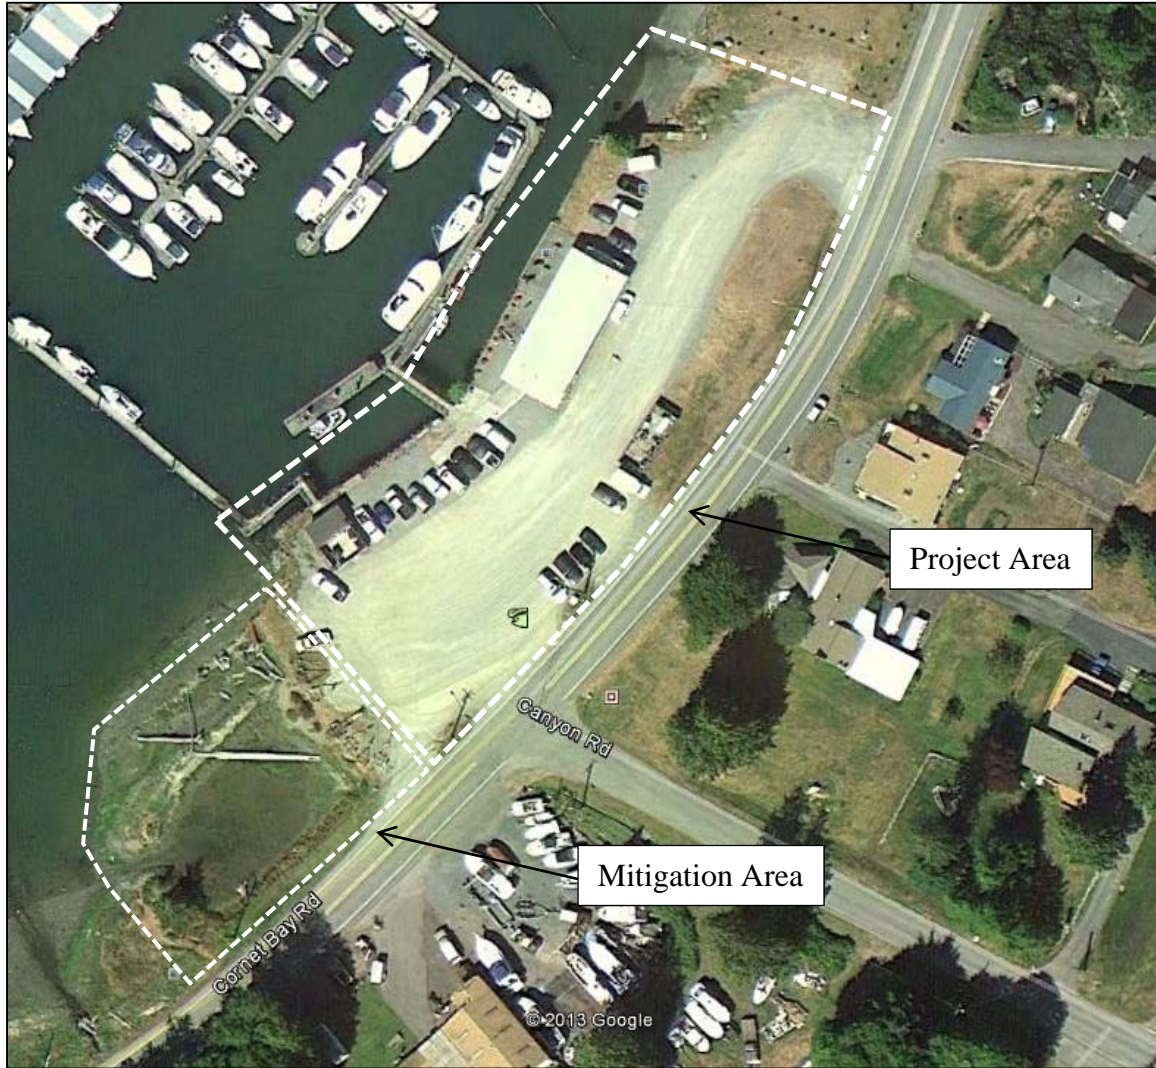
Figure 2. Proposed Mitigation Area.

Compensatory mitigation will occur on the Cornet Bay Marina property (Figure 2). Actions proposed at the site include creating 1,300 square feet of aquatic area, 1,720 square feet of wetland vegetation enhancement, and 1,750 square feet of wetland buffer enhancement.

The interior of the mitigation aquatic area will be graded down to approximately 7-8 feet (NAVD 88). This elevation will be refined upon topographic surveying and an analysis of the hydrologic conditions along the shoreline. The new mitigation area will be graded such that the new shoreline edges will be wavy and irregular.

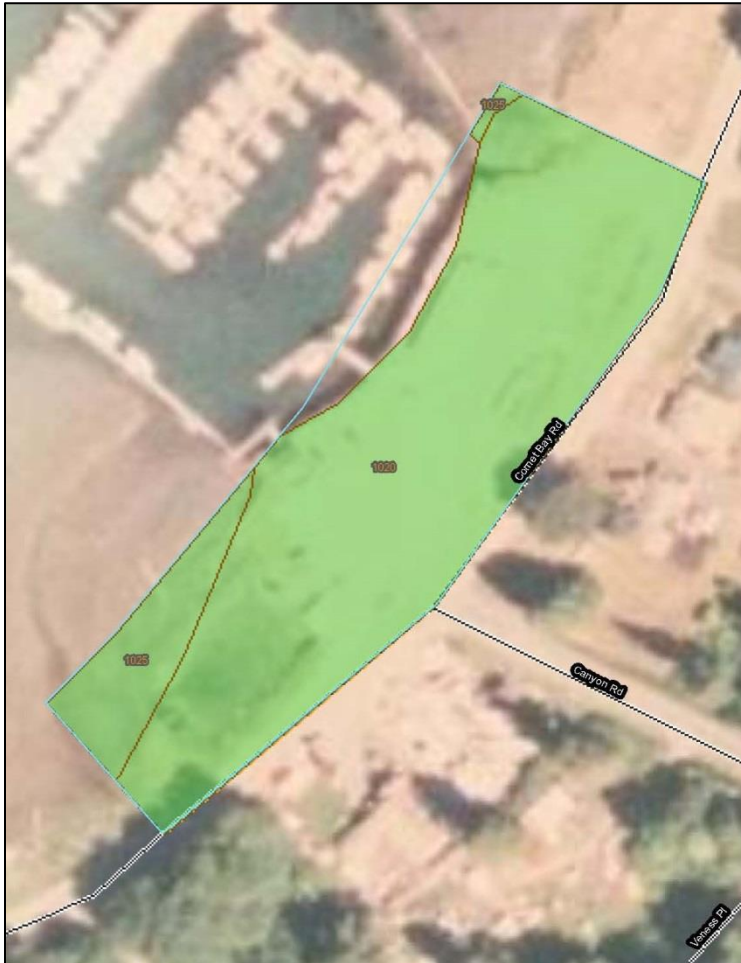
Figure 5. NRCS soil map

elevations between 0 to 20 feet. Both mapped soils are listed as partially hydric (NRCS 2013).

Hydric Rating by Map Unit— Summary by Map Unit — Island County, Washington (WA029)				
Map unit symbol	Map unit name	Rating	Acres in AOI	Percent of AOI
1020	Sholander, cool-Limepoint complex, 0 to 8 percent slopes	Partially Hydric	1.9	82.8%
1025	Beaches-Endoaquents, tidal-Xerorthents association, 0 to 5 percent slopes	Partially Hydric	0.2	10.5%
Subtotals for Soil Survey Area			2.2	93.3%
Totals for Area of Interest			2.3	100.0%

Soils within the study area are mapped by the NRCS as Sholander, cool-Limepoint complex and Beaches – Endoaquents, tidal – Xerorthents association. Soil test pits were examined to a depth of up to 22 inches. During the soil investigation two distinct soils were observed. In the southwest corner of the wetland there is an area that consists of a loamy mucky mineral soil. In a typical soil profile, the upper soil layer (0-18 inches) consists of a black (10YR2/1) (Munsell 2000) mucky clay loam. Within this layer, partially decomposed organic material was observed. Below this layer (18-22 inches) is a layer of very dark greyish brown (10YR3/2) sand with no redox features. The other soil profile documented within the wetland consisted of an upper soil layer (0-4 inches) of a very dark greyish brown (10YR3/2) silt. Beneath this upper layer (4-20 inches) is grey (7.5YR 5/1) clayey silty sand with prominent strong brown (7.5YR4/6) redox features.
