Dewatering Assessment

Cashmere Mill Site Remedial Excavation (Phase 2)
Cashmere, Washington

Washington State Department of Ecology

July 31, 2013

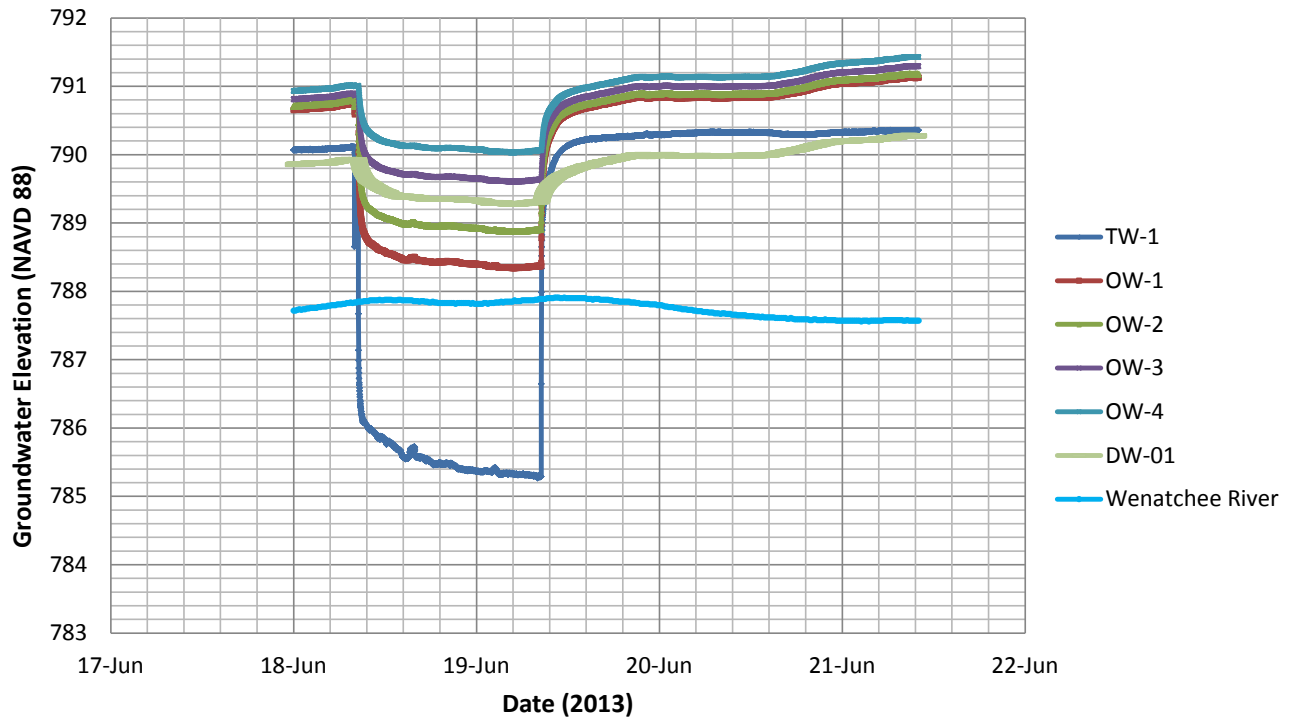
Figure 5

(a) Hydrograph - Section A-A' (Down-Valley)

(b) Hydrograph - Section B-B' (Cross-Valley)

1. Wenatchee River elevation data from USGS gauging station 12462500 at Monitor, WA, located approximately 100 feet lower in elevation than the site. An arbitrary value of 83 feet was added to the data to plot river changes during the test period.
2. Data is organized by alignment of observation wells relative to the test well, with down-valley being oriented NW-SE and cross-valley being oriented NE-SW, as depicted in Figures 2, 3, and 4.

A full presentation of the Pumping Test Hydrographs is shown in Figure 5, with the Constant-Rate Test Pumping Rate shown in Figure 6; the observed Drawdown in Pumping and Observation Wells during the constant-rate test is plotted against the logarithm of elapsed time (s vs. log t) in Figure 7 and depicts the transient drawdown trends defining the expanding cone of depression at each observation well. Recovery in Pumping and Observation Wells is plotted as residual drawdown against the logarithm of the time ratio (s vs. t/t') for each observation well in Figure 8. A Distance-Drawdown Plot shows a series of synoptic snapshots that depict the lateral development of the cone of depression in Figure 9. An attempt to fit the results to the Hantush (1960) Drawdown Analysis for partially penetrating wells was developed as output from the software program Aqtesolv in Figure 10. Each of these figures includes two plots, depicting aquifer test responses in both down-valley and cross-valley directions.

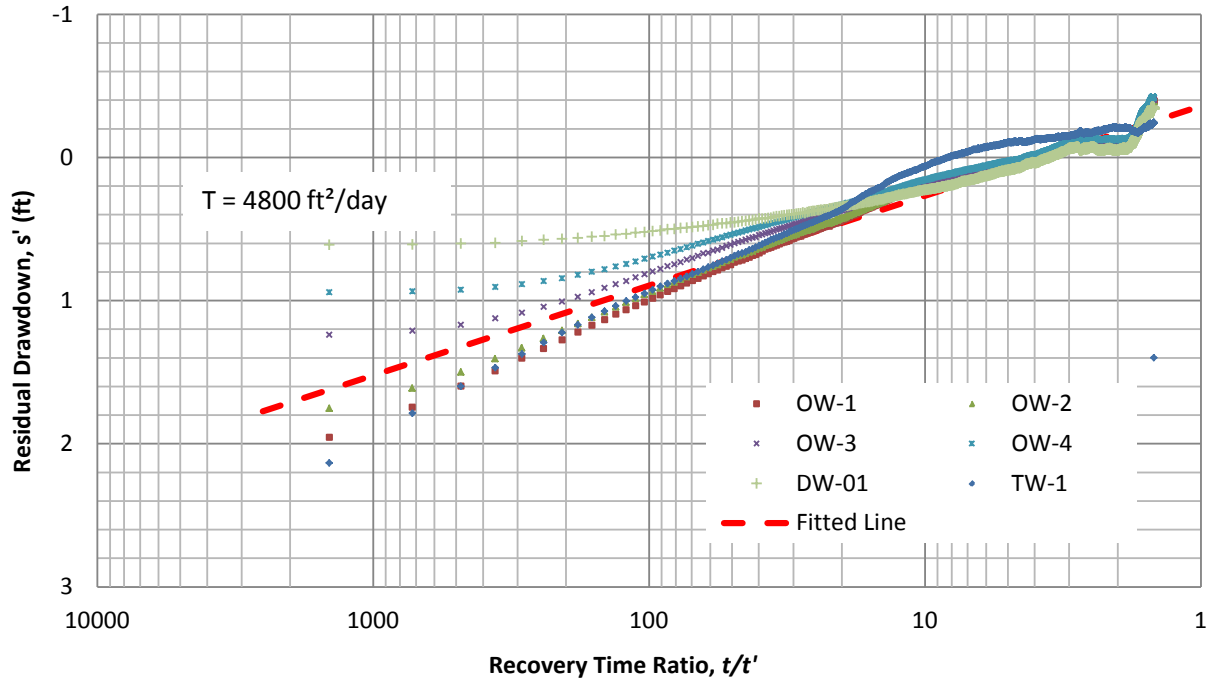
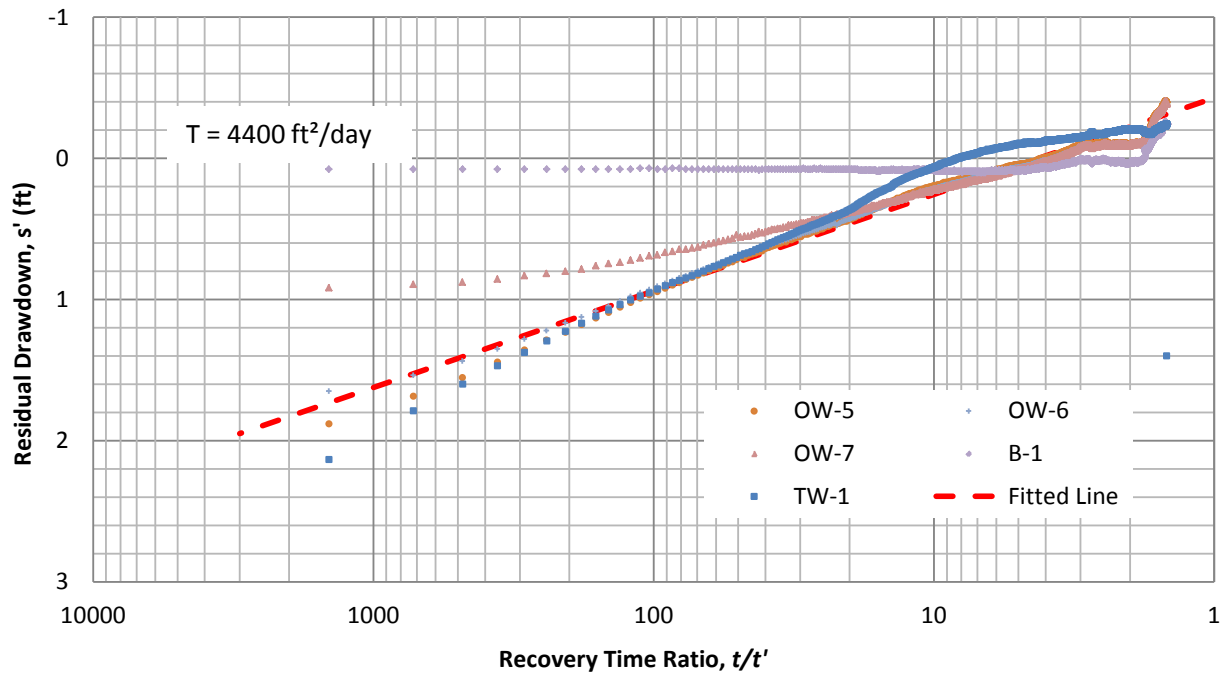
(a) Cooper-Jacob Composite Residual Drawdown Analysis (s' vs. t/t')
Section A-A' (Down-Valley)

(b) Cooper-Jacob Composite Residual Drawdown Analysis (s' vs. t/t')
Section B-B' (Cross-Valley)

1. Data is organized by alignment of observation wells relative to the test well, with down-valley being oriented NW-SE and cross-valley being oriented NE-SW, as depicted in Figures 2, 3, and 4.
2. Analysis conducted using Theis (1935).

A similar graphoanalytical method was developed by Theis (1935) for analyzing the recovery trends observed as water levels in the cone of depression rise or recover after the pump is turned off. The method requires that the recovering water level (or residual drawdown) is plotted against a time ratio, t/t' .

- Flattening of the drawdown trends in Figure 7, especially at late time.
- Extrapolation of the recovery trends (Figure 8) to a negative drawdown value at $t/t' = 1$.
- The difference in drawdown responses observed in wells parallel and perpendicular to Brender Creek.

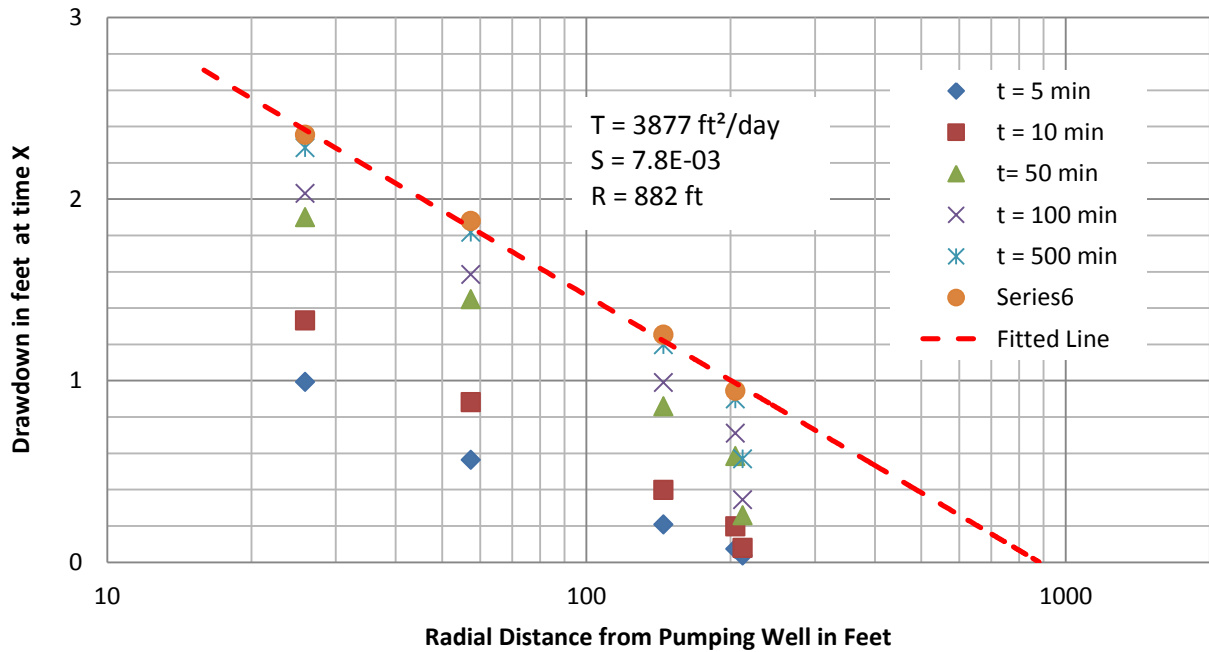
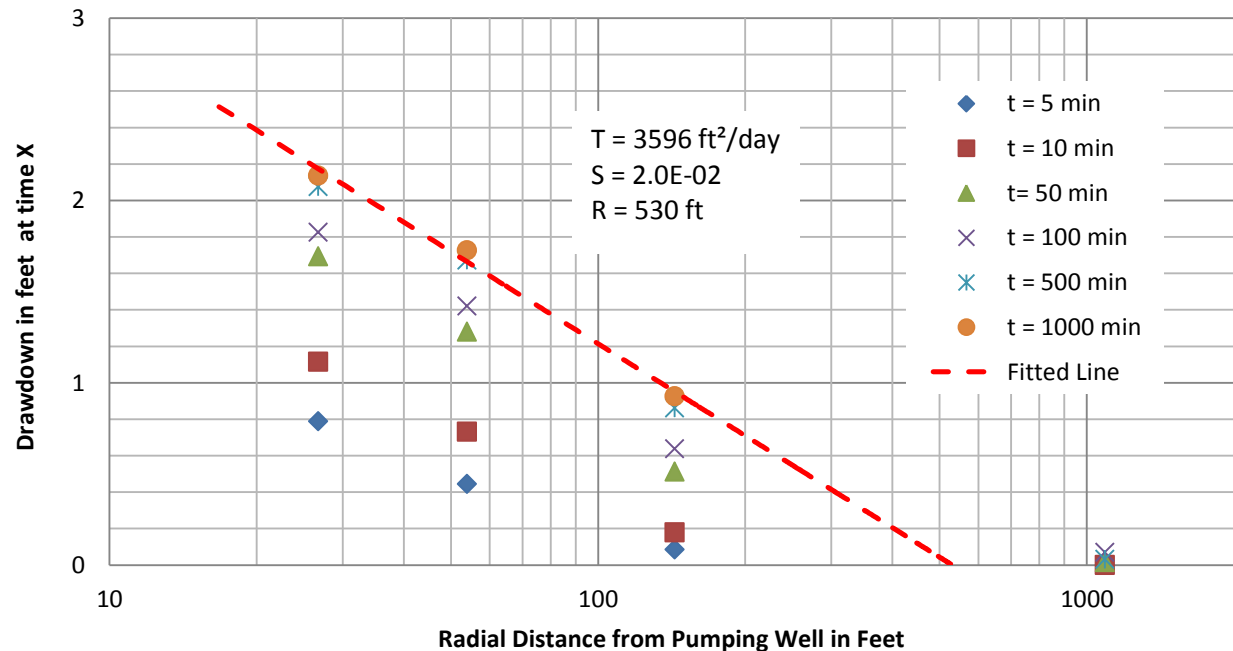
Distance Drawdown Plot

**(a) Distance-Drawdown Plot
Section A-A' (Down-Valley)**

**(b) Distance-Drawdown Plot
Section B-B' (Cross-Valley)**

1. Data is organized by alignment of observation wells relative to the test well, with down-valley being oriented NW-SE and cross-valley being oriented NE-SW, as depicted in Figures 2, 3, and 4.
2. Analysis conducted using Cooper-Jacob (1946).

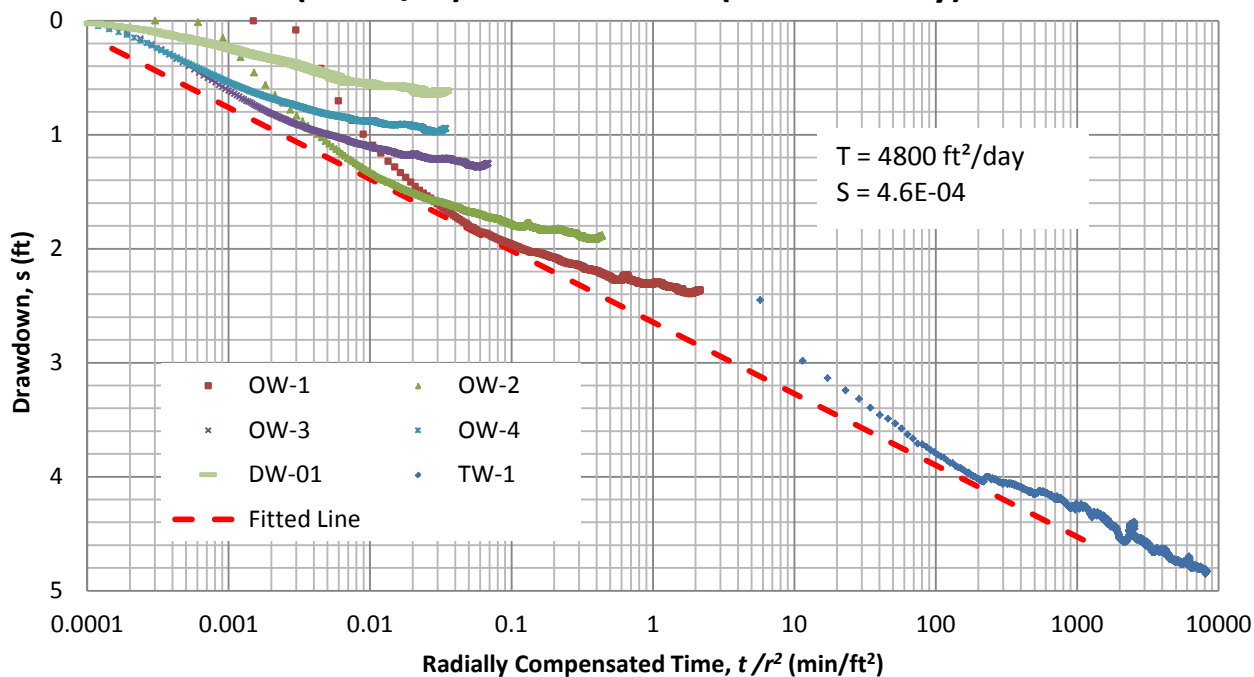
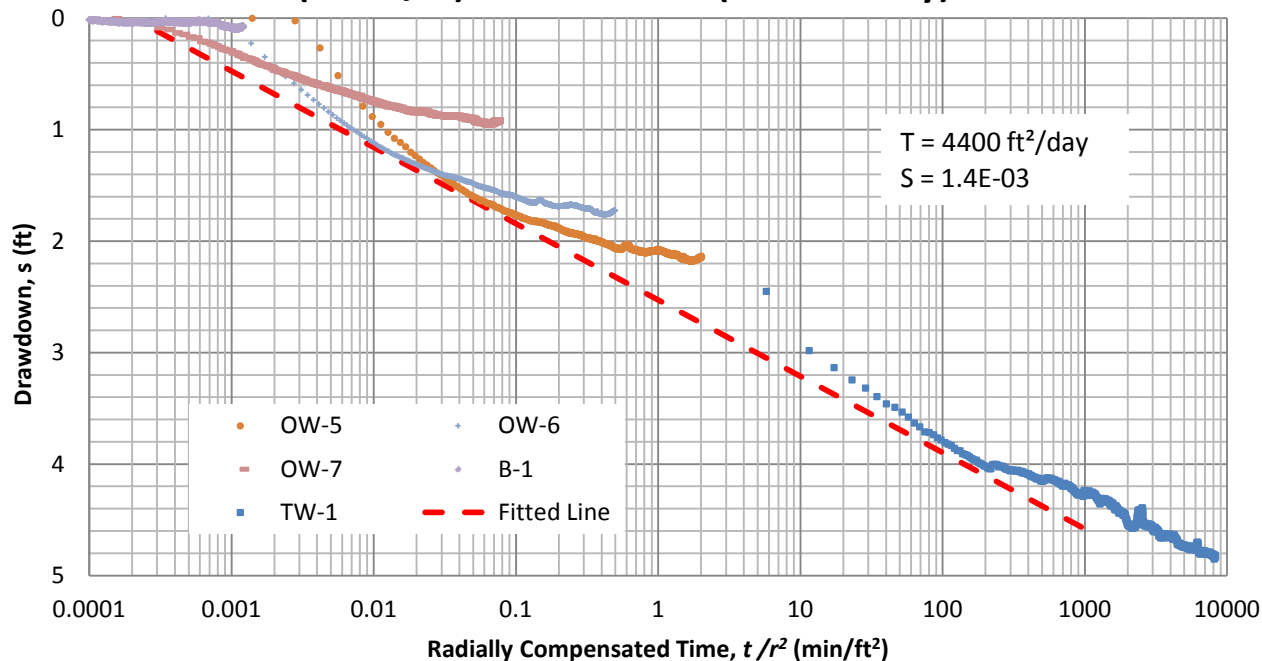
**(a) Cooper-Jacob (1946) Composite Drawdown Analysis
(s vs. t/r^2) - Section A-A' (Down-Valley)**

**(b) Cooper-Jacob (1946) Composite Drawdown Analysis
(s vs. t/r^2) - Section B-B' (Cross-Valley)**

- The drawdown data presented here is organized by alignment of observation wells relative to the test well, with down-valley being oriented NW-SE and cross-valley being oriented NE-SW, as shown in the cross section alignments A-A' and B-B', respectively, and as depicted in Figures 2, 3, and 4.
- Analysis conducted using Cooper-Jacob (1946).

To help identify a more appropriate aquifer model, we prepared a diagnostic plot that compares the drawdown observed in the pumping well and all observation wells together. This is done by plotting the drawdown against the ratio, t/r^2 .

Visual assessment of the deviations of the drawdown trends from the Theis type-curve, considered together with the geologic conditions at the site, can help in identifying an aquifer hydraulic model that is more representative than the classic Theis model. Diagnostic observations from Figure 11 are as follows:

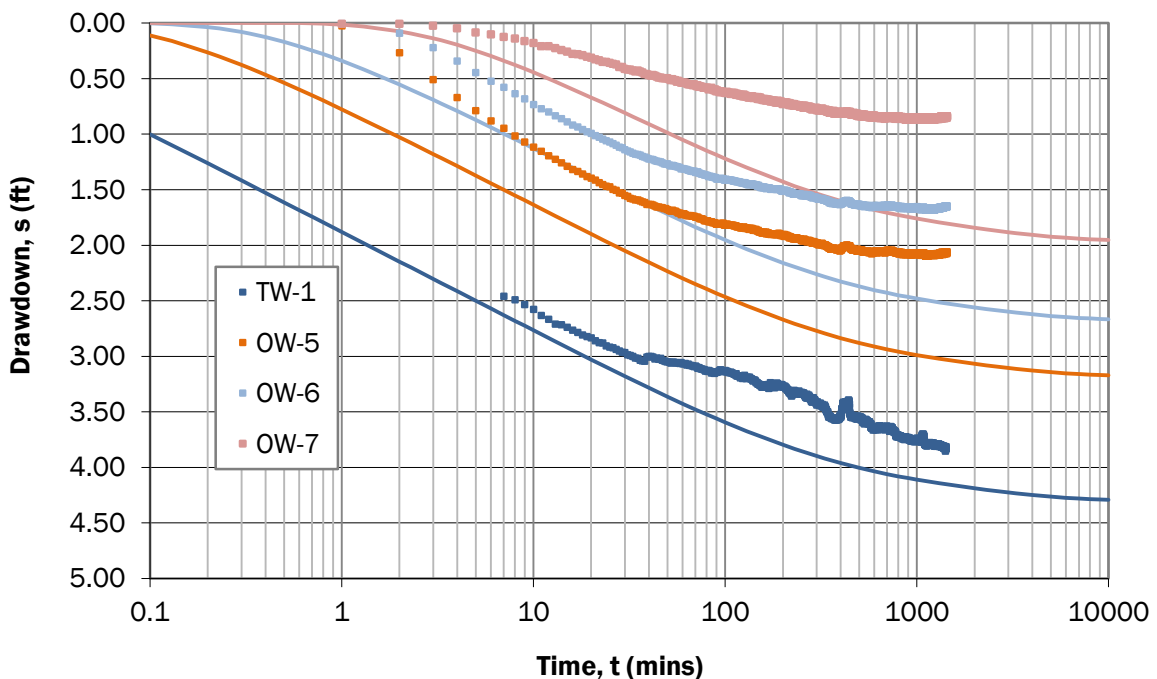
Hunt (2008) Drawdown Analysis - Down-Valley A-A'

Hunt (2008) Drawdown Analysis - Cross-Valley B-B'

1. Drawdown analysis completed using the analytical method presented in: Hunt, B. (2008), "Stream Depletion for Streams and Aquifers with Finite Widths", ASCE Journal of Hydrologic Engineering, Vol. 13, No. 2, 80-89.

The analytical concept is not perfect, and still represents a simplification of the often complex geologic and hydrologic conditions at a real world site; however, it has been found to generally provide a good match to drawdown data observed in monitoring wells located within the cone of depression, and is used as a good model to analyze the effects of pumping from wells that are influenced by an adjacent source of recharge. The results of our analysis using the Hunt (2008) model are shown in Hunt (2008) Drawdown Analysis, Figure 12 and Hunt (2008) Recovery Analysis, Figure 13 and summarized in Table 4 below.
