# Soil Completion Report Alexander Farm Site

March 2005

Alexander Farms Facility  
179101 West King Tull Road  
Prosser, Washington 99350

RCI Job No. 104-001-01

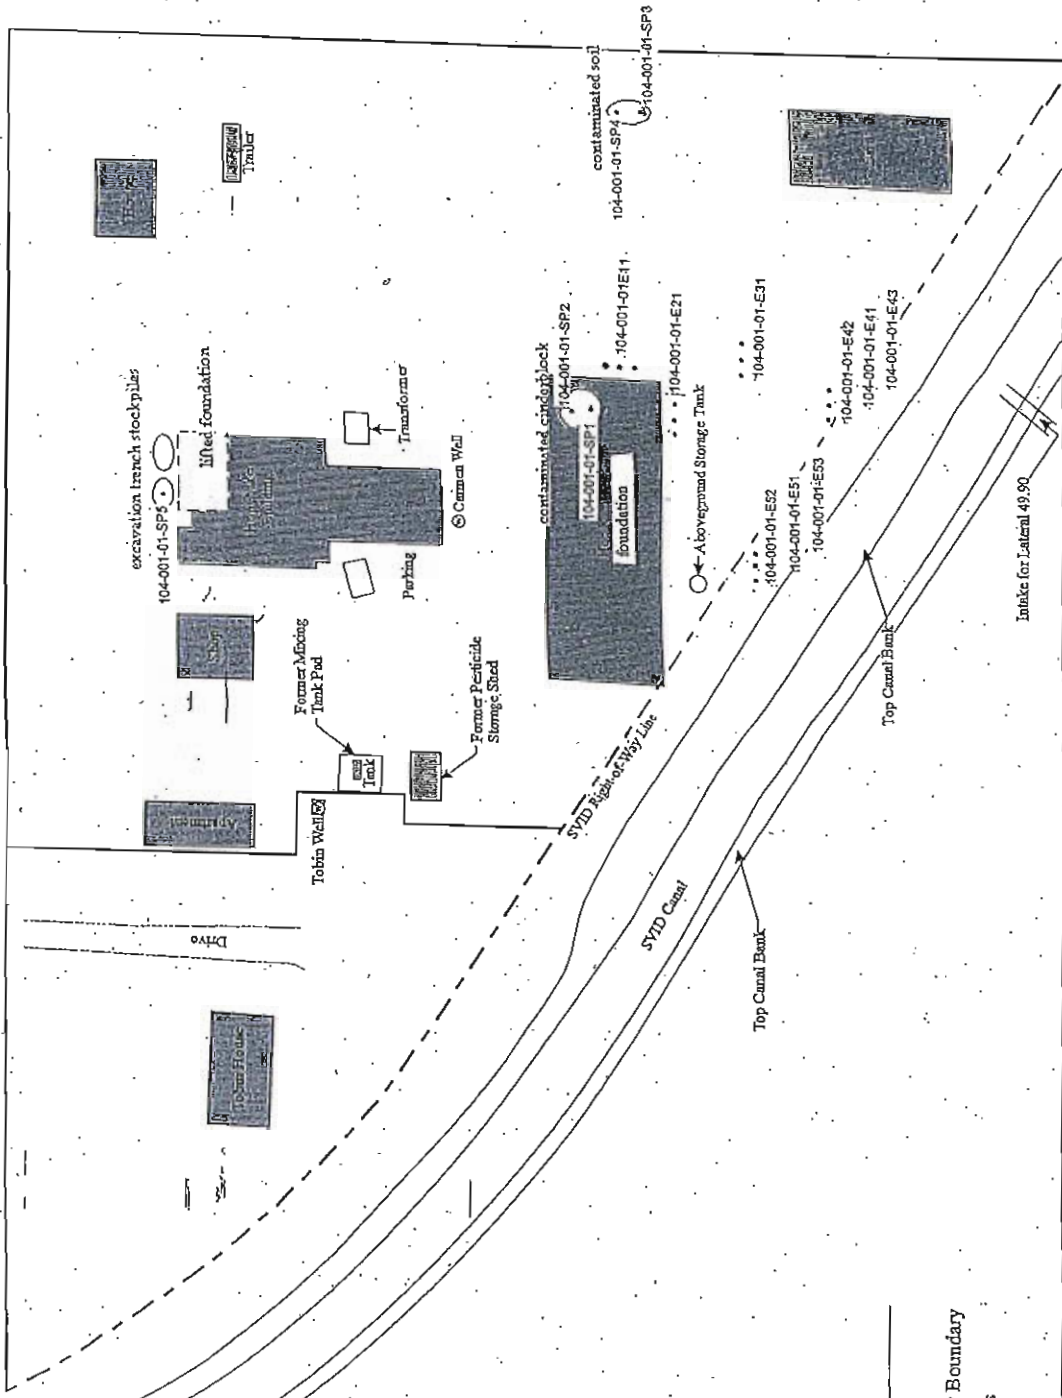
Figure 6-1  
SITE LAYOUT MAP

# Preliminary Soil Sampling Locations, Clean and Contaminated Stockpile Locations

Sample ID (RCI ID#)	Depth
104-001-01-FL2	ND
104-001-01-SW1	ND
104-001-01-SW2	ND
104-001-01-SW3	ND
104-001-01-SW8	ND
104-001-01-FL1	2000
104-001-01-SW4	ND
104-001-01-SW5	ND
104-001-01-SW6	ND
104-001-01-SW7	ND
104-001-01-SP3	11000
104-001-01-SP4	15000
104-001-01-FL3	330
104-001-01-FL4	720
104-001-01-SP5	230
104-001-01-E41	ND
104-001-01-E42	ND
104-001-01-E43	ND
104-001-01-E51	ND
104-001-01-E52	ND
104-001-01-E521	ND
104-001-01-E522	ND
104-001-01-E53	ND
104-001-01-E11	62
104-001-01-E21	ND
104-001-01-E31	7.1
104-001-01-SP1	2300
104-001-01-SP2	10000

Preliminary soil sampling locations were chosen based on previous soil sampling investigations and performed in several areas (Refer to Figure 6-1). The purpose of the preliminary soil sampling was to help delineate the horizontal and vertical extent of remaining dinoseb contamination on site. Upon receipt of analytical data from the preliminary soil sampling, the dimensions for the excavations were calculated. Results of the soil sampling are in the following Table.

According to the results of the preliminary soil sampling, the contaminated cinder block stockpile appears to be the only area of concern. Photodegradation and microbial breakdown may have played a role in reducing the concentration of dinoseb in the soil environment. Due to this apparent dinoseb degradation, the variation in previous soil sampling results compared with current sampling results is reasonable. The time lag between previous soil sampling and current soil sampling of the same areas is approximately four years. This is a sufficient amount of time for the degradation processes to occur.

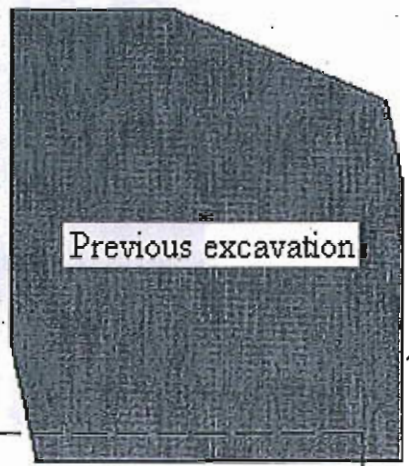
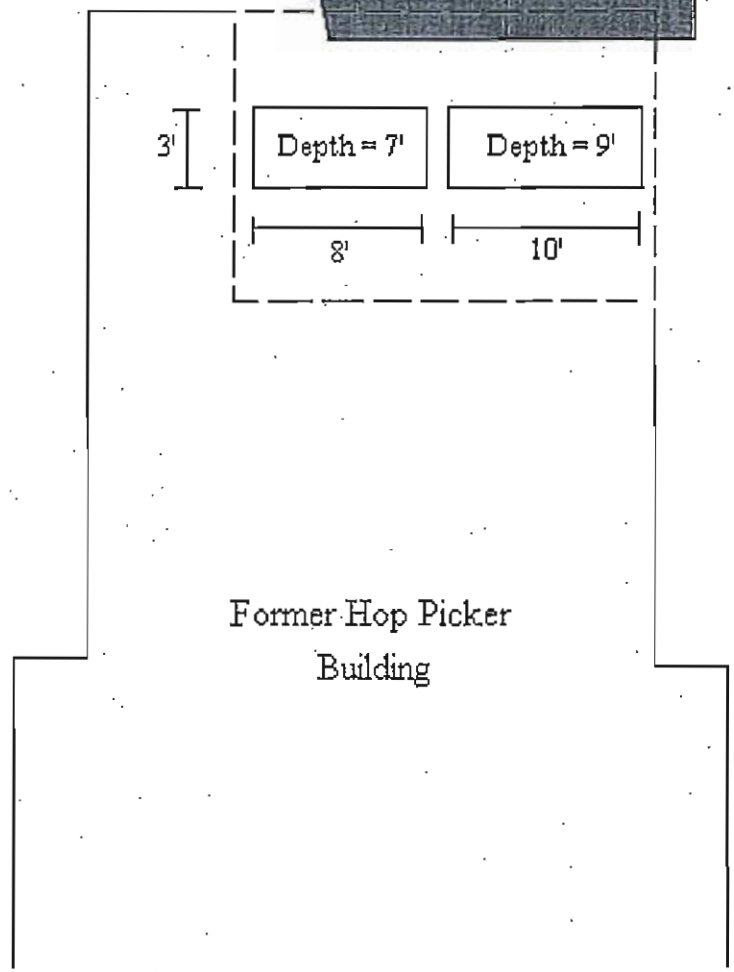
**Figure 6-2**  
**Excavation Trench Locations**

Past excavation done by EPA (has been backfilled)
-

Removed foundation
-

Present excavation trenches

Before sampling could be conducted at the northeast corner of the former hop picker building the foundation had to be demolished. Demolition was

done using the bucket and thumb of KKI's 50,000 lb. excavator. Following the removal of the foundation two trenches were excavated (Refer to figure 6-2). Results of the hop picker building excavation soil sampling are located in Table 6-2.

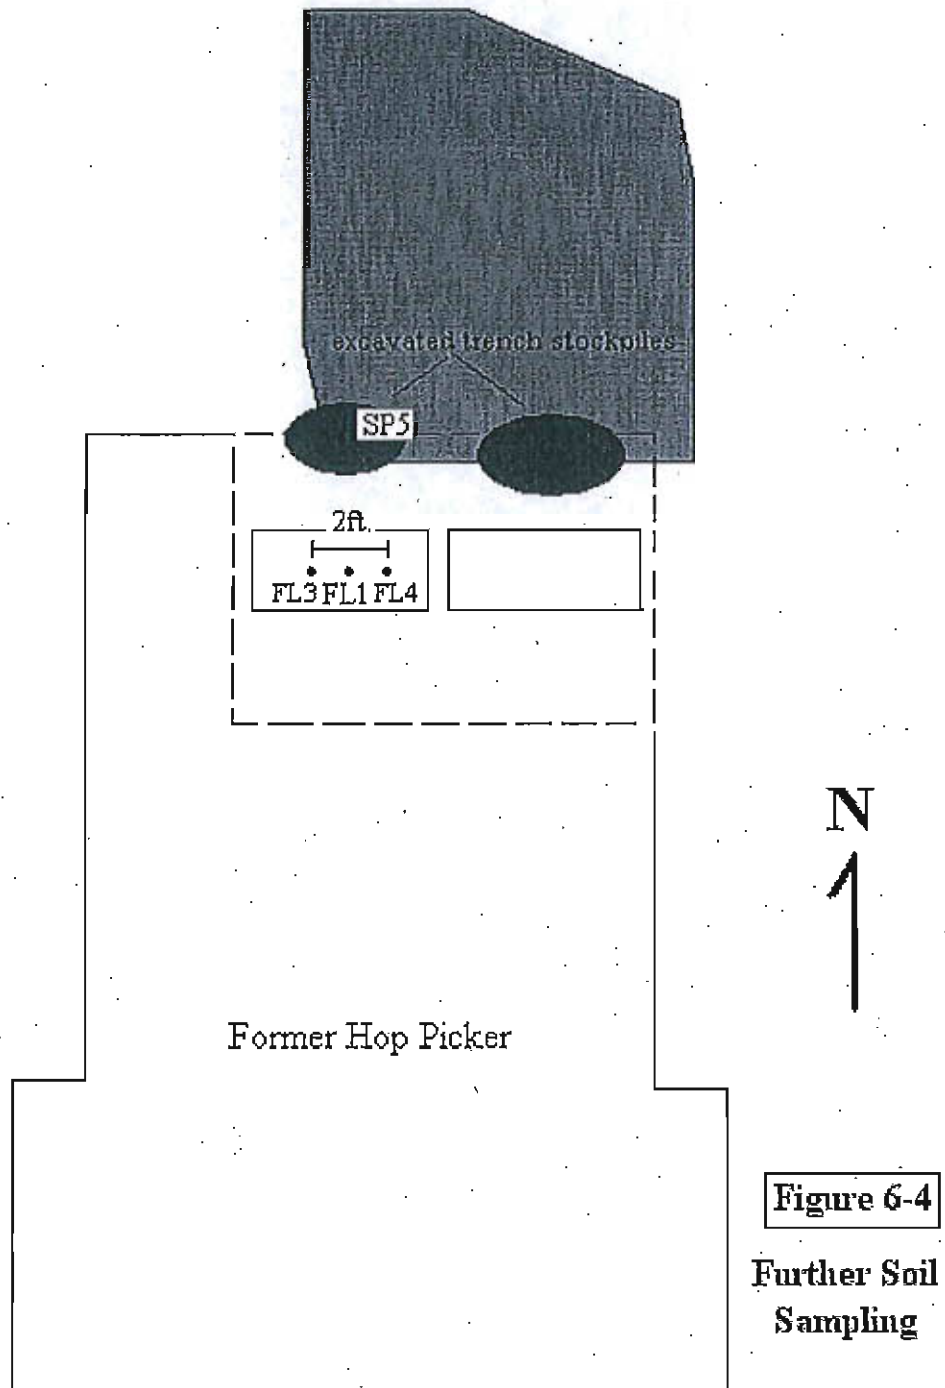
**Figure 6-4**

**Further Soil  
Sampling**

Sample locations can be found on Figure 6-3. According to the results of the sampling, the areas of concern include the old contaminated soil stockpile located on the eastern boundary of the site and sample ID# 104-001-01-FL1. Sample ID# 104-001-01-FL1 was collected 7 feet bgs in the trench excavated under the NE corner of the former hop picker building foundation. This sample exceeded the 1600 µg/kg (ppb) cleanup level for soil by 400 µg/kg (ppb). As a result of the analytical data from this sample, further sampling of this area was performed (See Figure 6-4). Sample ID# 104-001-01-FL3 was taken 1 foot west of Sample ID# 104-001-01-FL1 and Sample ID# 104-001-01-FL4 was taken 1 foot east of Sample ID# 104-001-01-FL1. The additional sampling results concluded this area was actually below the required cleanup level.

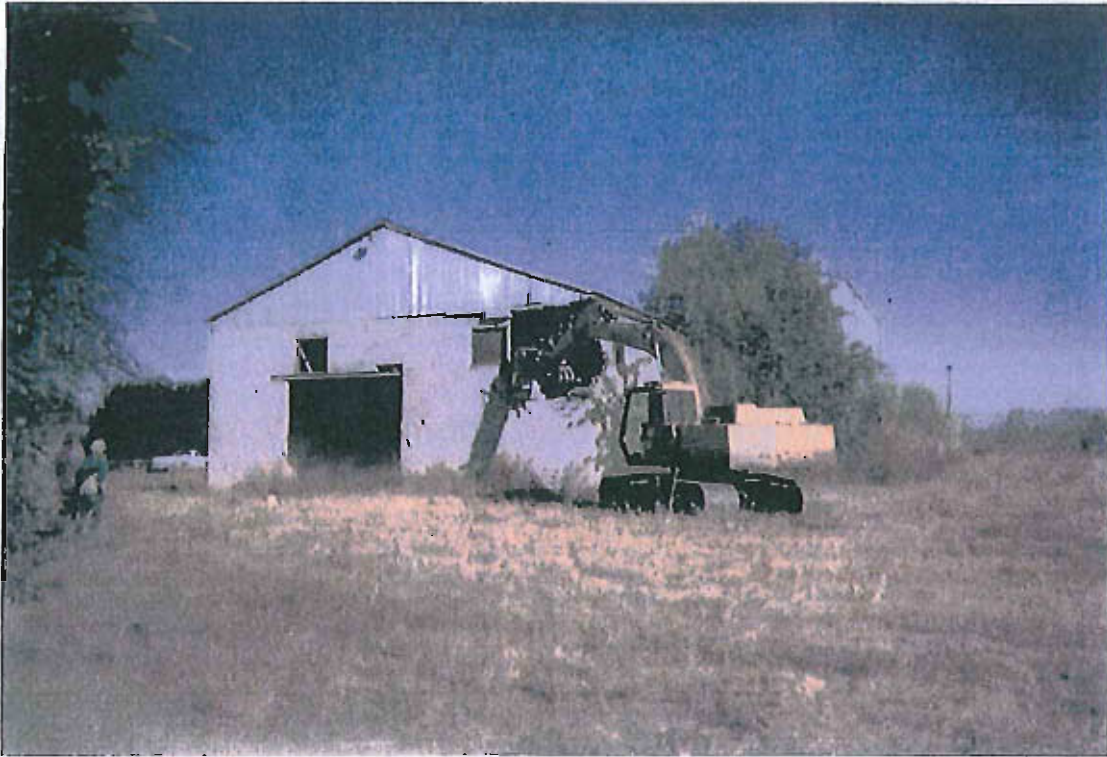
**Photo 1**

Demolition of hop picker building starts at 9:15 am Monday, October 4, 2004.  
Photo taken by Breean Zimmerman

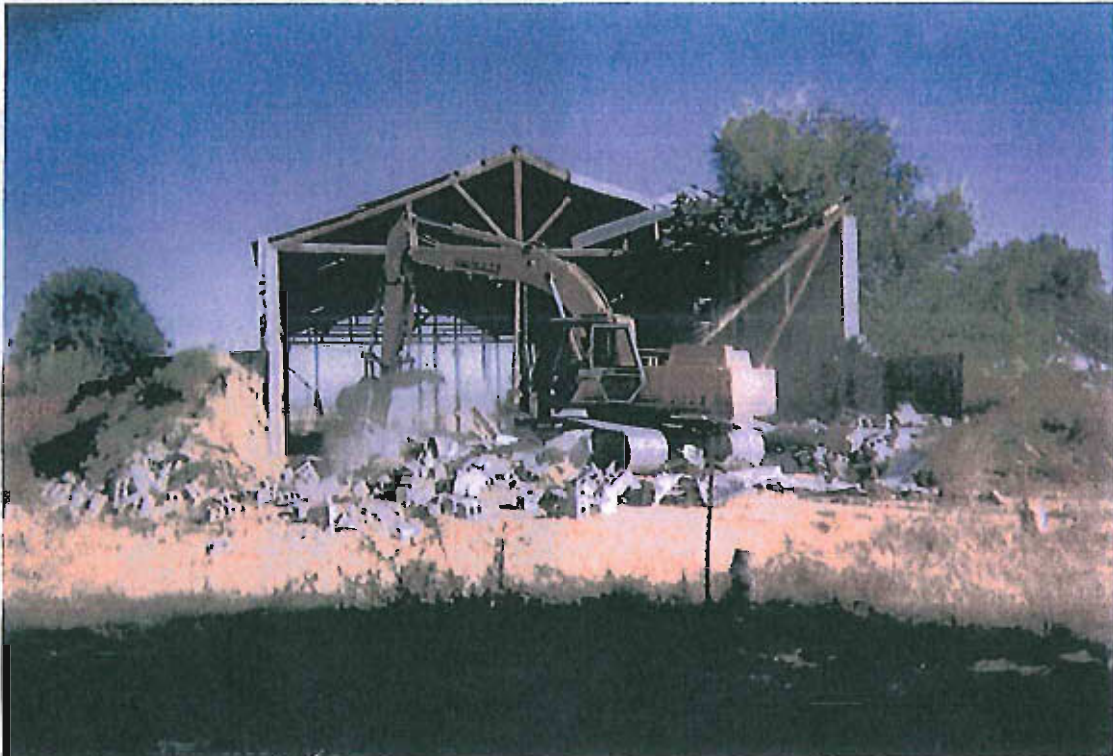
**Photo 2**

Demolition resumes (10/04/04)  
Photo taken by Breean Zimmerman
