RE: Site Cleanup Report
Gibson Road Everett, WA, Property
2328, 2400 & 2402 Gibson Rd
Everett, WA 98204
AEG Project Number: 11-140

Gibson Road Everett, WA - Site Cleanup Project Summary

Client Name: First Citizens Bank & Trust Company
Project Name: Gibson Road, Everett Property – Site Cleanup
Project Address: 2328, 2400, and 2402 Gibson Road, Everett, WA 98204
Dated: October 24, 2012

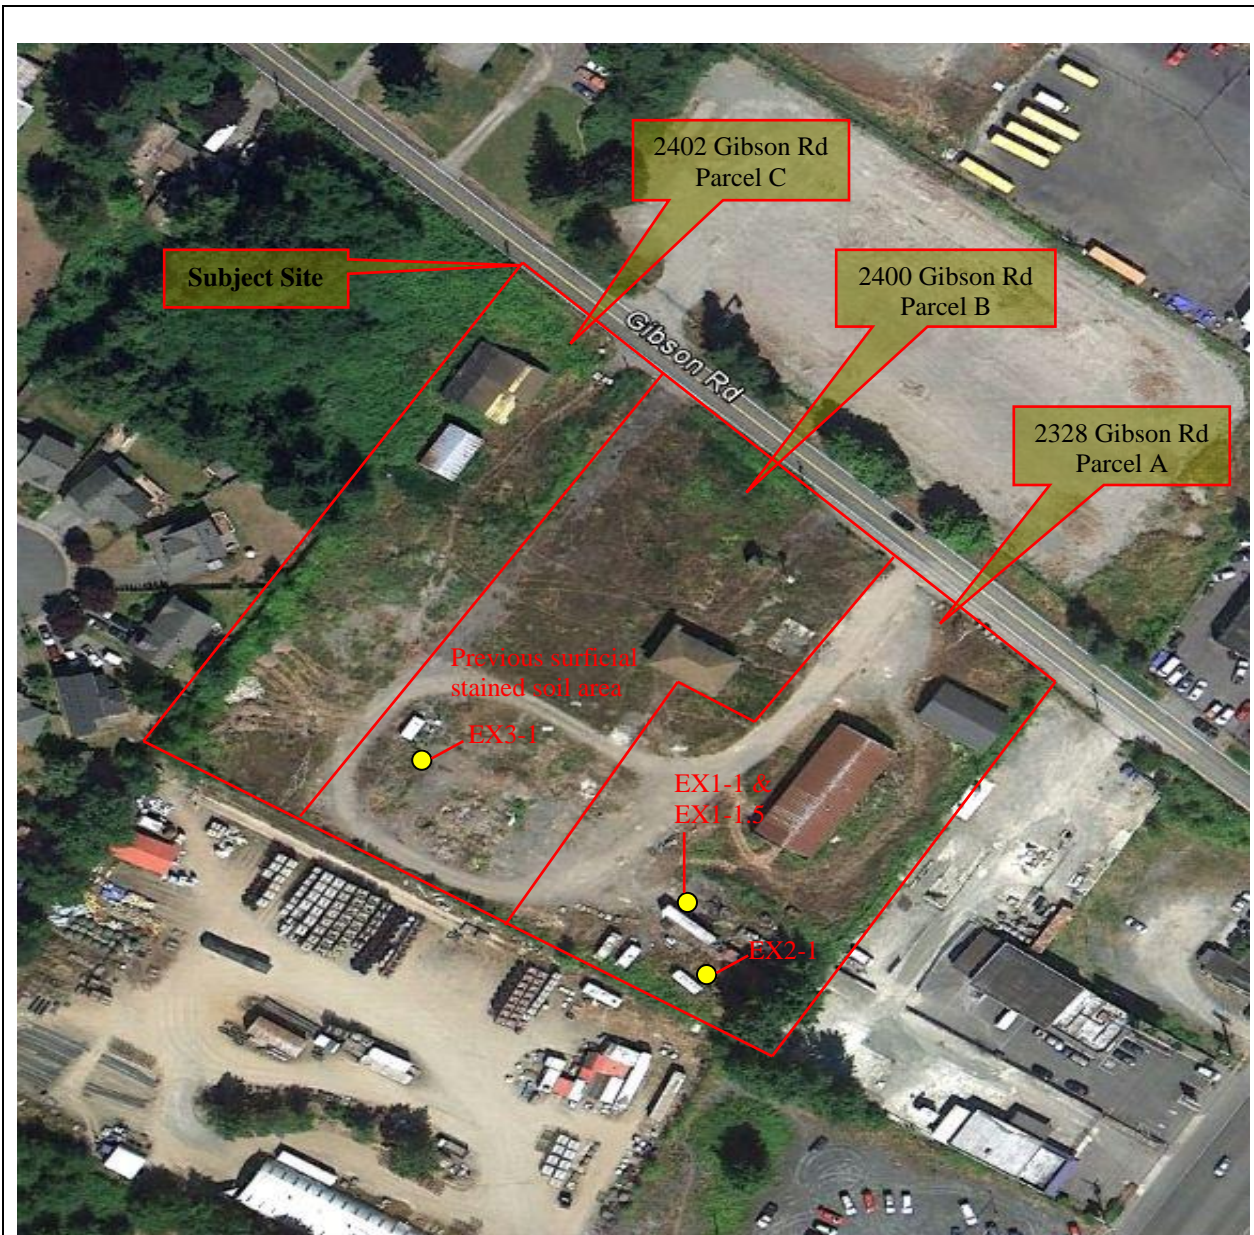
FIGURE 1 - Site Plan & Soil Sampling Locations

- Soil Excavation/Disposal & Confirmation Soil Sampling:
 - AEG provided oversight to Advance Environmental to excavate, remove, and dispose of surficial petroleum stained soil at three areas at the Site (refer to Figure 1, *Site Plan & Soil Sampling Locations*). These excavation and sampling activities occurred in September 2012 with final over-excavation work completed in October 2012.

● Confirmation soil sample at previous surficial stained soil area

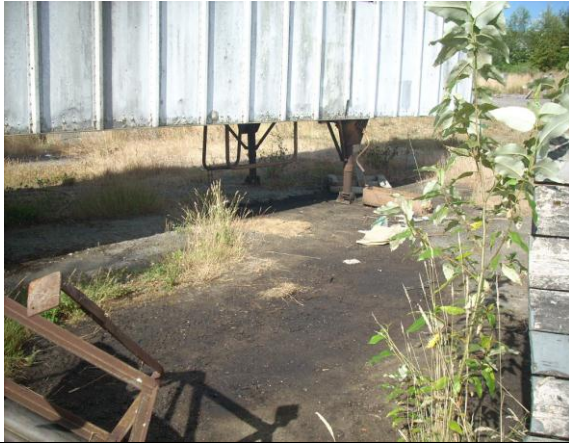
Photo #1: View of surficial petroleum stained soil near southeast corner of Site (see Figure 1, *Site Plan*, for aerial of site and sample location).

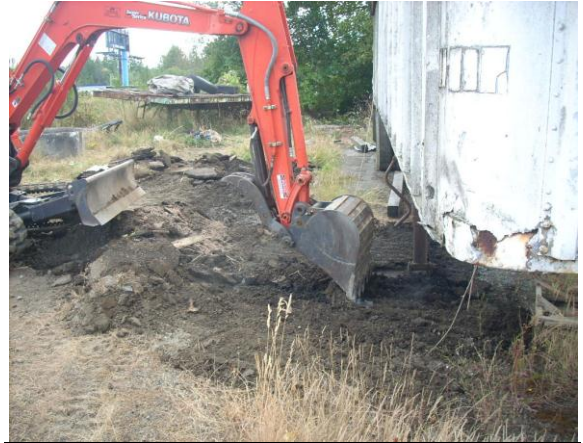
- Heavy oil range TPH (at 4,080 milligrams per kilogram – mg/Kg) was exhibited in soil sample EX1-1. This concentration is above Ecology MTCA Method A soil cleanup level of 2,000 mg/Kg. AEG provided oversight to Advance Environmental for additional soil excavation activities to obtain a secondary confirmation soil sample. The area of concern was excavated to approximately 1.5 feet bgs. A secondary confirmation soil sample, EX1-1.5, was collected on October 15, 2012.

Photo #2: View of petroleum stained soil being excavated and location of soil sample EX1-1 & EX1-1.5.

- Laboratory analytical results showed no presence of total petroleum hydrocarbons in the secondary confirmation soil sample EX1-1.5 (refer to Table 1 and Appendix C, *Laboratory Analytical Results*).

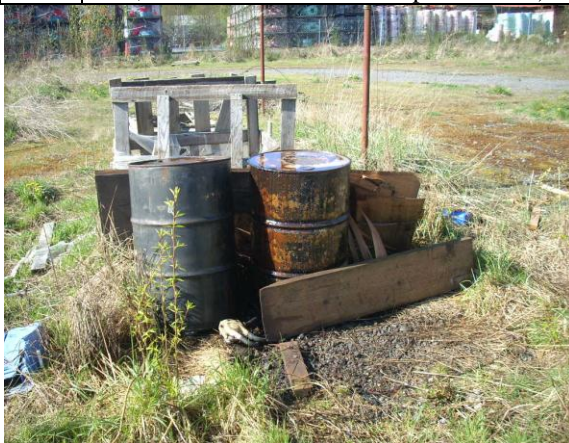
Photo #3: View of two of 12 drums throughout the site and location of soil sample EX2-1.

- Drums Removal/Disposal:
 - A total of 12 drums were removed from the Site and hauled to Advance Environmental on August 24, 2012 and temporarily stored at this facility awaiting final disposal.

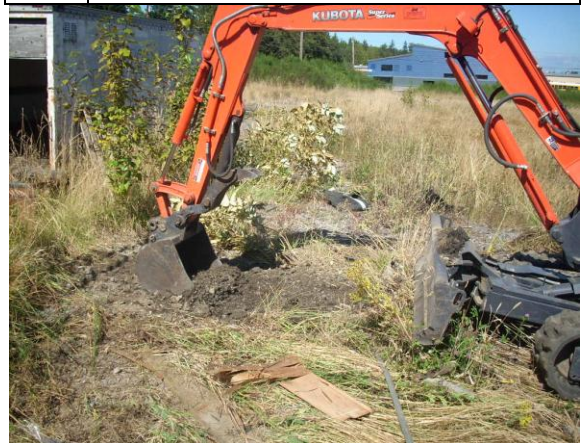
Photo #4: View of surficial petroleum stained soil being excavated at EX2-1.

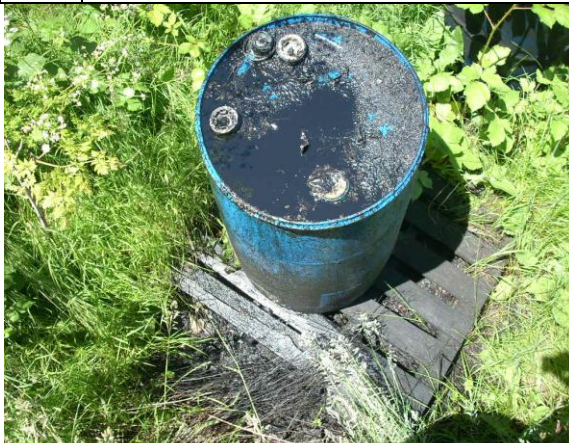
Photo #5: View of surficial staining near southeast corner of subject site and location of soil sample EX3-1.

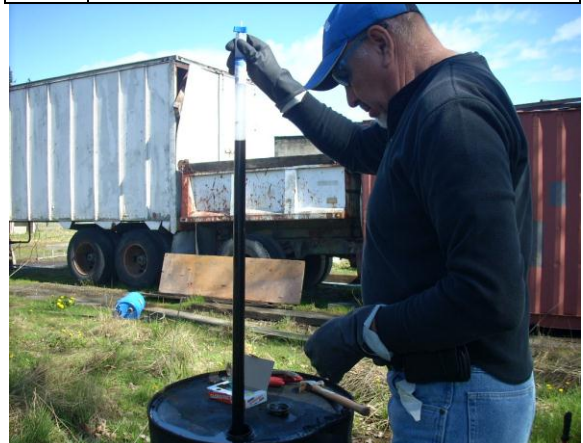
Photo #6: View of onsite drums being profiled for presence of solvents.

- On September 7, 2012, Arcom Oil of Tacoma, WA hauled 250-gallons of waste oil and 175-gallons of chlorinated waste oil which were stored in the drums removed from the Site. These drums were temporarily stored at Advance Environmental (see Attachment B, *Supporting Documents*).

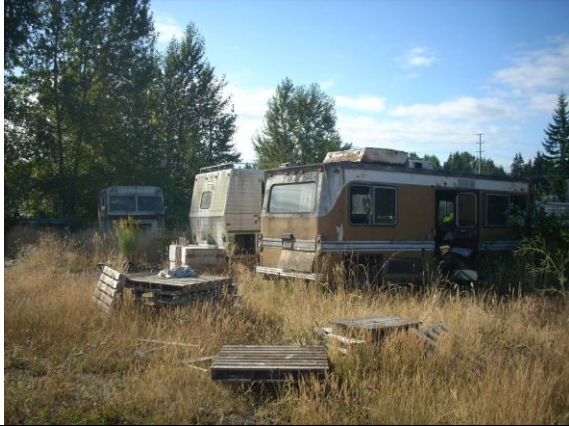
Photo #7: View of three of four abandoned motorhomes removed from Site.

- Junk Vehicles/Connex Containers & Fuel Tanks Removal/Disposal:
 - Advance Environmental coordinated with Top Dog Auto Removal to dispose of the following junk vehicles: 1) a 1960's Chevy C30 truck with boom; 2) three RVs/motorhomes single axles; 3) two homemade trailers; 4) two flat deck old military trailers; and 5) one semi-trailer, 40 foot in length. These vehicles were transported to NW Auto Recyclers in Lake Stevens, WA. Photo documentation of junk vehicles is presented in Appendix A. Appendix B provides documentation of the junk vehicles disposal.

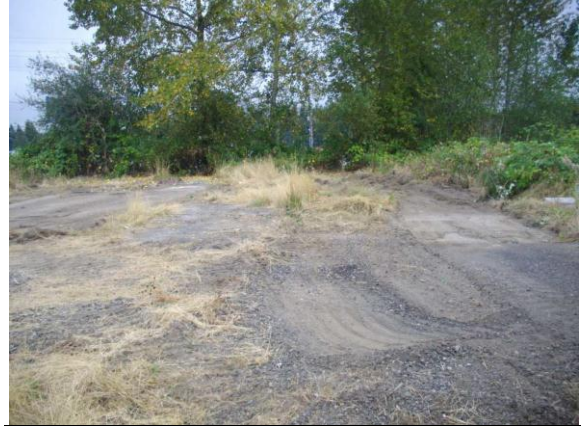
Photo #8: View after the three motorhomes and miscellaneous junk were removed.

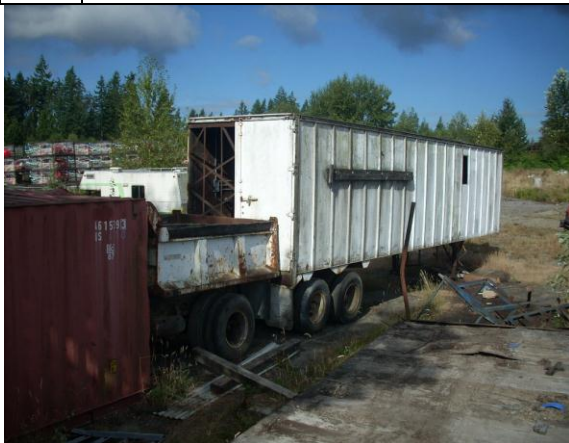
Photo #9: View of two of the three cargo/shipping (Connex) containers removed from the Site.

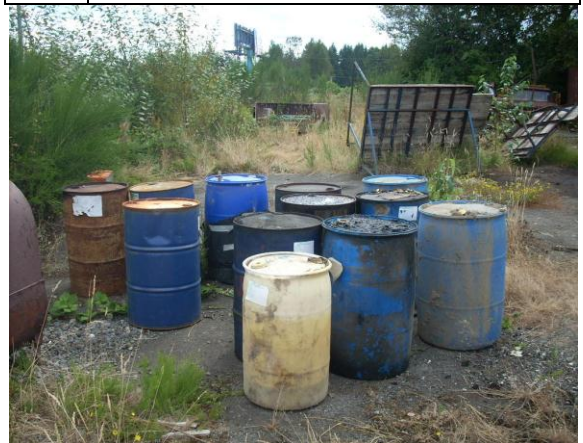
Photo #10: Representative view of drums found throughout the Site.

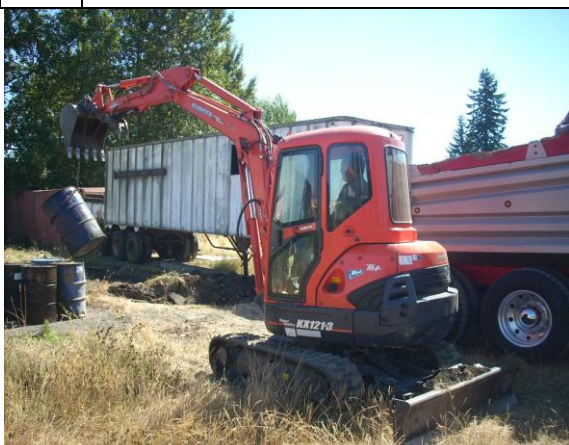
Photo #11: View of onsite drums being loaded into dump truck for removal.

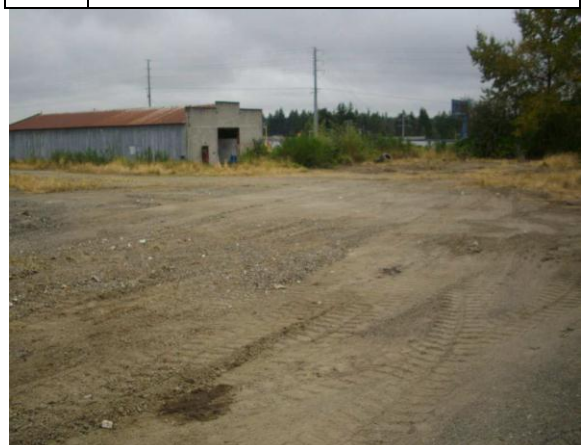
Photo #12: View looking east near southeast corner of Site following Site cleanup.

The Site poses no further environmental concerns due to the removal of drums, junk vehicles, solid waste, and over-excavation and removal/disposal of surficial stained soil (based on laboratory analytical results of confirmation soil samples). Furthermore, AEG provided oversight to Advance Environmental and coordinated with First Citizens Bank to establish a solid blockage to the Site via setting up Ecology concrete blocks along the northern property boundary (i.e., Gibson Road) to prevent further illegal access to the property for potential disposal of miscellaneous waste.
