## Phase II ESA – Subsurface Investigation

**2328, 2400 and 2402**  
Gibson Road  
Everett, Washington 98204

AEG Project #: 11-140

Date of Report: October 17, 2011

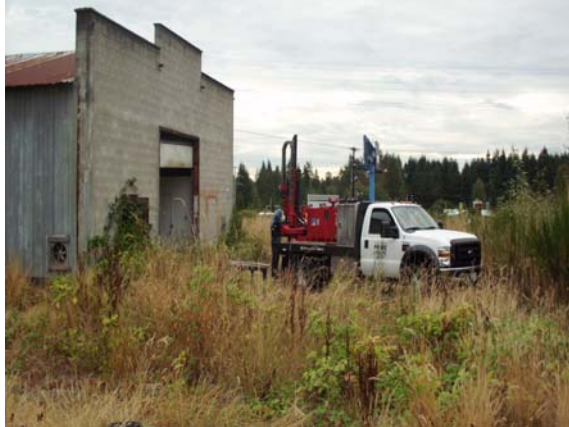
**Photo #1:** Direct push probe drilling at boring B-3 located on Parcel A. Note: former auto body shop to left. View looking east.

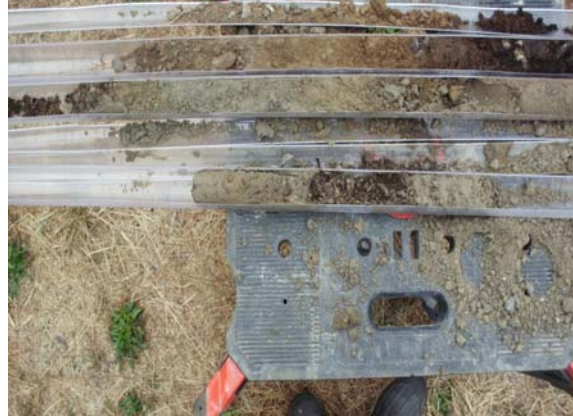
**Photo #2:** Soil profile from boring B-3 showing medium dense silty sand at surface (top right) which grades to stiff silt and very dense grey silty sand bottom right (refusal at 13 ft bgs)

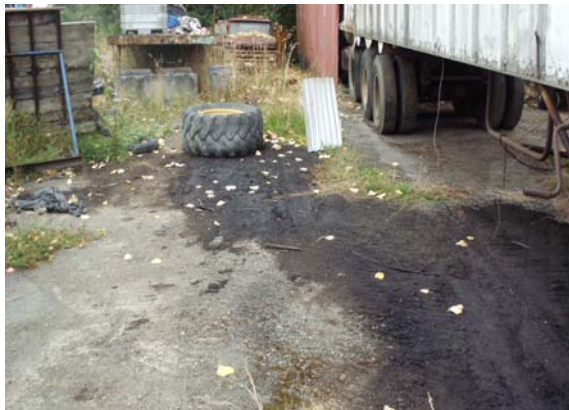
It appears at areas where surficial soil staining was observed that the surficial soil contamination is localized in depth (less than 1.0 foot) based on laboratory results. AEG collected soil samples at locations where surficial soil staining was observed, specifically at borings B-10 through B-13 at depths of 1.0 to 1.5 feet below ground surface. Laboratory analytical results indicated no detections of petroleum hydrocarbons in all these samples.

**Photo #3:** Surface stain south of former auto body shop in Parcel A. Sampling location B-13 bottom right in picture. View looking east.

The scope of work for this Phase II ESA was not intended to define the lateral and vertical extent of contamination, if encountered, at the Site due to its preliminary investigative nature. Therefore, at locations of surficial soil staining, AEG recommends removal of surficial soil, up to 2 to 4 inches, at these locations and disposal at appropriate landfill.

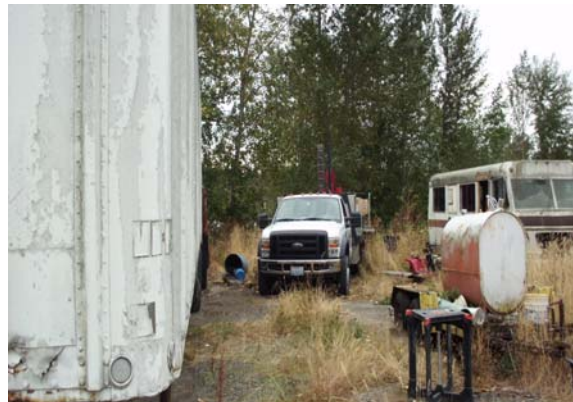
**Photo #4:** Direct push probe drilling at boring B-4 in southeast portion of Parcel A where stains on ground and unlabelled containers and 55 gallon drums were documented. View looking east.

AEG also recommends that drums, containers, and abandoned vehicles parts/vehicles should be removed from the Site. The storm water system at the property should also be identified and assessed for potential environmental concerns.

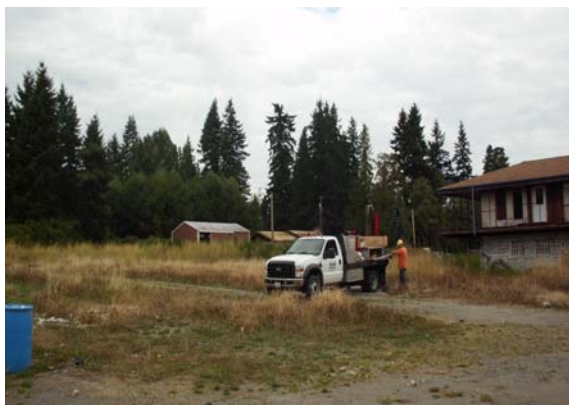
**Photo #5:** Direct push probe drilling at boring B-2 on Parcel B in vicinity of diesel fuel spill and former auto wrecking yard. View looking northwest.

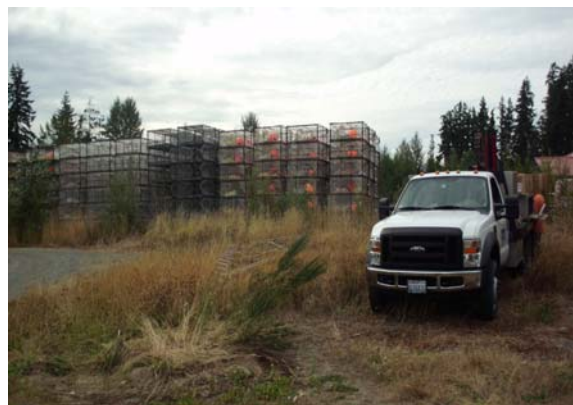
**Photo #6:** Direct push probe rig drilling at boring B-6 in Parcel C where documented hazardous materials were spilled on ground. View looking south.

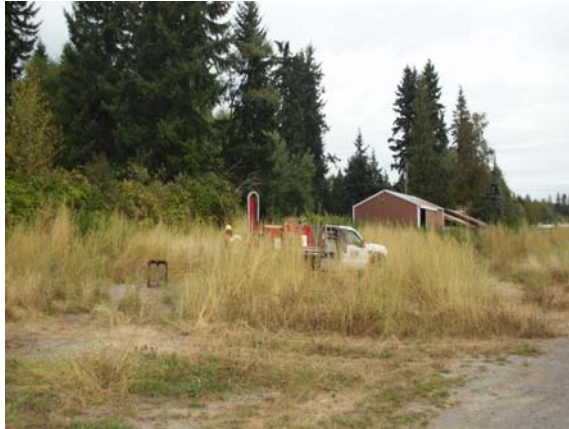
| Photo #7: | Direct push probe rig at boring B-7 in west central Parcel C. View looking north. |

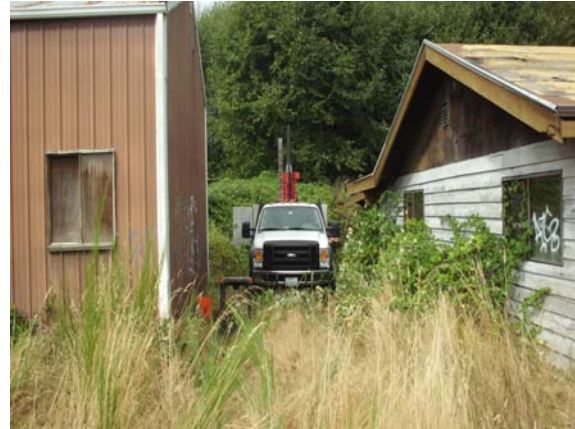
| Photo #8: | Direct push probe located at boring B-1 in the northwest portion of Parcel C where dumping of unknown materials occurred. View looking west. |

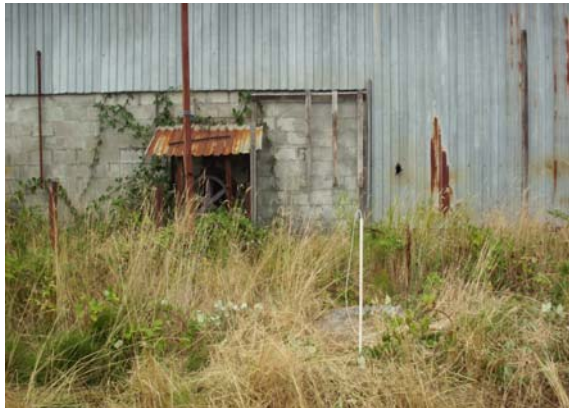
- AEG attempted to collect groundwater samples at borings B-3 and B-14 by placing a temporary PVC screen into each borehole for a minimum of two to four hours. However, AEG did not encounter any groundwater at the bottom of the borings. The lack of groundwater is most likely due to the presence of glacial till.

| Photo #9: | Temporary PVC screen placed in boring B-14 to attempt groundwater sampling in east central portion of Parcel A. Note: former auto body shop in background. View looking west. |

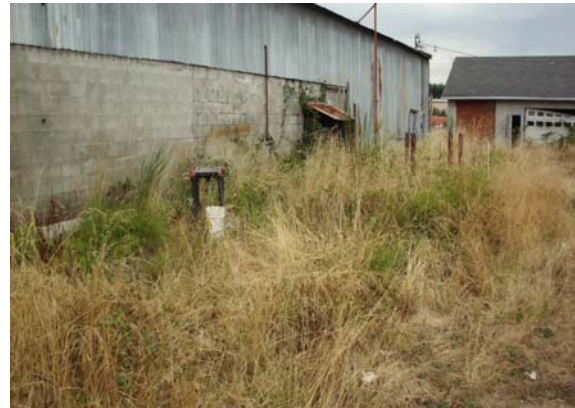
| Photo #10: | Boring B-8 (center in picture) in east central portion of Parcel A and adjacent to former auto body shop. View looking north. |
