# FINAL CLEANUP REPORT

**L&E AUTO SALES PROPERTY  
2101 BURWELL PLACE  
BREMERTON, WASHINGTON  
ECOLOGY FS ID: 14170/ CS ID: 11943**

**Project No. ESC13-E002  
July 21, 2013**

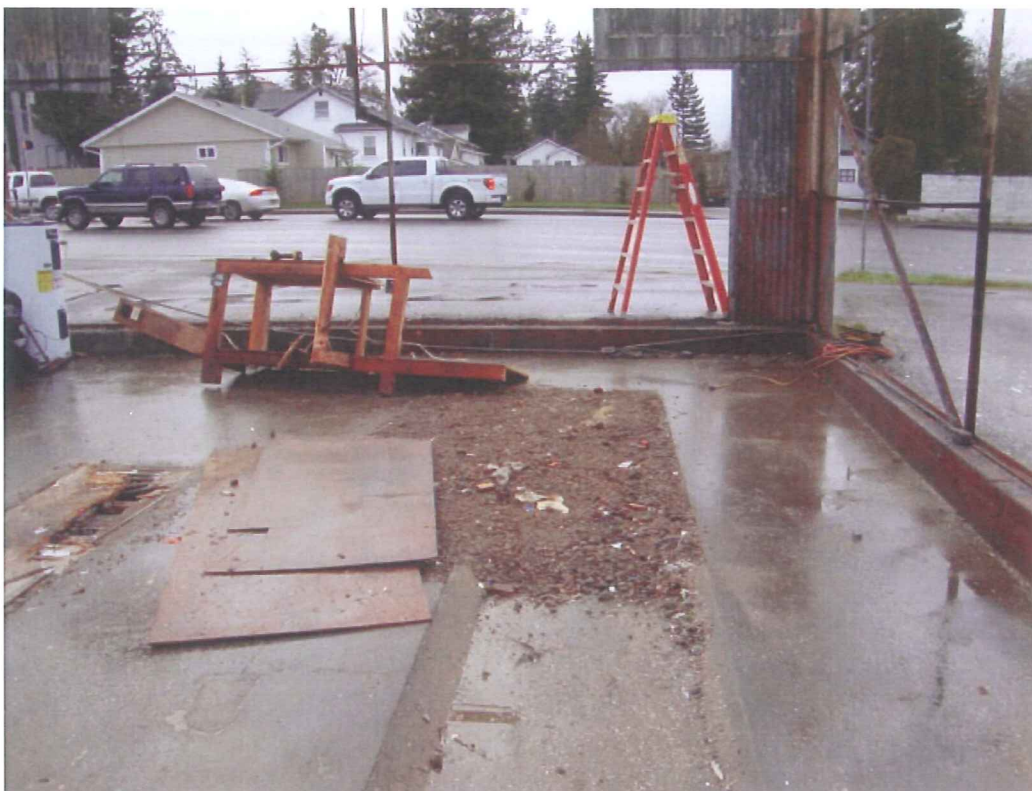
Photo 1: Former waste oil UST location in garage building. Building in process of being demolished.

DLH supervised the removal of a waste oil tank and a hydraulic lift in the small garage building. EnviroSound collected two samples from beneath the (former) garage building as well as one soil sample just outside (north) of the garage in the area of geoprobe B-1. Soil sample results were all below the detectable limits for heavy hydrocarbons. No stained soils or odors were observed during the excavation process.

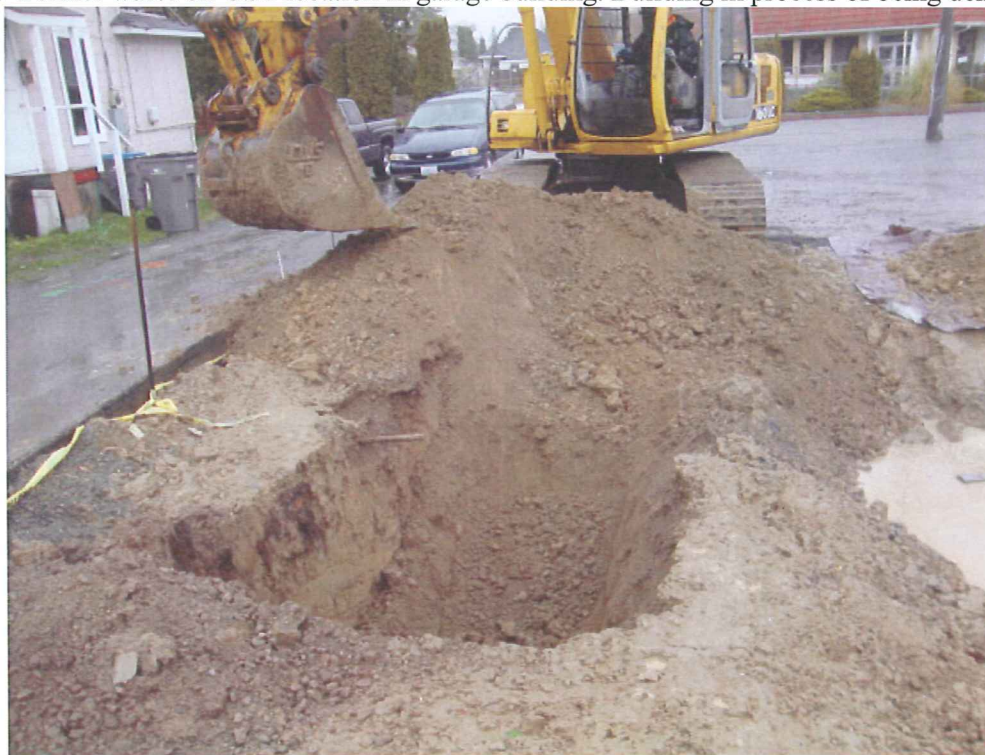
Photo 2: Excavation in former waste oil location.

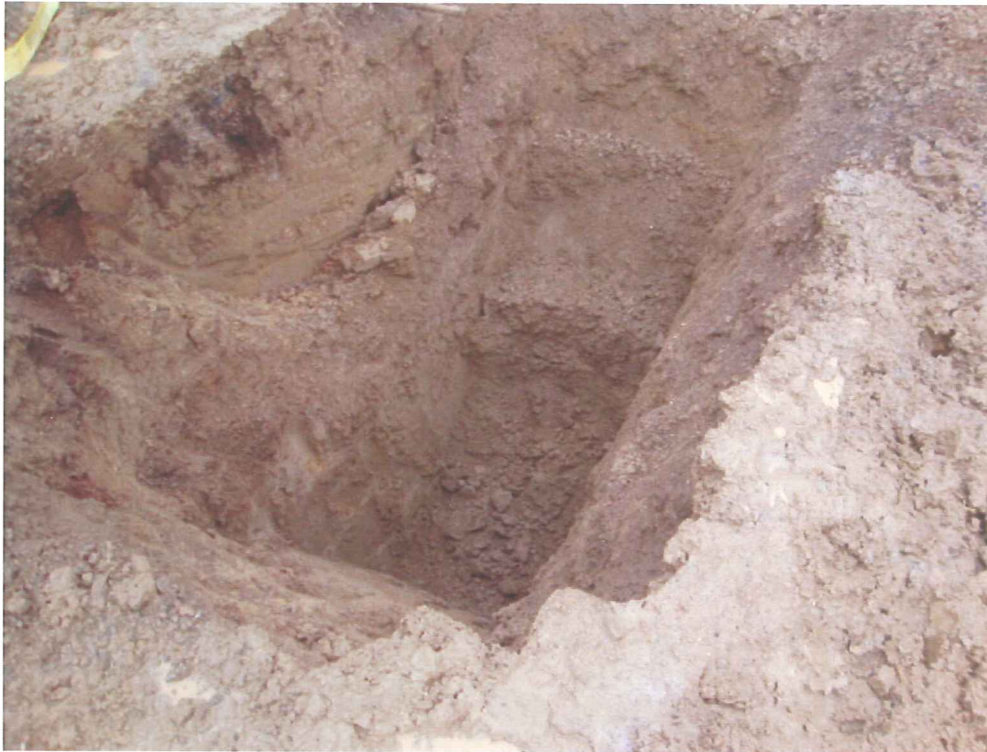
Photo 3. Sampling locations in the former waste oil UST area.

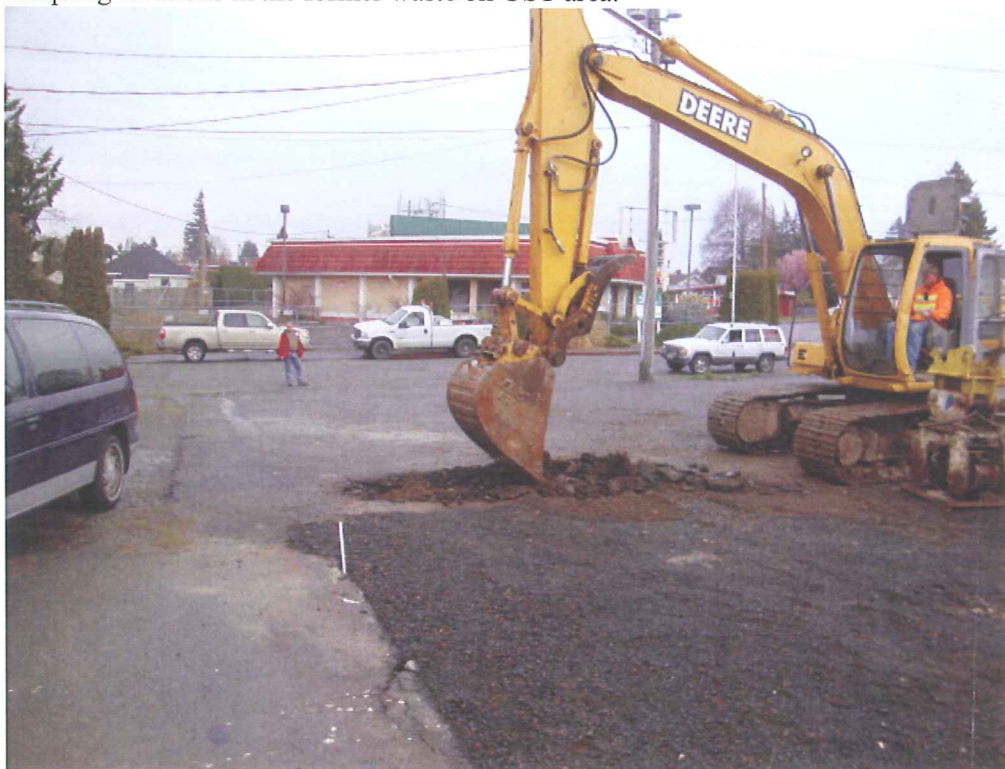
Photo 4. Begin excavation in the test pit outside the former garage building footprint.

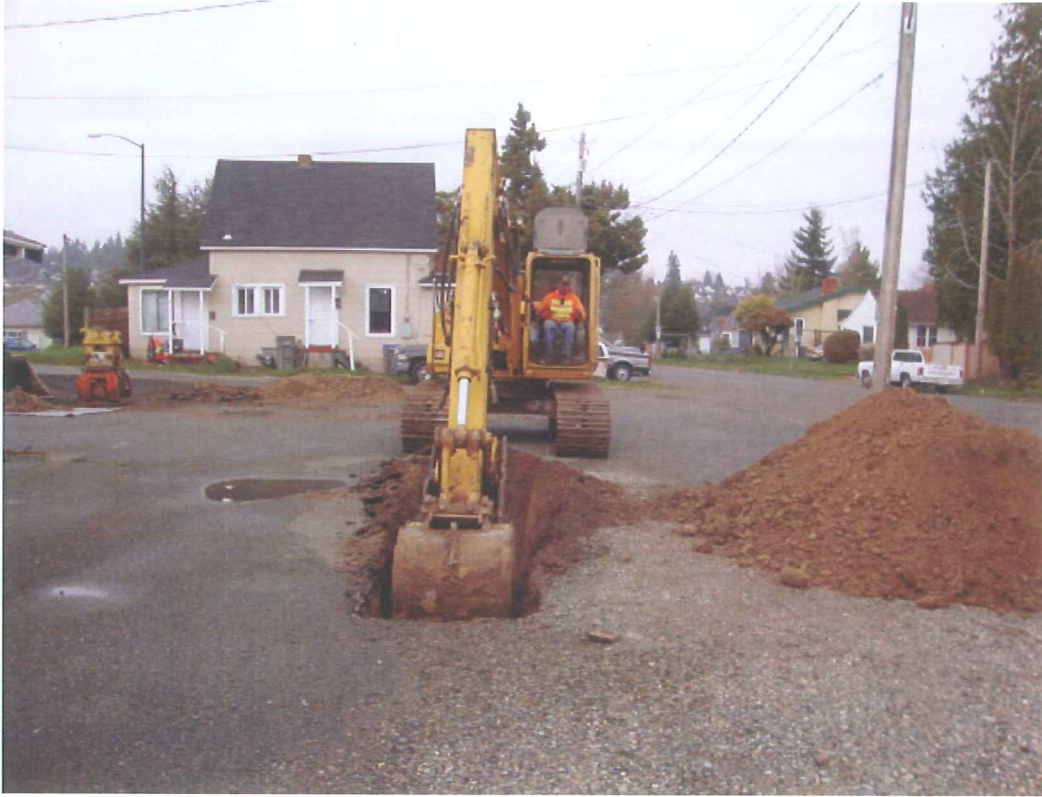
Photo 5. Excavation in the area of the former USTs.

DLH supervised the excavation and removal of three fuel UST's and 75.95 tons of PCS on the northeast corner of the subject property. A confirmation sample in the south portion of the UST excavation and the west portion of the excavation were above Ecology cleanup level guidelines. Both samples were approximately 14.0 feet in depth. EnviroSound supervised the excavation of a trench in the elevated sample areas. No visible evidence of PCS was observed and no petroleum odors were noted during excavation. Soil samples were collected at 15.0 feet to 16.0 feet below existing grade with soil sample results for Gas and BTEX below detection limits.

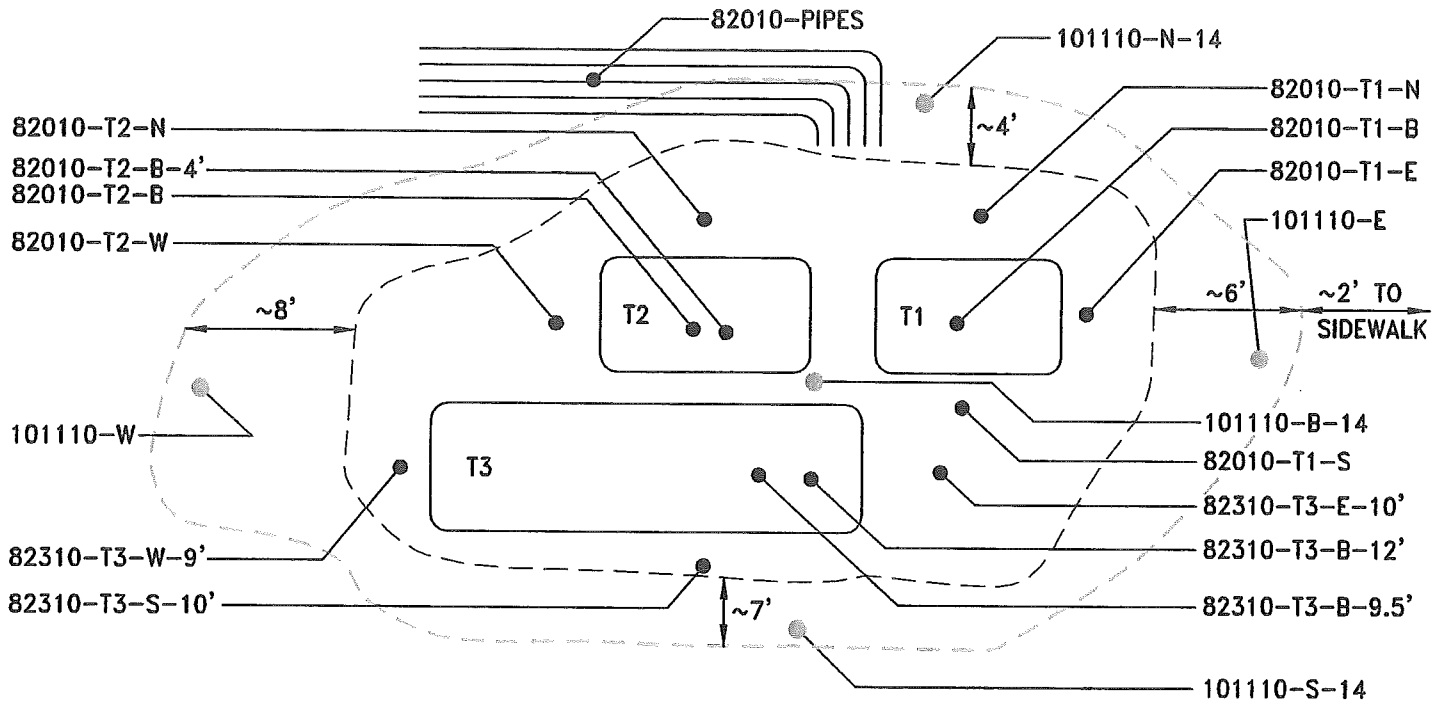
**UNDERGROUND STORAGE TANK REMOVAL**

Product lines were discovered during exploratory digging on the northeast corner of the site. The lines were exposed, and three major product lines and vent lines were unearthed. The product lines were followed until the tops of three (3) USTs were found. The tops of the USTs were exposed, then the tanks were inerted with dry ice and subsequently removed from the ground. The first two USTs (Tank 1 and Tank 2) were completely empty. Tank 3 had a little water in the bottom but all three tanks were in poor, rusty condition and full of holes.

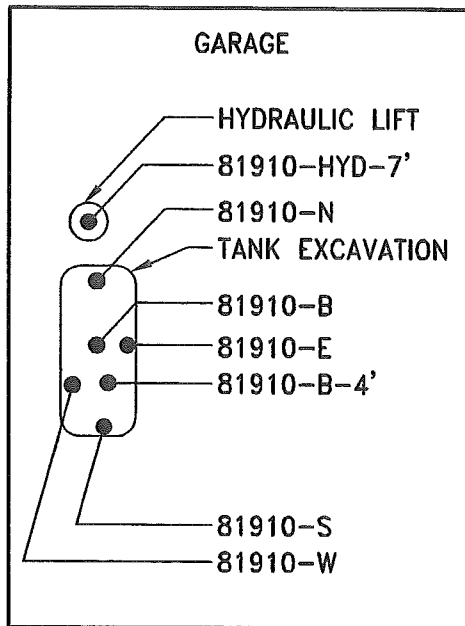
FIGURE 3  
 AUGUST-OCTOBER 2010

**WASTE OIL TANK & HYDRAULIC LIFT REMOVAL**

- - - - - FINAL OVEREXCAVATION
- - SOIL SAMPLE LOCATION
- - FINAL CONFIRMATIONAL SOIL SAMPLE LOCATION

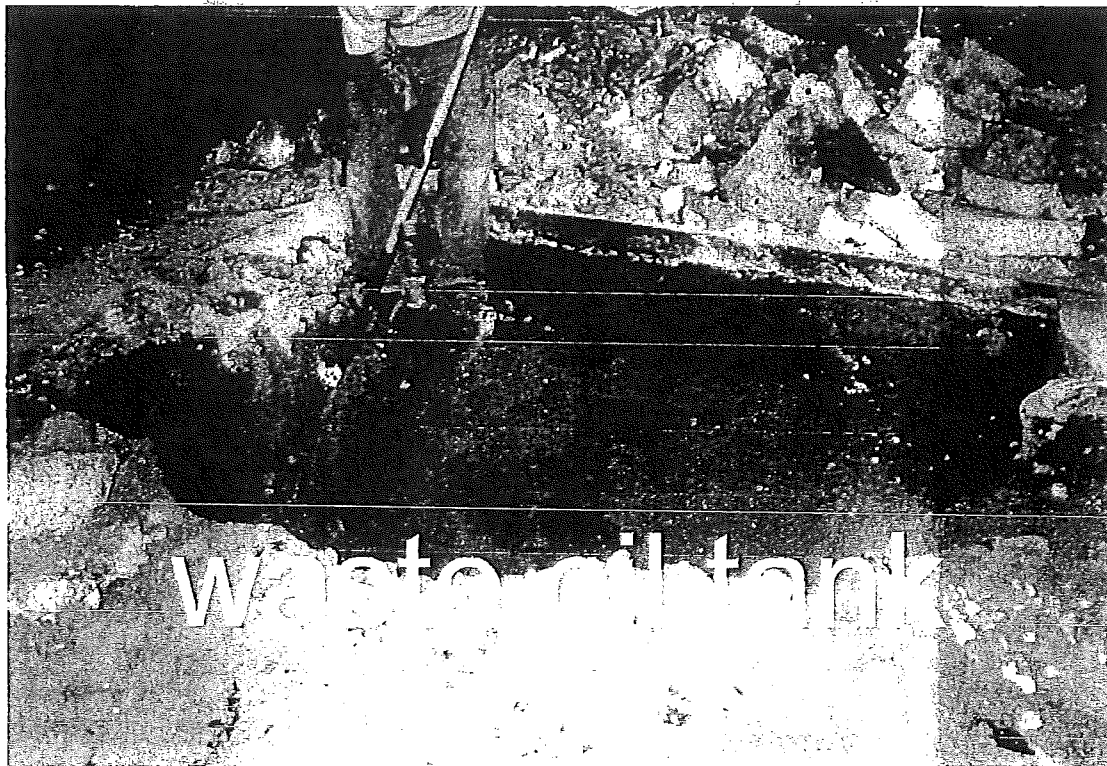
**waste oil tank**

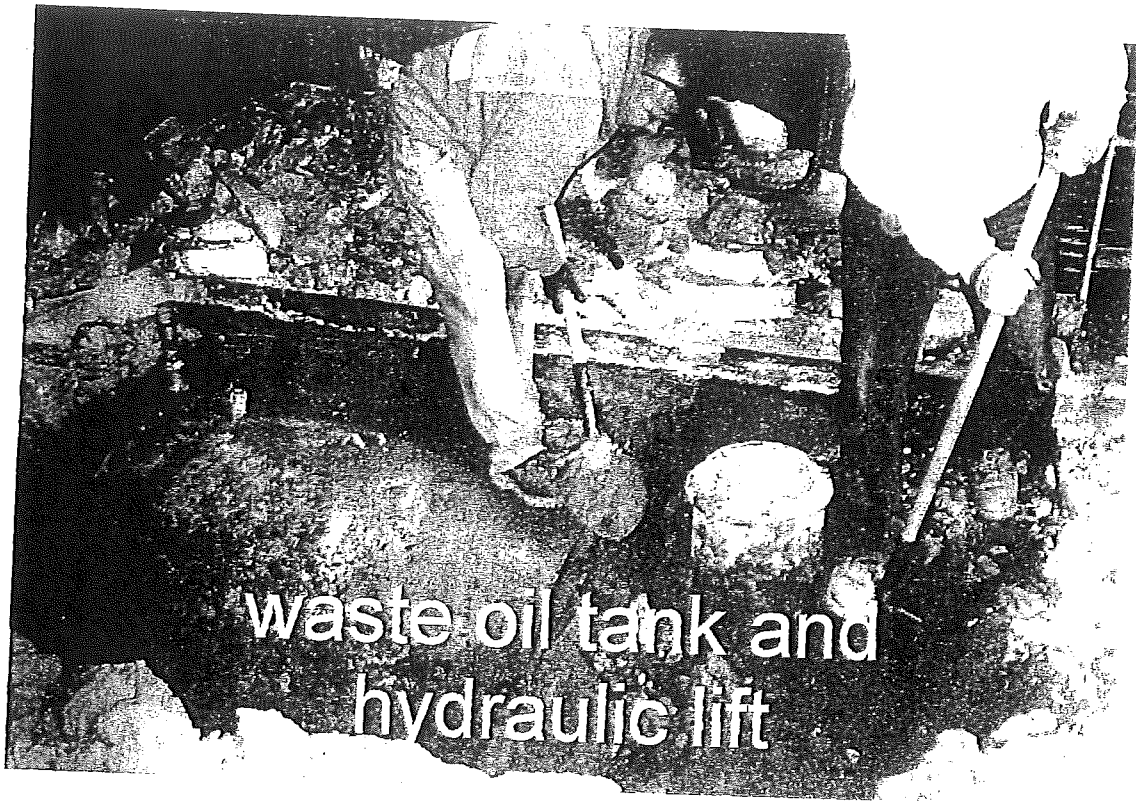
waste oil tank and  
hydraulic lift

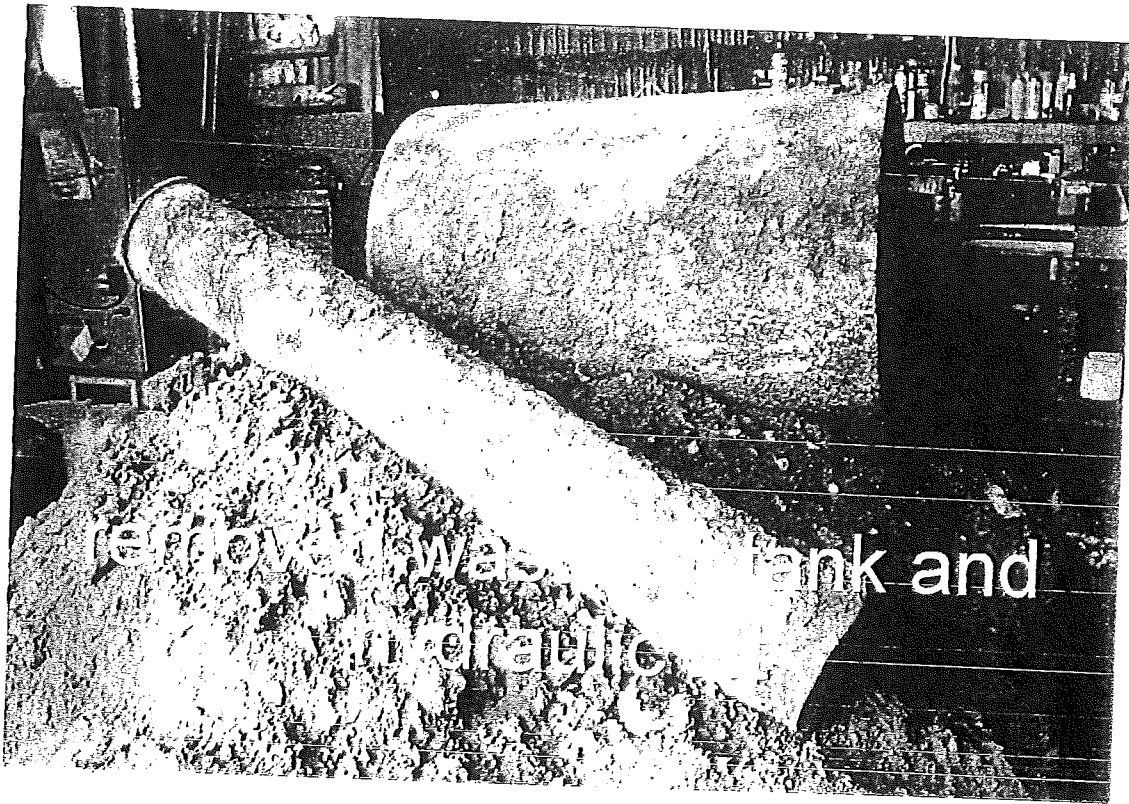
waste oil tank and  
hydraulic lift

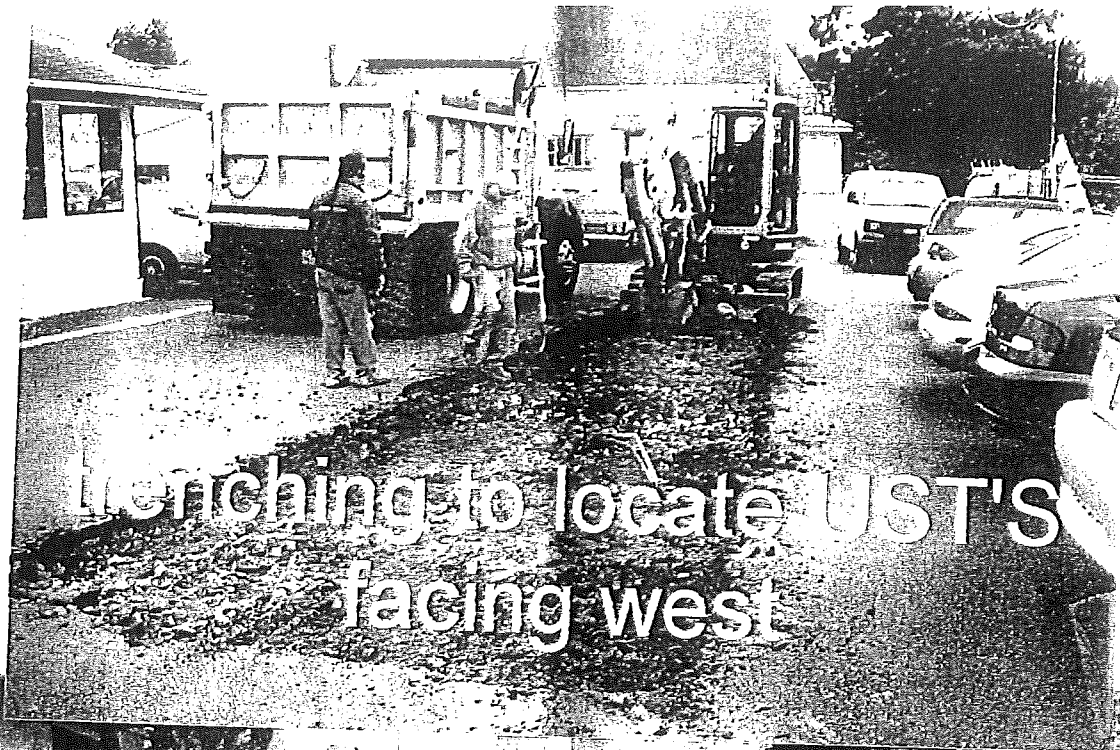
trenching to locate UST'S  
facing west

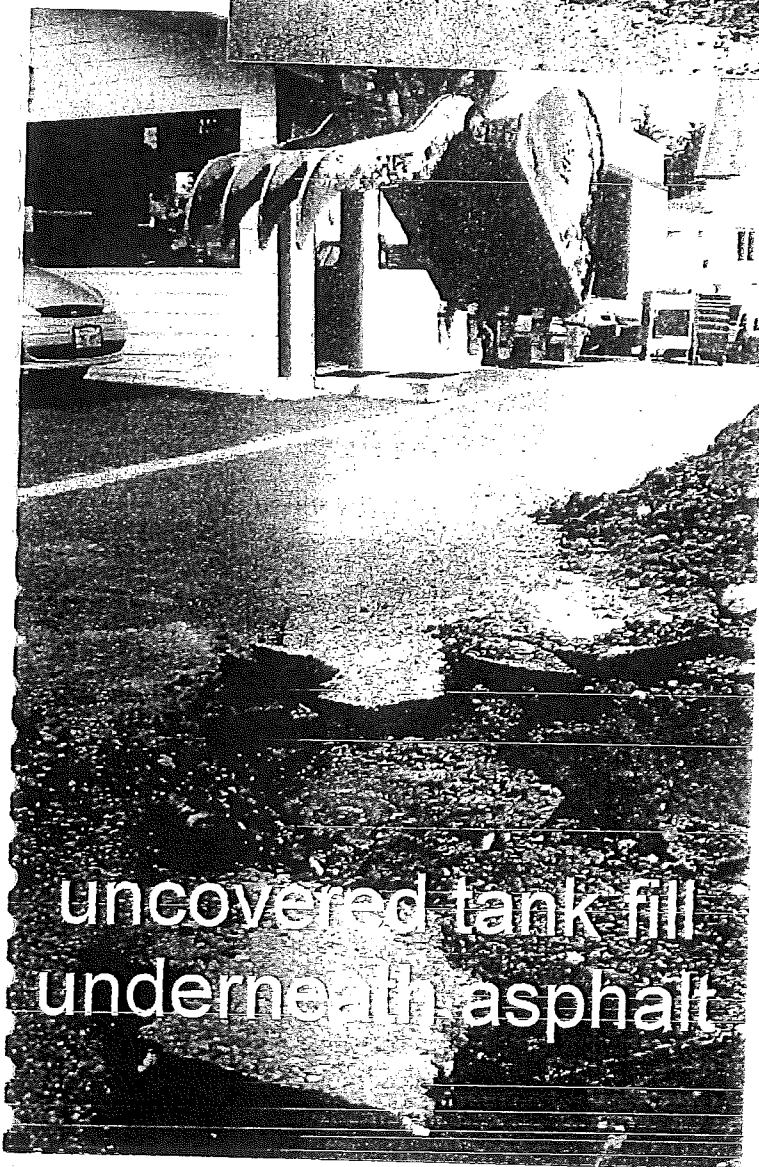
uncovered tank fill  
underneath asphalt

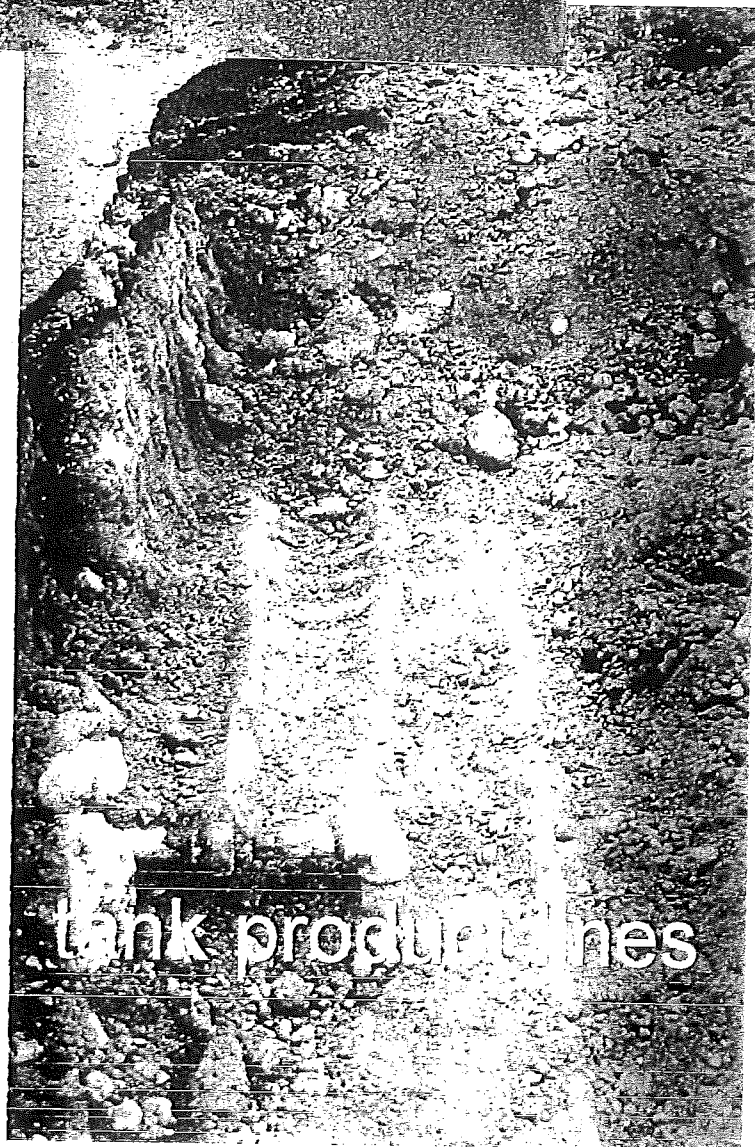
tank propellant lines

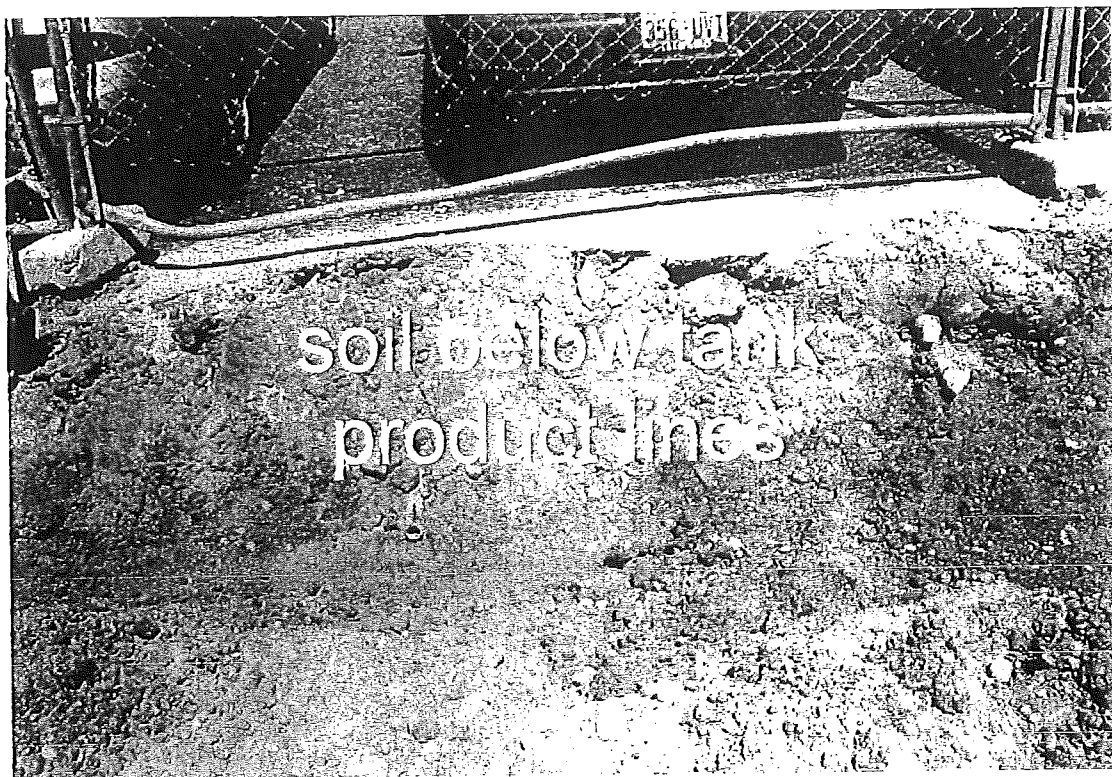
soil below tank  
product lines
