**FINAL REPORT
US BANK FACILITY
RICHLAND, WASHINGTON**

**Prepared for:
Dean Hull, Project Manager
David Evans and Associates
Portland, Oregon**

**By:
Michael Black, P.E., R.E.A.
E.P. JOHNSON CONSTRUCTION INC.
Kennewick, Washington**

This report describes findings to date, actions taken, and the recommendations associated with a site assessment for the decommissioning of underground storage tanks at the U.S. Bank Facility at 701 Stevens Drive in Richland, Washington. The site walk-through portion of the site assessment revealed two additional potential sources of contamination inside the facility, (1) a two stage sump serving drainage from the automobile painting room, wash rack, and floor drains, and (2) three hoist pits filled with water and hydraulic oil. We included the results of our findings with regards to these potential sources of contamination, as well. The topographic map in Appendix A provides the location of the facility at the northwest corner of Stevens Drive and Lee Blvd.

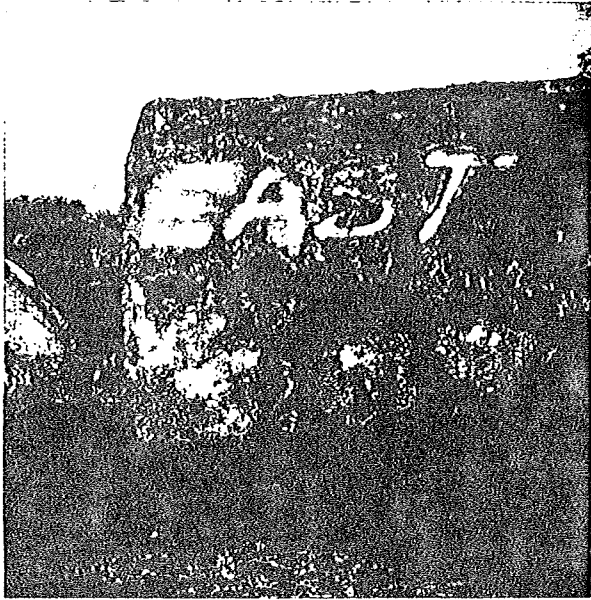
USB - TANK 1

We inspected each tank for signs of leakage or holes after they were removed and cleaned. Only Tank Nos. 1 and 4 provided any overt visual indication of leakage (Photo plates in Appendix C for Tank 1). These tanks contained large holes. Tank No. 3 contained one smaller hole on the west end. The nature of contamination found along with the location of the piping for the bunker oil leads us to suspect a leaky bunker oil line.

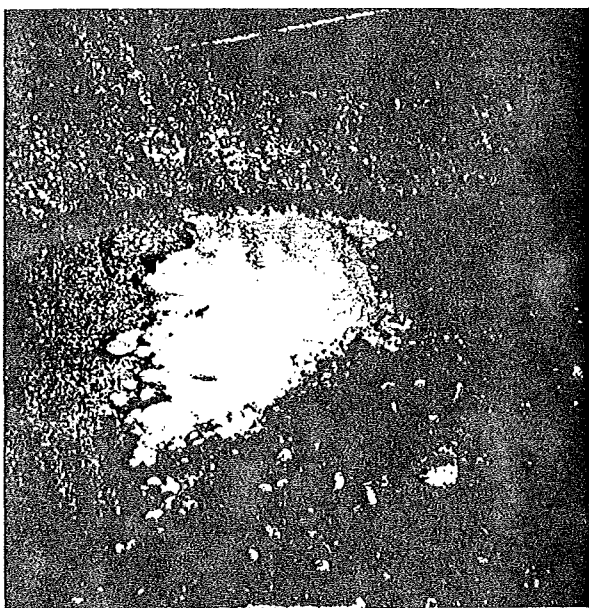
3/28/91 M. BLACK
 WORKING WEST AT
 THE OIL WASTE WATER
 UNDER TANK 4 USA
