***Abandoned Mine Lands  
Initial Investigation Report  
Hubbard Mine  
Northport, Washington***

***Prepared for  
Washington State  
Department of Ecology***

***December 28, 2006  
17274-00(HU)***

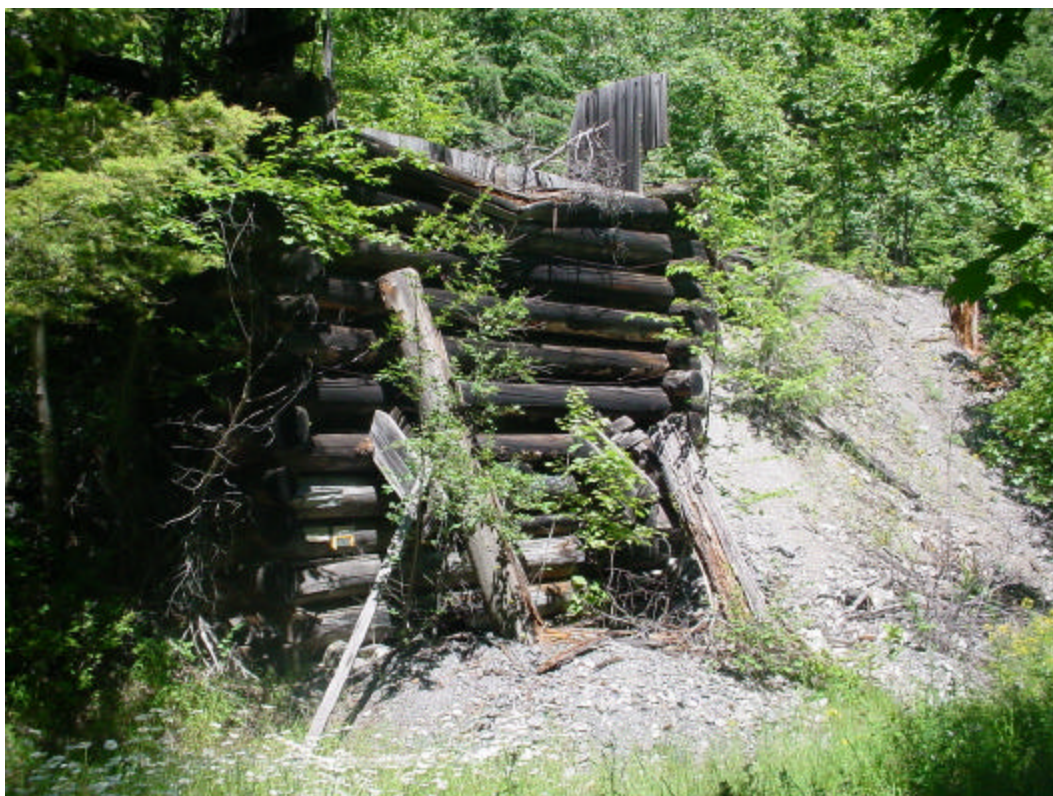
Building 1 is the first feature encountered on the site. It is an open-topped building filled with waste rock that sits adjacent to the access road at the south corner of the site. It has two chutes that face the road and may have been used to load rail cars. The waste rock pile, WR-1, lies in and around Building 1 and is also adjacent to the access road, extending across the southeast boundary of the site (Photograph 1). WR-1 is approximately 660 cubic yards in size and is generally composed of a dry, gray, slightly silty, sandy Gravel with cobbles. A small trestle-like structure at the top of WR-1 may have been used to transport ore to Building 1. An ephemeral drainage channel runs over the top of WR-1 and connects with a natural break where the waste rock meets Building 1. The access road forks west near Building 1 and switches back, passing over Adit 1. A second building, potentially used as a dwelling, is located at the switchback.

Photograph 1 - View of Building 1 and WR-1 (note chutes on side of structure)

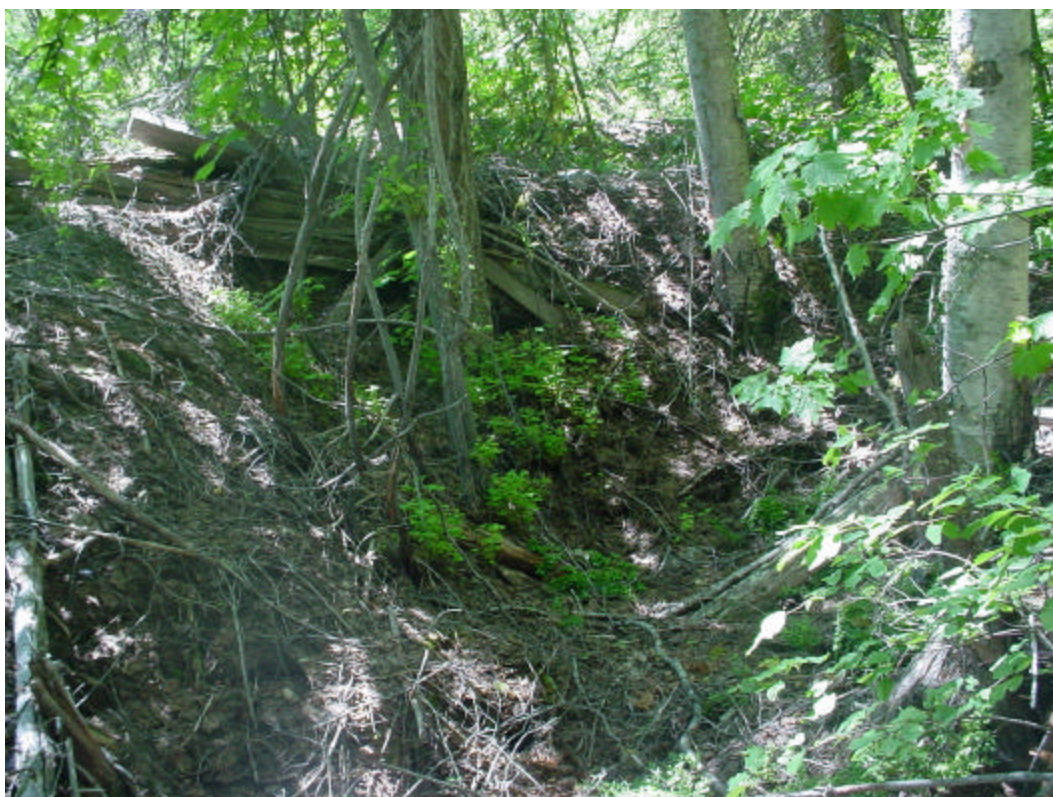
A collapsed adit, Adit 2, is located at the north corner of WR-1. A pile of boards sits on top of the adit and small pieces of metal debris are scattered within the prospect (Photograph 2). Adit 1 is an open adit northwest of WR-1. There is water within the adit and an ephemeral drainage channel courses from the adit, through the prospect, and ends. Partially collapsed timbers support boards and metal that hang over the prospect of Adit 1 (Photograph 3). Boards and a small tank, about 2 by 2 by 1.5 feet in size, lie in front of the adit (Photograph 4). A cool breeze could be felt near Adit 1. This breeze may be due to airflow from the shaft above, or changing temperature gradients created by the shade inside the prospect.

Photograph 2 - View of Adit 2.

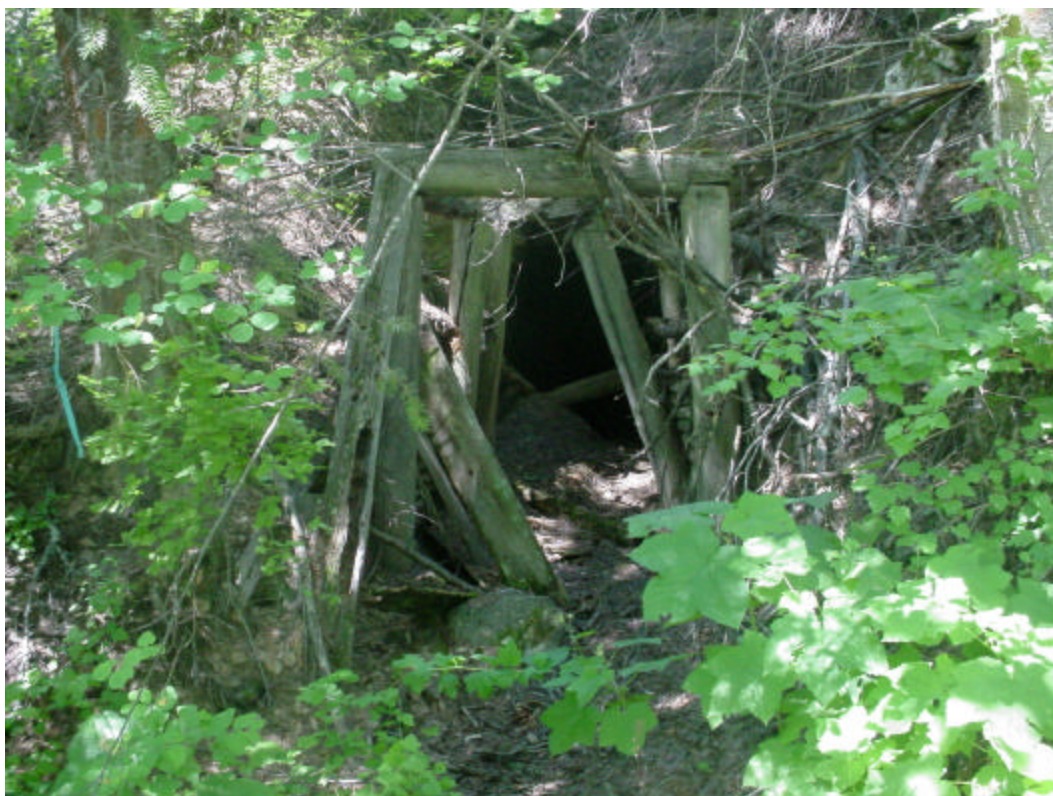
Photograph 3 - View of Adit 1 and support timbers

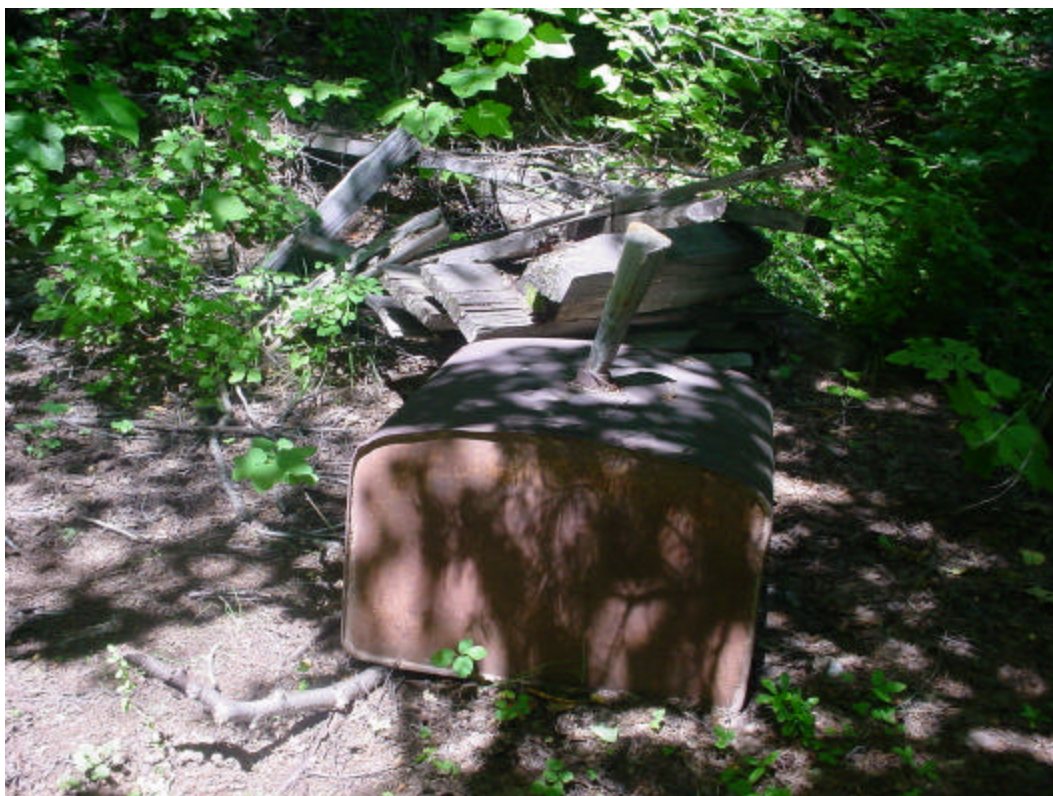
Photograph 4 - Tank and boards in front of Adit 1.

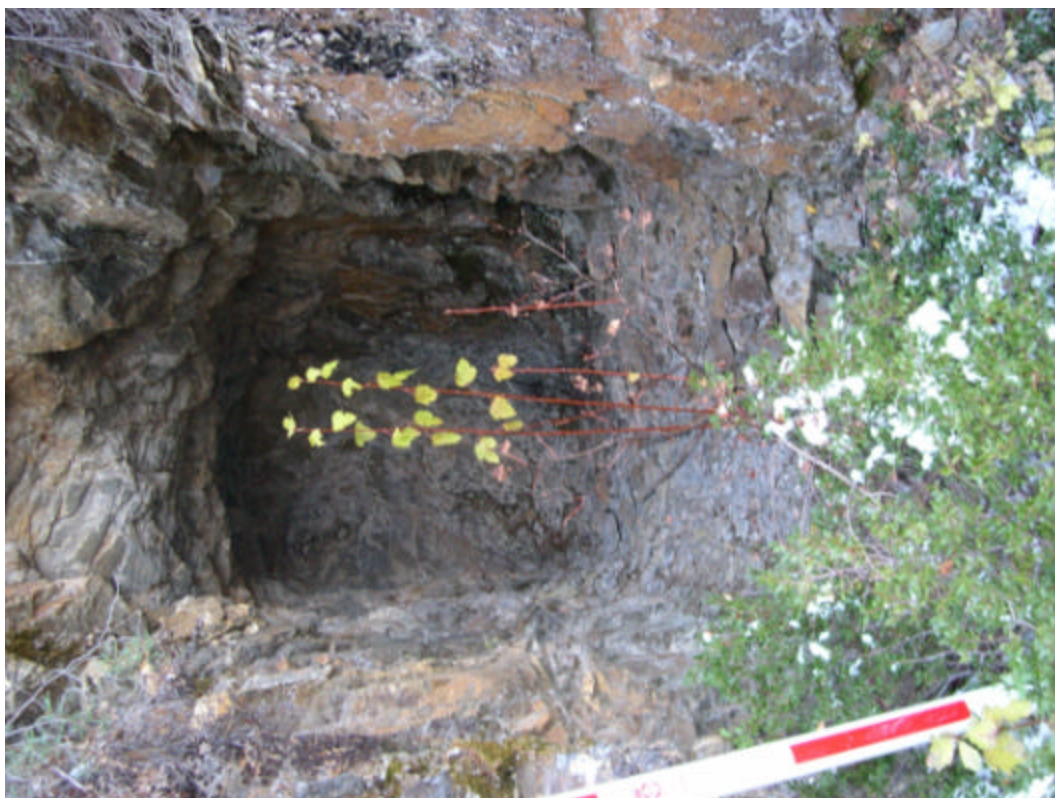
A road departs from the Lower Hubbard site in an eastern direction. A small trail is located near the first switchback, leading to the east adit, Adit 3. The east adit is a small prospect with about a 5- by 10-foot opening that extends approximately 12 feet into a rock face. The prospect is solid rock on all sides, and we did not observe any water or drainage channels (Photograph 5).

Photograph 5 - View of Adit 3 ← Up

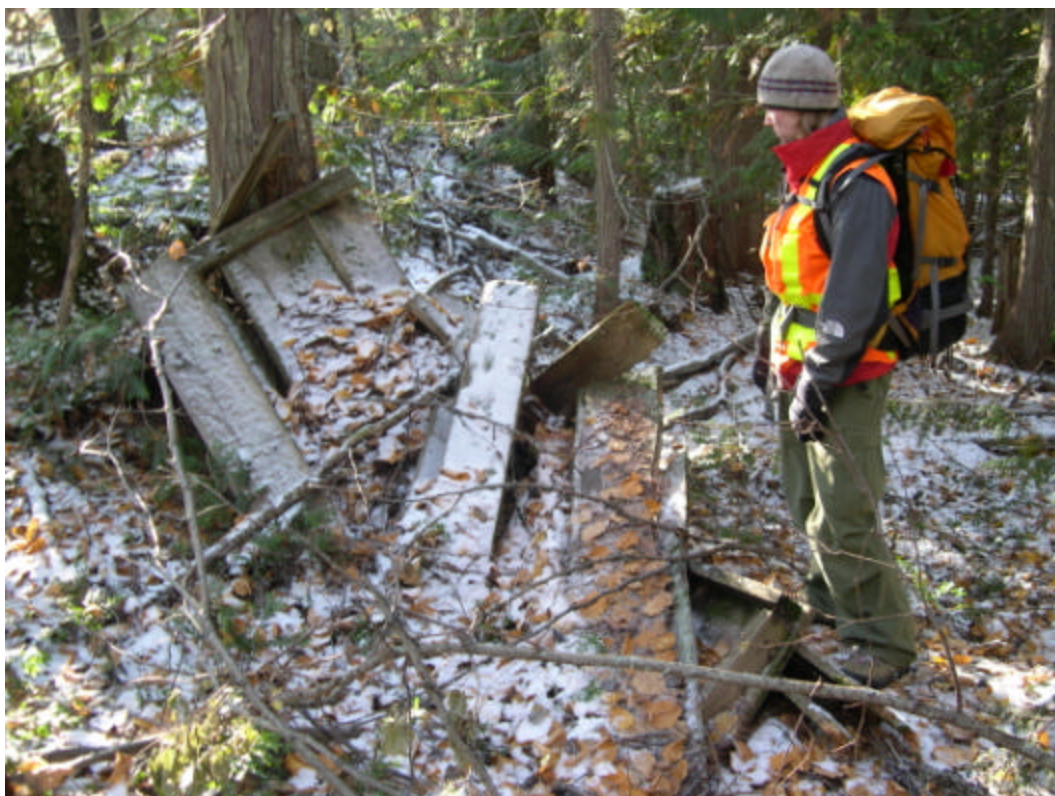
Photograph 6 - View of collapsed outhouse-like structure

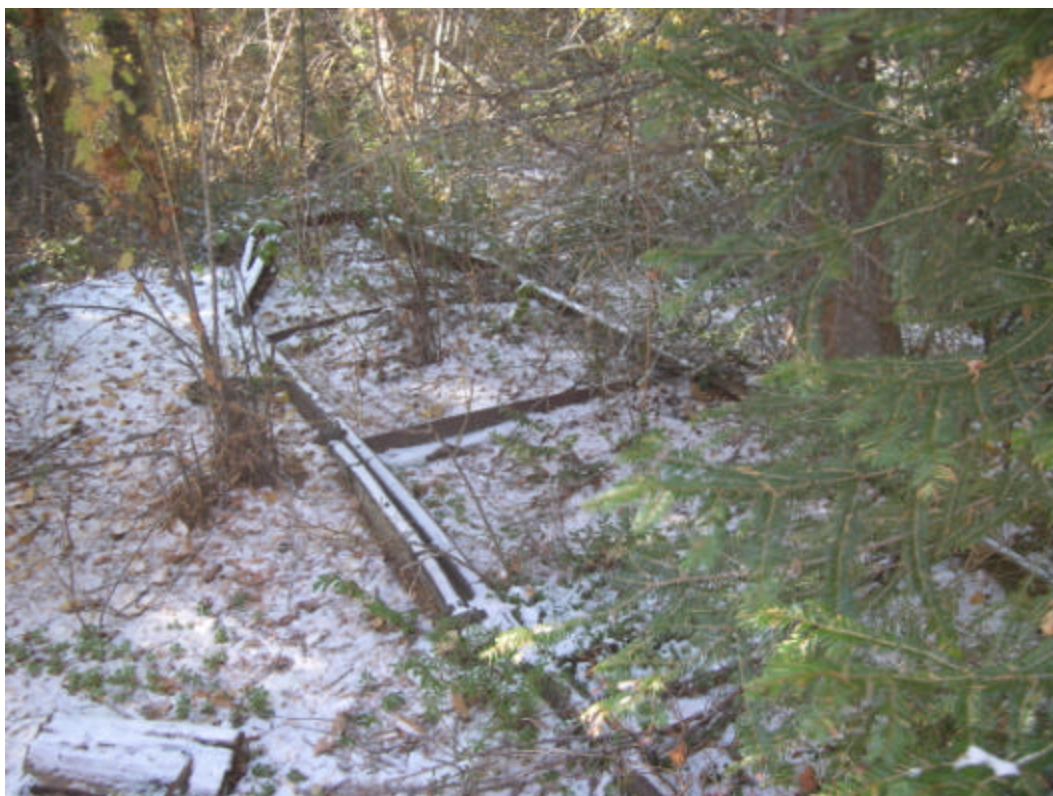
frame, a stove, and an unidentified wood and metal structure (Photograph 7) were observed within the pile of debris.

Photograph 7 - Unidentified wood and metal structure.

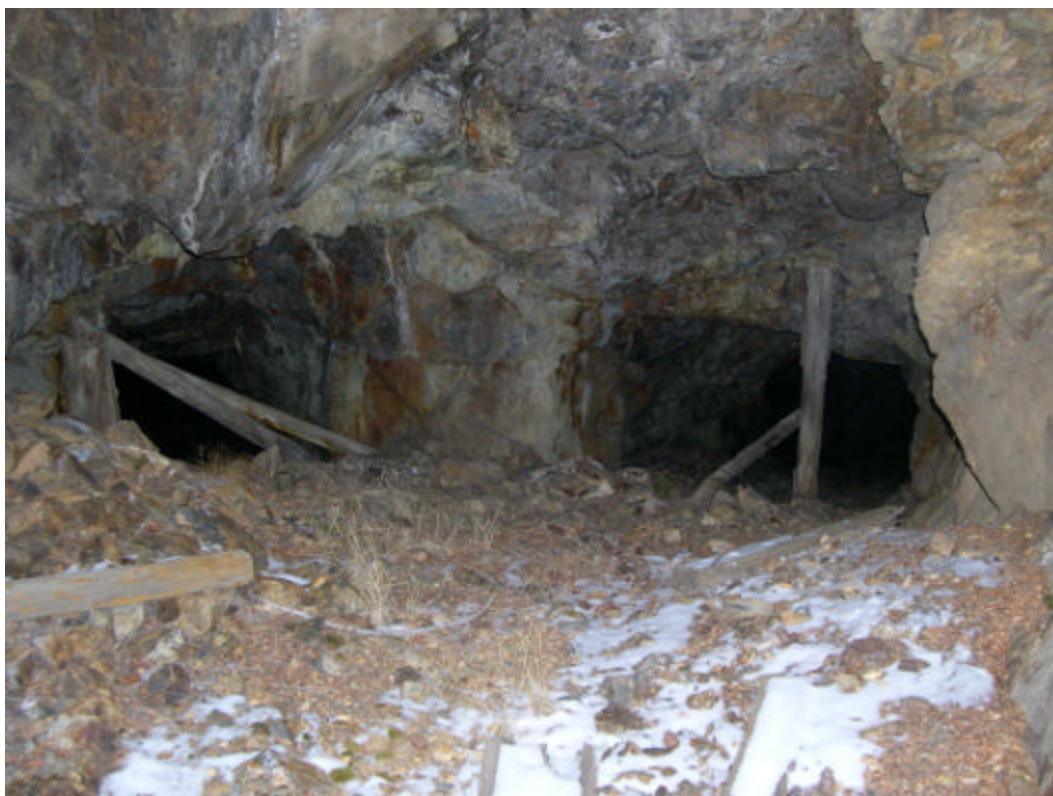
The road into the Upper Hubbard Mine site leads past a building (Building 3) before reaching Adits 4 and 5 and WR-2 (Photographs 8 and 9). The building contains a stove and shelves and may have been used as housing. Adits 4 and 5 were filled with water, although Adit 4 appears to be shallow and may not extend more than approximately 15 feet into the rock face. The road cuts through WR-2 and continues east below the waste rock pile. WR-2 contains damp, tan, slightly silty, very sandy Gravel with cobbles and is approximately 1,275 cubic yards in volume.

Photograph 8 - View of Adits 4 and 5

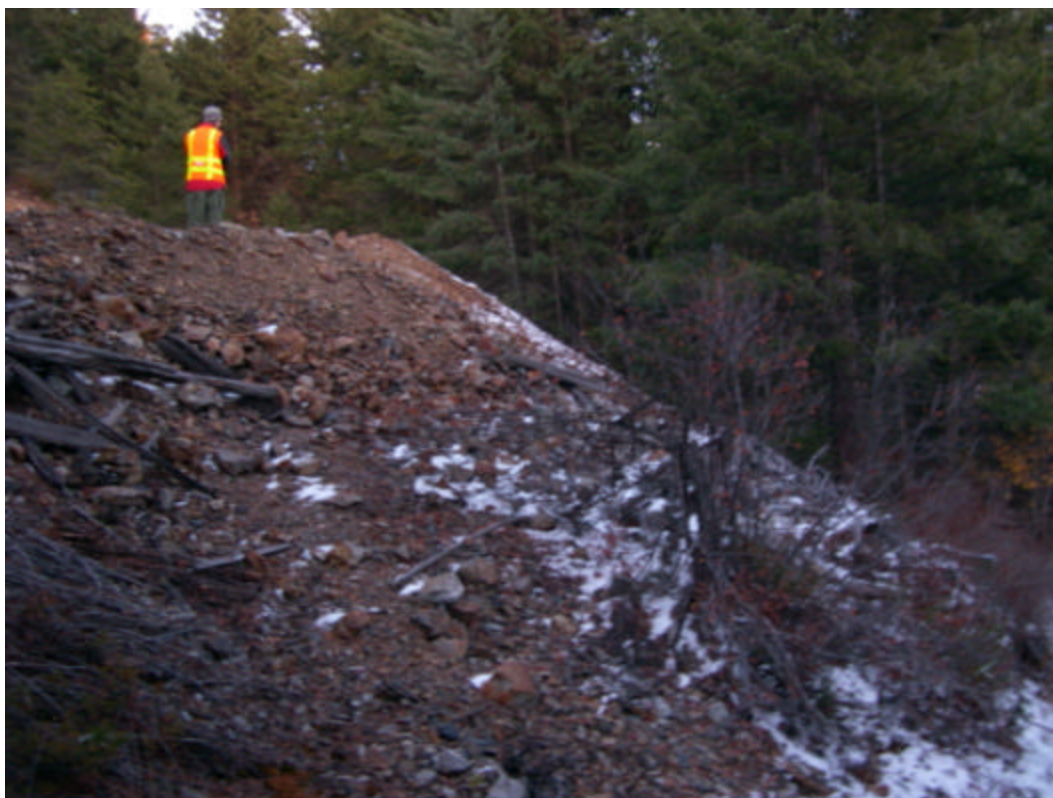
Photograph 9 - View of WR-2

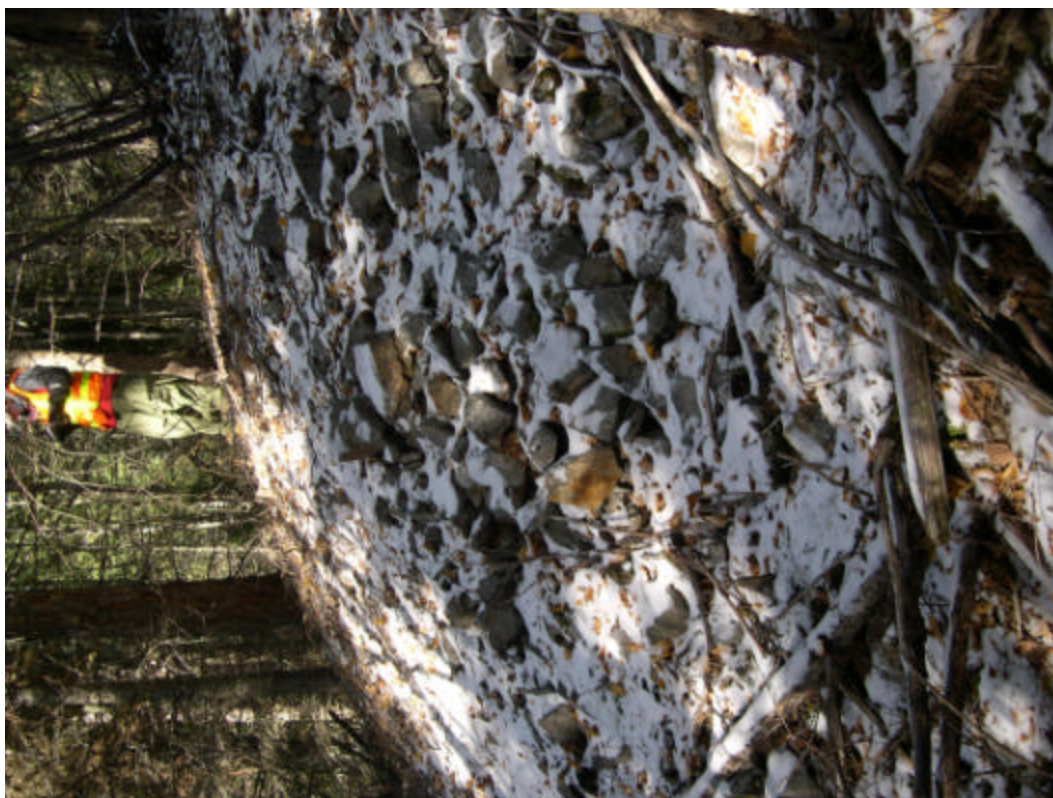
A shaft and a third waste rock pile, WR-3, are located south of WR-2. The shaft is approximately 10 feet in diameter, but the depth could not be determined. A metal trashcan was observed near the shaft. WR-3 is 410 cubic yards in volume (Photograph 10). Wood debris (boards and timbers) lie at the top of the pile.

Photograph 10 - View of WR-3 ←Up

One waste rock sample was collected from WR-3. The metals concentrations in this sample exceeded MTCA Method A criteria for arsenic, cadmium, lead, and mercury, Method B criteria for arsenic; and ecological protection criteria for arsenic, cadmium, lead, mercury, silver, and zinc.
