**SITE HAZARD ASSESSMENT
WORKSHEET 1
SUMMARY SCORE SHEET**

Dearborn Corporation Campus Goodwill
1400 S Lane ST & 1200-1590 S Dearborn
Seattle, WA 98144
King County
T-24N, R-4E, Sec-5
Facility Site ID# 6258254
Longitude: 122° 18' 52.00"
Latitude: 47° 35' 48.00"
Site assessed for February 21, 2007 update.

Site Hazard Assessment Site
 Dearborn Corporation Campus Goodwill
 Rainier Avenue S & S Dearborn Street
 Seattle, WA 98144

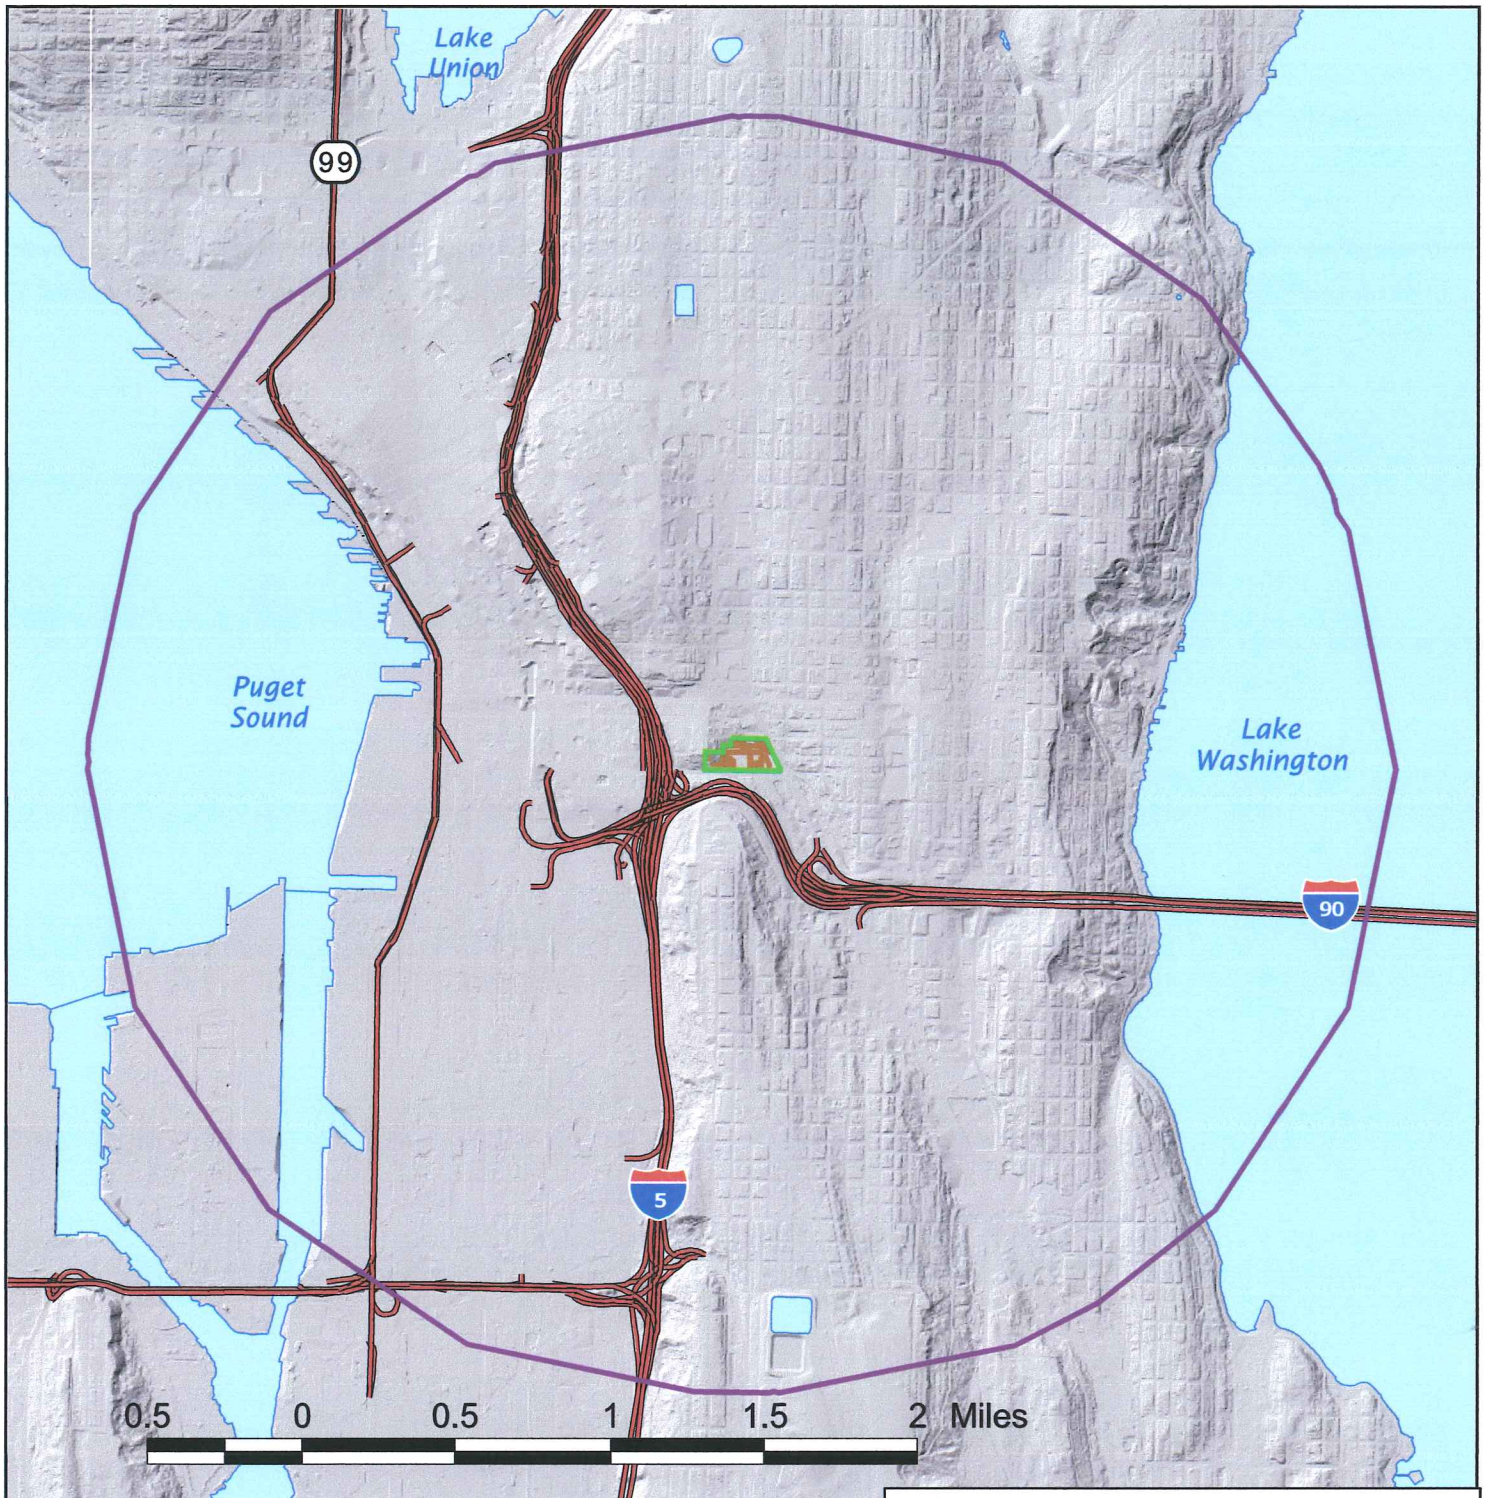
**Site Hazard Assessment
No Wells Within a Two Mile Radius**

**Dearborn Corporation Campus Goodwill
Rainier Avenue S & S Dearborn Street
Seattle, WA 98144**
