***Abandoned Mine Lands  
Initial Investigation Report  
McNally Mine  
Orient, Washington***

***Prepared for  
Washington State  
Department of Ecology***

***December 28, 2006  
17274-00(MC)***

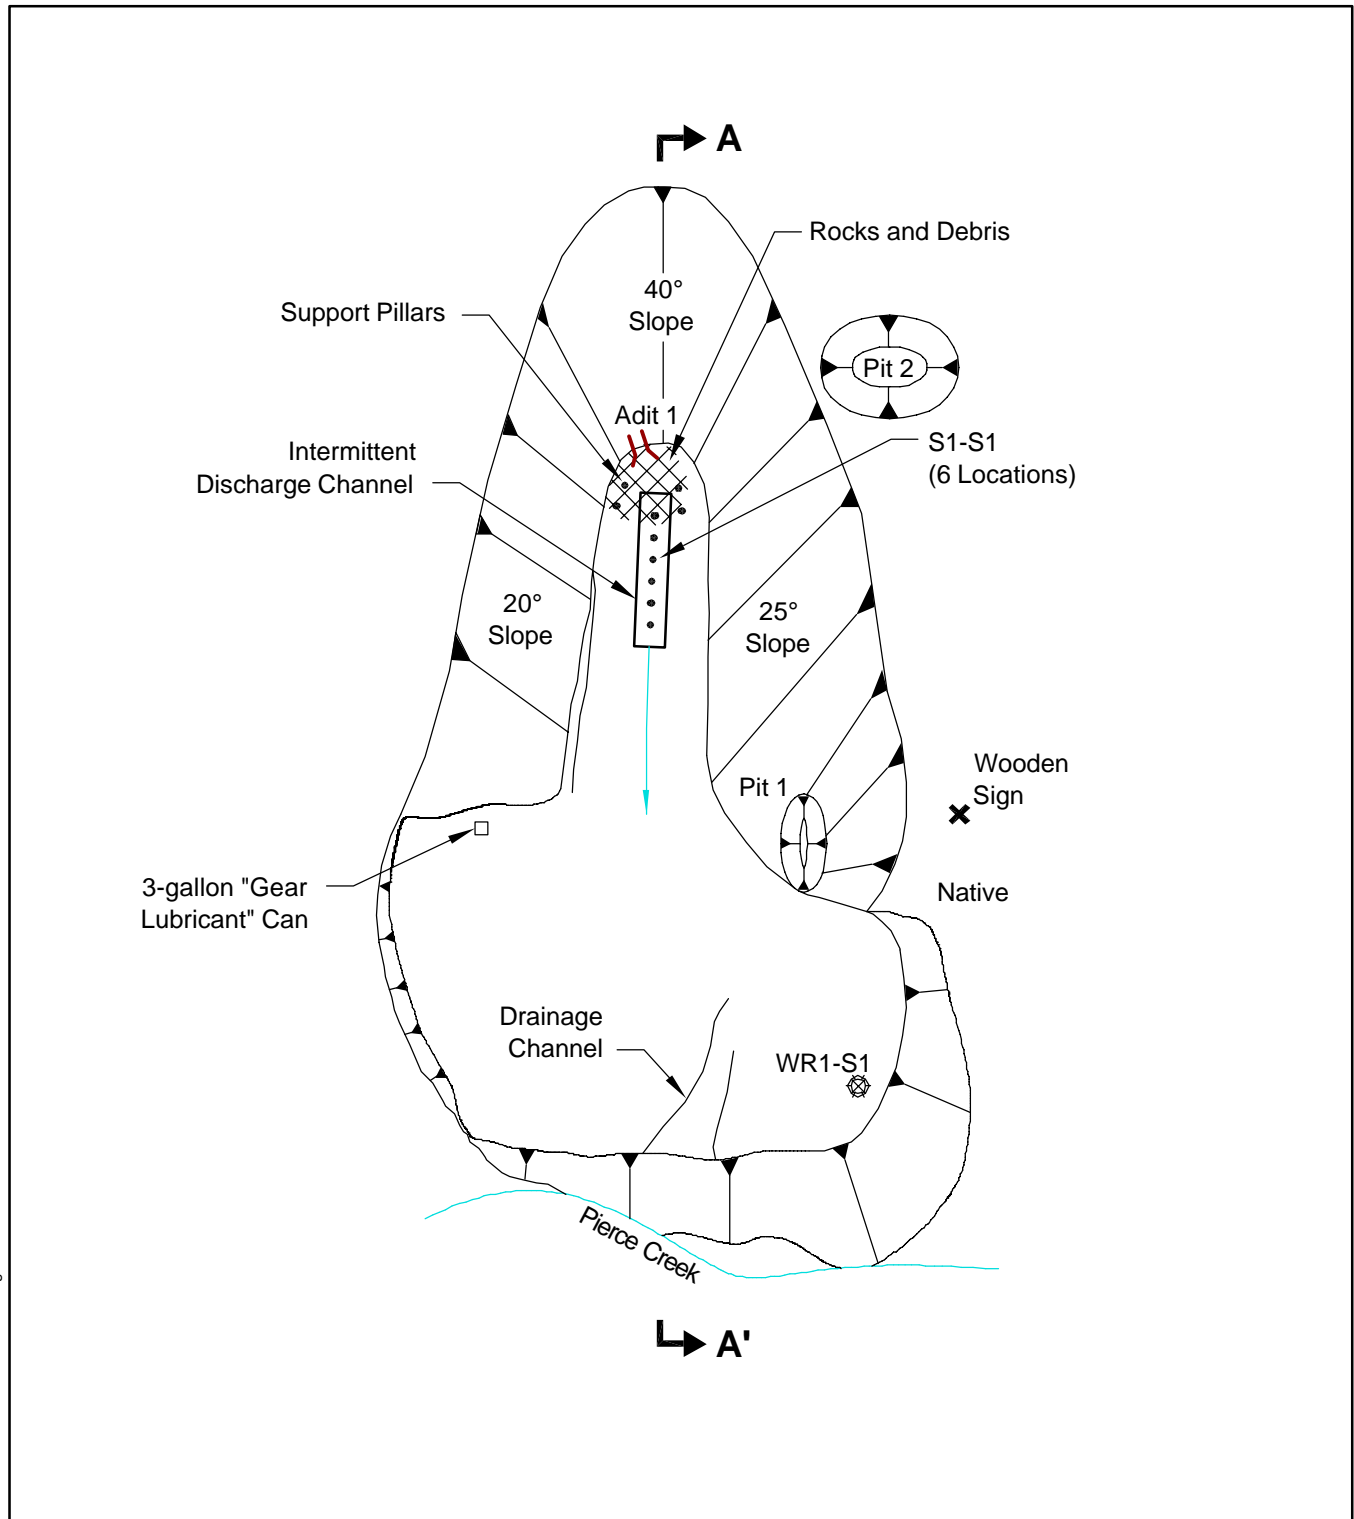
# Site Plan McNally Mine

The initial investigation of the McNally Mine site took place on July 14, 2006. Site sketches were created, GPS data and waste rock samples were collected, and site photographs were taken. Sample locations, site photograph locations and directions, and GPS waypoints are presented on Figure 3.

One waste rock sample, McNally-WR1-S1, was collected during a site visit on July 14, 2006. The sample is a moist, light gray, slightly silty, sandy Gravel with cobbles. The sample location is shown on Figure 3.

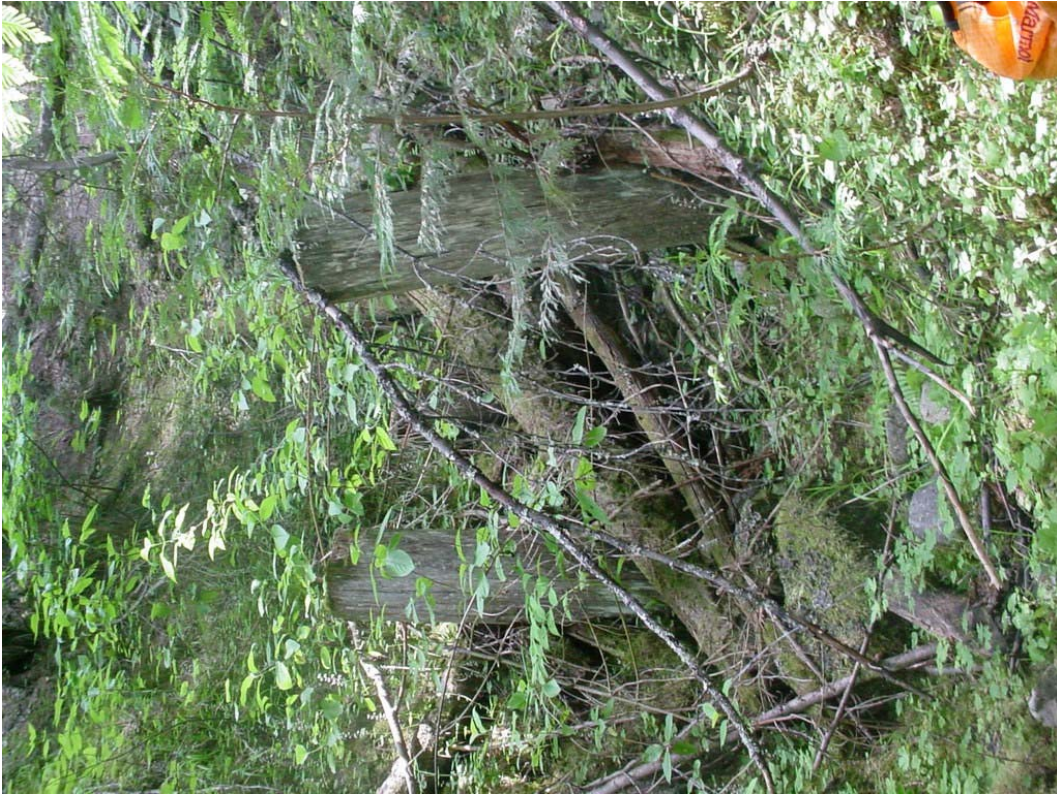
The McNally Mine site lies adjacent to Pierre Creek, at the bottom of a steep-sided valley. Adit 1 is at the base of a steep slope. The adit is covered with rocks and debris and support pillars stand in front of the opening (Photograph 1). A drainage channel was observed exiting between the support pillars at the adit opening and heading toward the waste rock pile (Figure 3). Pondered water was observed near the adit, but was not actively flowing through the drainage channel or over the waste rock pile. No seeps or springs were observed.

Photograph 1 - View of Adit 1. ←Up

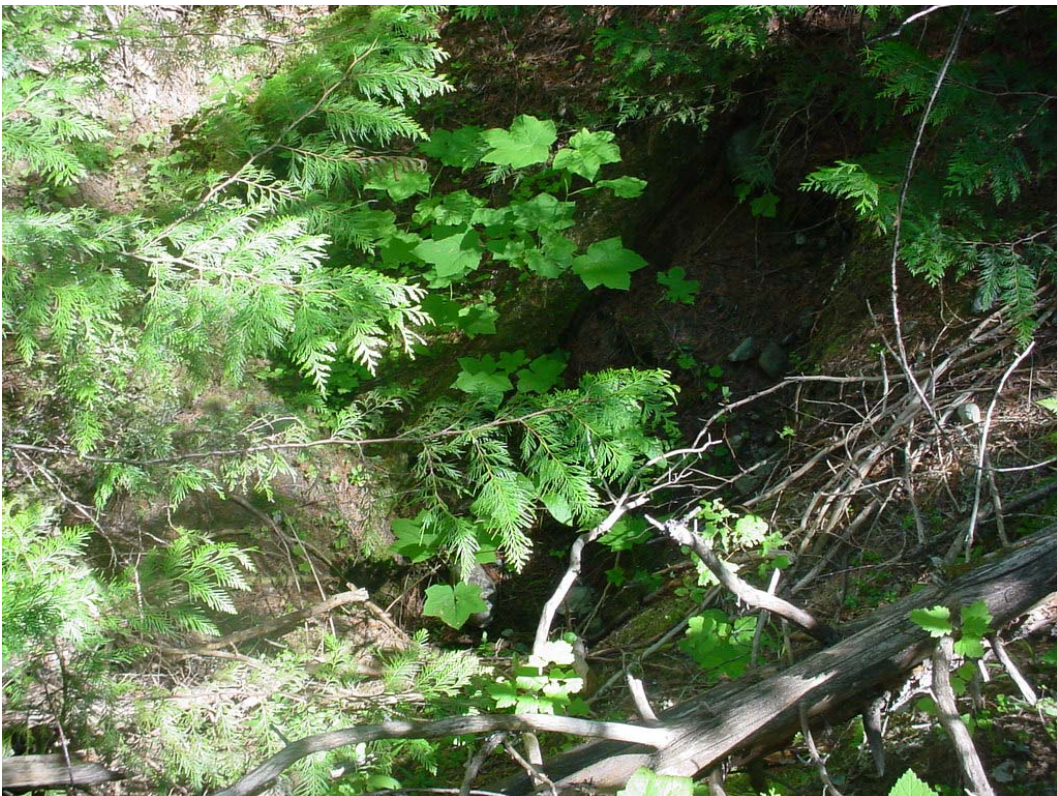
A small pit, measuring 7 by 15 by 10 feet deep is located on the west side of the prospect. A larger pit, 20 by 15 by 15 feet deep is located on the slope above the adit, to the west (Photograph 2).

Photograph 2 - View of Pit 2.
