***Abandoned Mine Lands
Initial Investigation Report
Princess Maude Mine
Republic, Washington***

***Prepared for
Washington State
Department of Ecology***

***December 28, 2006
17274-00(PM)***

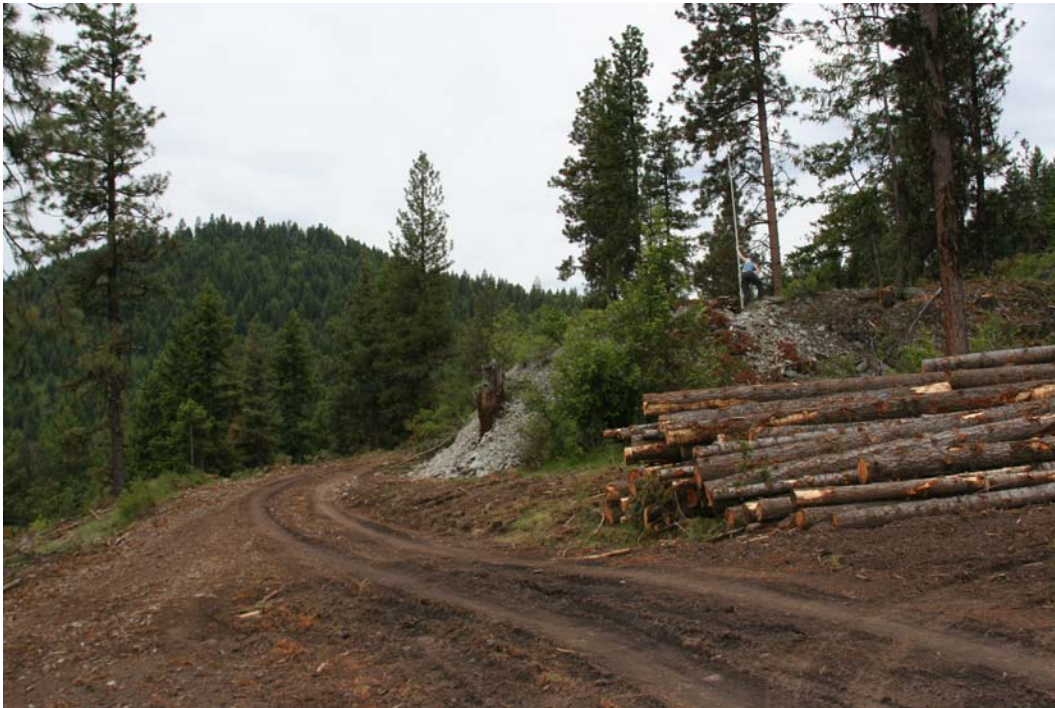
down. A waste rock pile, WR-1, of approximately 500 cubic yards lies downslope of a collapsed adit and contains light gray andesite (Photograph 1).

Photograph 1 - View of WR-1 and access road.

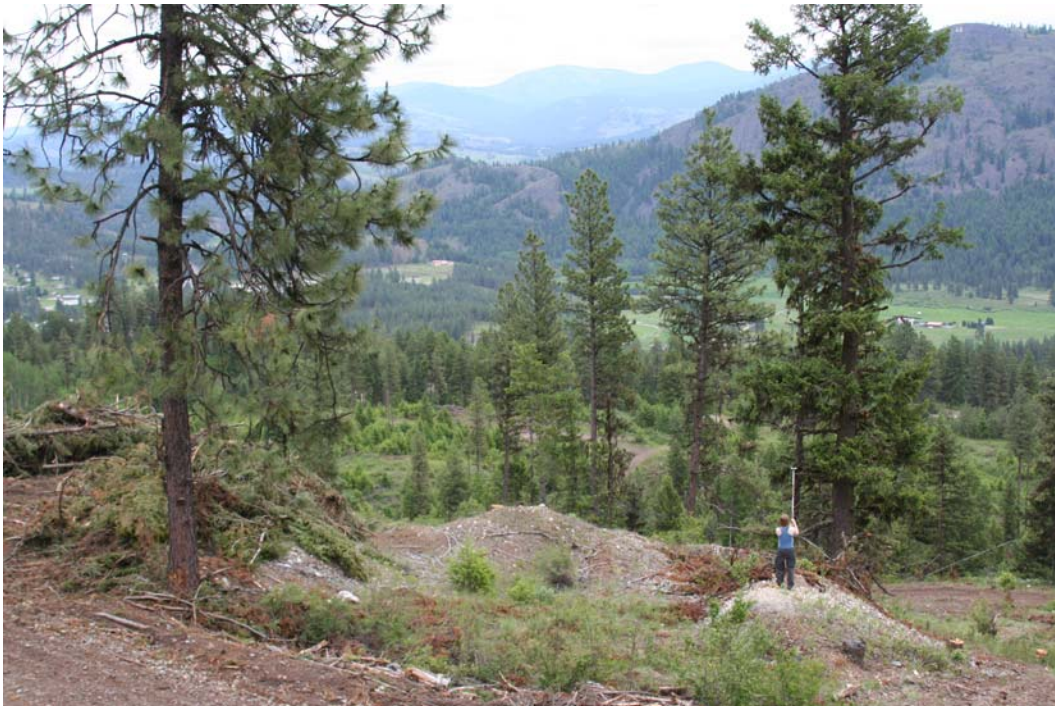
A second waste rock pile, WR-2, of approximately 300 cubic yards is north and downslope of WR-1 (Photograph 2). Five pits of varying size are arranged in a line extending east from WR-2. The average size of these pits is approximately 10 by 12 by 6 feet deep (Photograph 3).

Photograph 2 - View of WR-2.

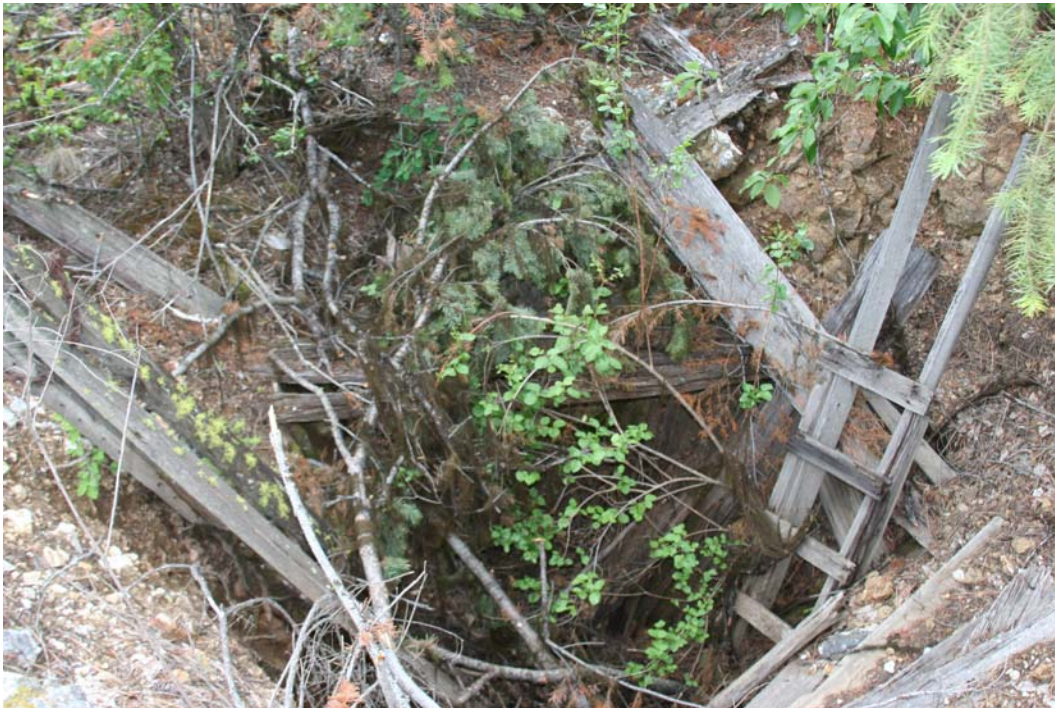
Photograph 3 - View of Pit 3.
