***Abandoned Mine Lands  
Initial Investigation Report  
Robert E. Lee Mine  
Metaline Falls, Washington***

***Prepared for  
Washington State  
Department of Ecology***

***December 28, 2006  
17274-00(RL)***

Prepared by  
**Hart Crowser, Inc.**

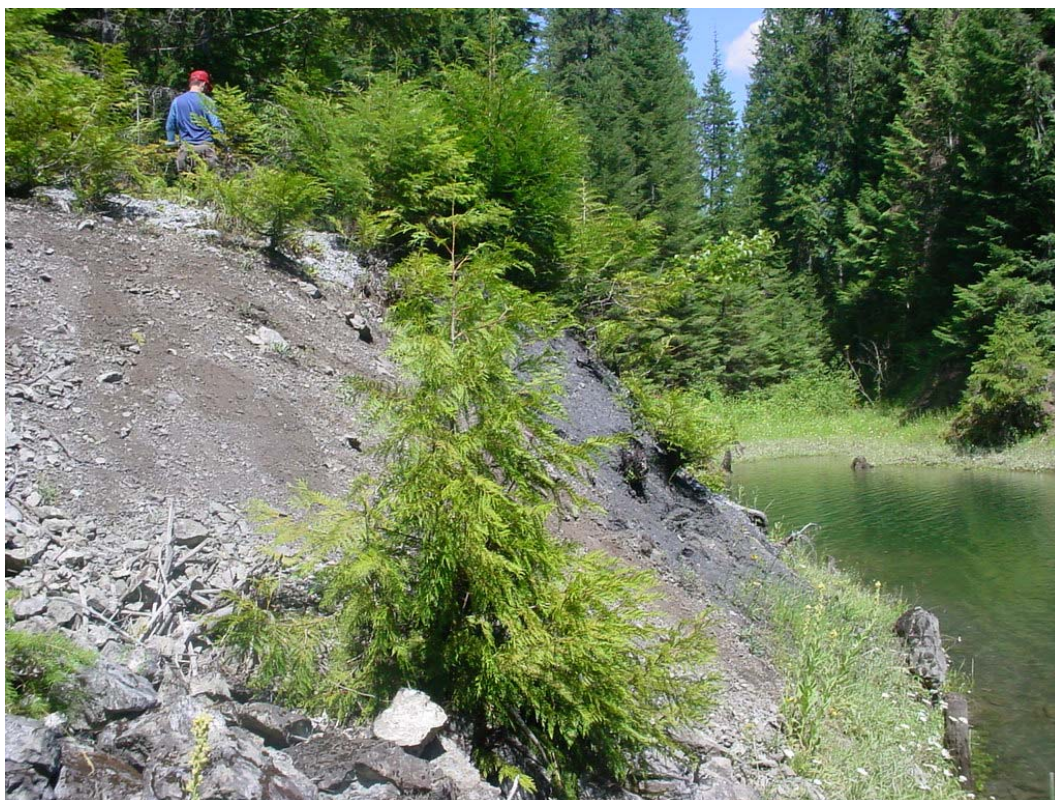
A single waste rock pile, WR-1, approximately 320 cubic yards in volume, extends from the adit beyond the natural bank of the Pend Oreille River (Photograph 1). WR-1 contains three different zones of material. The majority of the waste rock is dry, gray, sandy Gravel (Zone 3). Zone 1 is dry, dark gray, gravelly, silty Sand with slight cementation, and Zone 2 is dry, brown, silty, gravelly Sand with slight cementation. The slopes of the waste rock pile vary from about 52 degrees in Zone 1 to about 30 degrees in Zone 2, with Zone 3 having slopes of about 38 degrees. Waste rock from Zones 1 and 3 extend approximately 6 feet into the river at an estimated slope of 20 degrees (Photograph 2). Water from the Pend Oreille River has washed the fines out of the lower portion of the waste rock in Zones 1 and 3.

Photograph 1 - WR-1: Zone 1 (black material on right slope), Zone 2 (brown material on facing slope), and Zone 3 (gray material on top).

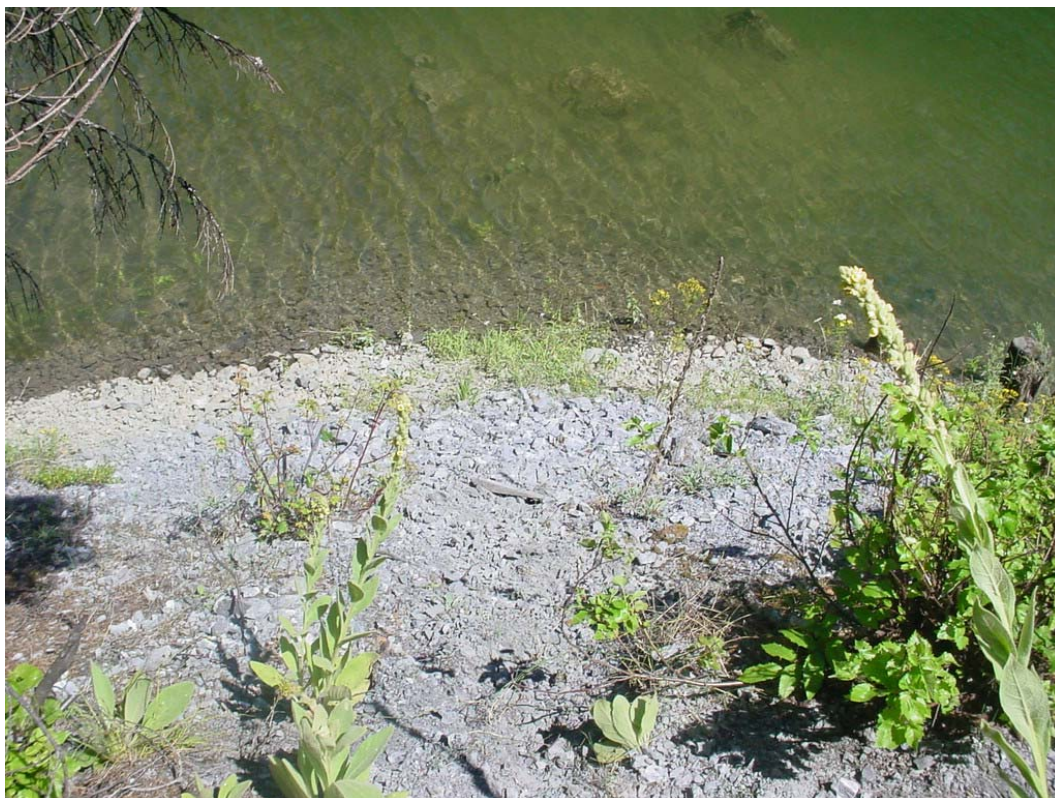
Photograph 2 - WR-1 showing Zone 3 material above and below the waterline.

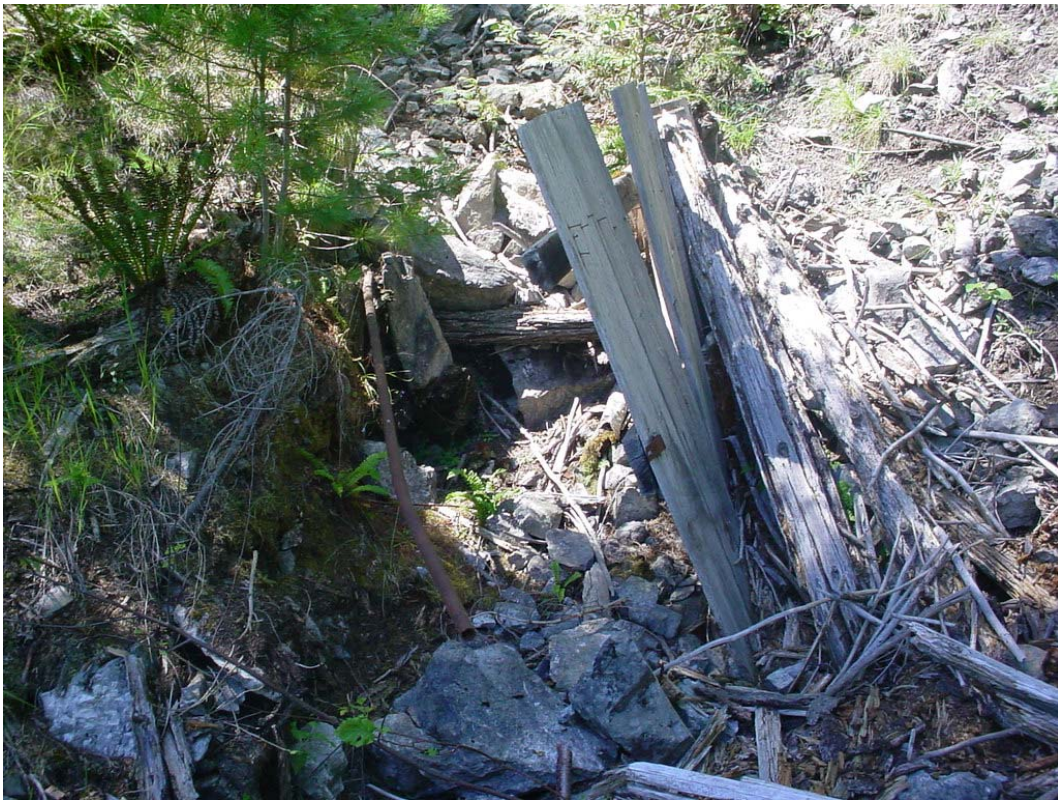
A collapsed, dry adit, Adit-1, approximately 4 feet wide by 5 feet high was the only opening discovered at the site (Photograph 3). A wooden adit door with a latch is present, and a rusted metal pipe extends from the slope over Adit-1. A pile of approximately 60 logs, cut to 3 feet long by 6 inches in diameter, is located adjacent on top of WR-1.

Photograph 3 - View of Adit-1.
