***Abandoned Mine Lands
Initial Investigation Report
San Poil Mine
Republic, Washington***

***Prepared for
Washington State
Department of Ecology***

***December 28, 2006
17274-00(SA)***

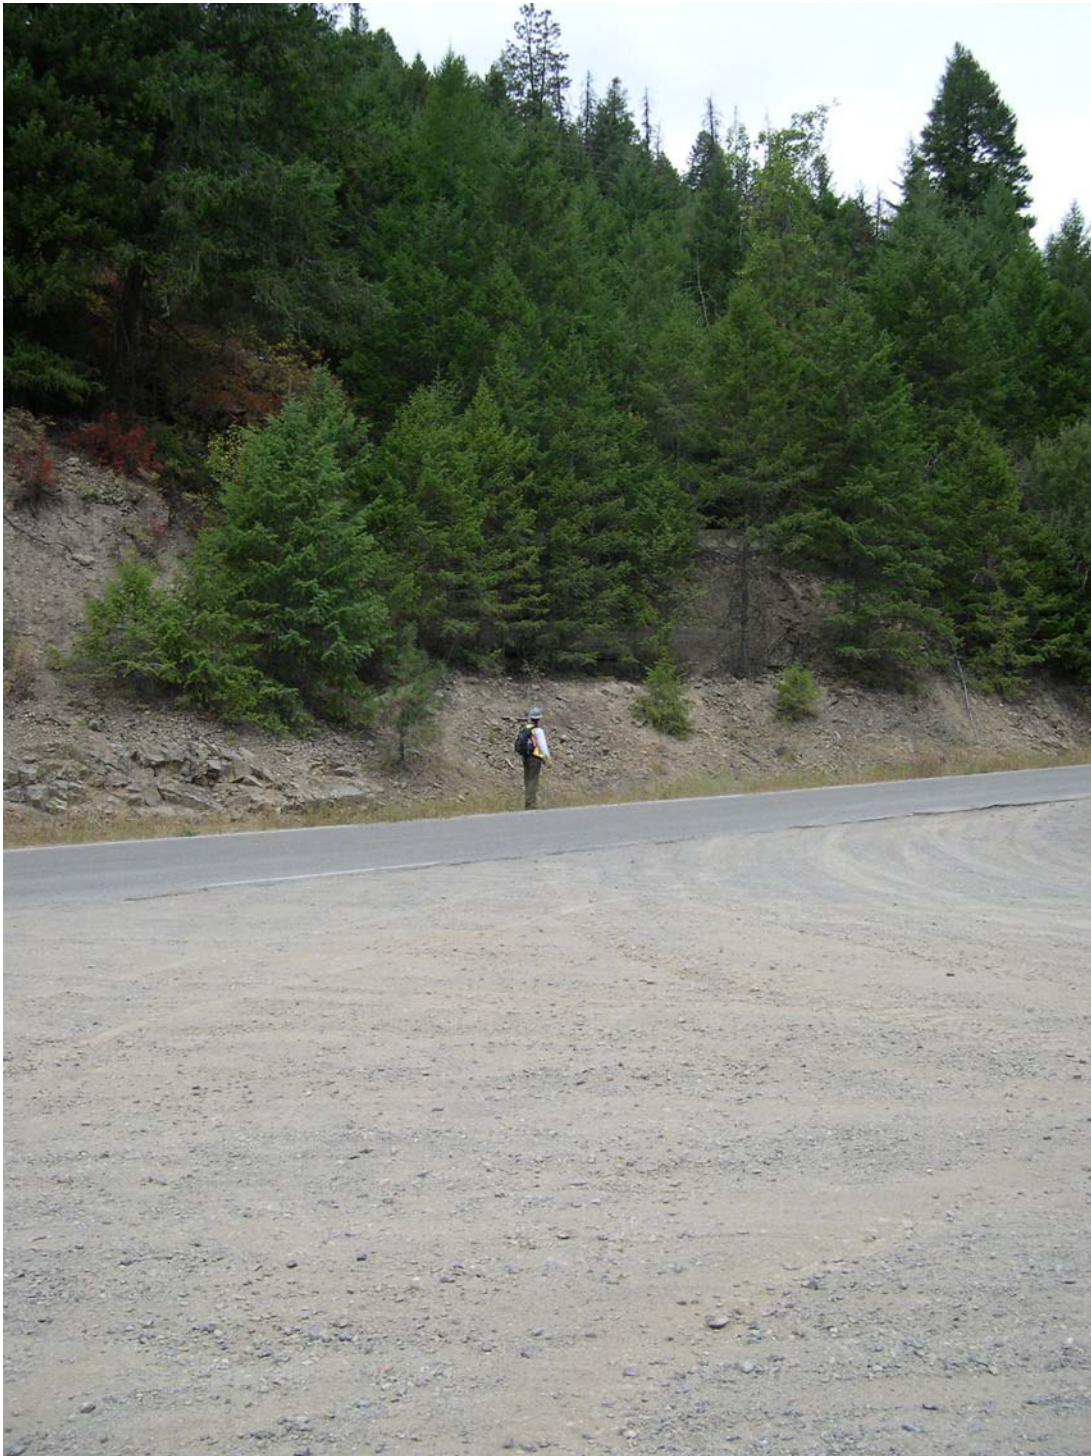
- After 200 feet Klondike road curves north and becomes Knob Hill Road.
- After 1.4 miles Knob Hill East Road will be on the right (east) and the San Poil Mine is on the left (west) (Photograph 1).

Photograph 1 - View of San Poil Mine from Knob Hill Road East, looking northwest.

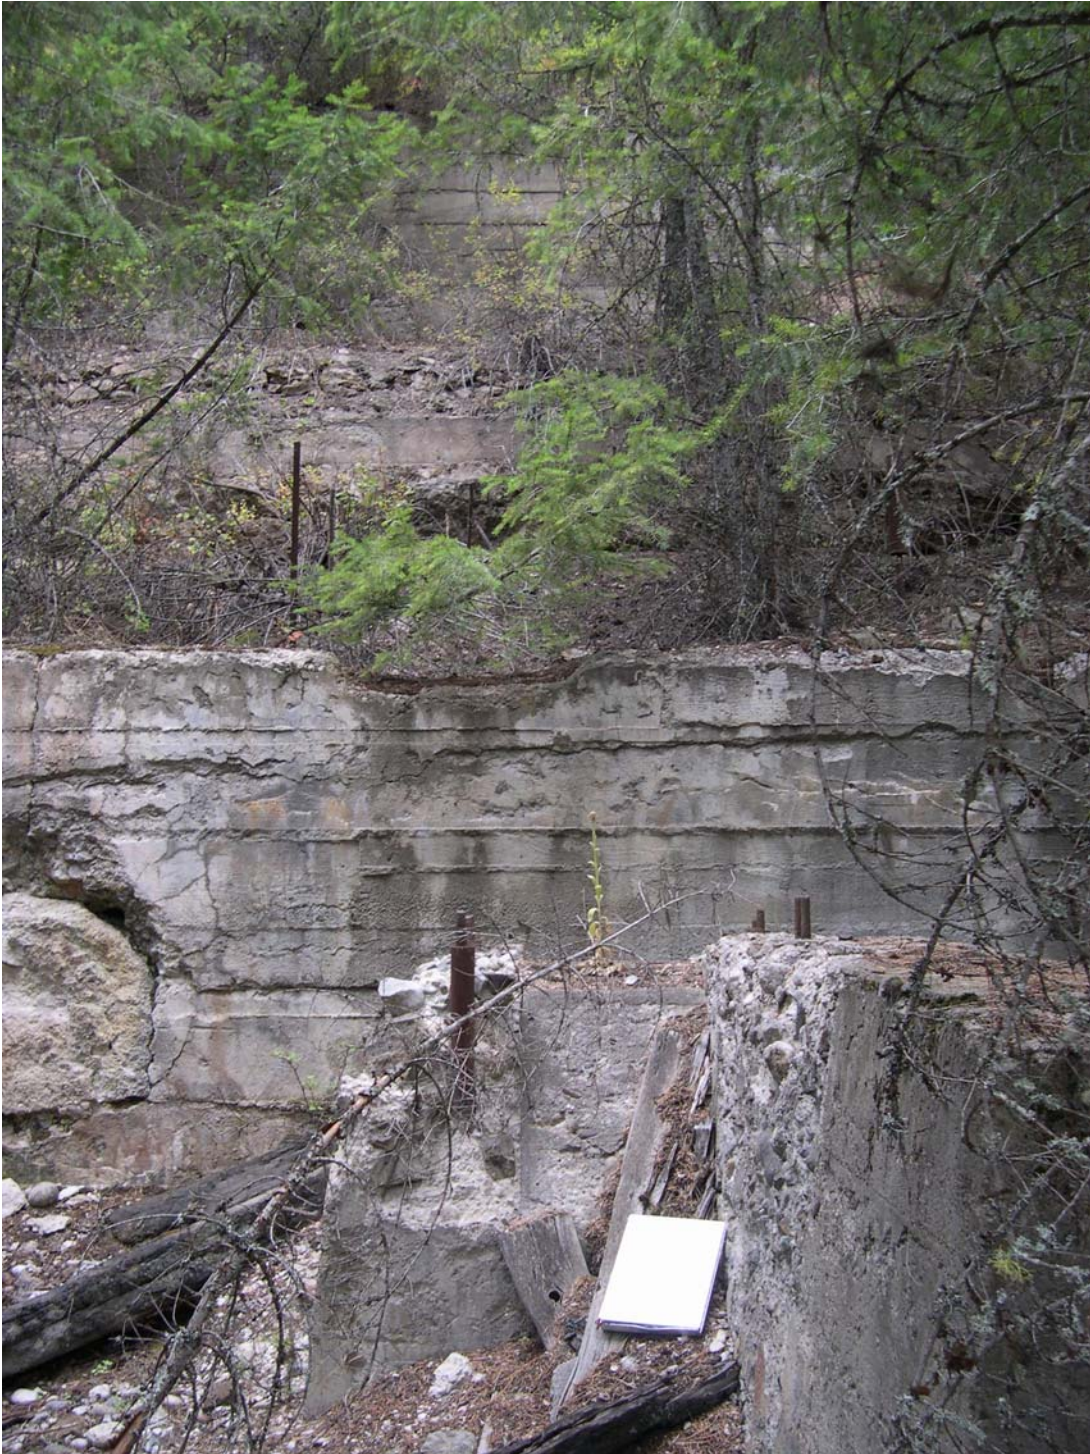
The site is located between the Knob Hill Road on the east, and the former railbed on the west (Figure 3). Photograph 2 and Figure 3 show the layout of the concrete foundations of mill buildings once occupying the site. The main floor is approximately 10 feet above Knob Hill Road.

Photograph 2 - View of concrete foundations of former mill buildings.

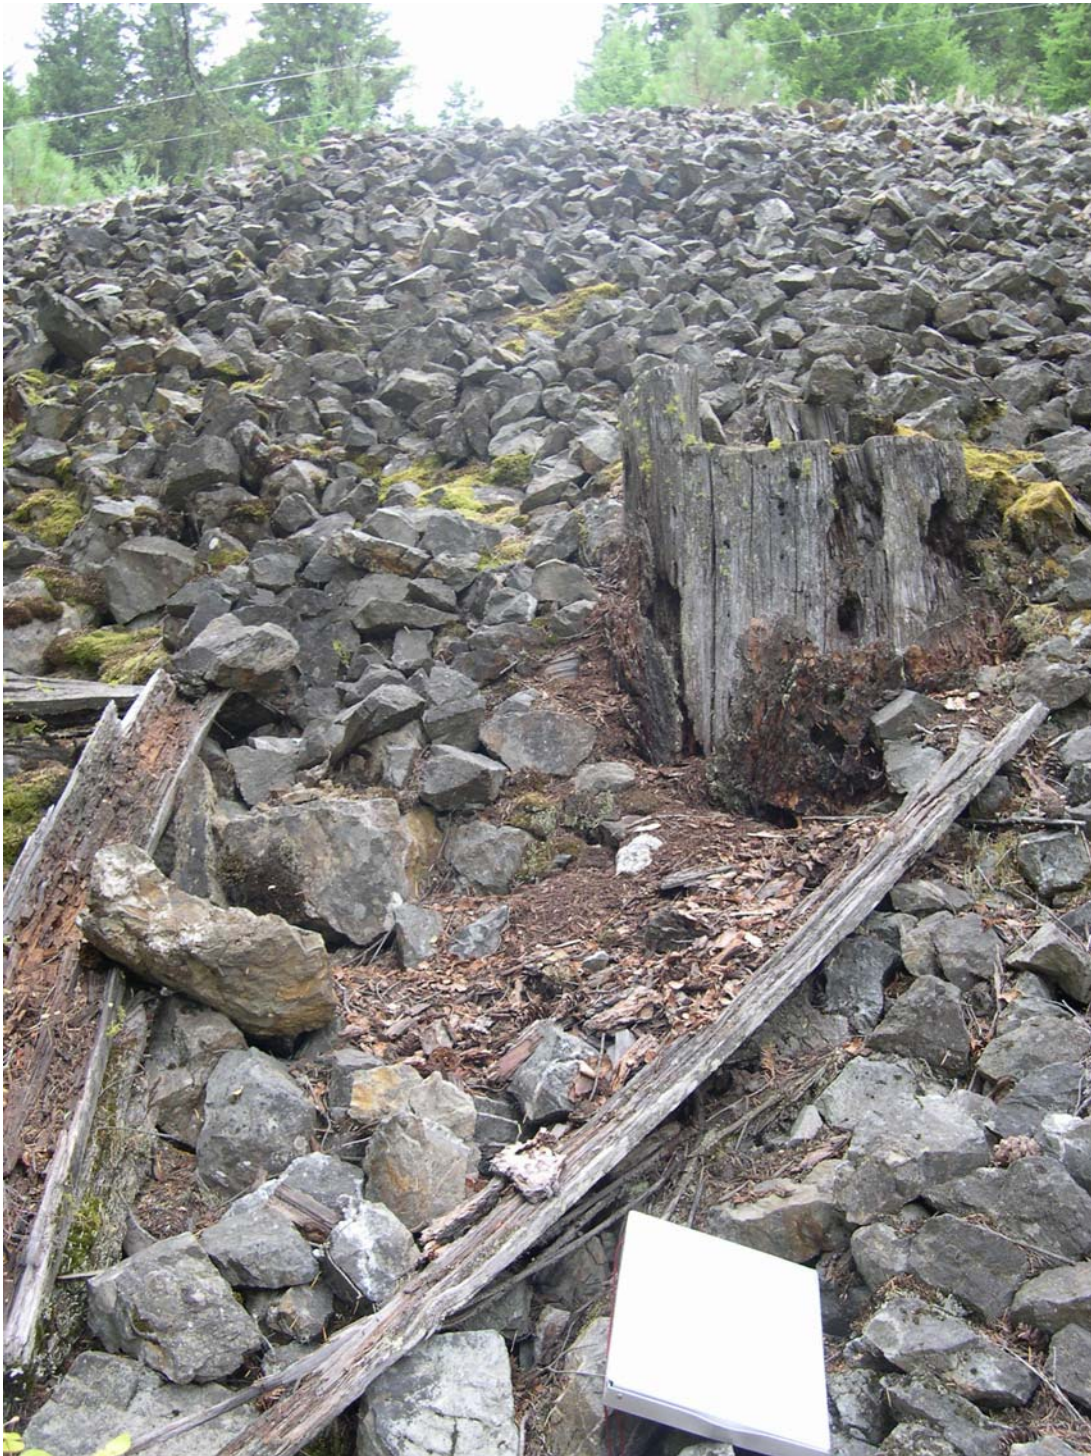
There are two waste rock piles south of the mill, WR-1 and WR-2, which may be of a later date. WR-1 is approximately 22 cubic yards in volume, and WR-2 is approximately 150 cubic yards in volume (Photograph 3). Both contain angular, coarse gravel to cobbles up to 10 inches. As previously mentioned, some waste rock also surrounded the mill foundations, WR-3, indicating waste rock may have been used for fill around the mill foundation.

Photograph 3 - View of WR-2.

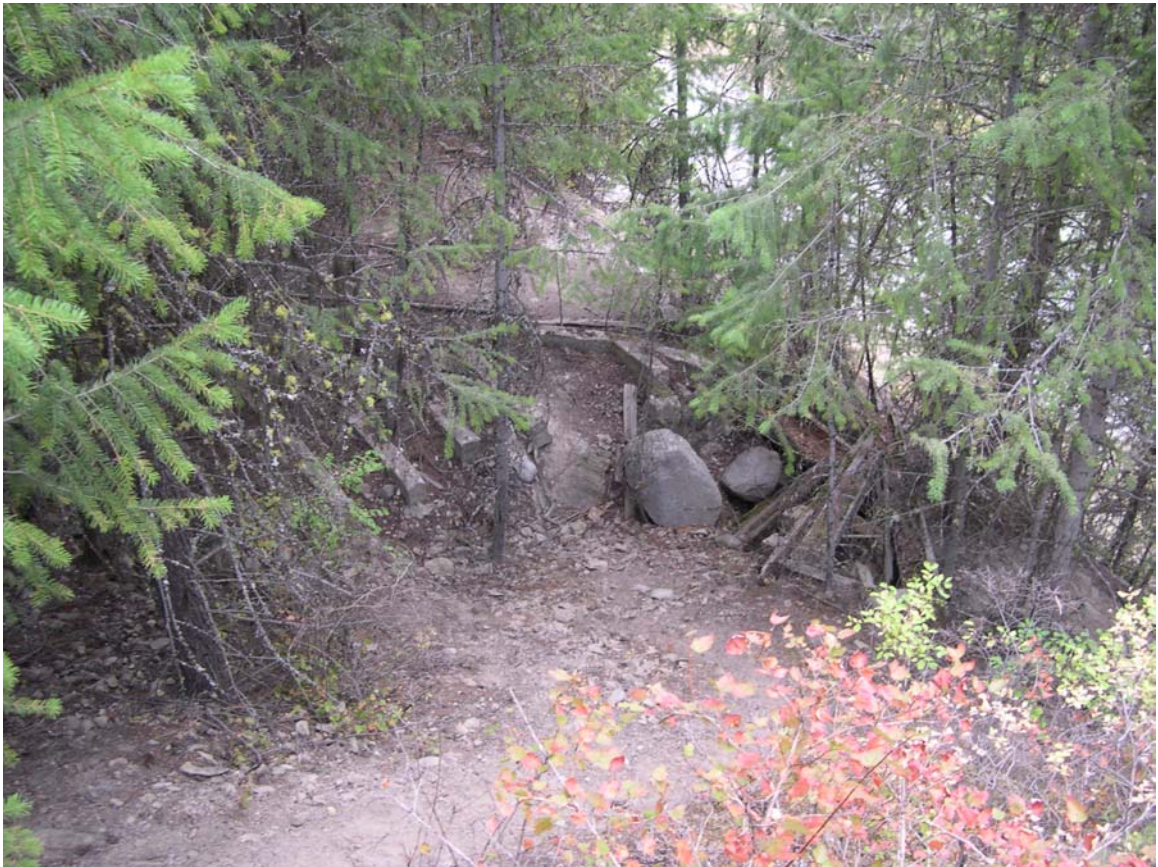
The southeast section of the main floor of the mill appeared to be by the drainage pathway for the site (Photograph 4). There was evidence of minor surface soil transport toward the east, downhill, into the ditch at the base of the slope. The ditch drains south eventually intersecting Eureka Creek, which drains to the south into Granite Creek, and Granite Creek flows south into the San Poil River.

Photograph 4 - View of seasonal drainage area in southeastern corner of the site (below boulders).
