***Abandoned Mine Lands  
Initial Investigation Report  
Shoemaker Mine  
Colville, Washington***

***Prepared for  
Washington State  
Department of Ecology***

***June 25, 2007  
17274-01(SM)***

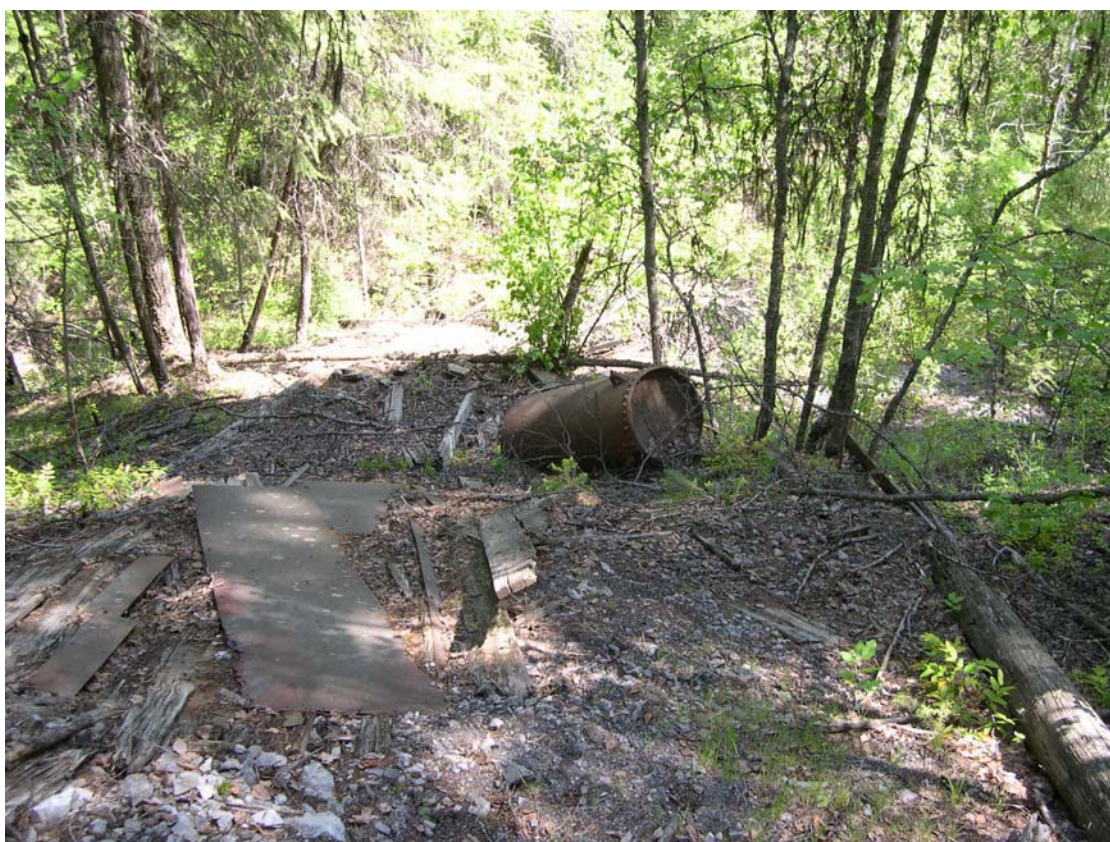
A large waste rock pile, WR-1, is located below Upper Road and east of an adit, Adit 1 (Photograph 1). WR-1 is approximately 540 cubic yards in volume and is composed of moist to dry, light gray to brown, silty, sandy Gravel to gravelly, very silty Sand with occasional cobbles. WR-1 has timber and metal debris scattered over it, including 4- x 6-inch timbers and pieces of plywood with metal

bolted to their surface. Metal and plywood are also located below the waste rock. WR-1 also has a timber structure at the base of the slope, which appears to have been a loading structure. WR-1 may be the location of a rock run used to transport ore and/or waste rock downslope to the possible loading structure below. Approximately one-third of WR-1 is located on private property to the east. National Forest boundary markers were observed on trees adjacent to WR-1. No evidence of seepage from WR-1 was observed.

A rusted steel tank (possible boiler or process vessel) approximately 80 gallons in volume is located on the southern edge of WR-1 on the private property east of the mine (Photograph 1).

Photograph 1 - View of WR-1. Note timber and sheet metal debris and boiler tank.

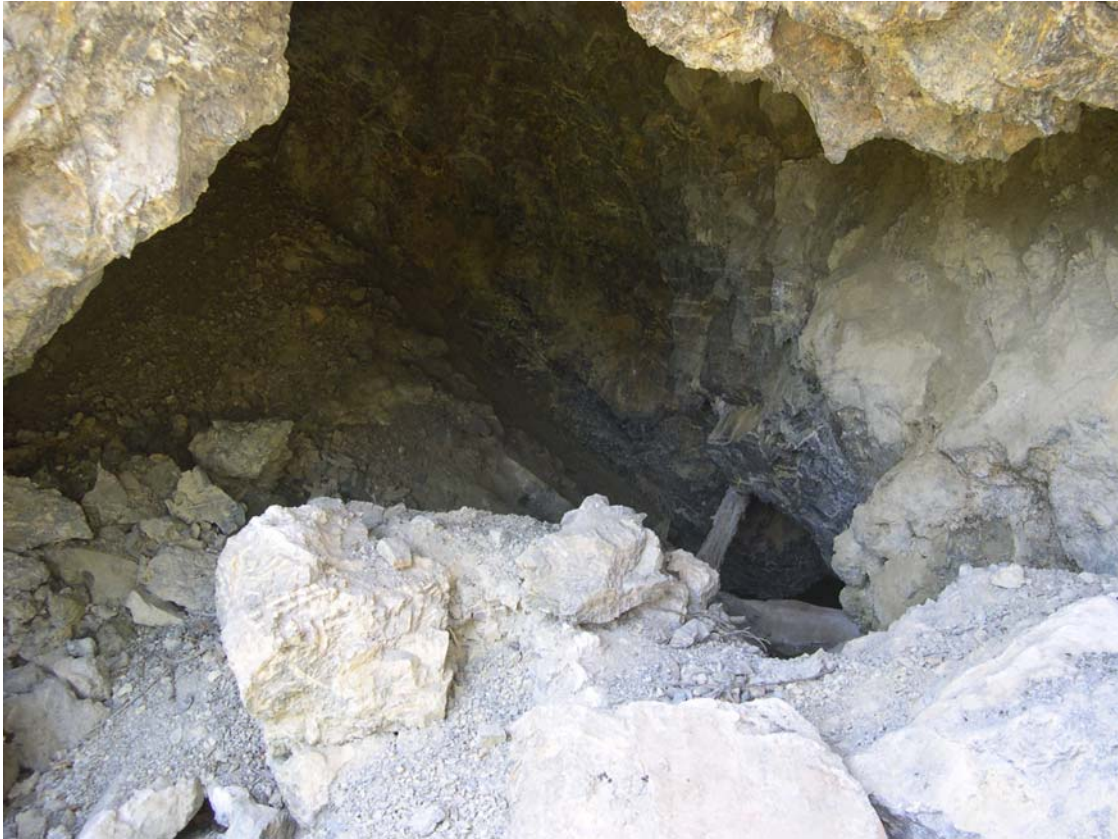
Adit 1 is located approximately 25 feet west of Upper Road (Photograph 3). Adit 1 was approximately 10 feet wide by 8 feet tall and is blocked and partially closed. Timber and scrap metal covering an area of approximately 25 square feet and 5 feet tall were observed between Upper Road and Adit 1. The timbers were 4 to 12 inches in diameter and appeared similar to timber used for telephone poles. The metal debris was only slightly rusted. Rodent scat was observed inside Adit 1. Adit 1 was dry with no evidence of drainage away from it.

Photograph 3 - View of Adit 1.

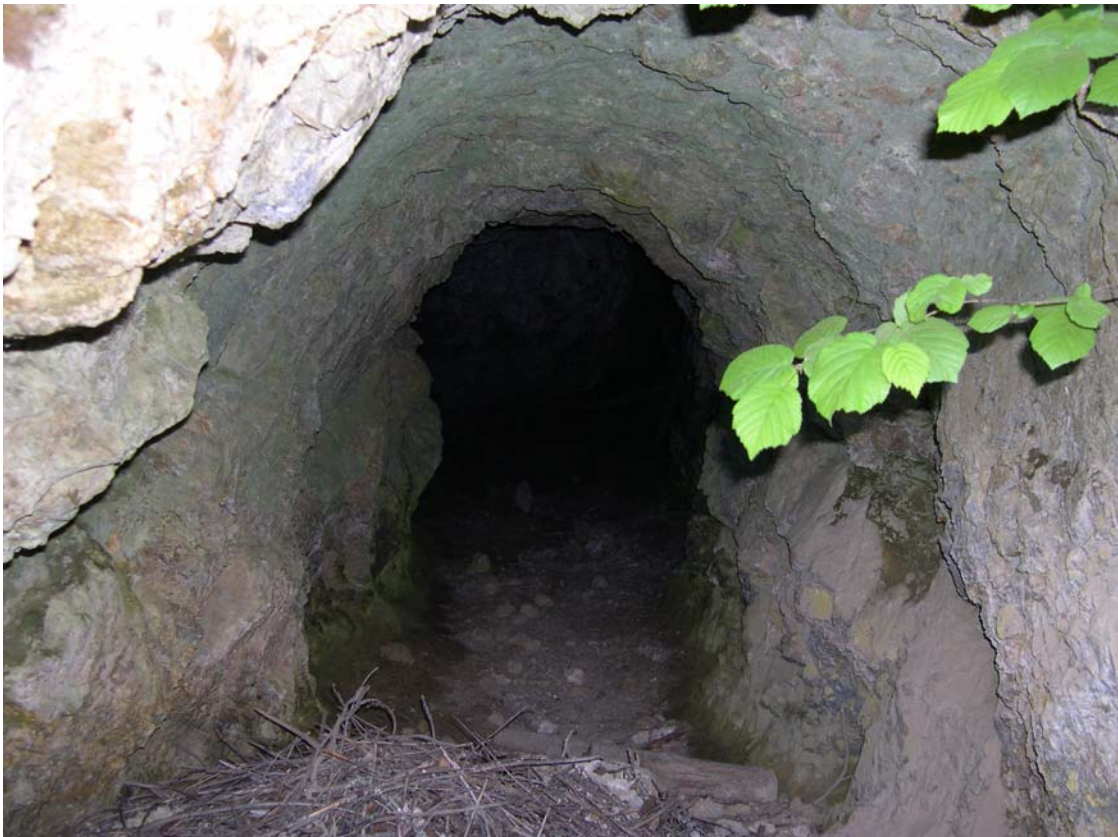
Adit 2 is located west-southwest of Adit 1 and is approximately 35 feet above Upper Road (Photograph 4). Adit 2 is approximately 4 feet wide by 5 feet tall and is visibly 20 feet long. A 2-foot square piece of corrugated sheet metal was observed adjacent to Adit 2. No evidence of animal activity in Adit 2 or drainage from Adit 2 was observed.

Photograph 4 - View of Adit 2.

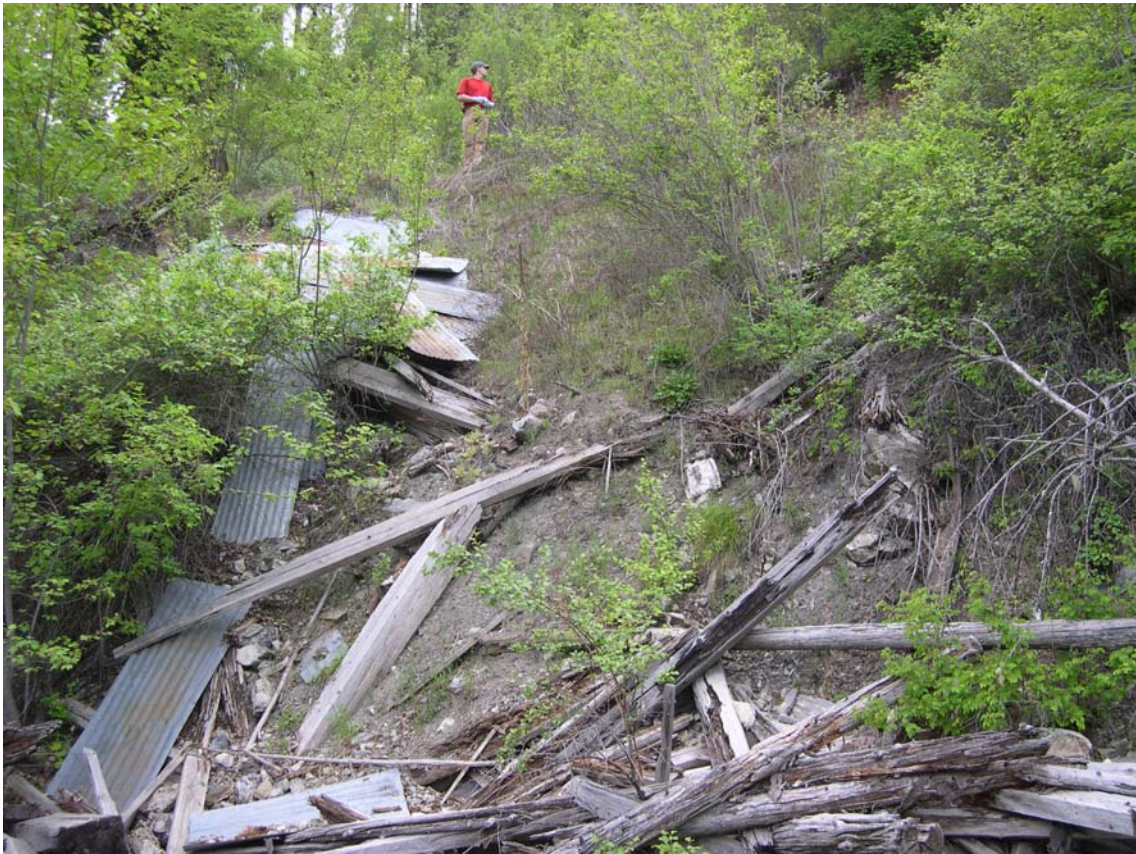
Waste rock, WR-4, associated with an adit, Adit 3, is present below Upper Road extending downslope to Lower Road 1 and below Lower Road 1 (see Figure 4 and Photograph 5). WR-4 is approximately 210 cubic yards in volume and is composed of moist, gray to light brown, slightly silty to silty, sandy Gravel with occasional cobbles. WR-4 is covered in large amounts of debris, DB-3. WR-4 is too steep to safely access and characterize the lower extent of the pile. WR-4 may be in the location of a remnant loading structure. No evidence of seepage from WR-4 was observed.

Various scattered debris and piles of debris were observed at Shoemaker Mine (South). DB-3 is approximately 100 feet long by 20 feet wide with an extra 30-foot by 30-foot lobe to the northwest and is approximately 1 to 2 feet thick (Photograph 5). DB-3 contains timbers; rusted rails; slightly rusted, corrugated sheet metal; and rusted sheet metal and plywood (similar to the WR-1, rockrun). A rusted, 5-gallon bucket with no lid was observed at the northeast end of DB-3 but was inaccessible to determine its contents. DB-4 is a 30-foot-long by 10-foot-wide by 1-foot-thick pile of timbers between Upper Road and Lower Road 2 and south of DB-3. A 4-foot by 5-foot wooden door, Door 1, on Lower Road 1 is southeast of DB-4. A ladder; 1-gallon, rusted, empty can of Shell Zone brand antifreeze; and an aluminum Pepsi can (circa 1980s-1990s) were observed adjacent to Door 1. A 3-inch-diameter, rusted metal pipe, Pipe 1, extends across Lower Road 1 northeast of DB-4. A debris pile, DB-6, located just off Upper Road south of Adit 3 is about 6 feet wide by 8 feet long by 2 feet tall and contains timbers and rusted, corrugated sheet metal. An 8-foot-wide by 10-foot-long by 1-foot-thick pile of timber debris, DB-7, was observed at the south end of Lower Road 2. A degraded, yellow plastic glove and a 2-liter plastic bottle were observed near Adit 4.

Photograph 5 - View of upper sections of WR-4 and DB-3.

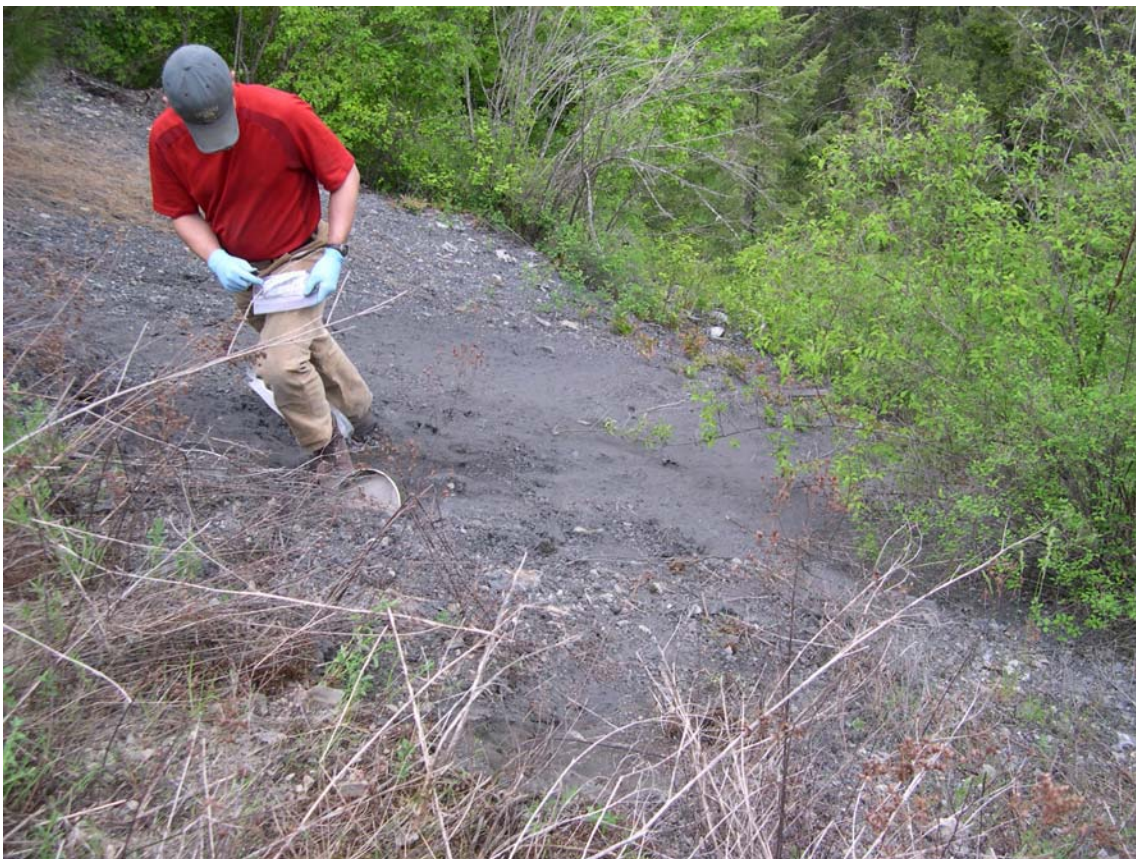
Another waste rock pile, WR-6, is located east of WR-4, below Lower Road 2, and adjacent to an adit, Adit 4 (Photograph 6). WR-6 slopes approximately 44° downward toward the east and is only marginally stable. WR-6 was not safe to hike down and was completely characterized from Lower Road 2. WR-6 is approximately 620 cubic yards in volume and is composed of moist, gray, very silty, gravelly Sand. No evidence of seepage from WR-6 was observed.

Photograph 6 - View of WR-6.

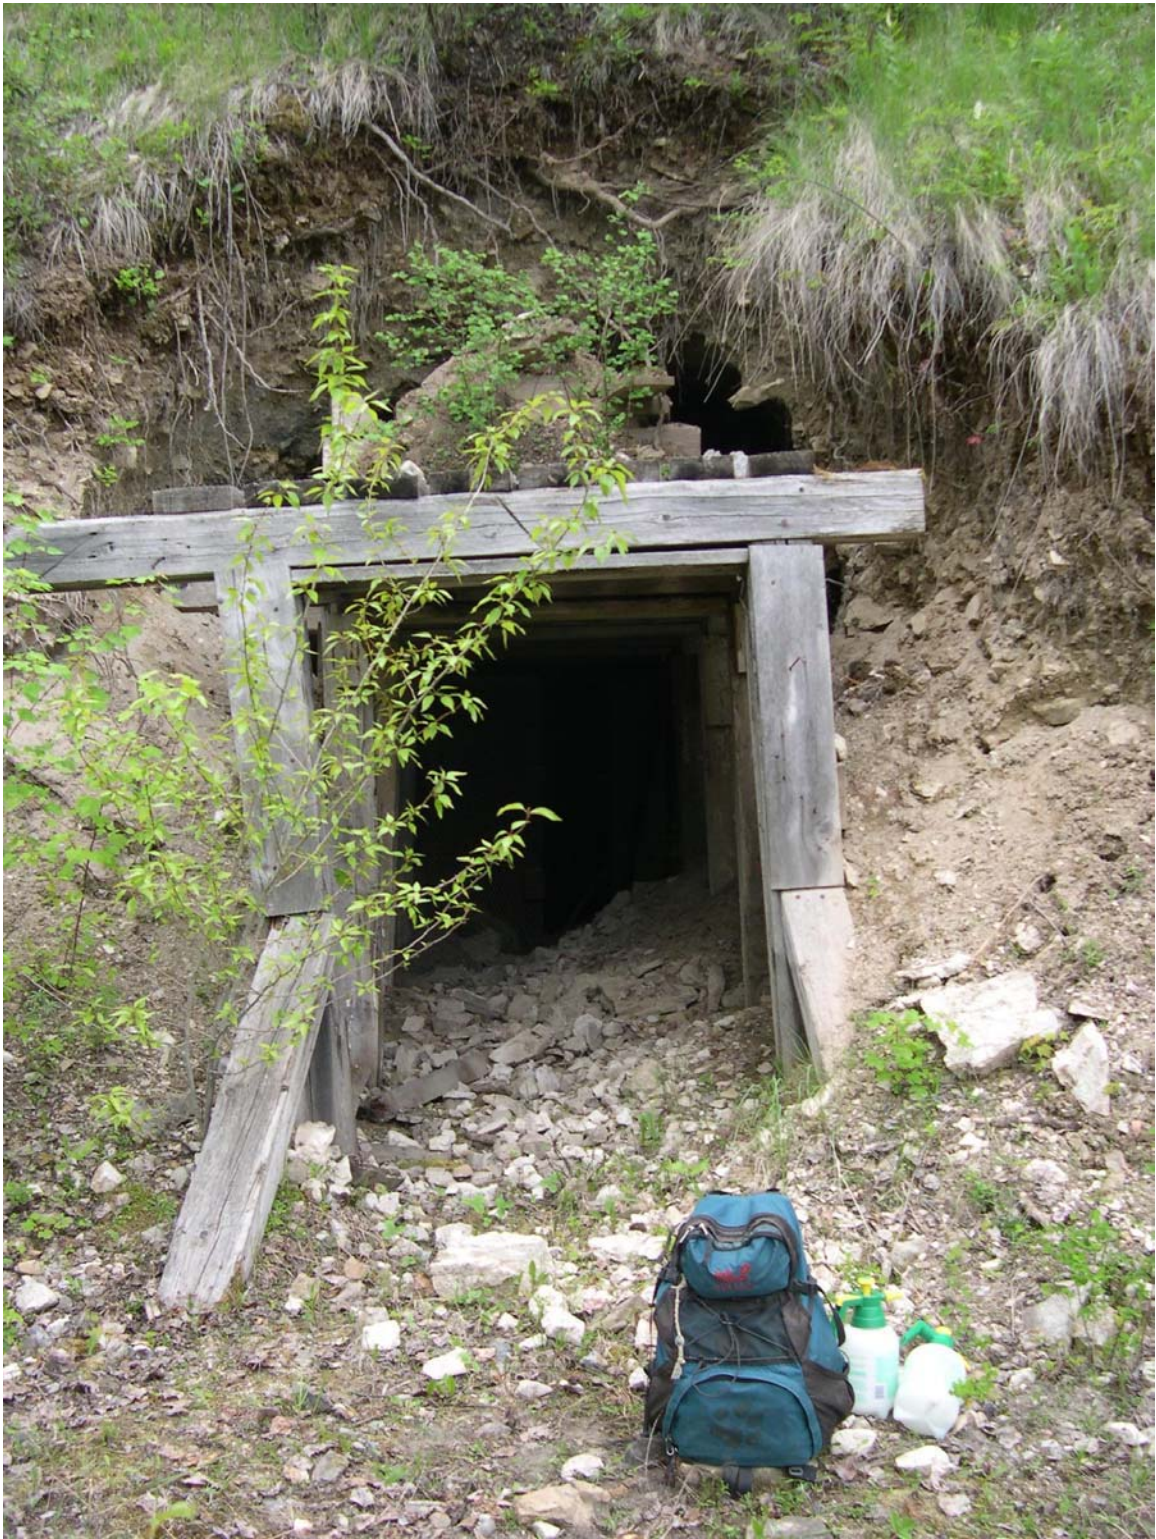
Adit 3 is located on the west side of Upper Road. Adit 3 is open and approximately 6 feet tall by 6 feet wide and is visibly, approximately 30 feet long (Photograph 7). The timber entryway structure is still intact. Metal cage doors are located at the mouth of Adit 3 and were open. A wood feature, possibly a door, was observed approximately 30 feet into Adit 3. Adit 3 was dry with no evidence of drainage away from it. Rodent scat was observed in the entryway structure.

Photograph 7 - View of Adit 3.

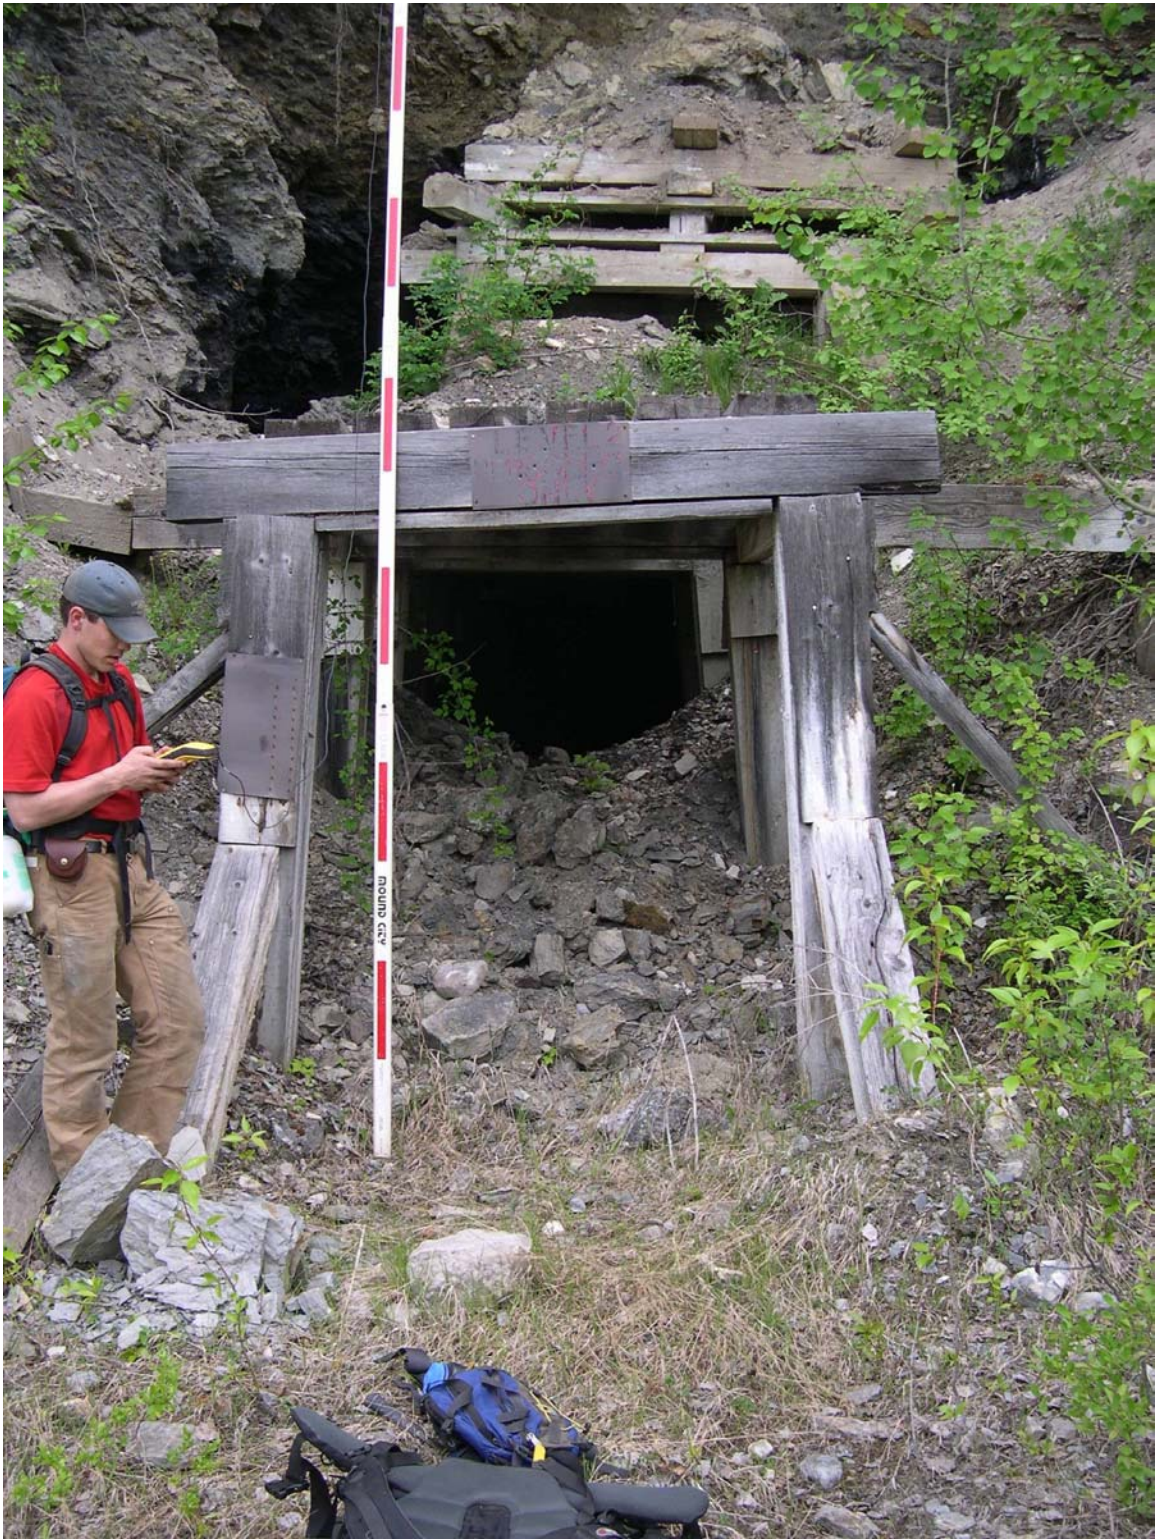
Adit 4 is located east of and below Adit 3 and on the west side of Lower Road 2 (Photograph 8). Adit 4 is partially blocked but open and is approximately 6 feet tall by 6 feet wide and is visibly, approximately 25 feet long. The timber entryway structure is still intact. Two signs were located on the face of the entryway structure: (1) a sign in/out board with a list of names and a heading reading "General Mine, Truices Corp., Level 3" and (2) a sign reading "Level 3 Personnel Only." Half of a wood door was observed approximately 25 feet into Adit 4. Adit 4 was dry with no evidence of drainage away from it. No evidence of animal activity was observed in Adit 4.

Photograph 8 - View of Adit 4.
