***Abandoned Mine Lands
Initial Investigation Report
Sterling Mine
Metaline, Washington***

***Prepared for
Washington State
Department of Ecology***

***June 25, 2007
(Revised September 13, 2007)
17274-01(ST)***

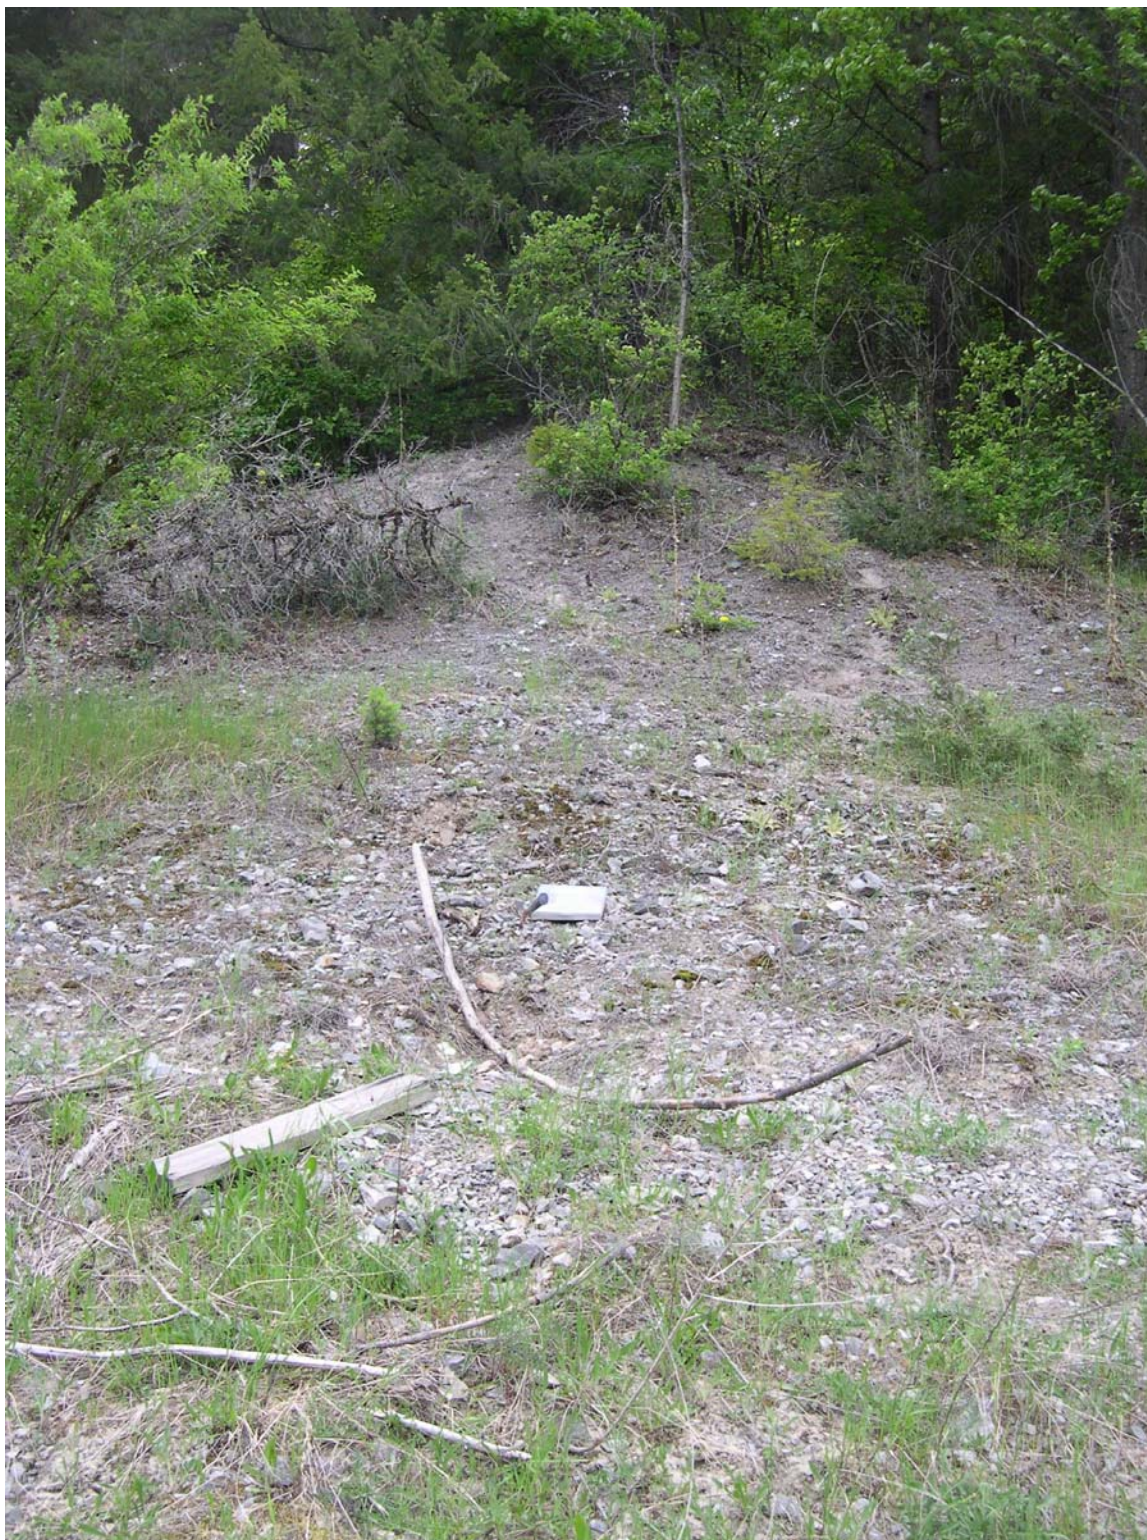
Photograph 1 - View of WR-1. Note waste rock extends beyond bottom of picture frame, where it is covered in grasses and mixed with river sediment.

Waste rock, WR-1, is located across from an adit, Adit 2, on the slope facing down and extending to the Pend Oreille River down and extends to the west bank of the Pend Oreille River (Photograph 1). WR-1 is approximately 125 cubic yards in volume and contains dry, gray, silty, sandy Gravel with occasional cobbles. Some oxidation of the waste rock is visible. Minor amounts of waste rock were visible in the Pend Oreille River during the field visit. The lower portion of WR-1 is mixed with river sediments and is covered in grassy vegetation, except where recent bank scour has occurred (Photograph 2). No evidence of seepage from WR-1 was observed.

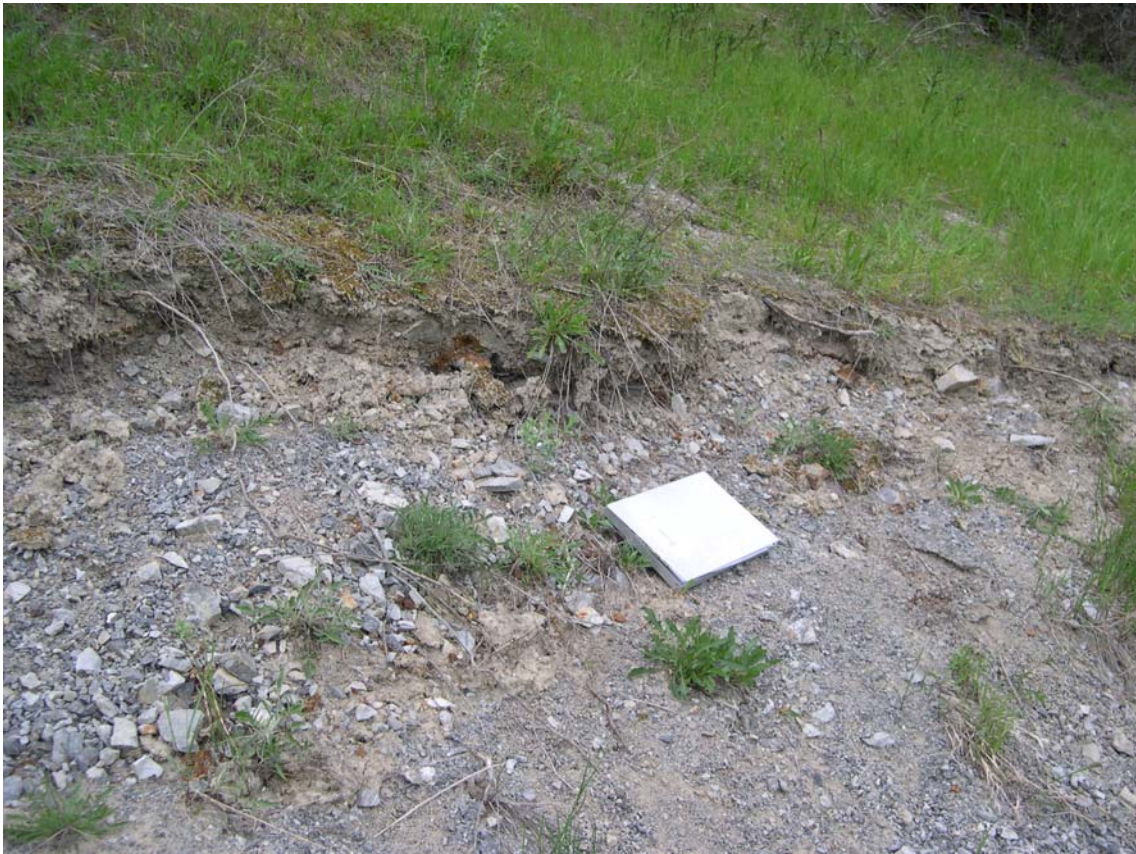
Photograph 2 - View of WR-1 waste rock mixed with river sediments in location of recent bank scour along Pend Oreille River.

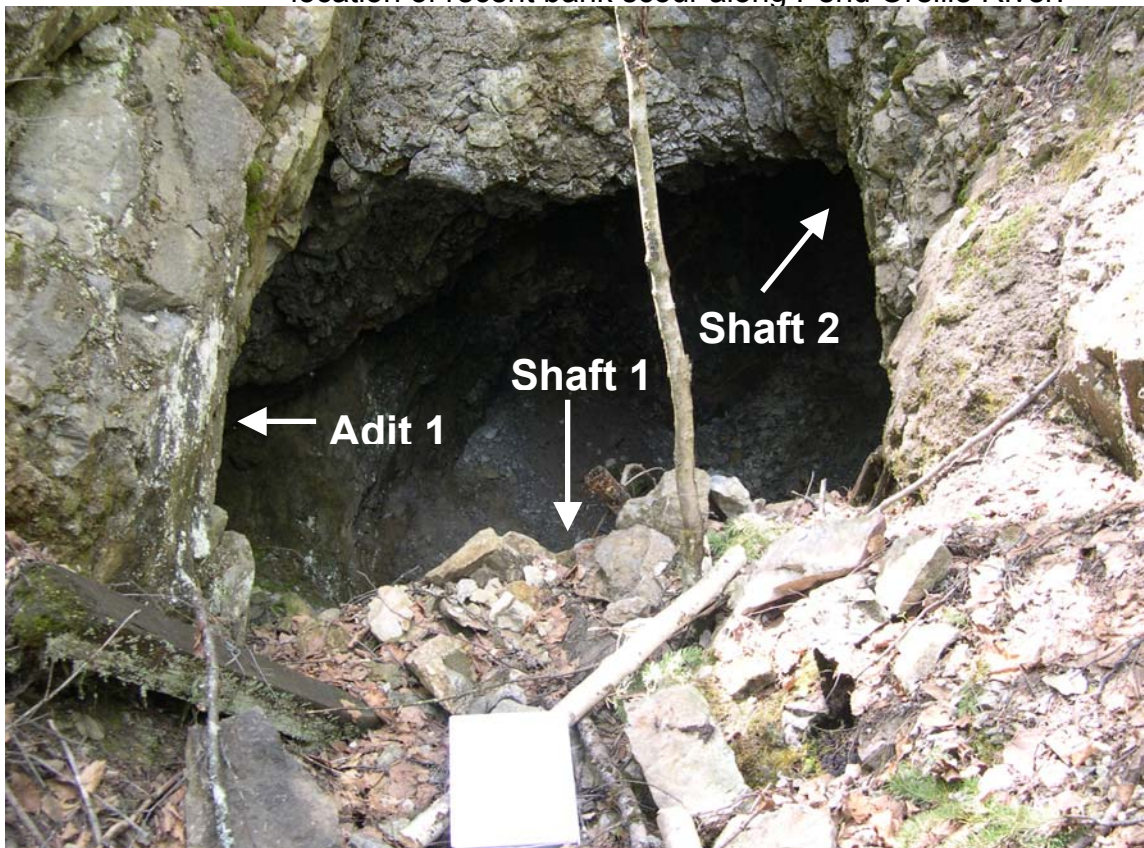
Photograph 3 - View of Shaft 1 showing locations of Shaft 2 and Adit 1.

Three mine openings are centrally located in Sterling Mine (Photograph 3). A closed shaft, Shaft 1, is approximately 6 feet in diameter by 5 feet deep. Shaft 2 is northwest upslope from Shaft 1. Shaft 2 is approximately 6 feet in diameter by 15 feet long and is open to Shaft 1 below it. Adit 1 is blocked by soil but open to Shaft 1 to the north. Adit 1 is approximately 5 feet tall by 4 feet wide and 10 feet long. A trench, Trench 2, leads from the Adit 1 south-southeast to the old road. Trench 2 is approximately 4 feet deep by 4 feet wide by 75 feet long. All

of these features were dry with no evidence of drainage from them. Also, no evidence of animal activity was observed in these features.

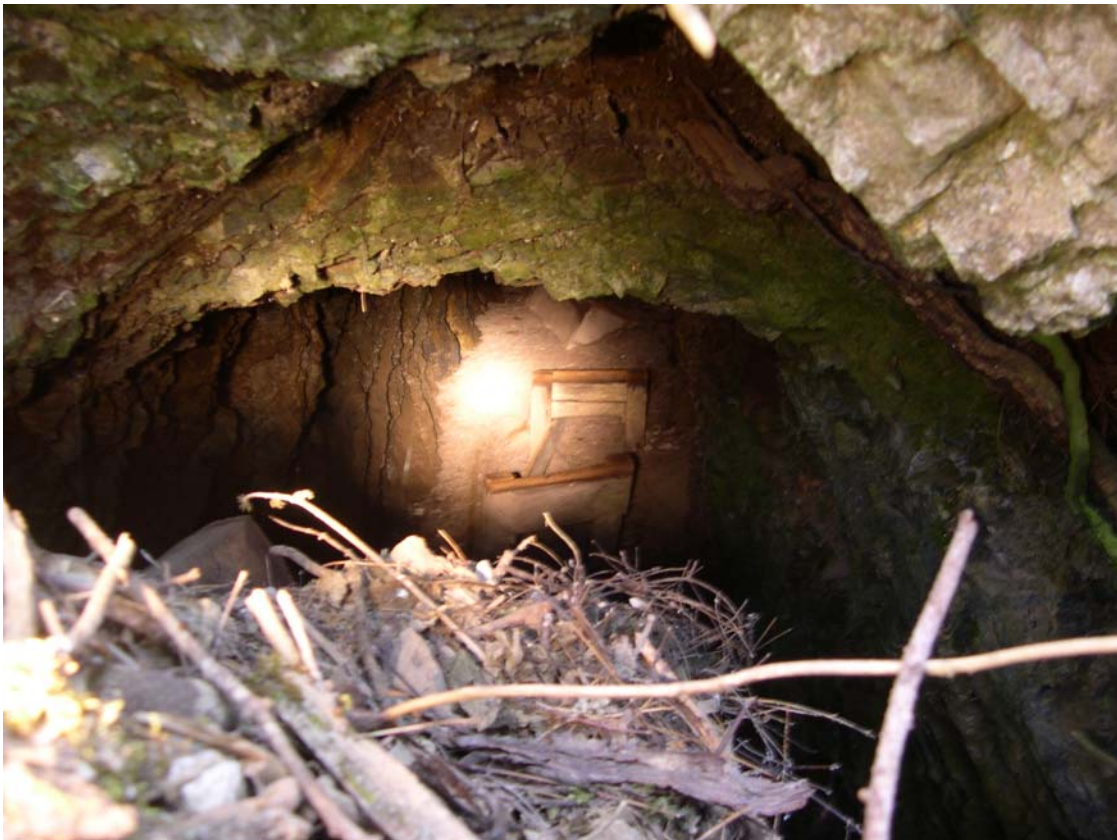
Photograph 4 - View of Adit 2.

Adit 2 is north of WR-3 and is blocked but remains open (Photograph 4). Adit 2 is approximately 6 feet tall by 5 feet wide and greater than 30 feet in length. Adit 2 was dry with no evidence of animal activity. A wooden bench and wooden box were observed inside Adit 2, as well as a plant growing on the wooden box inside the adit.

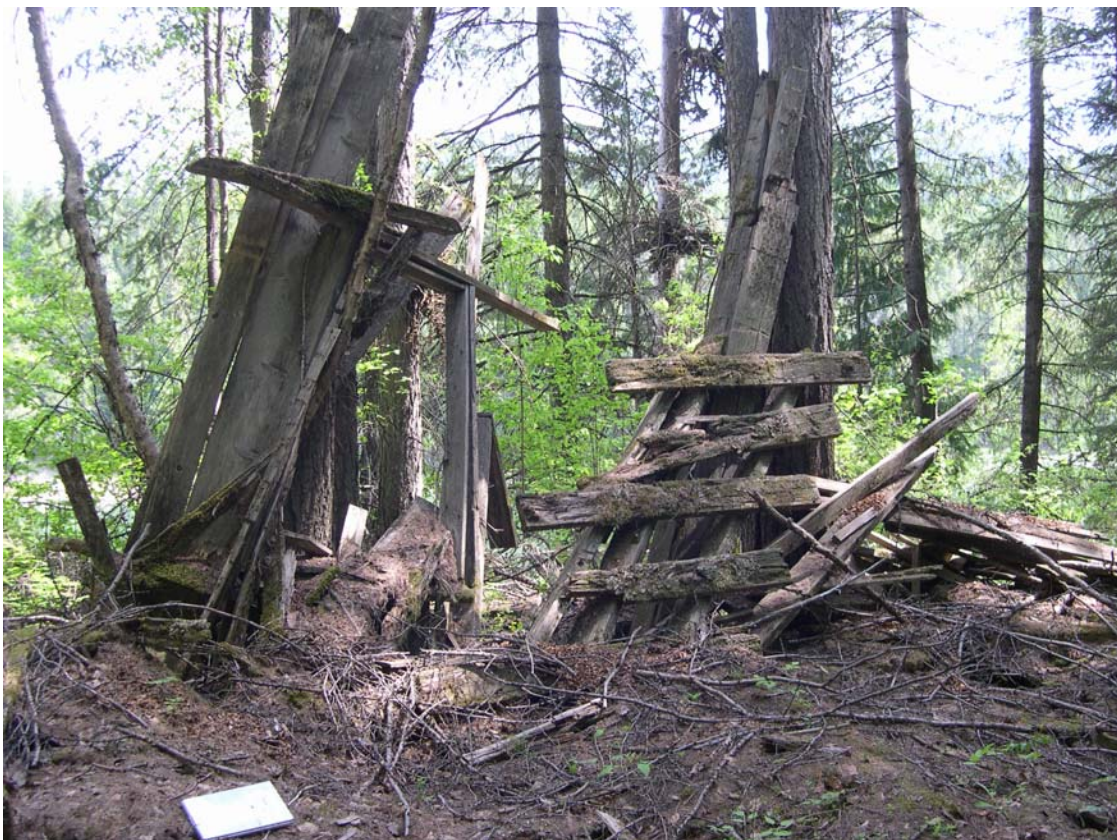
Photograph 5 - View of collapsed structure at east end of DB-1.

A debris pile, DB-1, is located southeast of the intersection of Trench 1 and WR-2 (Road). DB-1 is approximately 50 feet long by 30 feet wide by 0.5 foot deep. DB-1 contains a mix of timber debris and rusted scrap metal parts, including rail car parts, stacked rail car ties, and steel cable. A collapsed structure remains at the east end of DB-1 (Photograph 5). Miscellaneous metal debris is spread around especially in the vicinity of DB-1 at the site. Two cut halves of a rusted, metal 55-gallon drum are located north of DB-1, adjacent to two concrete foundations, F-1. F-1 includes a southern 4-foot-long by 2-foot-wide by 2.5-foot concrete foundation with metal bolts protruding and a northern 3.5-foot square by 2-foot-tall foundation or potential assay furnace with a 2-cubic-foot cavity.
