PHASE II
ENVIRONMENTAL SITE ASSESSMENT

Columbia Oil Company-Sgt. Bubs Site
1345 Lee Blvd.
Richland, Washington

April 19, 2005

Project Number: E2005/0310

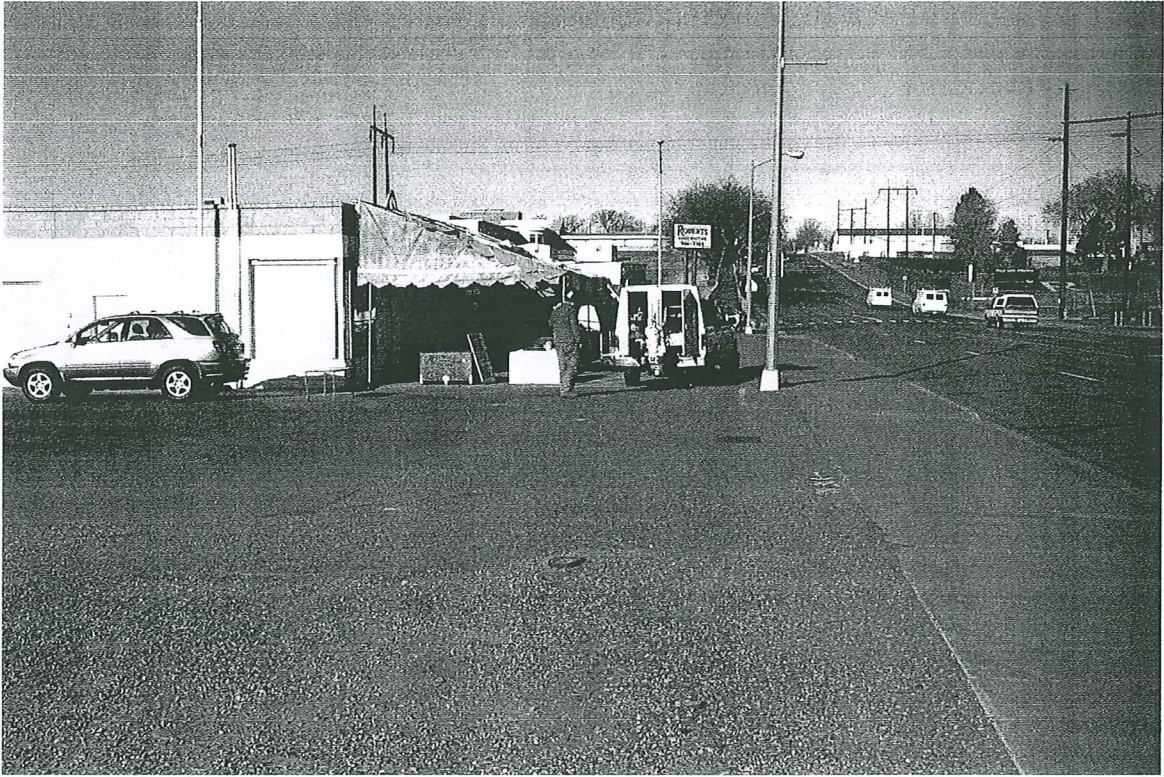
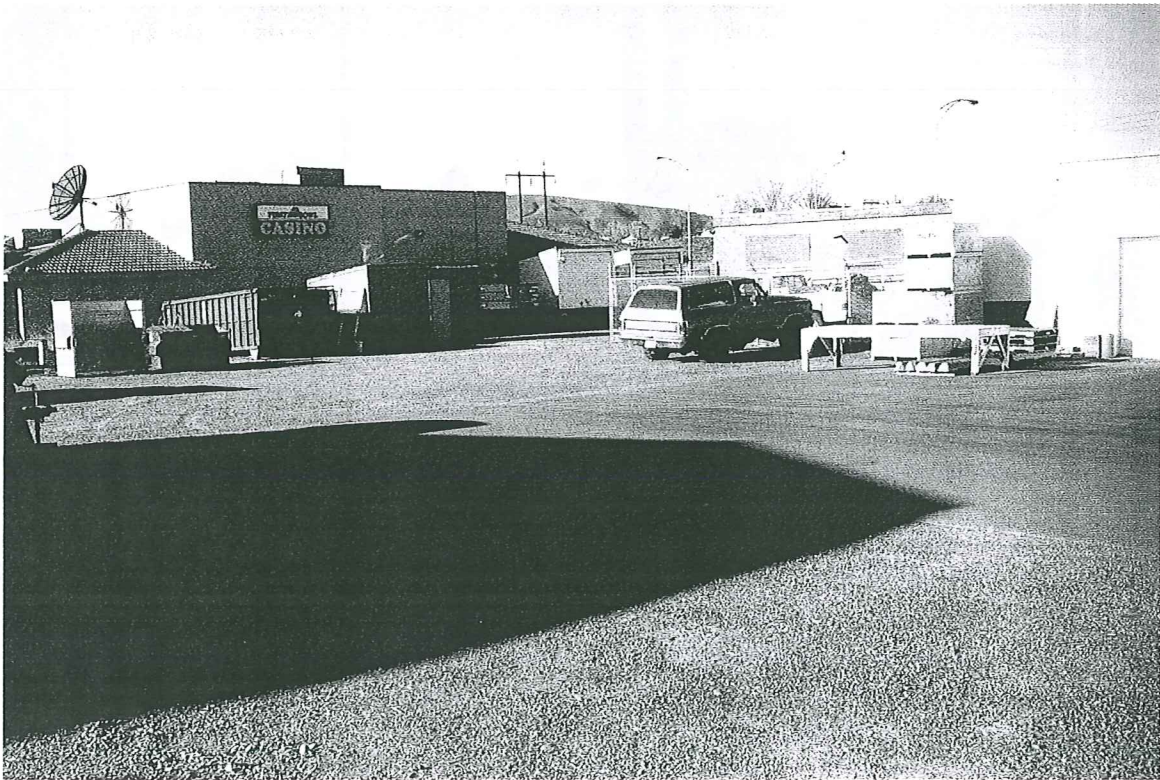
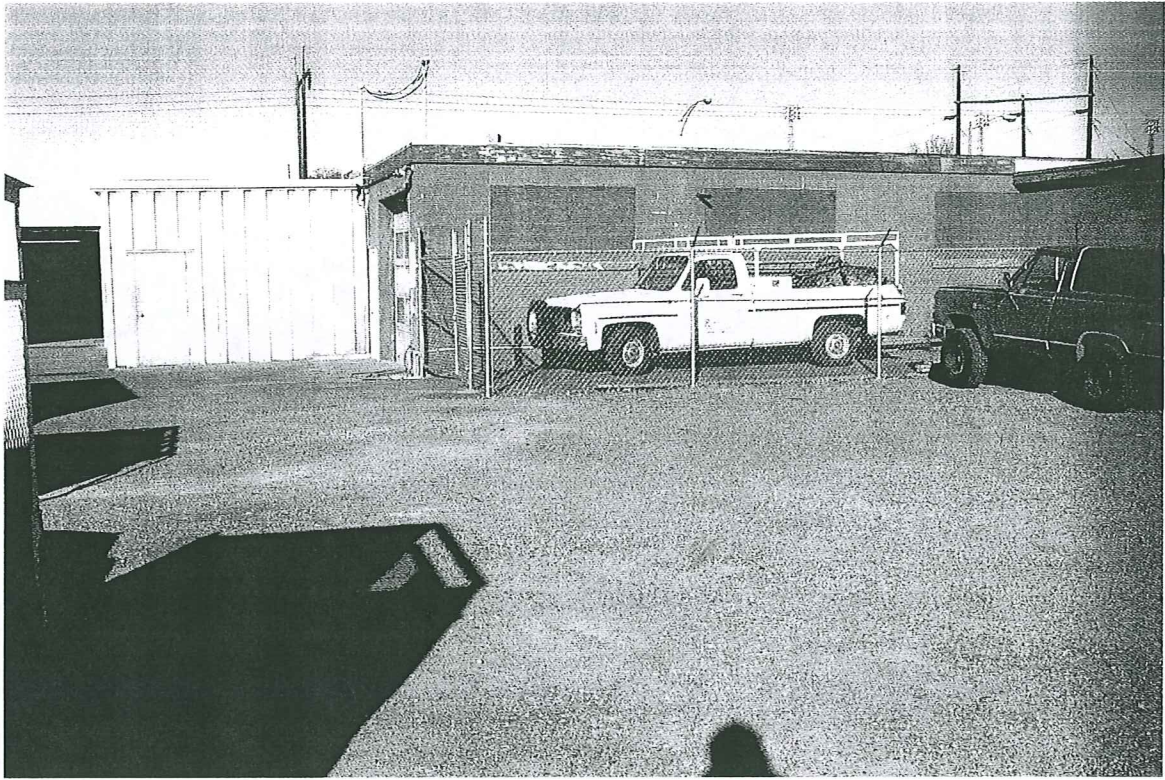
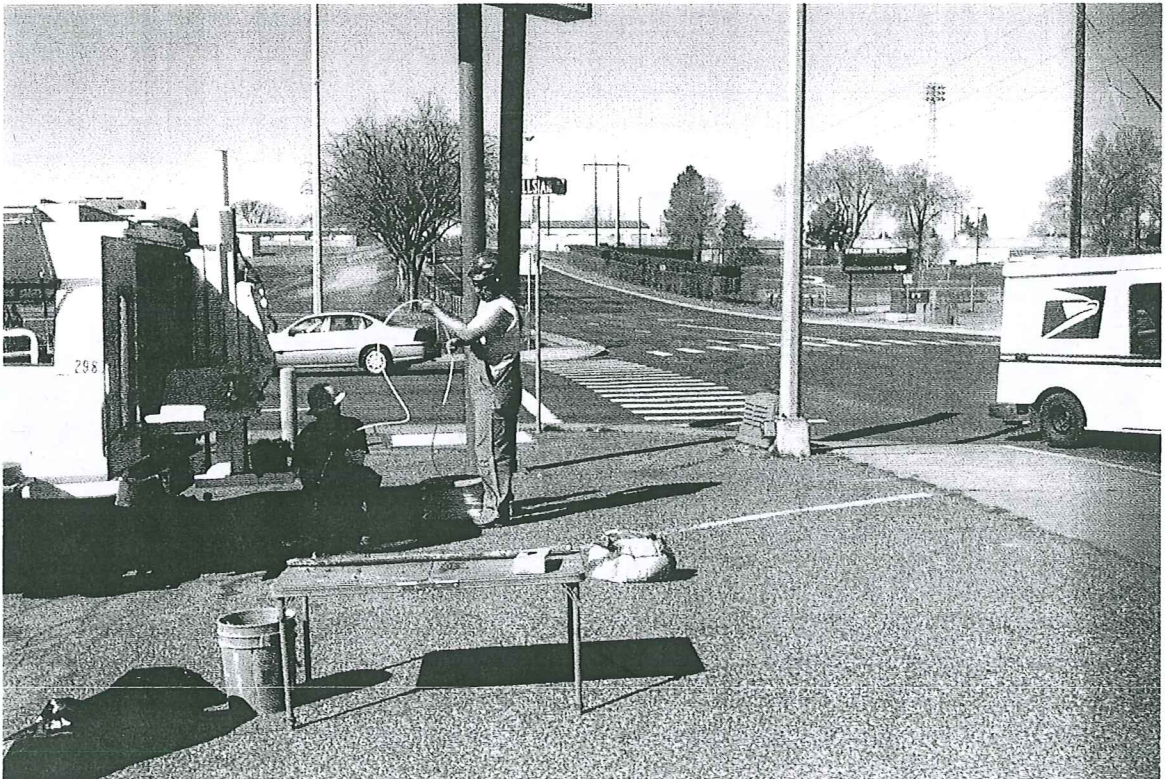
The soil samples for the laboratory were collected from the PVC liner fitted inside the two inch tube sampler (see photo documentation). The boring and sampling equipment was cleaned between each boring with an Alconox solution and triple-rinsed with distilled water. Soil samples were collected from the liner with new latex gloves, labeled with sample number, date and time collected, and placed in an ice chest containing 'blue-ice' for UPS overnight delivery to OnSite Environmental Laboratory, in Redmond, Washington.
