***Abandoned Mine Lands
Initial Investigation Report
Washington Mine
Metaline Falls, Washington***

***Prepared for
Washington State
Department of Ecology***

***December 28, 2006
17274-00(WA)***

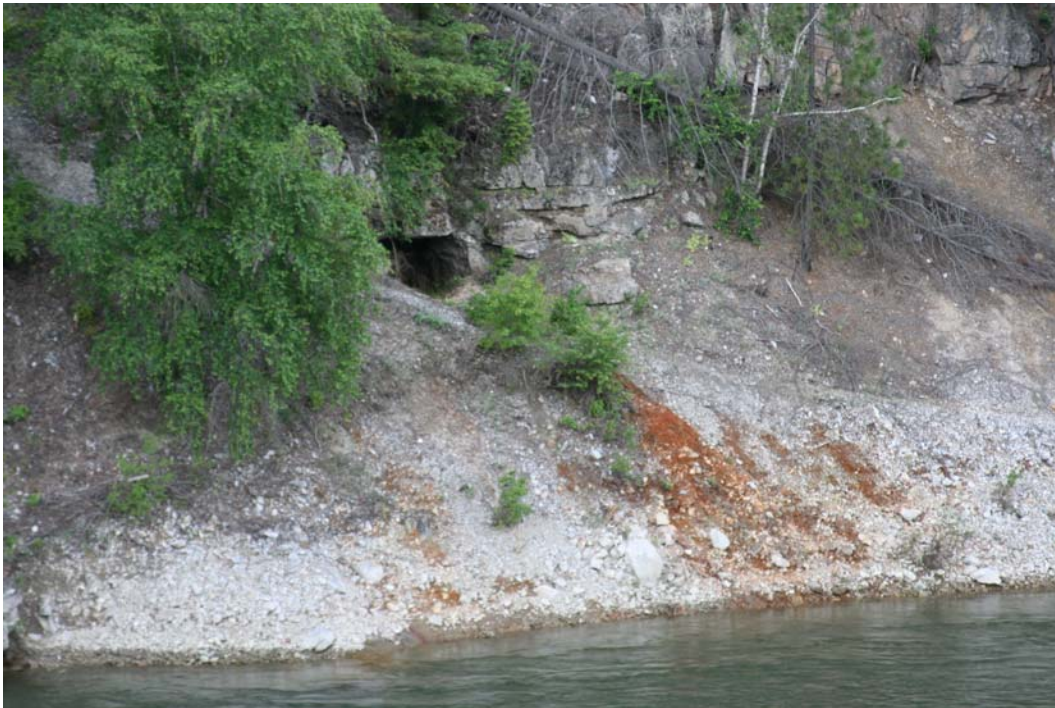
The Washington Mine is an inactive lead, zinc, silver, and iron mine. A large, open, flooded adit lies at the base of Washington Rock, adjacent to the Pend Oreille River (Photographs 1 and 2). A short trail leads to the adit, which is visible from Highway 31. Iron staining was observed leading from the adit into the river (Photographs 2 and 3). No waste rock is visible, although it may have been washed downstream. A Site Plan and cross section view of the site are shown on Figures 3 and 4, respectively.

Photograph 1 - View of Adit 2 above the Pend Oreille River.

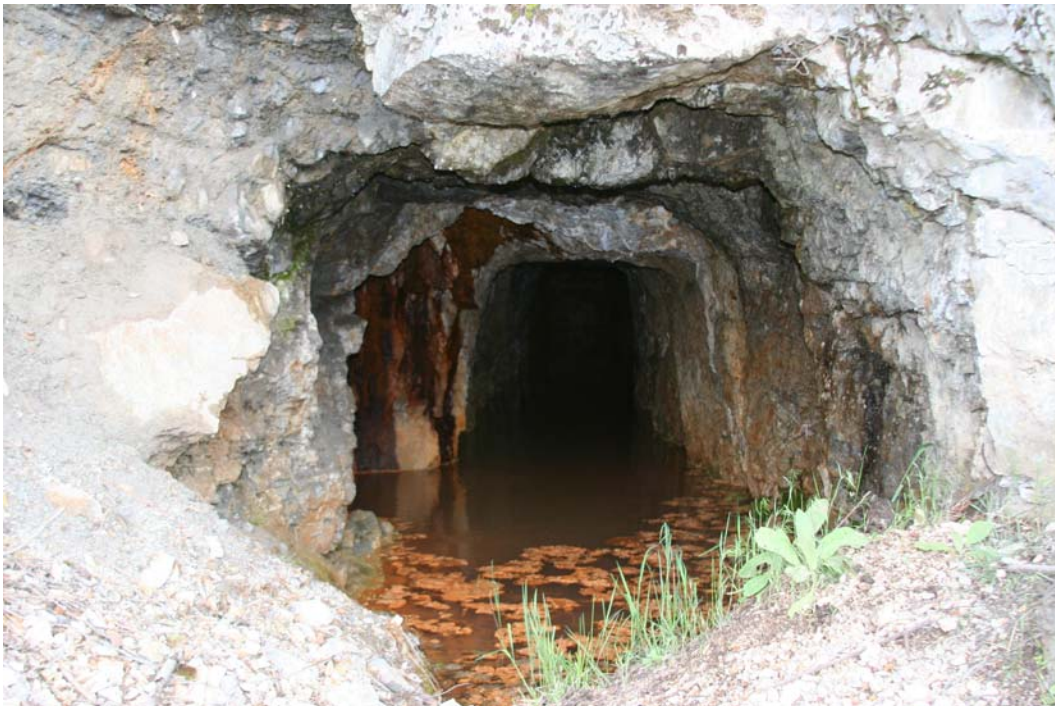
Photograph 2 - View of Adit 2.

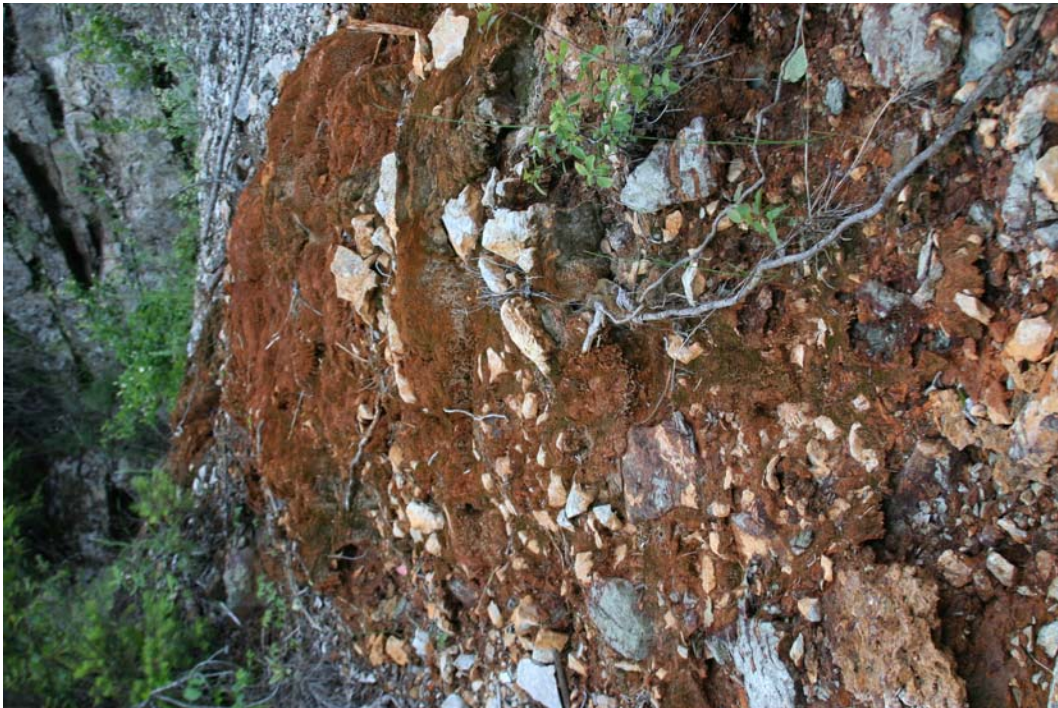
Iron deposits and ferricrete have formed on the hillside leading from the open adit to the Pend Oreille River (Photograph 3). A five-point composite sediment sample was collected along the dry drainage path between the adit and the river.

Photograph 3 - Ferricrete below Adit 2. ←Up

Additional surface water sampling and analysis are recommended when water from the adit is flowing to the river. At the same time, a sample of upgradient river water should be collected for hardness analysis so that the site-specific hardness dependent criteria can be calculated. Lead TCLP analysis of a sediment sample is recommended to determine whether the material might be dangerous waste. Human health risks would most likely be limited to potential recreational users. MTCA Method A and B screening criteria may overestimate risk to recreational users since their exposure duration is less than the duration for a residential scenario. A site-specific terrestrial ecological evaluation (TEE) would be required to evaluate ecological risks.

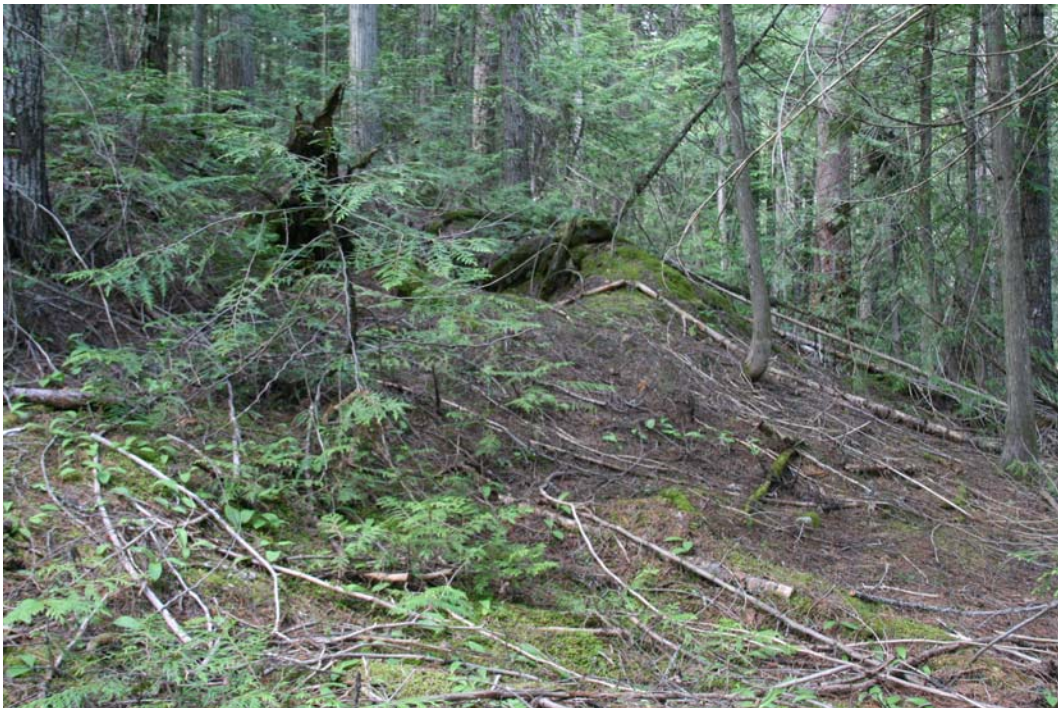
Hunting indicates that the Washington Mine is located on top of Washington Rock. An apparent collapsed prospect excavation (adit?) was located on a small hill at the top of Washington Rock (Photograph 4), but this prospect may not be a part of the Washington Mine. The hill sits above a wetland that drains to the east (Photograph 5). No drainage channels were observed exiting from the prospect, and no waste rock was visible near the collapsed feature. The wetland is fed by several small seeps to the south. Plan and cross-sectional views are depicted on Figures 5 and 6.

Photograph 4 - View of Washington Rock Prospect.

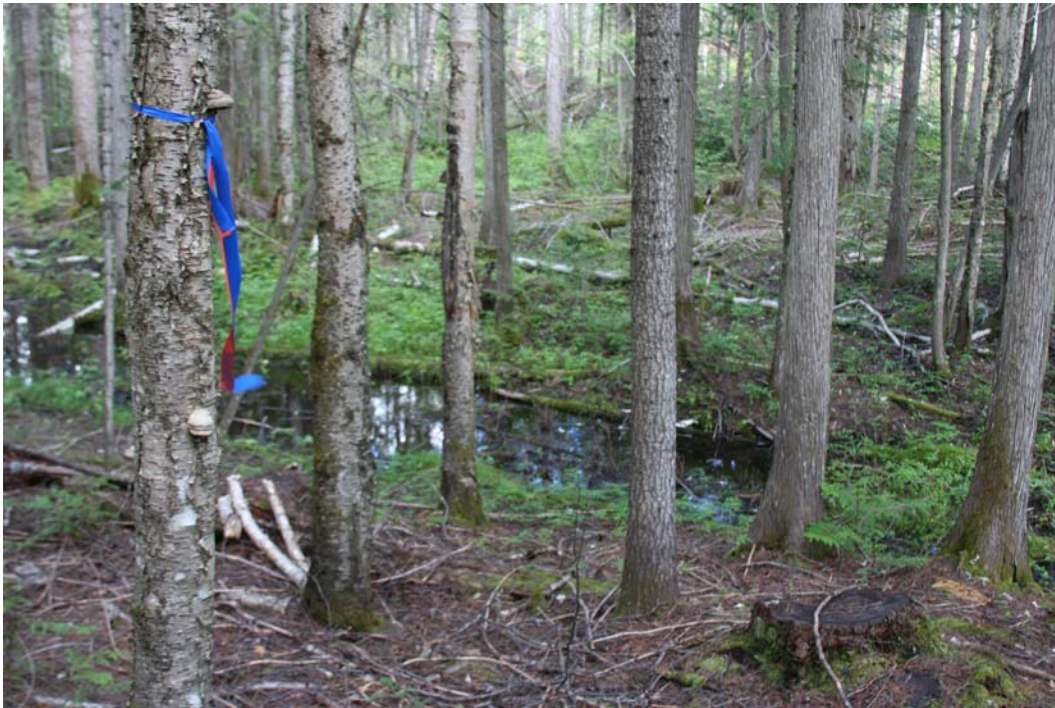
Photograph 5 - Wetland near Washington Mine Prospect.
