RE: Limited Soil Investigation Report

**NOLAND-DECOTO FLYING SERVICE
LIMITED SOIL INVESTIGATION REPORT**

**2810 West Washington Avenue
Yakima, Washington**

Project Number 08-635

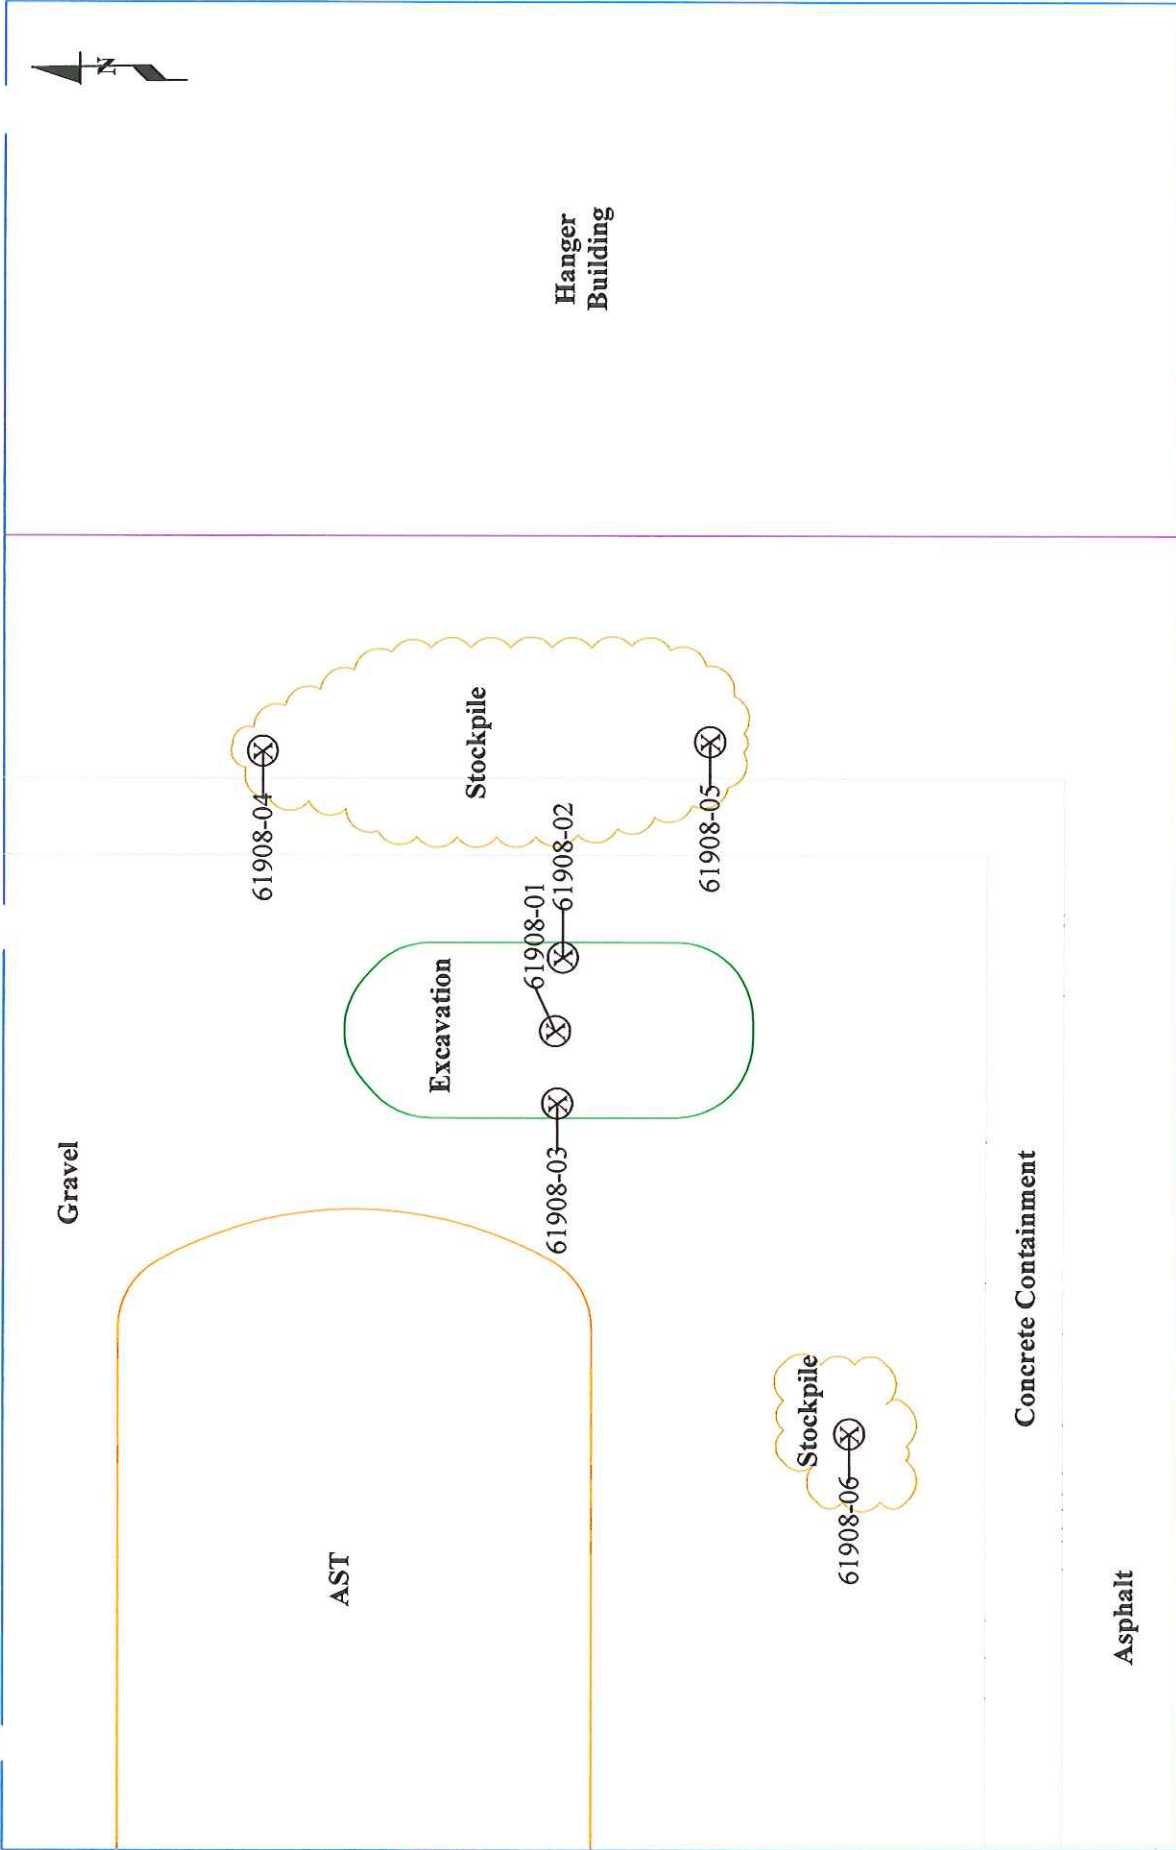
Figure 2
Sample Locations Map
 2810 West Washington Avenue
 Yakima, Washington

Three samples were collected from the excavation pit, consisting of one sample from the bottom of the excavation, and two additional samples from the east and west sidewalls of the excavation.

Three additional samples were collected from the stockpiled soils estimated at 3-cubic yards. Two were collected from the larger eastern stockpile and one from the smaller western stockpile.

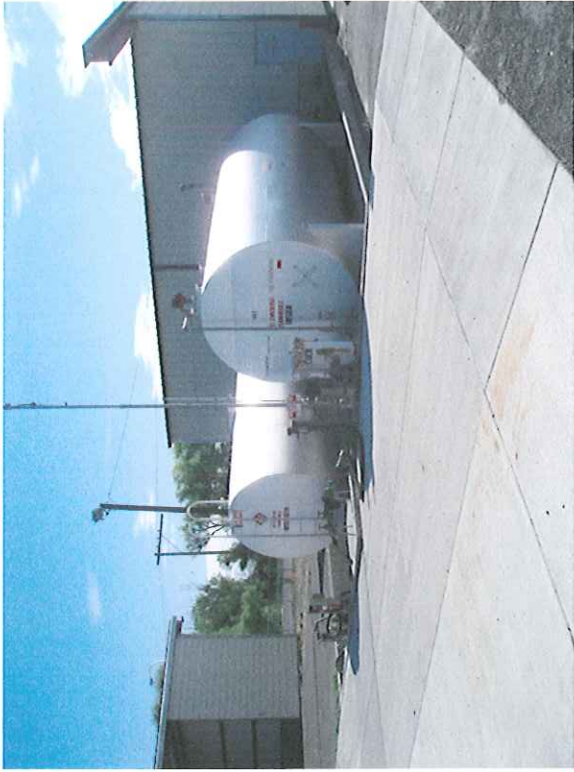
The Noland-Decoto facility is located at 2810 West Washington Avenue in Yakima, Washington. The site is located north and adjacent to McAllister Field. Two, approximately 10,000-gallon ASTs utilized for JET A fuel storage are located on the northeastern portion of the site. The tanks are utilized for onsite aircraft refueling.

Jet A Fuel Aboveground Storage Tanks

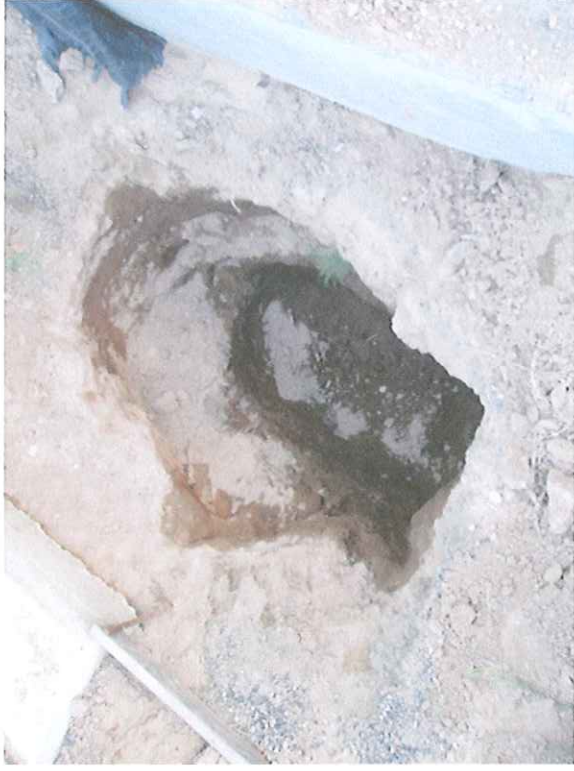
Fulcrum's visual inspection of the excavation area identified clean soil with no odor or petroleum staining. The excavation area was 4-feet by 5-feet wide at the surface and completed to a depth of 4-feet below ground surface (bgs). At a depth of 2-feet bgs, the excavation narrowed to 2-feet by 4-feet wide. Excavated soils totaled approximately 3-cubic yards. See Appendix C for site photographs.

Surface soils consisted of imported gravel from the surface to a depth of 2 to 3-inches. Underlying native soils consisted of dry, light to medium brown, silty loam material to the depth of excavation.

Excavation

Fulcrum recommends no additional investigation be completed as no further action is warranted.

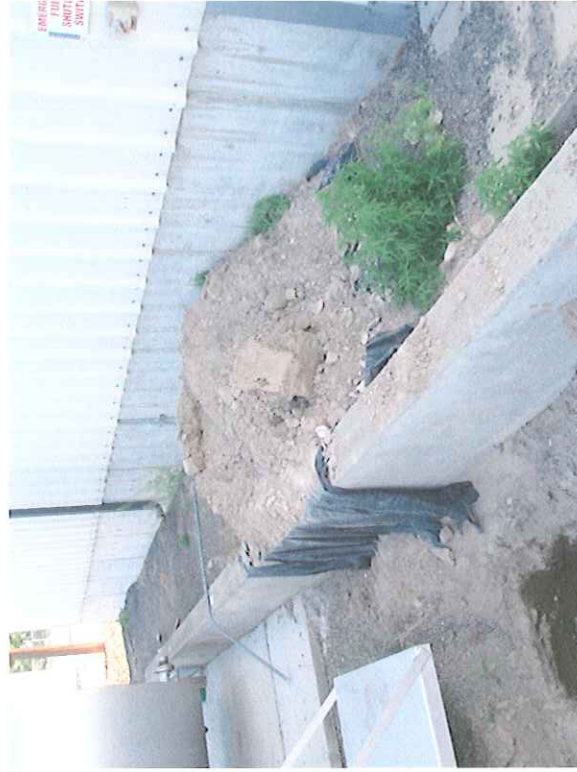
East Stockpile and Concrete Containment

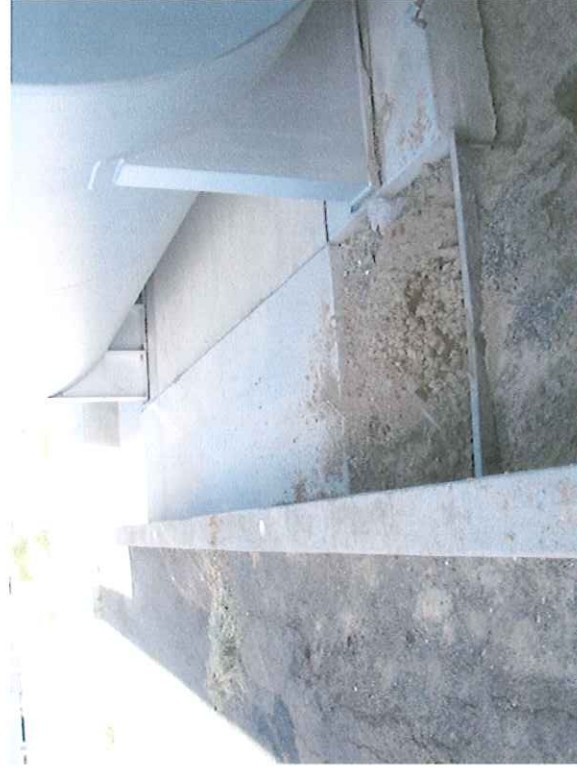
South Stockpile and Concrete Containment
