GN Northern Job No. 198-334
GN Northern Document No. 198-334.RPT

UNDERGROUND STORAGE TANK SITE ASSESSMENT
SPORTLAND MINI-MART TEXACO
4400 BULLFROG ROAD
CLE ELUM, WASHINGTON

October 22, 1998

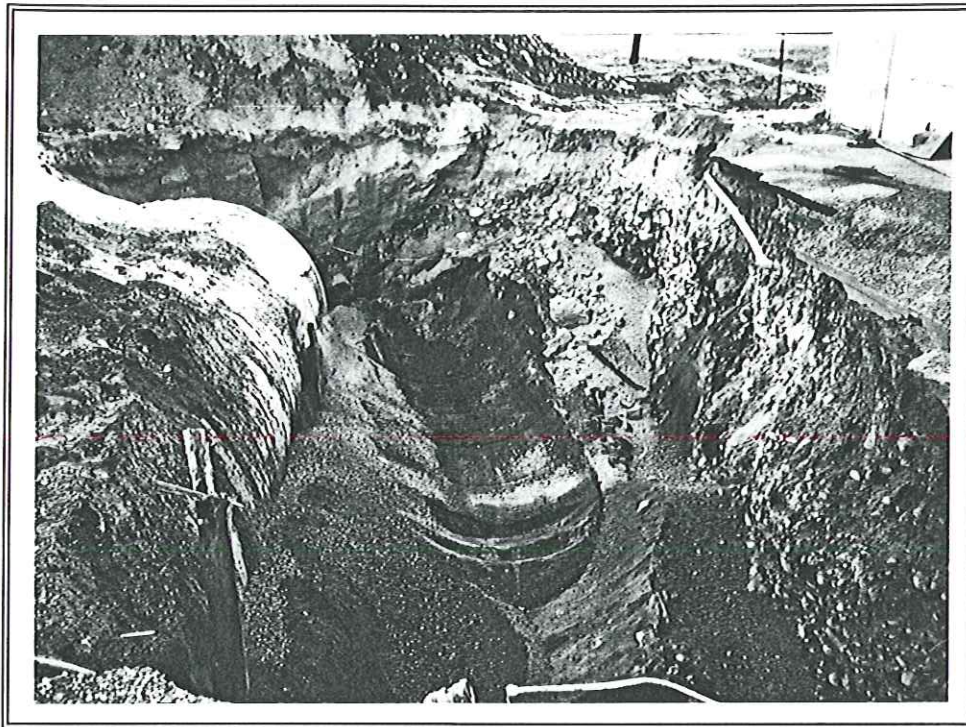
VIEW: Underground storage tank excavation,
