# **North Boeing Field/ Georgetown Steam Plant Site Remedial Investigation/Feasibility Study**

## **Remedial Investigation/Feasibility Study Work Plan**

### **VOLUME 2: FIGURES**

November 11, 2013

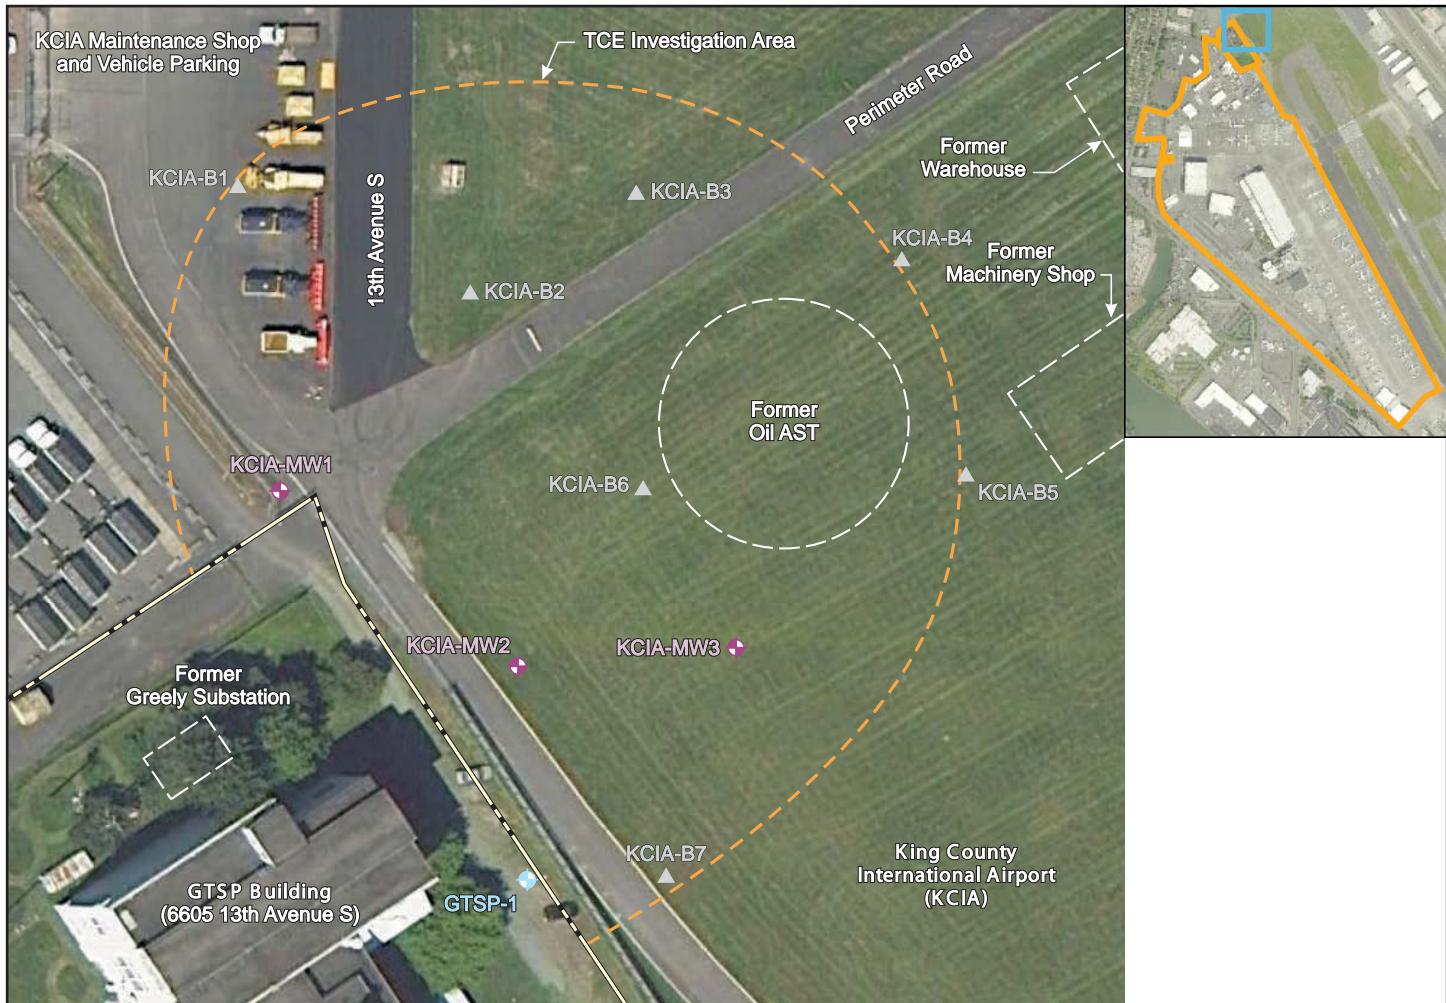
**Figure 7.1–7b. Soil and Groundwater Investigation of TCE Contamination at KCIA (2011)**

Figure 3  
**KCIA TCE Investigation Area**

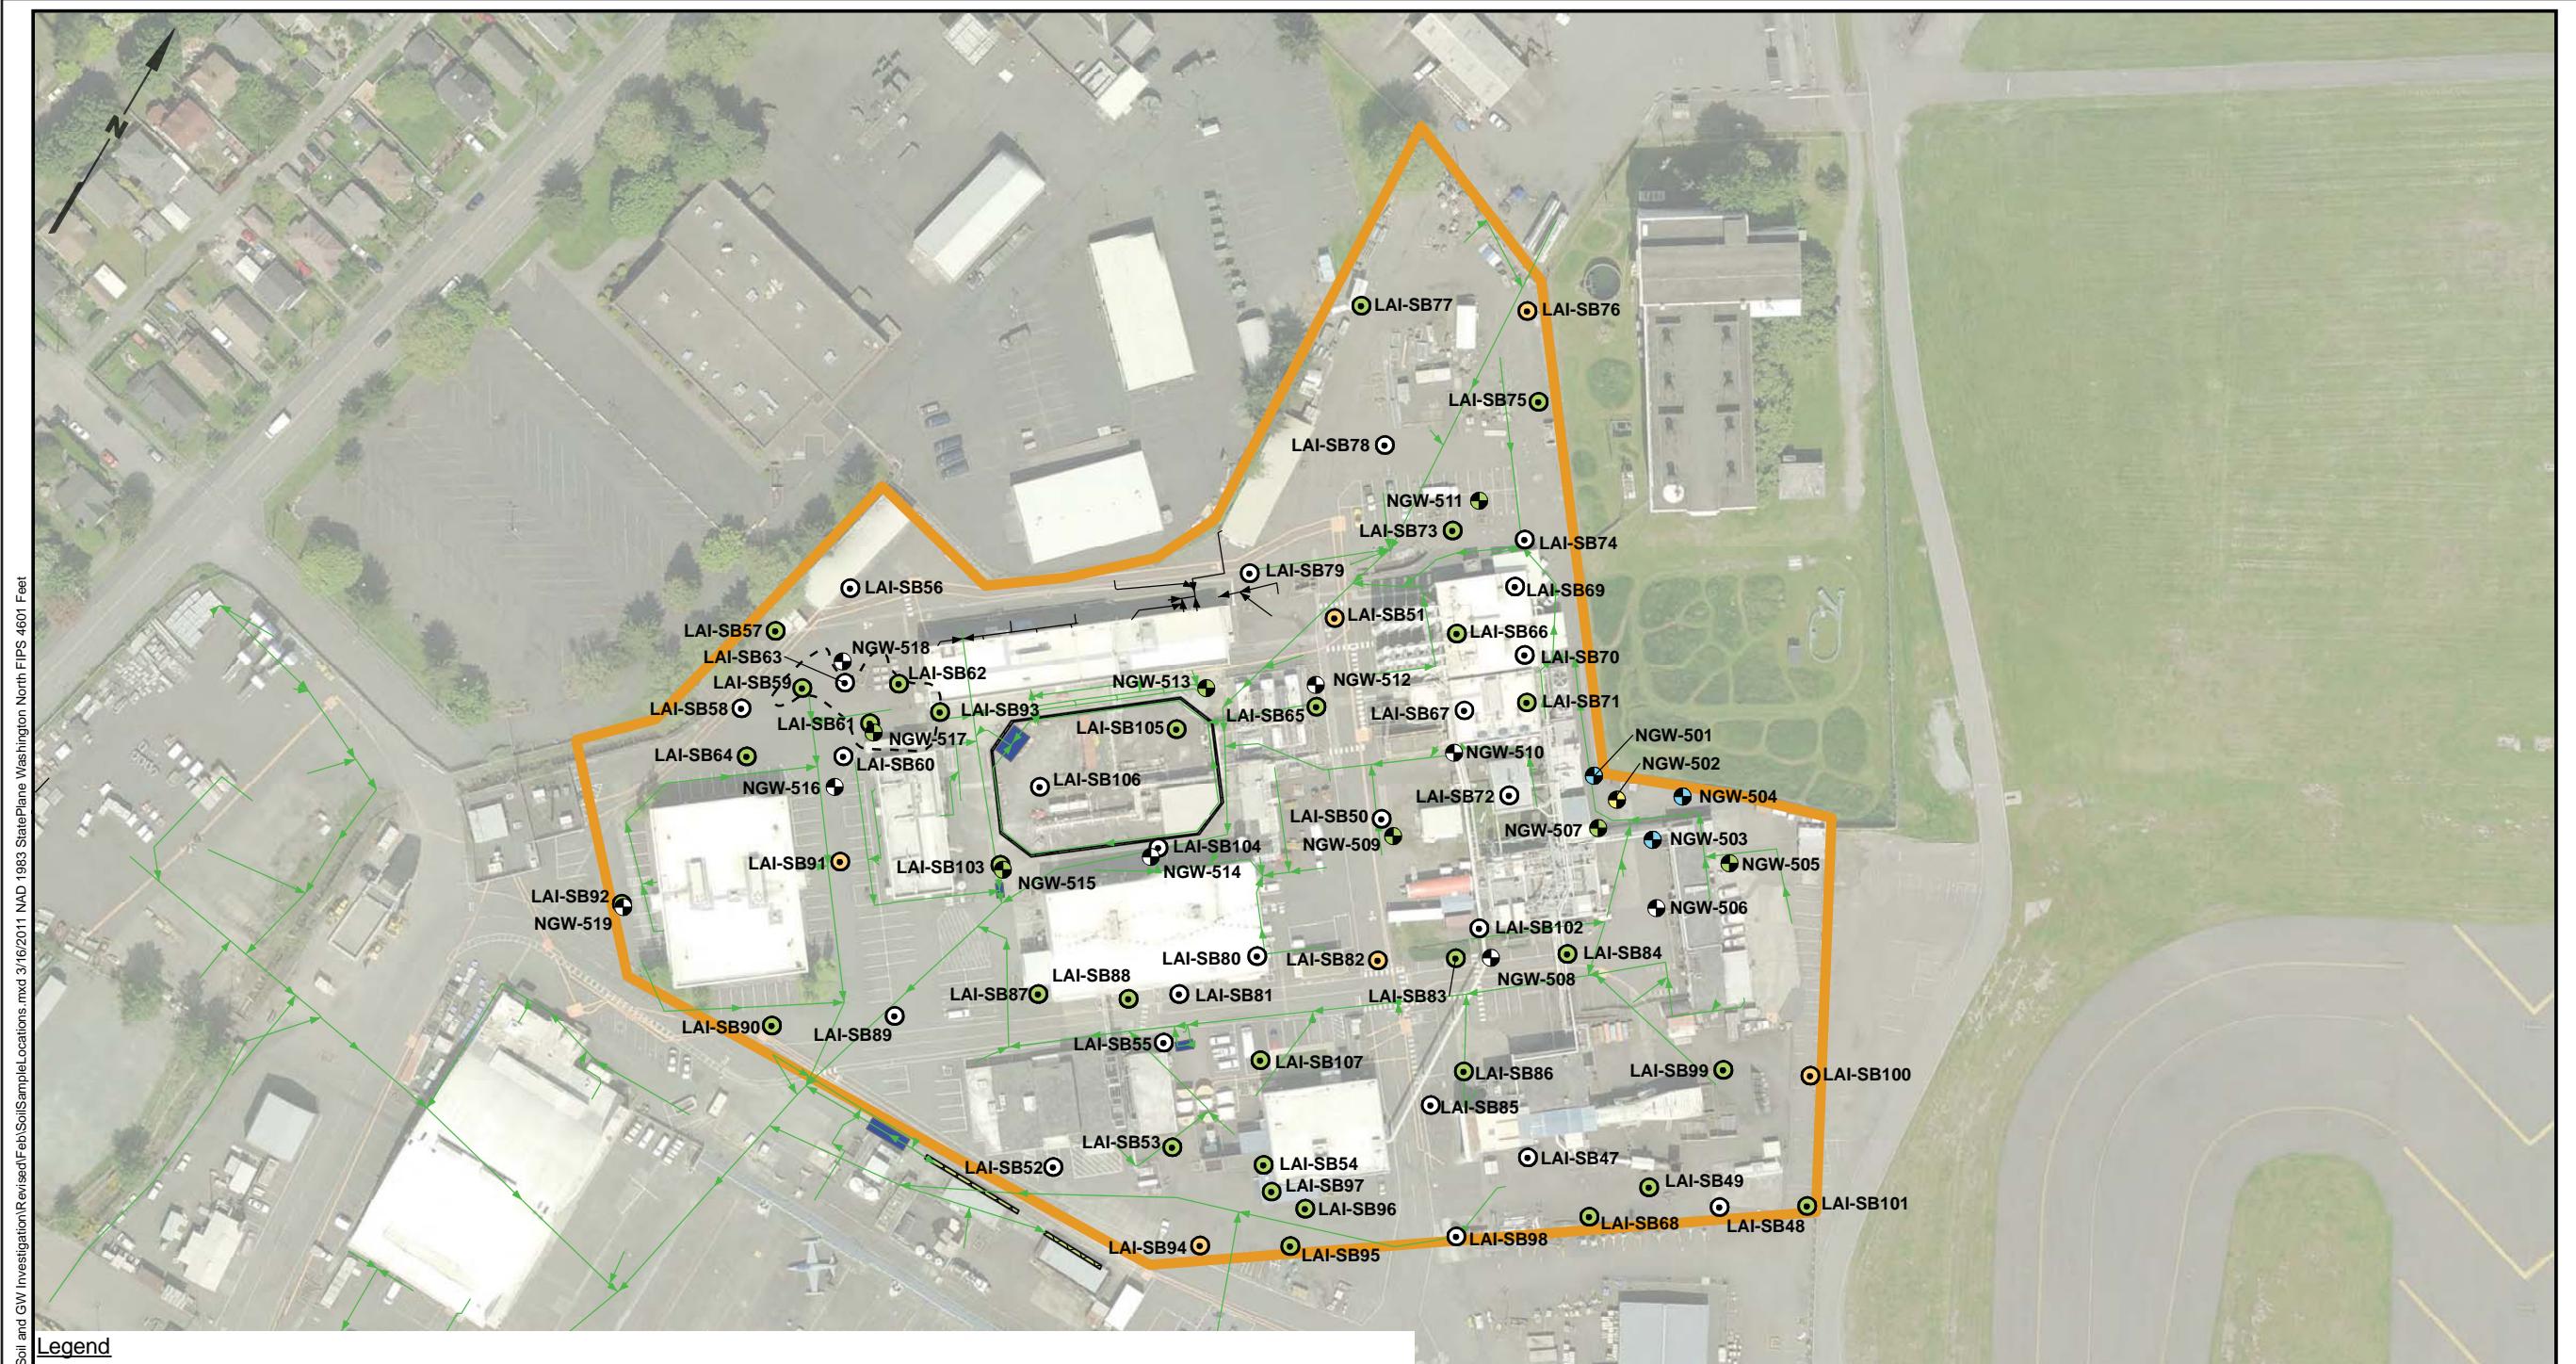
Figure 7.1-18. Focused Investigation Soil Sample Locations (2010)

### Soil Sample Locations and Sample Analytes
