**STORMWATER BIOSWALE REMEDIATION
PILOT TRAVEL CENTER #583
1678 MAIN STREET
FERNDALE, WASHINGTON**

October 16, 2013

Whatcom Environmental Services
228 East Champion Street #101
Bellingham, Washington 98225

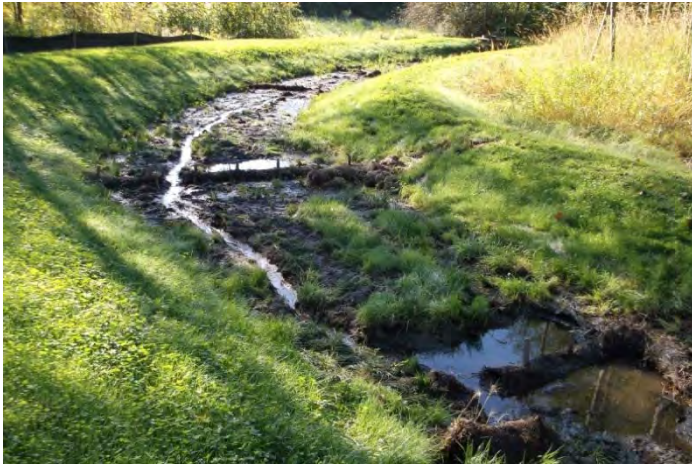
Photo 1. Stormwater bioswale prior to cleanup.

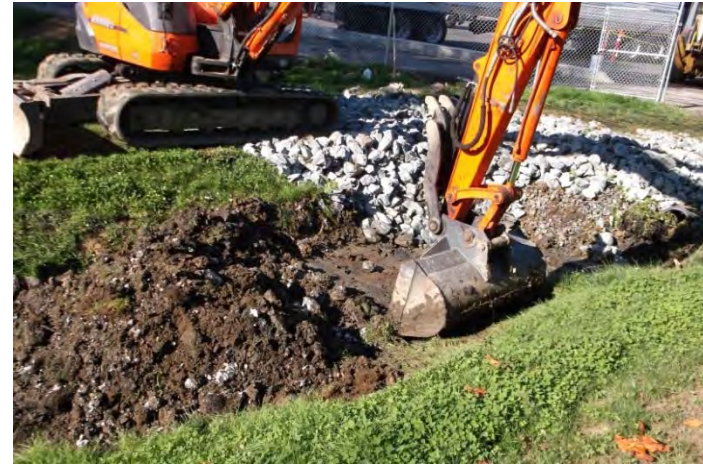
Photo 2. The stained soil was removed using an excavator.

Initial removal of the top three inches of soil was conducted on September 12, 2013 at three distinct areas which were impacted by the diesel release. Those areas included:

- 1) The grassy slope where parking lot sheet-flow runs under the chain link fence and enters the bioswale.
- 2) The floor of the bioswale.
- 3) Immediately downstream of the bioswale where the final storm basin (Basin #2) discharges into a vegetated wetland area.

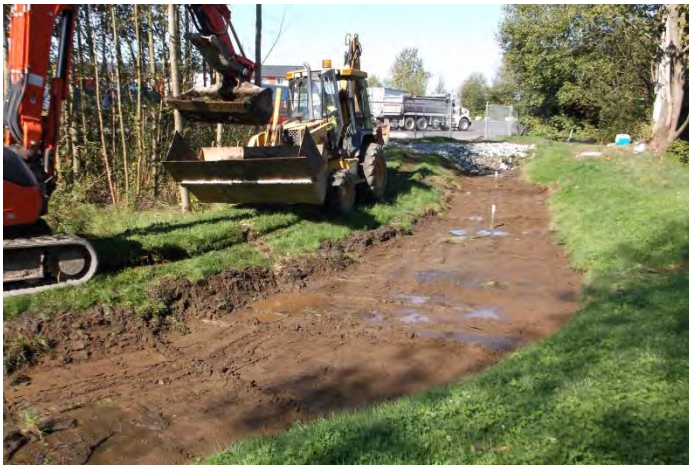
Photo 3. Excavated material was placed in a backhoe for removal from the site.

Approximately 37 tons of soil were removed from the site during the PCS removal action and transported to Waste Management, Inc in Seattle, Washington for disposal. Waste Management is a licensed soil disposal facility. The Waste Management soil disposal records are provided in Appendix C.

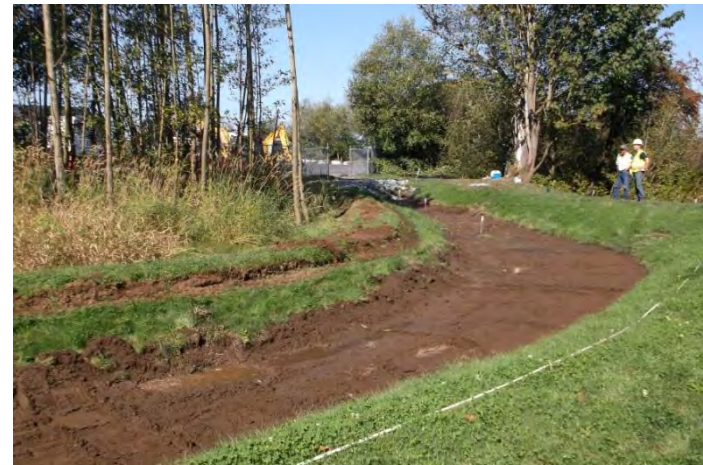
Photo 4. View of cleaned bioswale.

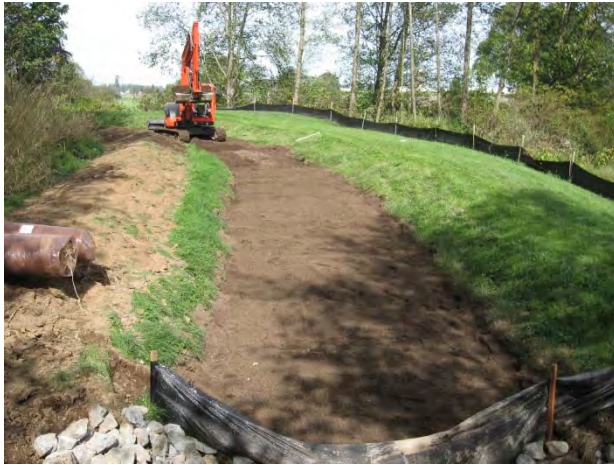
Photo 5. Topsoil was replaced in the clean bioswale.

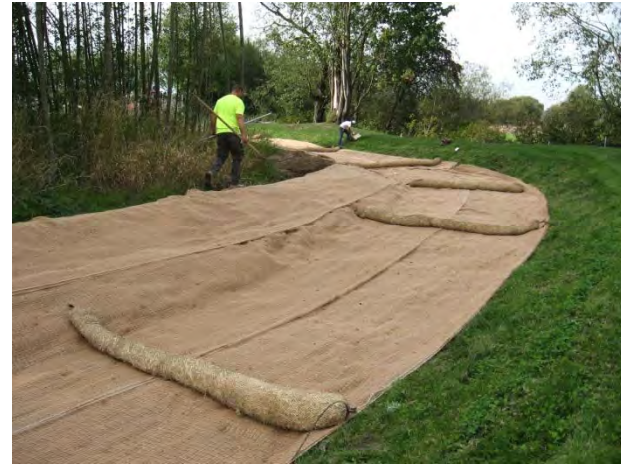
Photo 6. Jute matting and straw wattles were placed over the new topsoil.

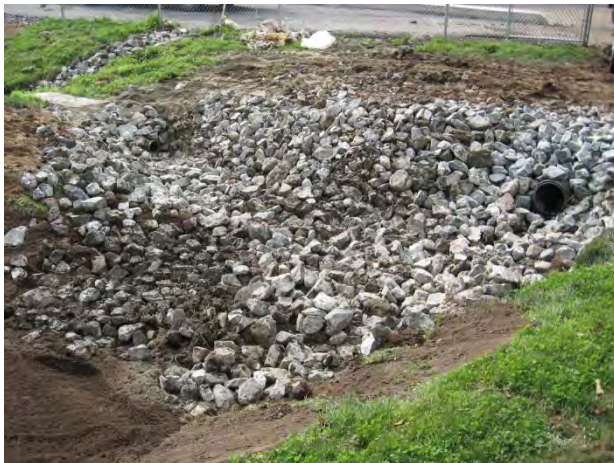
Photo 7. Rock was removed and replaced at the upper end of the bioswale below the inflow pipes.

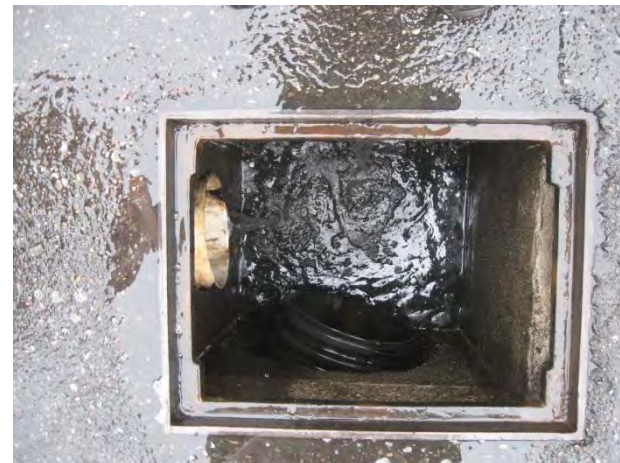
Photo 8. View of cleaned parking lot catch basin.

Bayside Services, of Bellingham, Washington, provided stormwater infrastructure cleaning services on August 27, 2013. An industrial sewer cleaning truck utilizing high pressure water and fluid vacuuming was used to wash the stormwater infrastructure including the parking lot catch basin and underground piping which initially conveyed the spilled product to the bioswale, and the oily water separator located inside the bioswale. Approximately 1,500 gallons of wash water were removed from the site for disposal.
