## Remedial Action Report Tacoma Silver Cloud Inn Property 2317 Ruston Way Tacoma, Washington

February 1, 2013

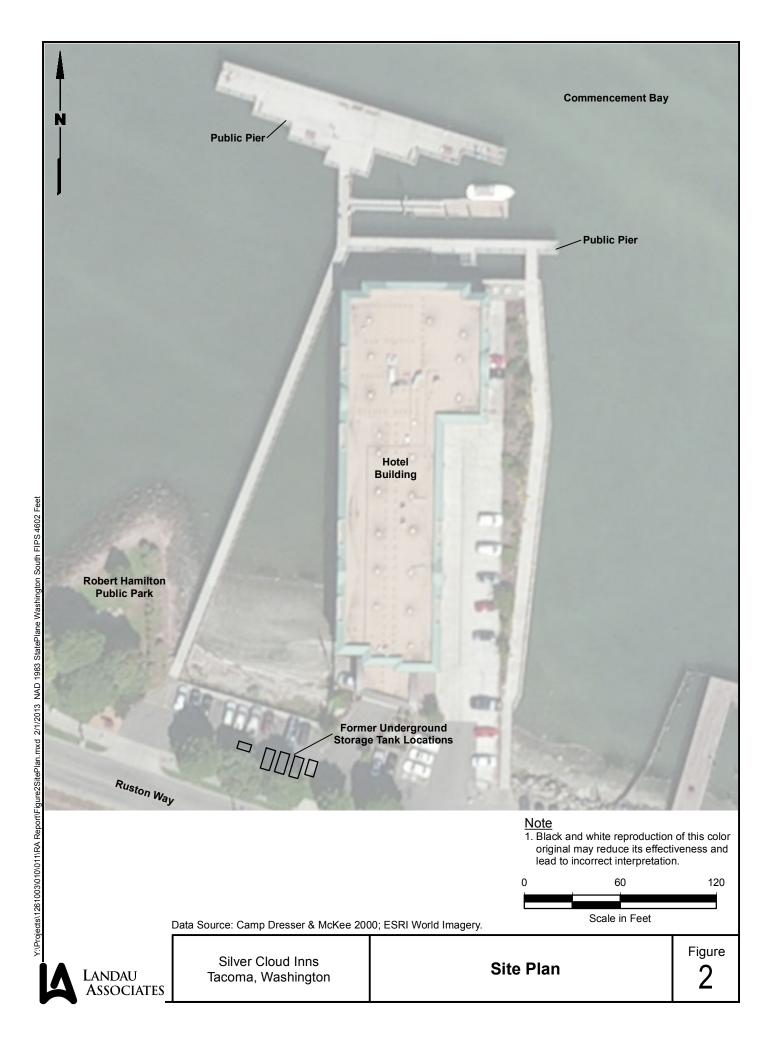
The geophysical survey identified five USTs located near the southern subject property boundary along Ruston Way (Figure 2). Information was not available regarding the history of use, size, or contents of the USTs. Silver Cloud Inns subsequently entered into an AO with Ecology for removing the tanks, conducting a remedial investigation to determine the extent of contamination present in soil and groundwater resulting from any leaks in the tanks, and completing any associated cleanup that was determined necessary based on the results of the investigation. The AO also required additional sediment sampling to evaluate migration of upland contaminants to the intertidal area and to confirm the effectiveness of the sediment remedial action.

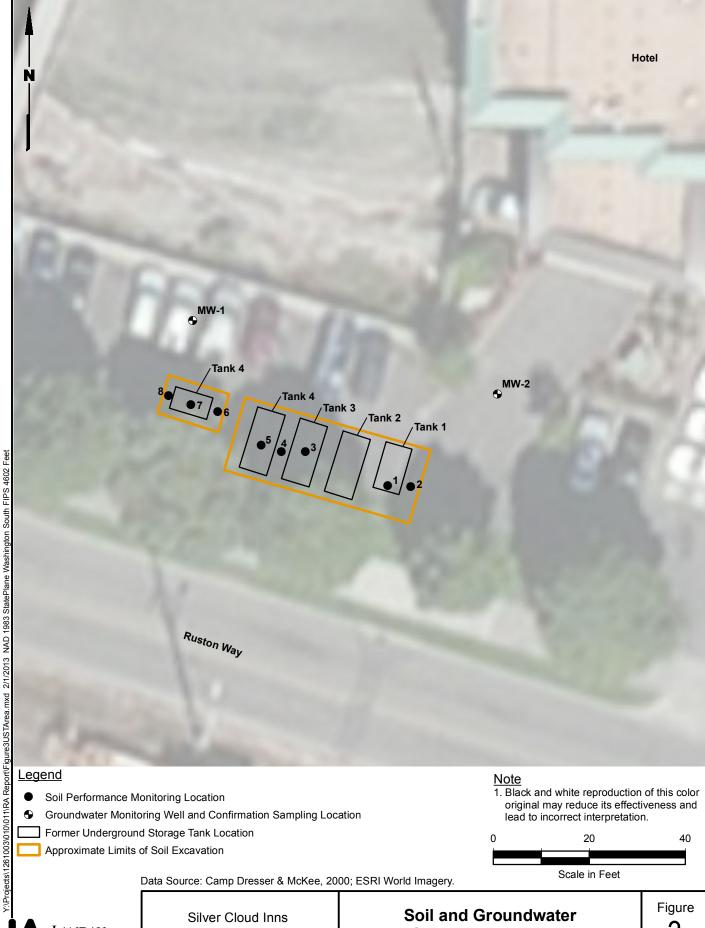
Silver Cloud Inns Tacoma, Washington Soil and Groundwater Sampling Locations 3

Based on the field observations and the analytical results, the TPH-D and TPH-G concentrations in soil at the excavation for Tank 5 (Sample 7) were below the applicable cleanup levels, but the TPH-D concentrations in soil at the excavation for Tanks 1 through 4 (Samples 1, 4, and 5) were greater than the cleanup level; local groundwater contamination by petroleum hydrocarbons was also observed. Following discussions with Ecology, the excavations were backfilled with imported material and Silver Cloud Inns agreed to install two monitoring wells (identified as MW-1 and MW-2) at the subject property to further define the extent of the contamination associated with the tanks and to implement a monitored natural attenuation approach to address the residual petroleum hydrocarbon contamination. The number of wells and the locations of the monitoring wells were negotiated under the AO (CDM 2000). The monitoring well locations are shown on Figure 3.

As previously described, following the remedial actions at the subject property and as agreed to with Ecology, Silver Cloud Inns installed two monitoring wells at the subject property in 2002 (Figure 3), and initiated a groundwater monitoring program to document petroleum hydrocarbon concentrations in groundwater. Groundwater samples were initially collected from the two monitoring wells between January 2002 and June 2005, and submitted to a laboratory for analysis of TPH-O and TPH-D using Method NWTPH-Dx. The results of the initial sampling indicated the presence of TPH-D in groundwater at concentrations greater than the MTCA Method A cleanup level (0.5 mg/L); however, the TPH-D concentrations showed a decreasing trend (CDM 2009).

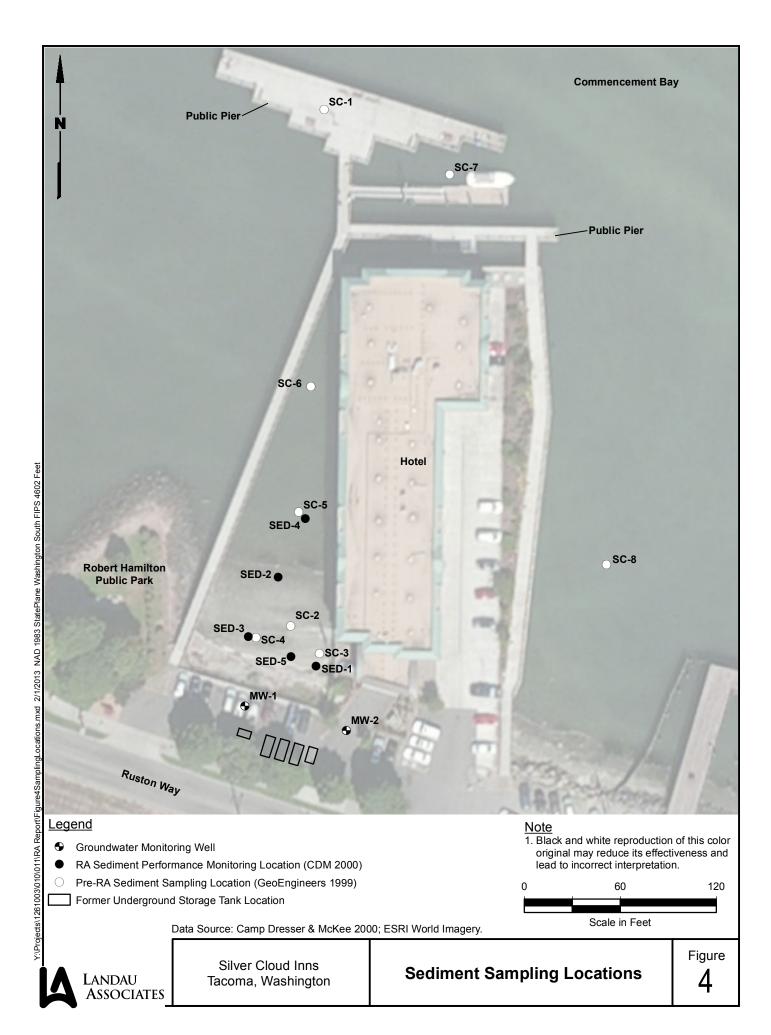
The sample locations are shown on Figure 4, and designated SED-1 through -5 in contrast to the previous characterization sample locations that are designated SC-1 through -8. The sediment data for the "SED" samples are summarized in Tables 1 through 3 of the 2002 CDM report, which are provided in(Appendix A of this report.
