## ***PNG ENVIRONMENTAL, INC.***

November 4, 2008

Subject: **Supplemental Site Characterization Work Plan**  
Former Plaid Pantries Store #324  
10645 16<sup>th</sup> Avenue SW  
Seattle, Washington  
Ecology Site ID #97464

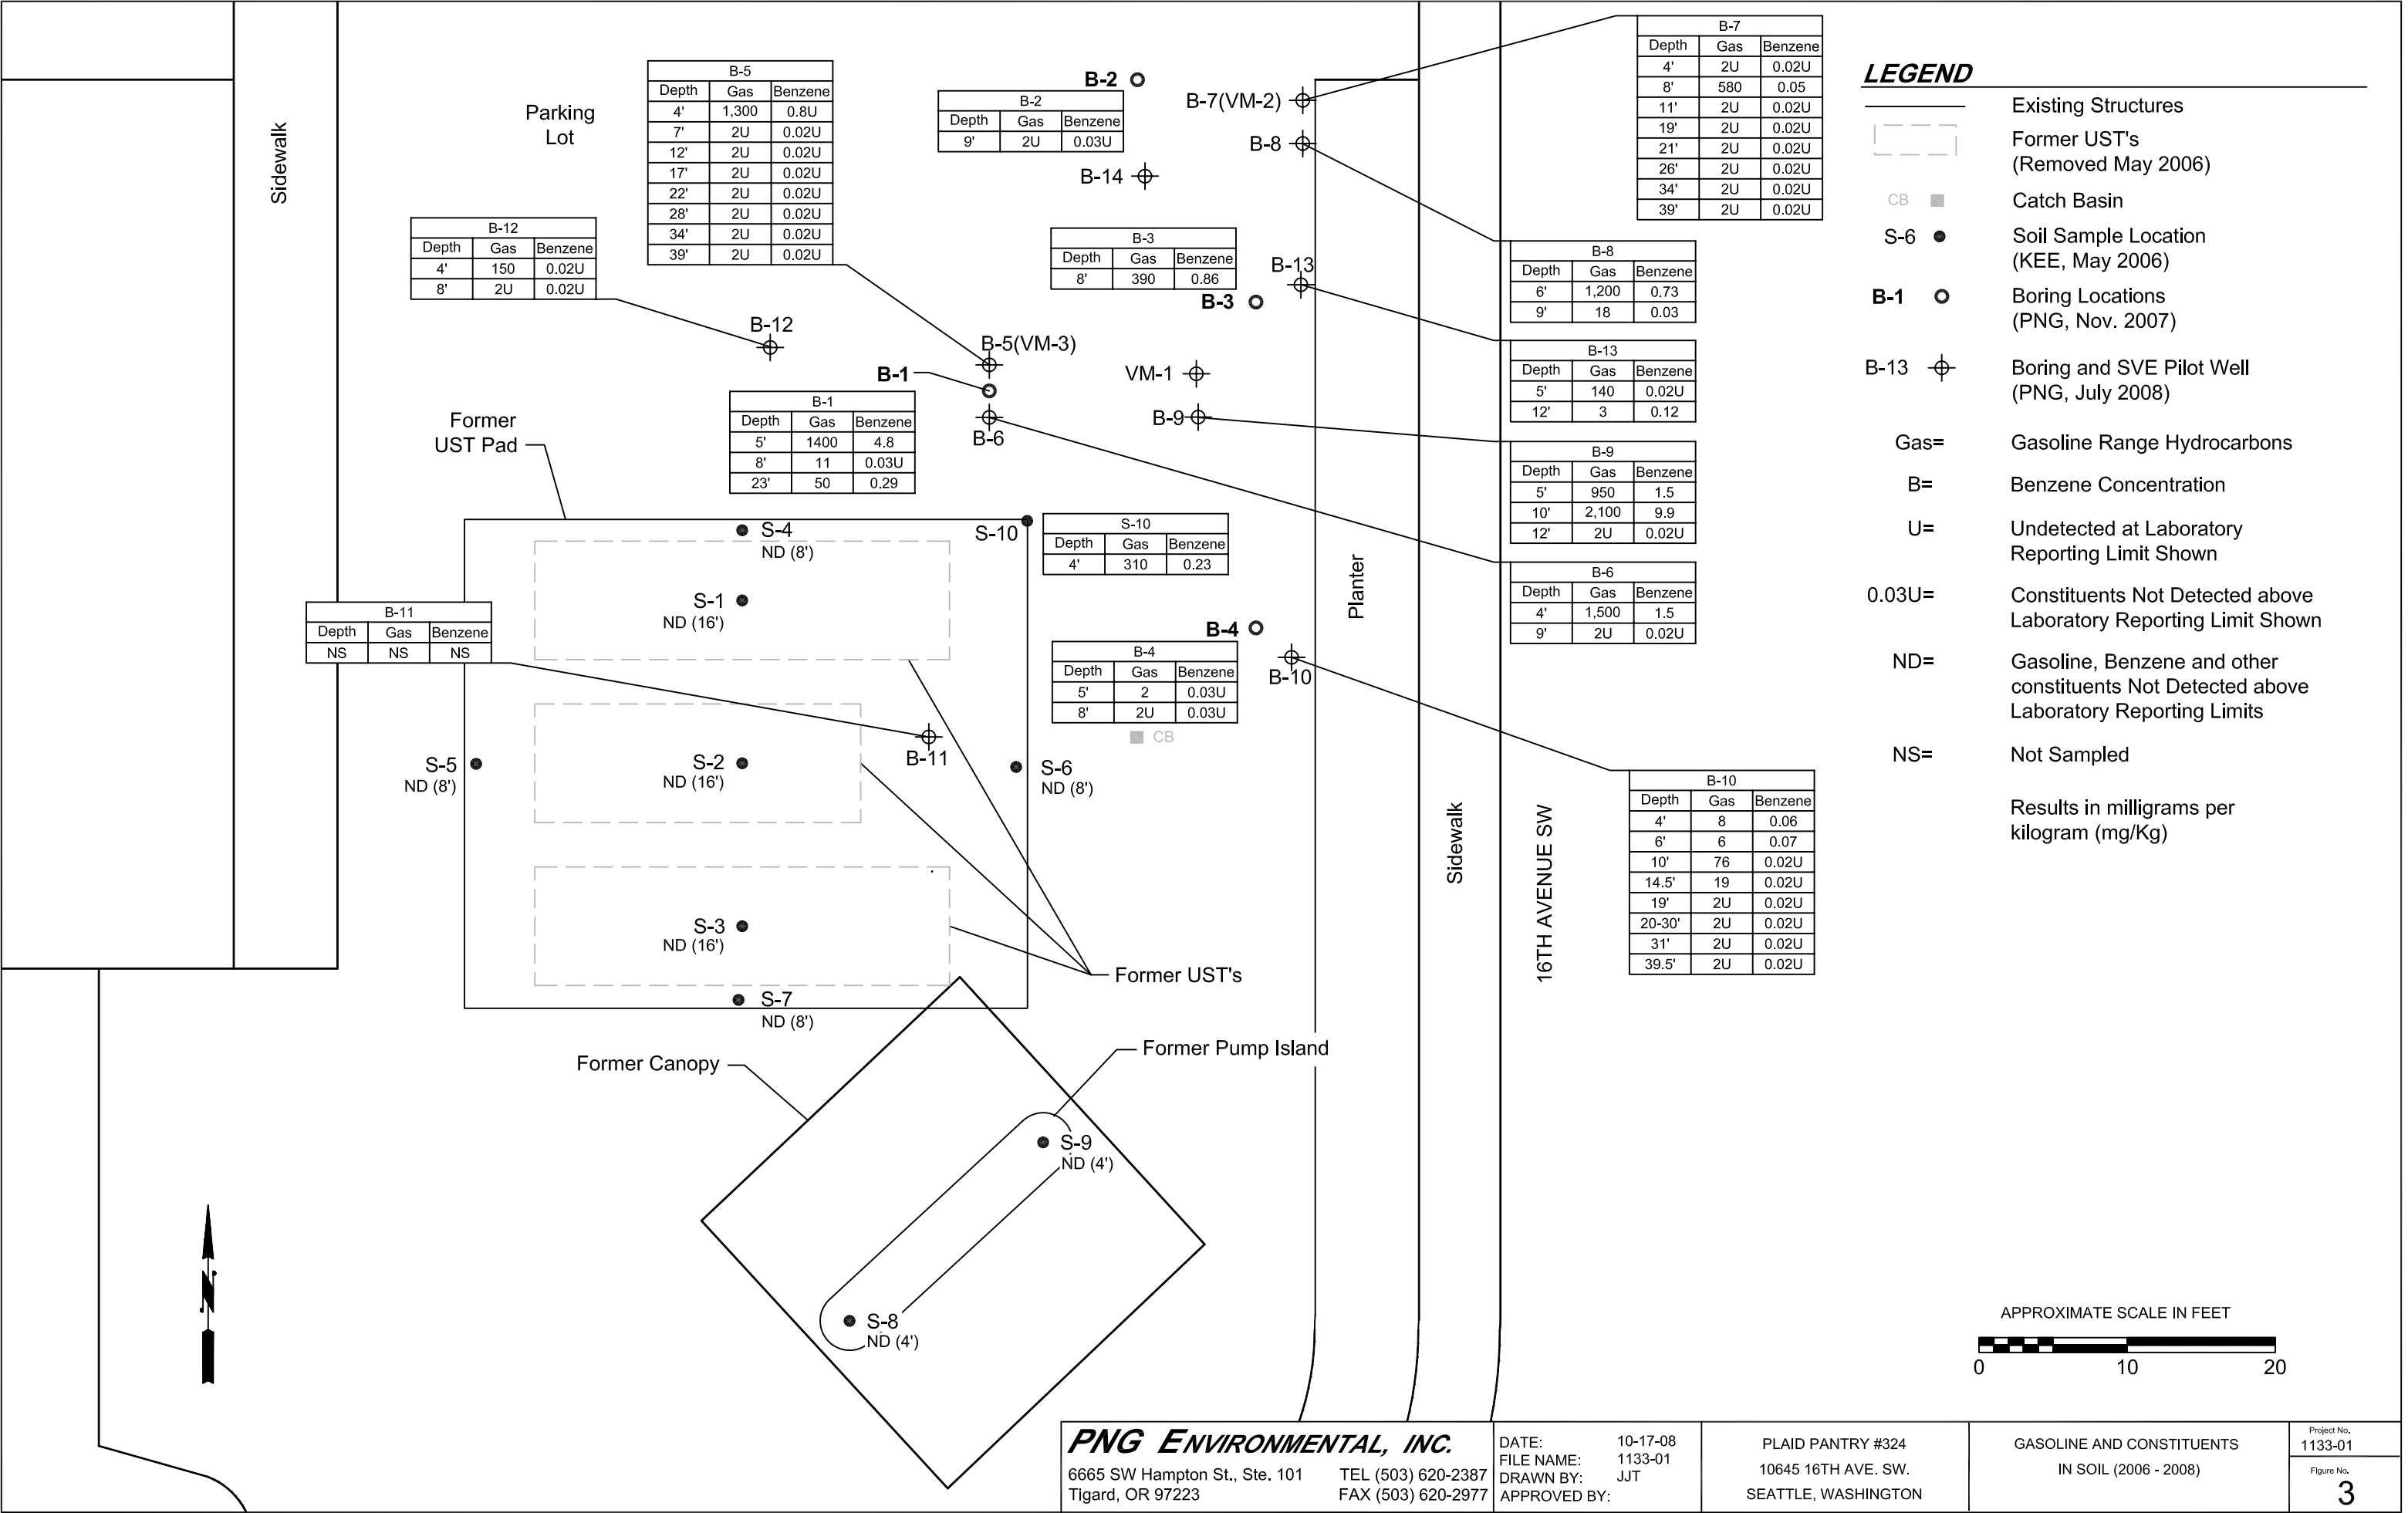
were identified in soil near the former UST system, as summarized below and illustrated in Figure 3.

- Soil samples were collected from various depths in each of the four boreholes (designated B-1 through B-4).
- Gasoline was detected in five of the seven soil samples submitted, ranging (where detected) from 2.0 to 1,400 mg/Kg. Three of the samples exceeded the MTCA Method A soil cleanup level of 30 mg/Kg, including samples collected from B-1 at five feet (1,400 mg/Kg) and 23 feet bgs (50 mg/Kg), and B-3 at eight feet bgs (390 mg/Kg).

- The lateral extent of impacted soils north and east of the former tank cavity has not been fully delineated (see Figures 3 and 4). Further site characterization may also be required by Ecology to determine if offsite soils are affected and such evaluation would need to consider various utilities beneath the sidewalk along 16th Avenue.

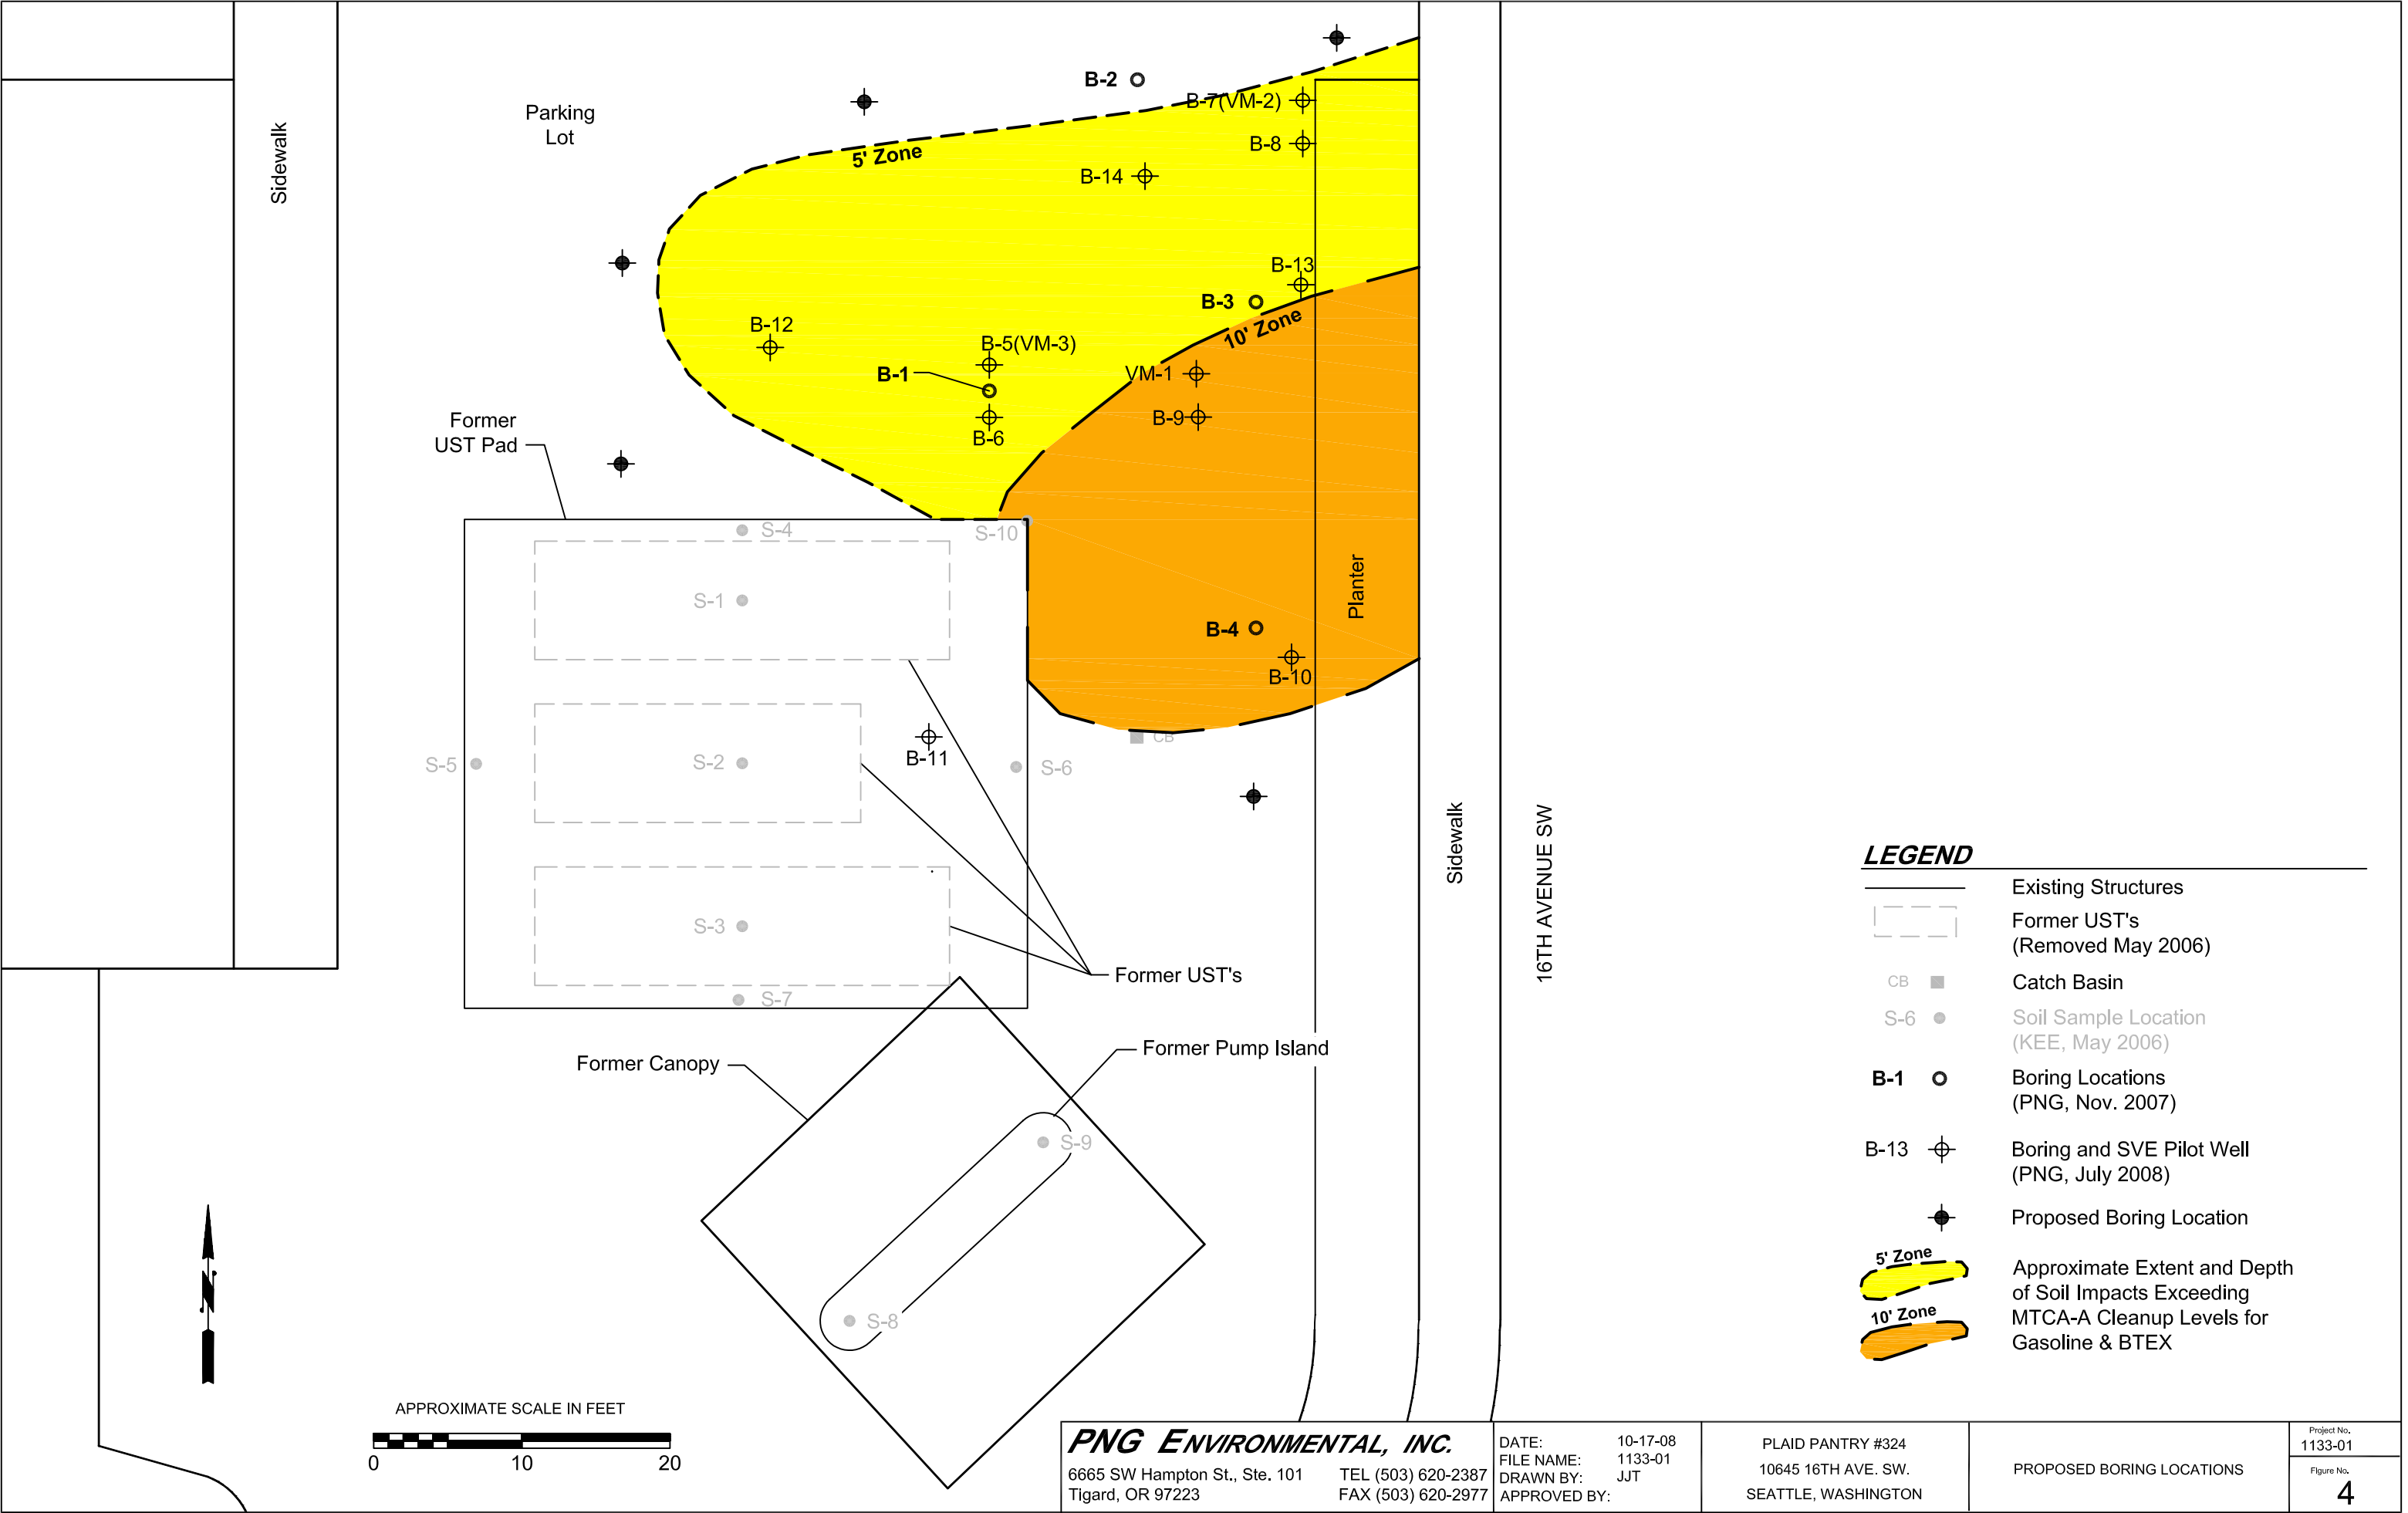
unit at the subject parcel. Proposed boring locations are illustrated on Figure 4. Specific work scope tasks are described below.

- Direct field operations for soil boring using direct-push "GeoProbe" drilling techniques for five onsite borings (approximately one field day). Proposed boring locations are illustrated on Figure 4, but all boring locations may be modified based on the results of utility mapping and other site access considerations. PNG will collect and log continuous soil samples if possible, field screen the soil samples for volatile hydrocarbons using a photo ionization detector (PID), and submit selected samples for laboratory gasoline and volatile organic compound (VOC) analyses (assume two to three samples per boring).

Based on the UST decommissioning results, Plaid requested that PNG conduct a site assessment to provide preliminary evaluation of the possible gasoline release. PNG's field activities included soil sampling at four boring locations in November 2007 and the Site Assessment Report was issued on January 25, 2008. Analytical results are summarized below and illustrated in Figure 4.
