**UST Closure Action Report  
Zip Market & Gas  
Seattle, Washington**

Subject: UST Closure Action Report  
Zip Market & Gas  
10645 16<sup>th</sup> Ave SW  
Seattle, WA 98106

Reference Job Number: ZM052306-3

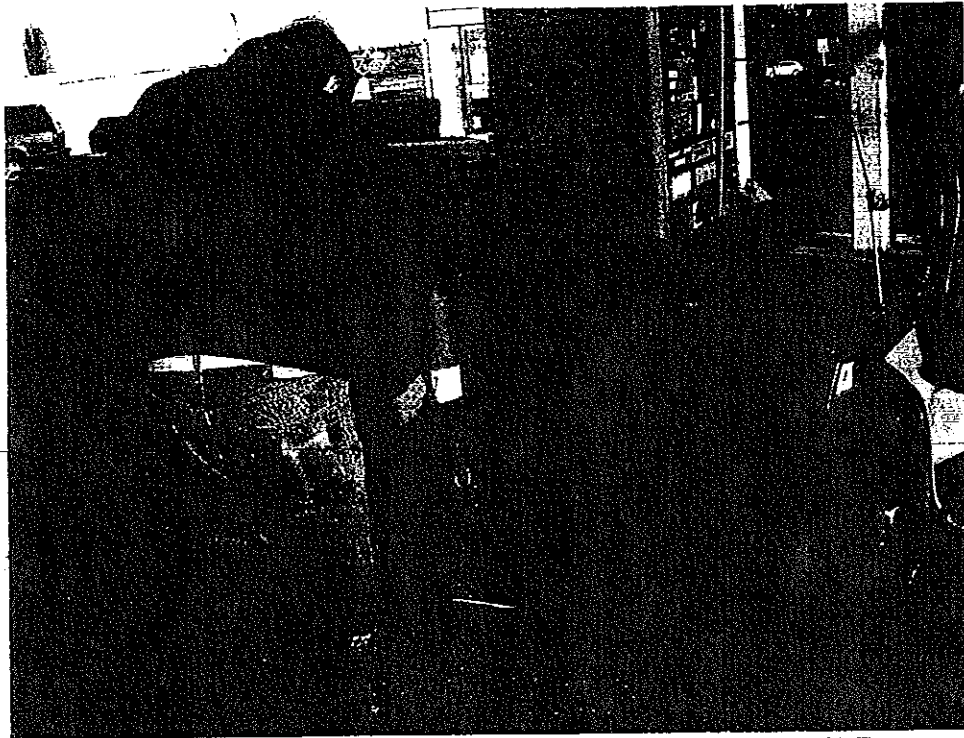
Checking underground utilities including pipe lines with GPR

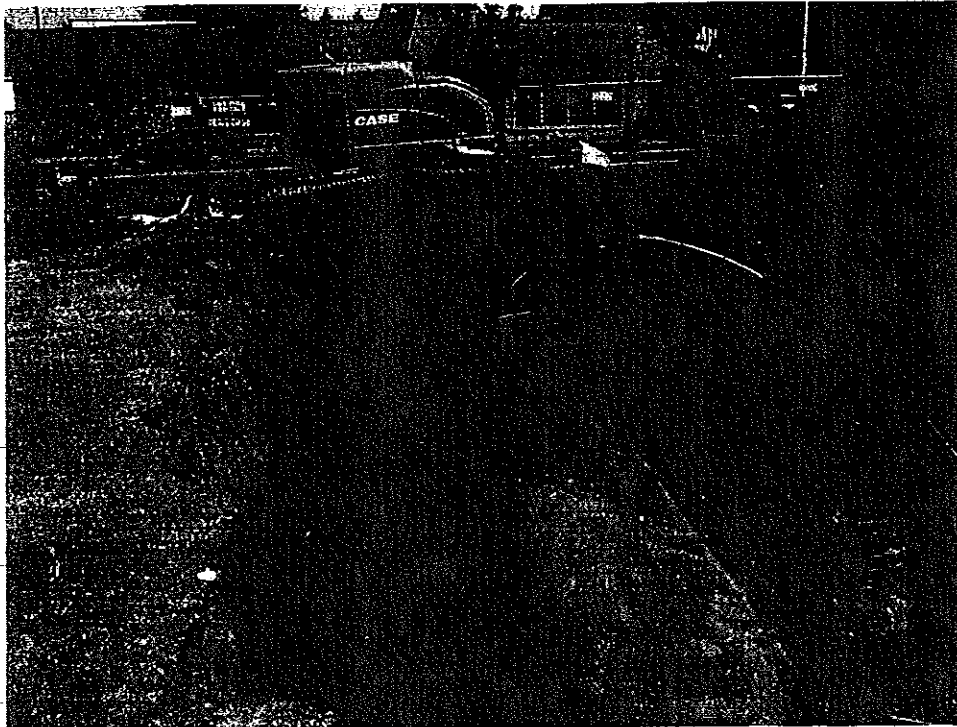
**Excavating the first tank located at north end of the tank site**

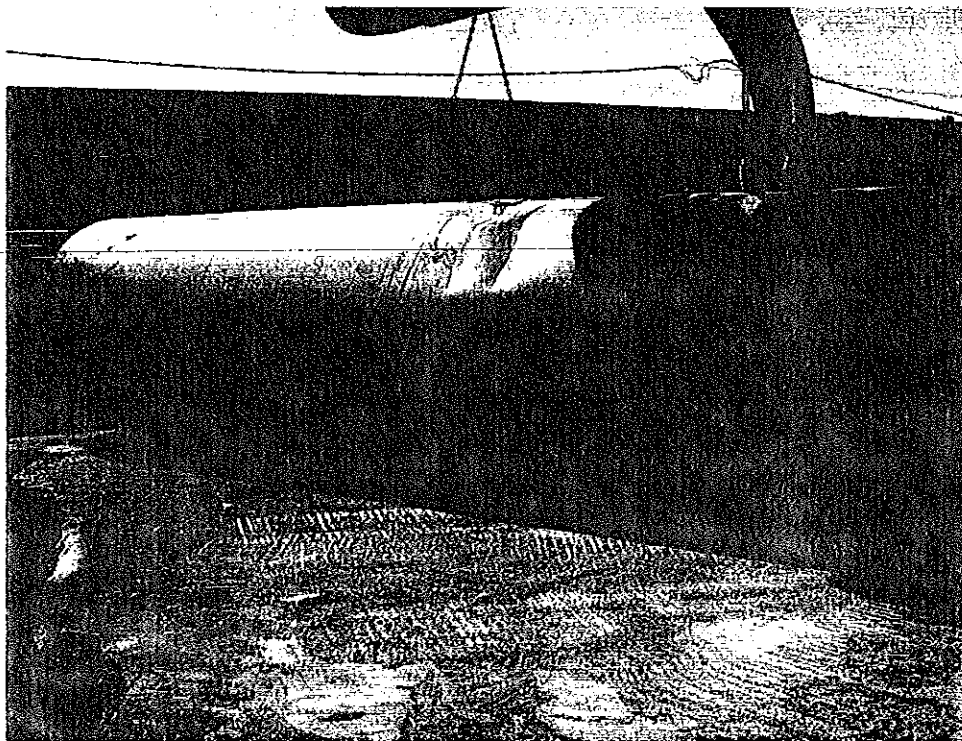
Staging the first tank on the asphalt pavement

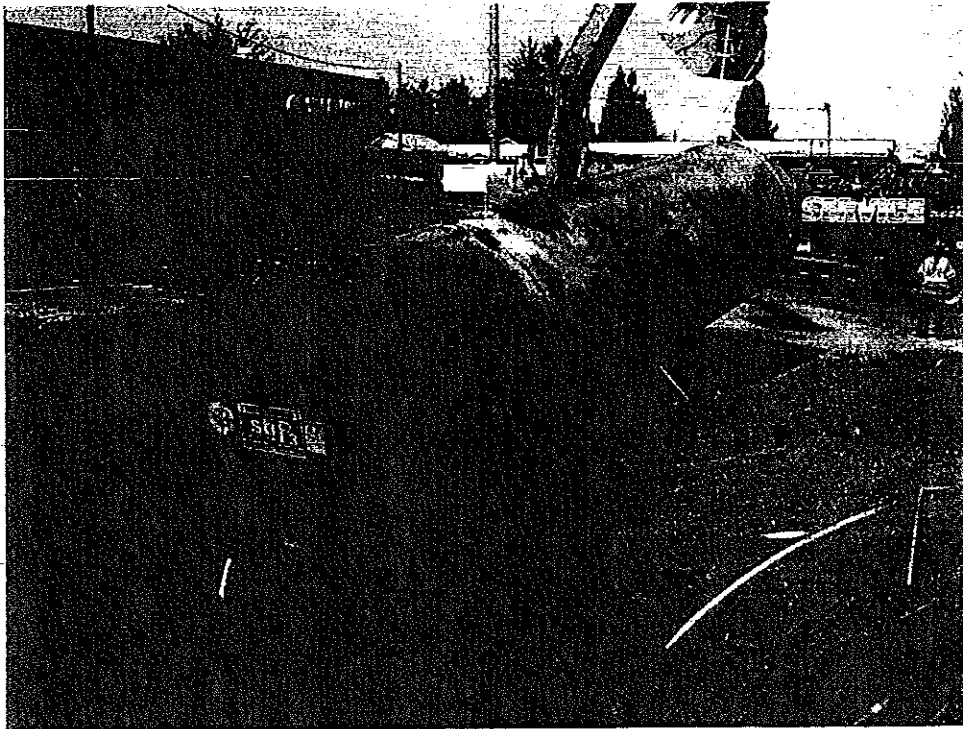
**Pulling another tank from the tank site**

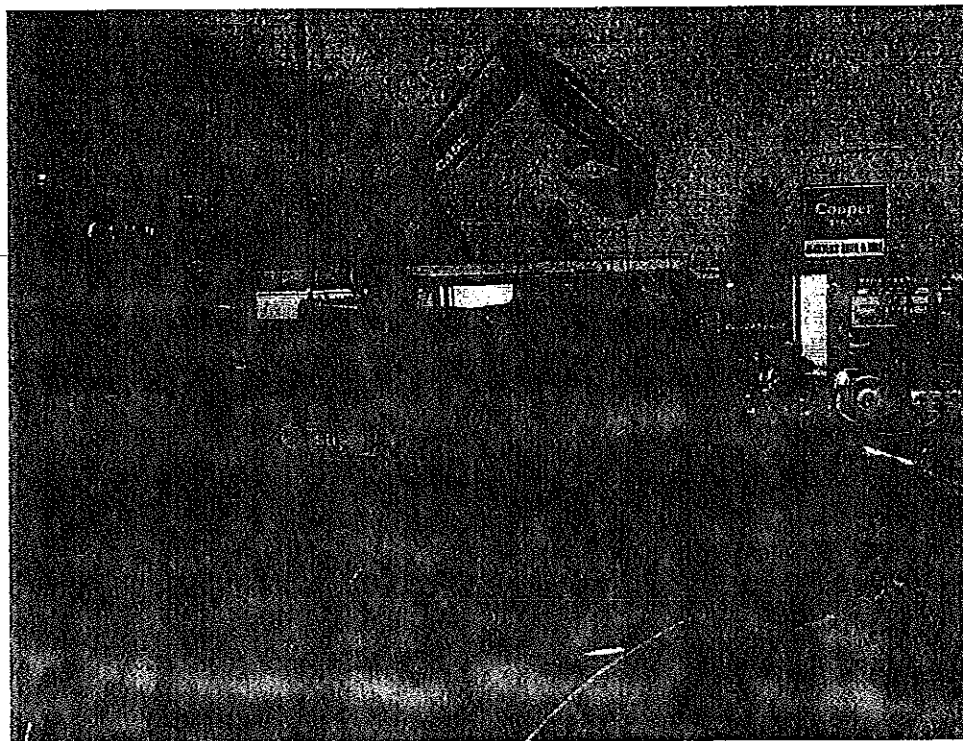
**Pulling another tank from the tank site with the excavator**

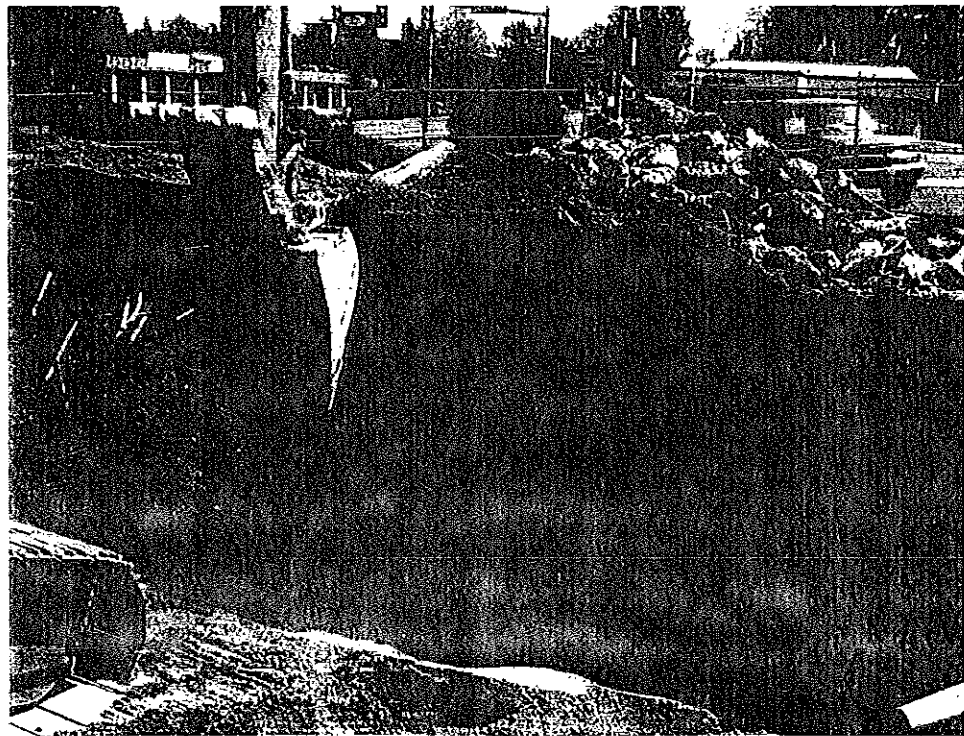
Taking another wall sample at the south end wall of the tank cavity

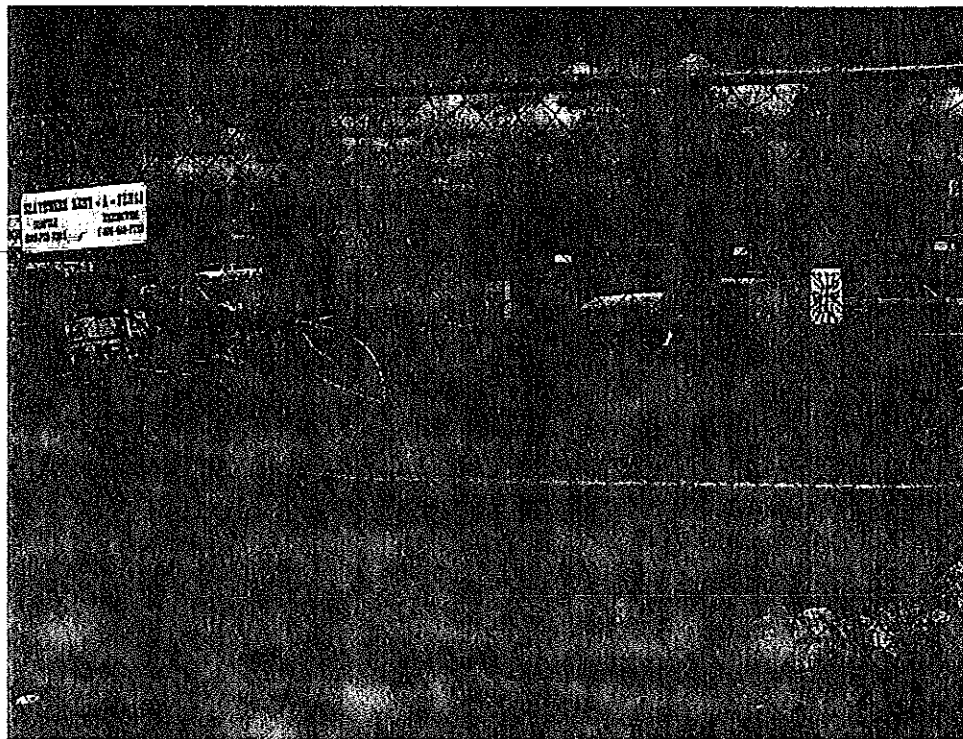
**Another view of the backfilling the tank cavity**

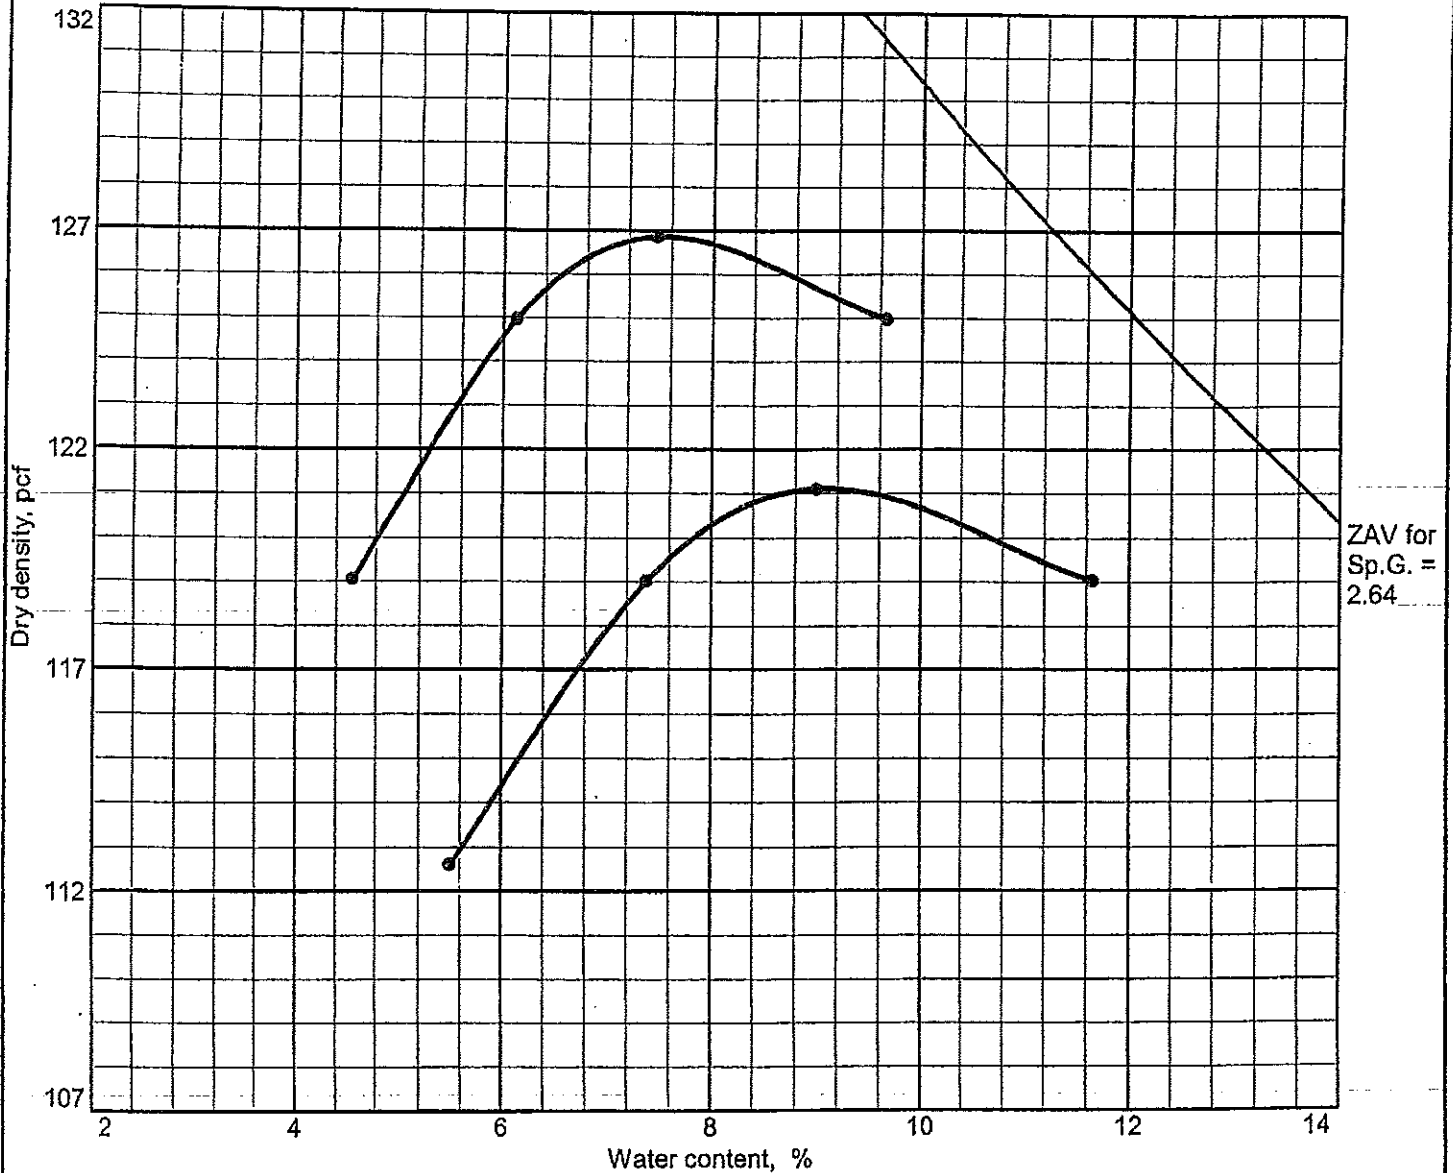
# COMPACTION TEST REPORT

Test specification: ASTM D 1557-91 Procedure B Modified  
 Oversize correction applied to each point

Elev/ Depth	Classification		Nat. Moist.	Sp.G.	LL	PI	% > 3/8 in.	% < No.200
	USCS	AASHTO						
				2.64			17.1

ROCK CORRECTED TEST RESULTS	UNCORRECTED	MATERIAL DESCRIPTION
Maximum dry density = 126.9 pcf	121.1 pcf	Native Soil
Optimum moisture = 7.5 %	9.1 %	Lt. Brown, Sl. Gravelly Fine Sand

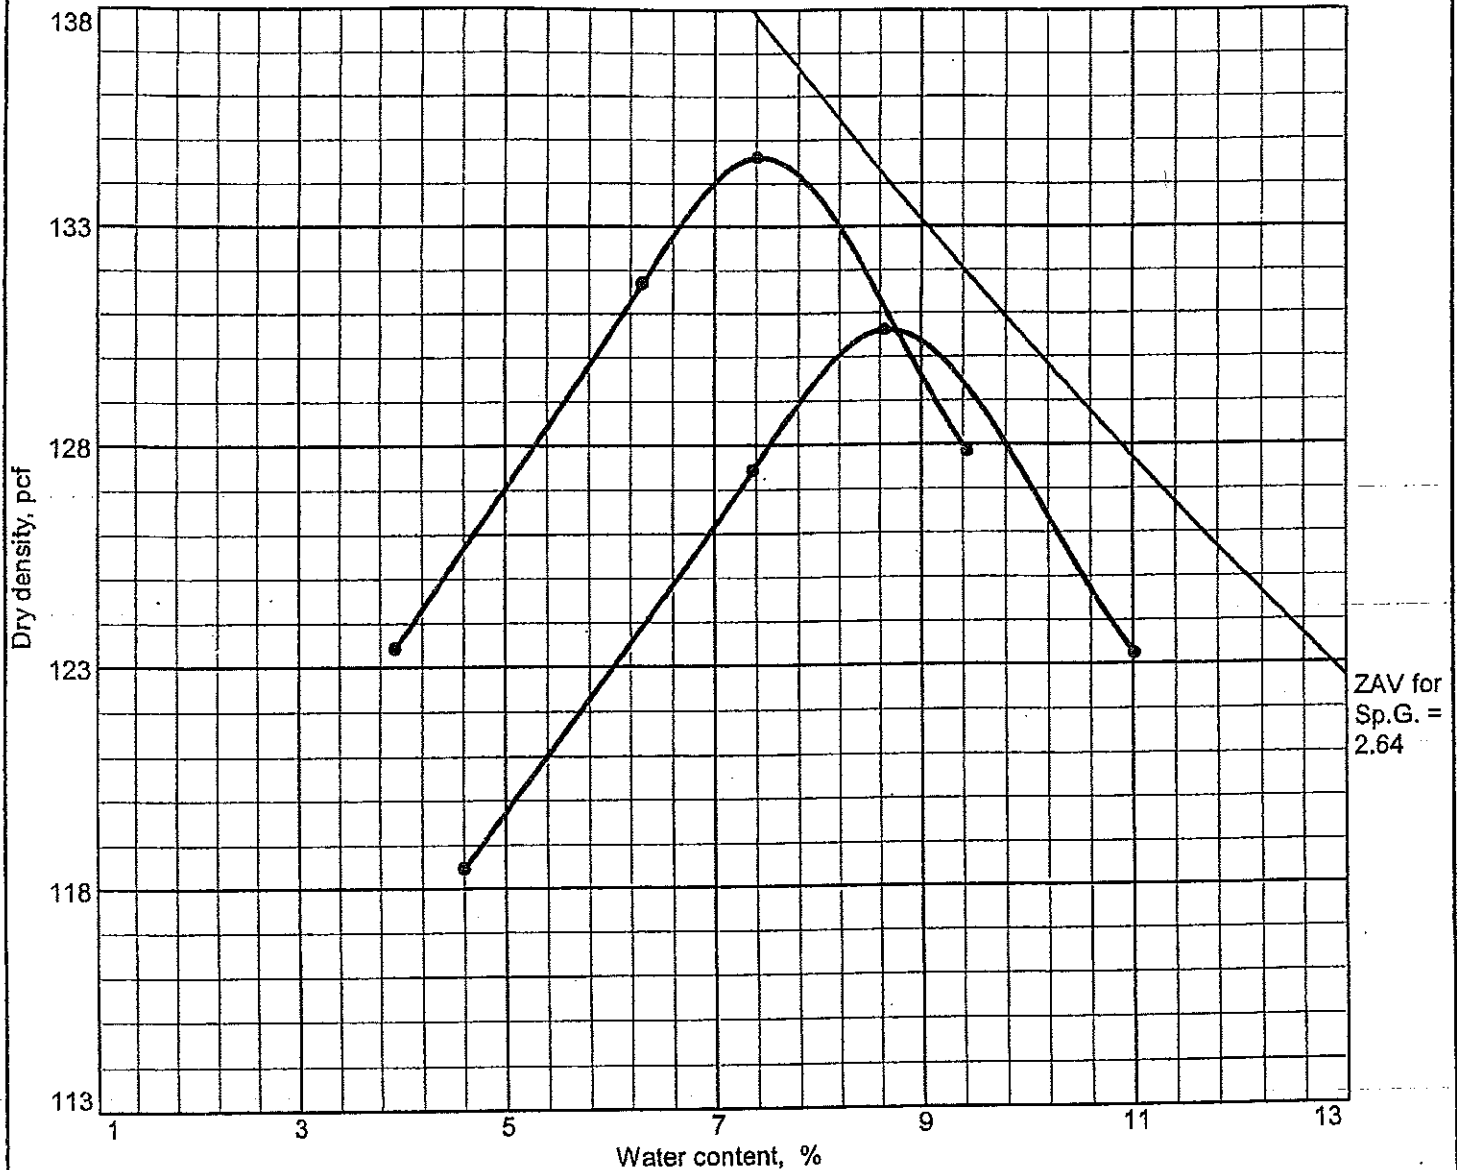
# COMPACTION TEST REPORT

Test specification: ASTM D 1557-91 Procedure B Modified  
Oversize correction applied to each point

Elev/ Depth	Classification		Nat. Moist.	Sp.G.	LL	PI	% > 3/8 In.	% < No.200
	USCS	AASHTO						
				2.64			14.3

ROCK CORRECTED TEST RESULTS	UNCORRECTED	MATERIAL DESCRIPTION
Maximum dry density = 134.6 pcf	130.6 pcf	Import
Optimum moisture = 7.4 %	8.7 %	Tannish Brn, Sl. Gravelly, Very silty, Fine Sand
