Soil Remediation Report

Pink Elephant Carwash 616 Battery Street Seattle, Washington

January 3, 2013

ECI Project No.: 05023-01

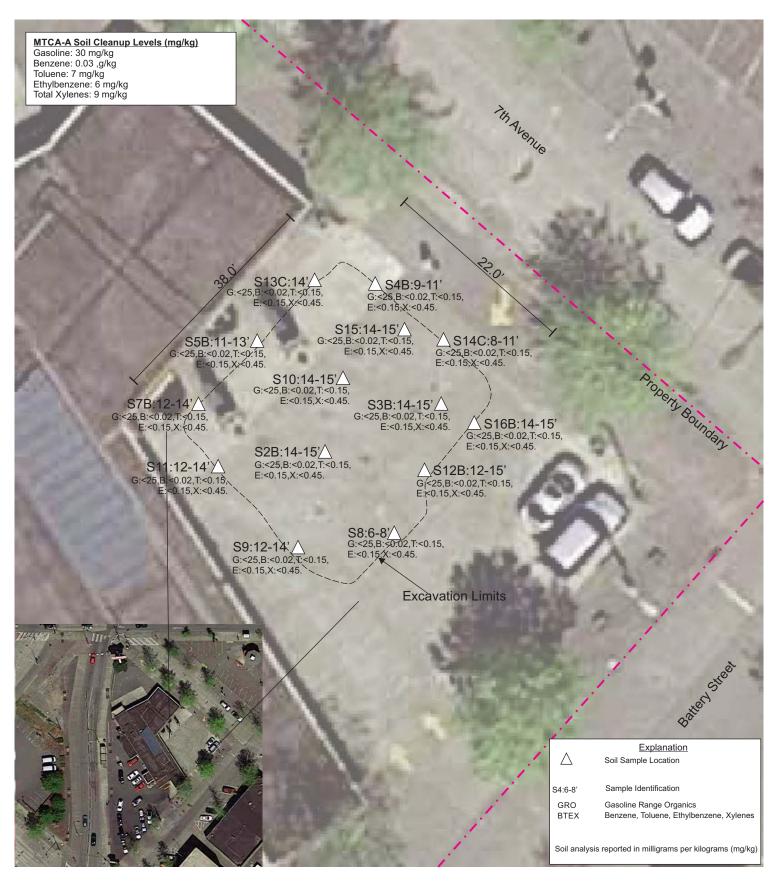
03 Sheet 03 of 04

Site Location Map Site Remediation 616 Battery Street Seattle, Washington Date: January 1, 2014
Completed By: K. Spencer
Reviewed By.: S.Spencer
Version: ECI-001

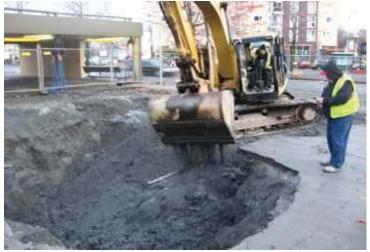
Photograph 01: Soil excavation.

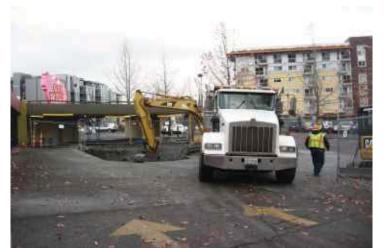
Photograph 03: UST 2 - View of site excavation.

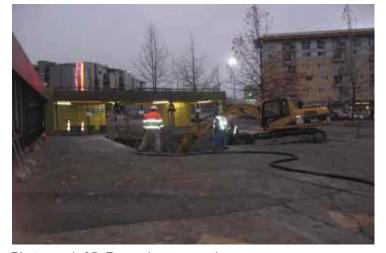
Photograph 05: Removing excavation water.

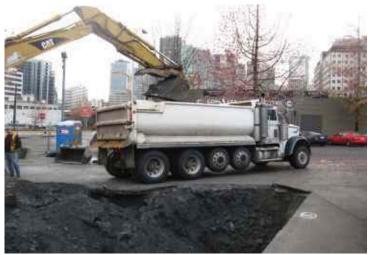
Photograph 02: Loading disposal transport.

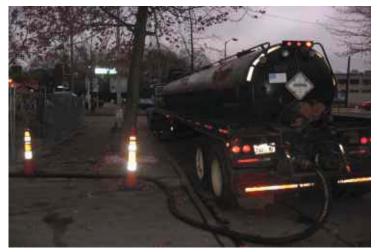
Photograph 04: Pump truck.

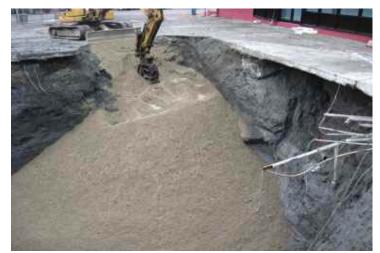
Photograph 06: Backfill.

After sampling the excavation and transporting the contaminated soil to the disposal facility, the excavation was backfilled. The backfill consisted of imported clean fill material including recycled concrete, pit run and gravel, which was brought to grade and compacted.
