**INTERIM REMEDIAL ACTION REPORT
PHASES 1 & 2
RAMCO ALUMINUM WASTE DISPOSAL SITE
PORT OF KLICKITAT INDUSTRIAL PARK
DALLESPORT, WASHINGTON**

June 4, 2008

**Robert D. Swackhamer, PE
Toxics Cleanup Program
State of Washington
Department of Ecology**

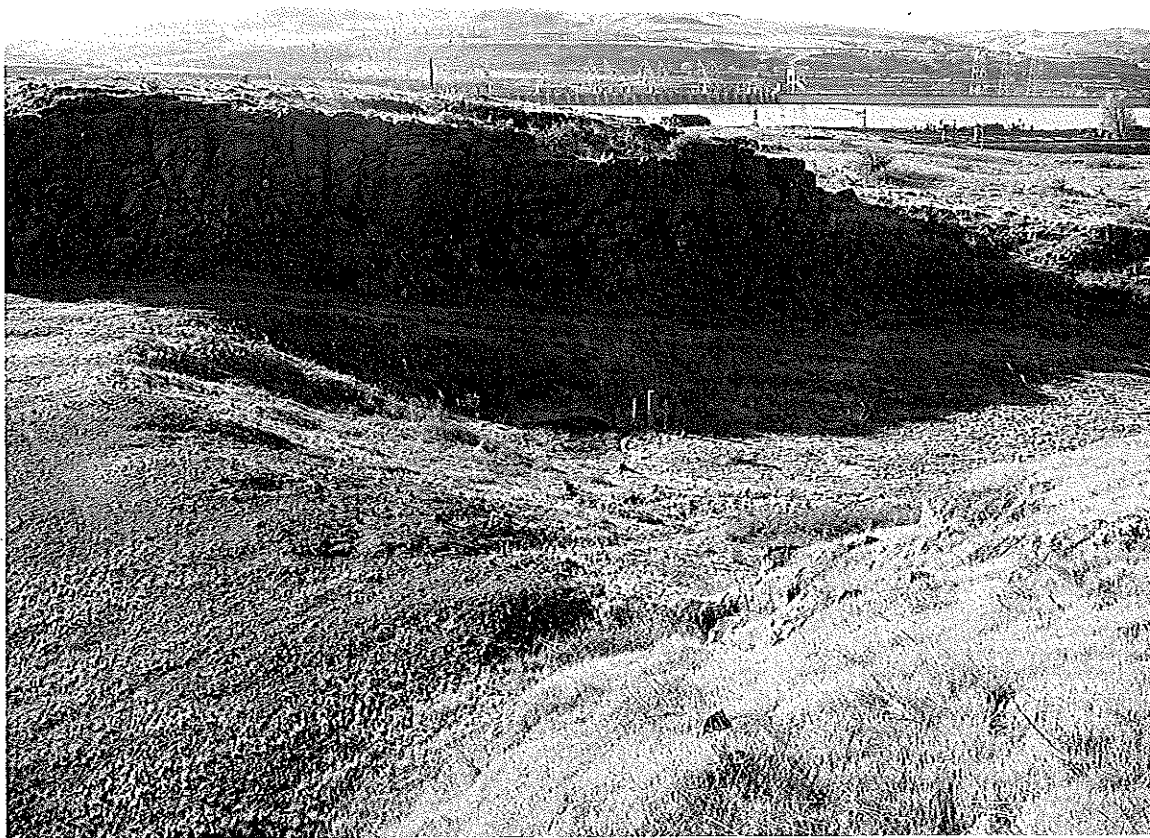
Photo # 1 Before – West toe of the disposal site occupies the center left and lower left of photo. Basalt outcrop bluff in upper left and center forms the south wall of the bowl in which the unlined disposal site sits. Columbia River, also known as Lake Celilo at this point, is in the background to the south. Orange pipes in center indicate position of monitoring well MW-2. (Photo by Jeff Newschwander)

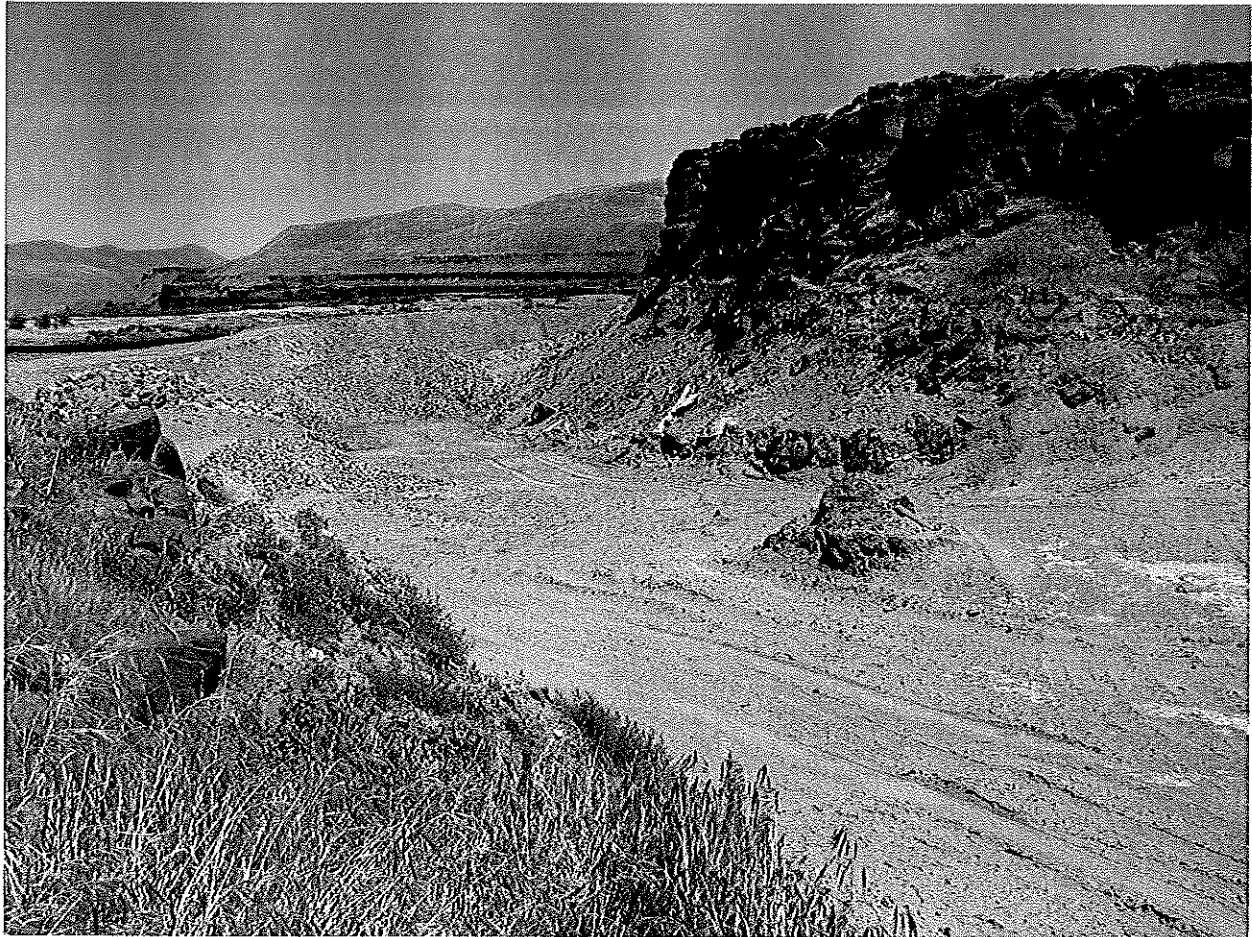
Photo # 1 After Phase 2– The orange pipe in the center indicates the location of the remnant of monitoring well MW-2. The gray aluminum waste below the rock outcropping shows the height of the waste prior to excavation.

Monitoring well MW-2 was damaged beyond repair when a piece of mobile equipment collided with it. State well construction regulations require that the well be decommissioned by a licensed well driller (or a professional engineer or architect.) The most efficient method would be to fill the PVC casing with bentonite chips, but this method is not appropriate if material has entered the casing and bridged it, thus preventing the bentonite from reaching the bottom of the casing. Preliminary indications (one measurement) are that this might be the case. If the blockage cannot be cleared in some way such as with compressed air, the alternative of over-drilling this relatively deep well will be costly.

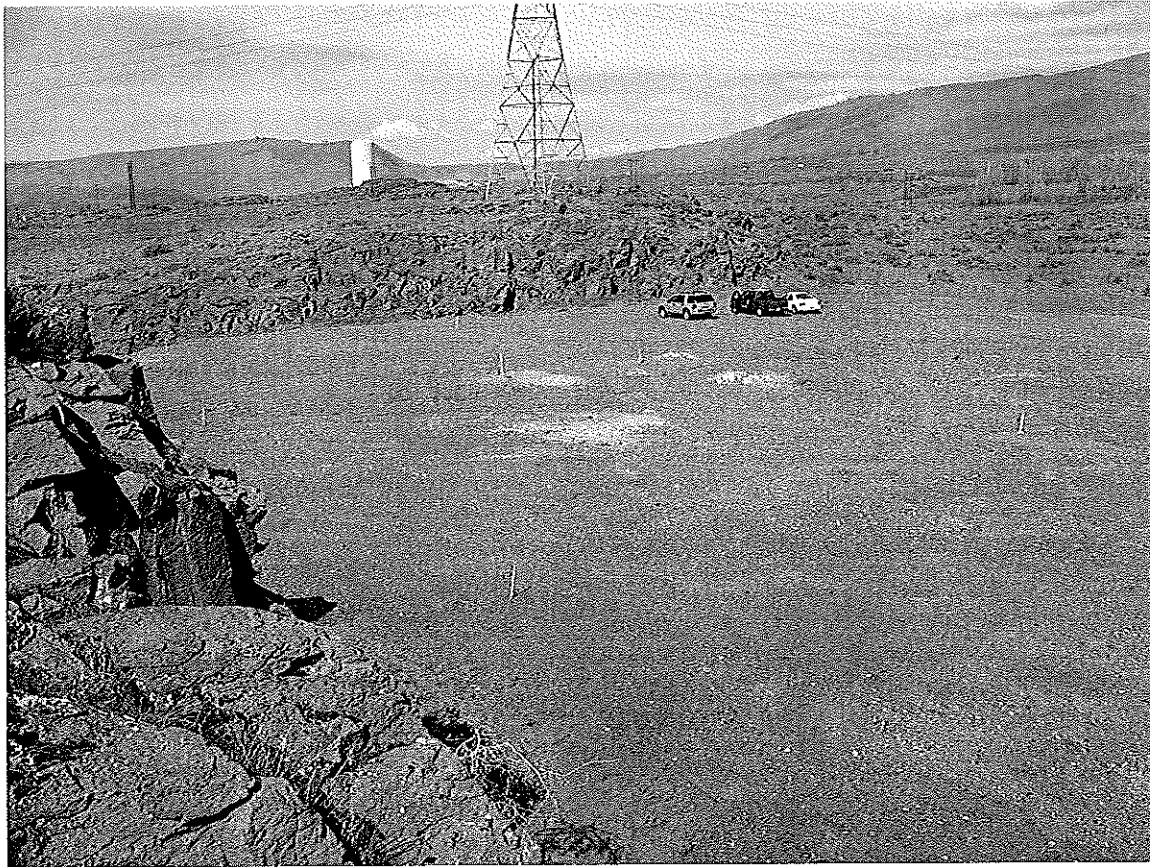
Photo # 2 Before– Looking northwest and down on disposal site cover from atop basalt outcrop bluff that forms southern wall of bowl in which the disposal site sits. The disposal site cover is the relatively flat area that occupies most of the photograph. The vehicles are parked on the disposal site cover. Note Bonneville Power Administration electrical power transmission lines and tower. (Photo by Jeff Newschwander)

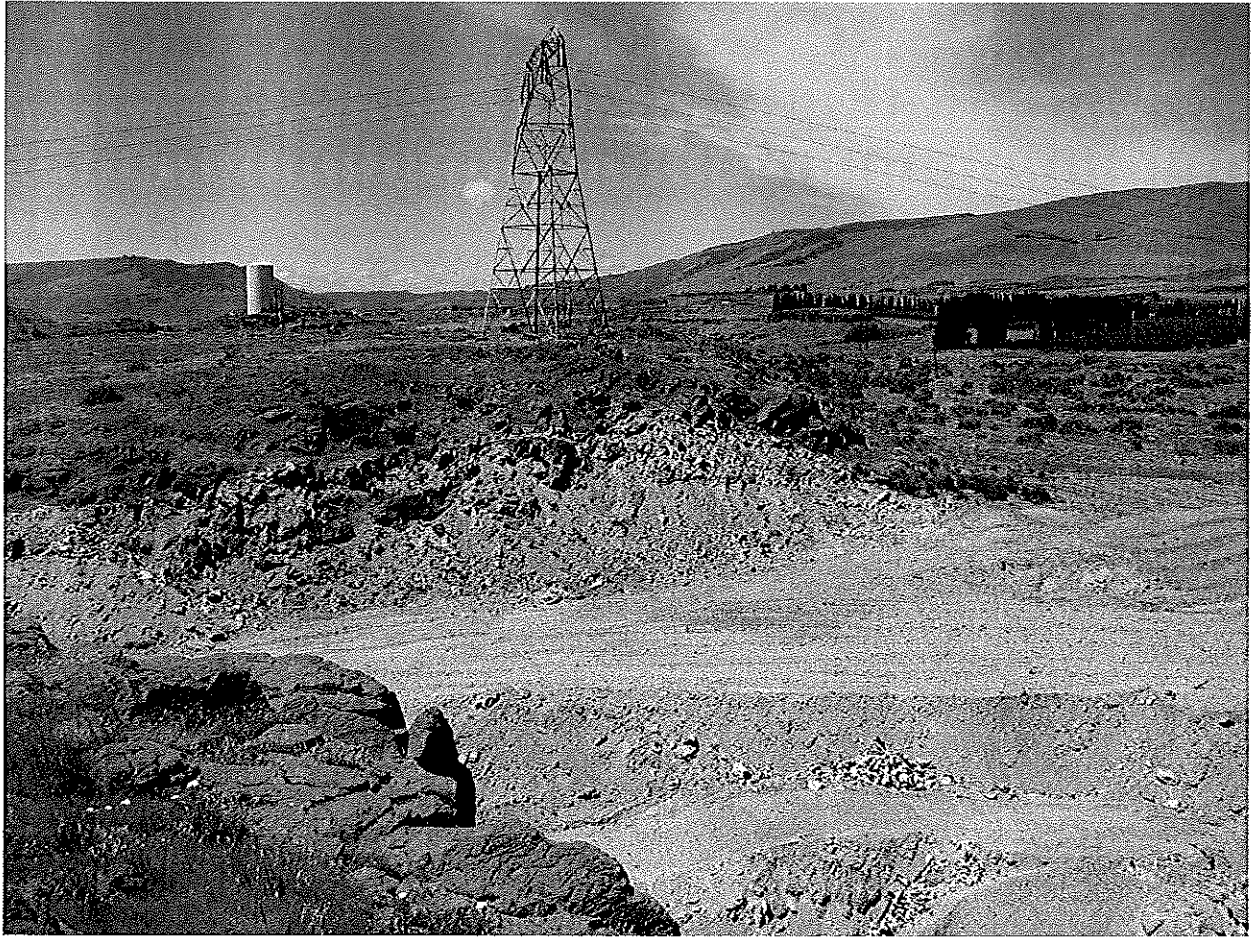
Photo # 2 After – Again, the gray aluminum waste beneath the rocks on the north side indicate both the original height of the waste and the depth of the excavation thus far.

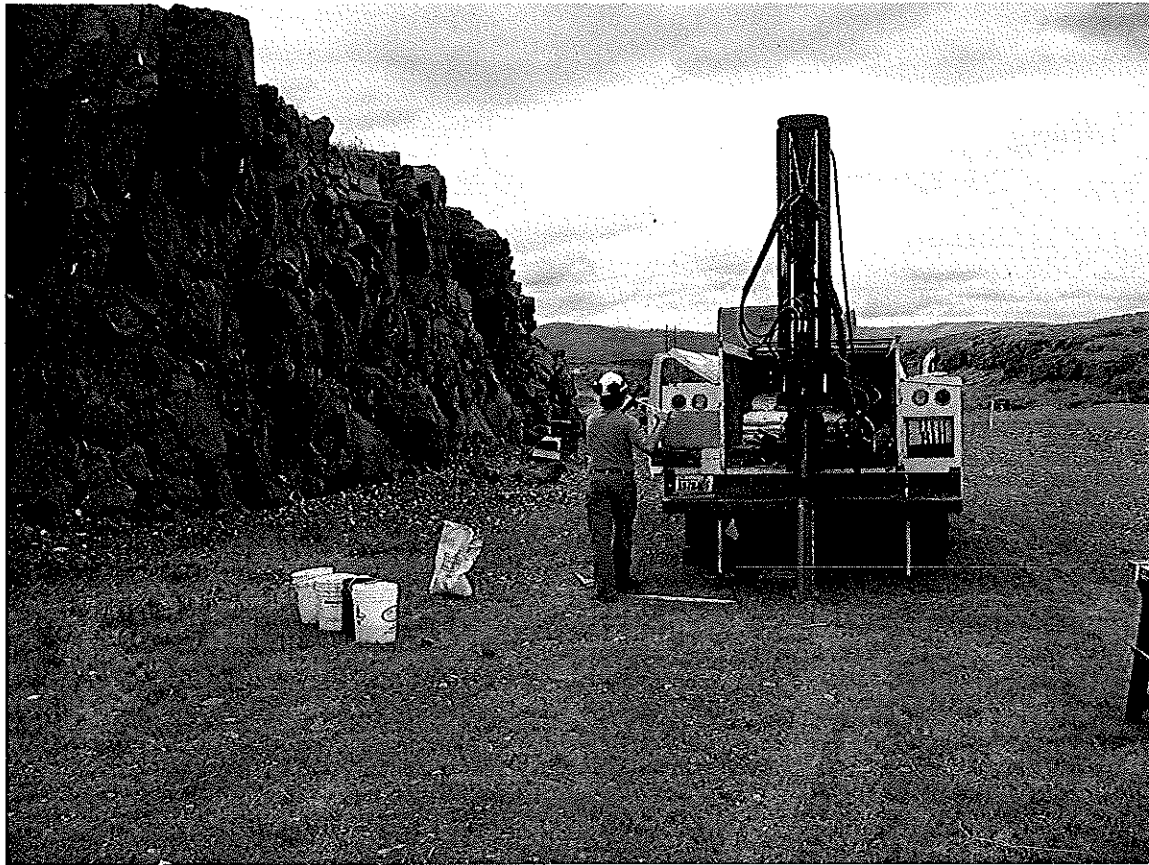
Photo # 3 Before – Geoprobe machine sitting on cover of disposal site and operator indicate scale of basalt outcrop bluff which forms south wall of bowl in which the disposal site sits. (Photo by Jeff Newschwander)

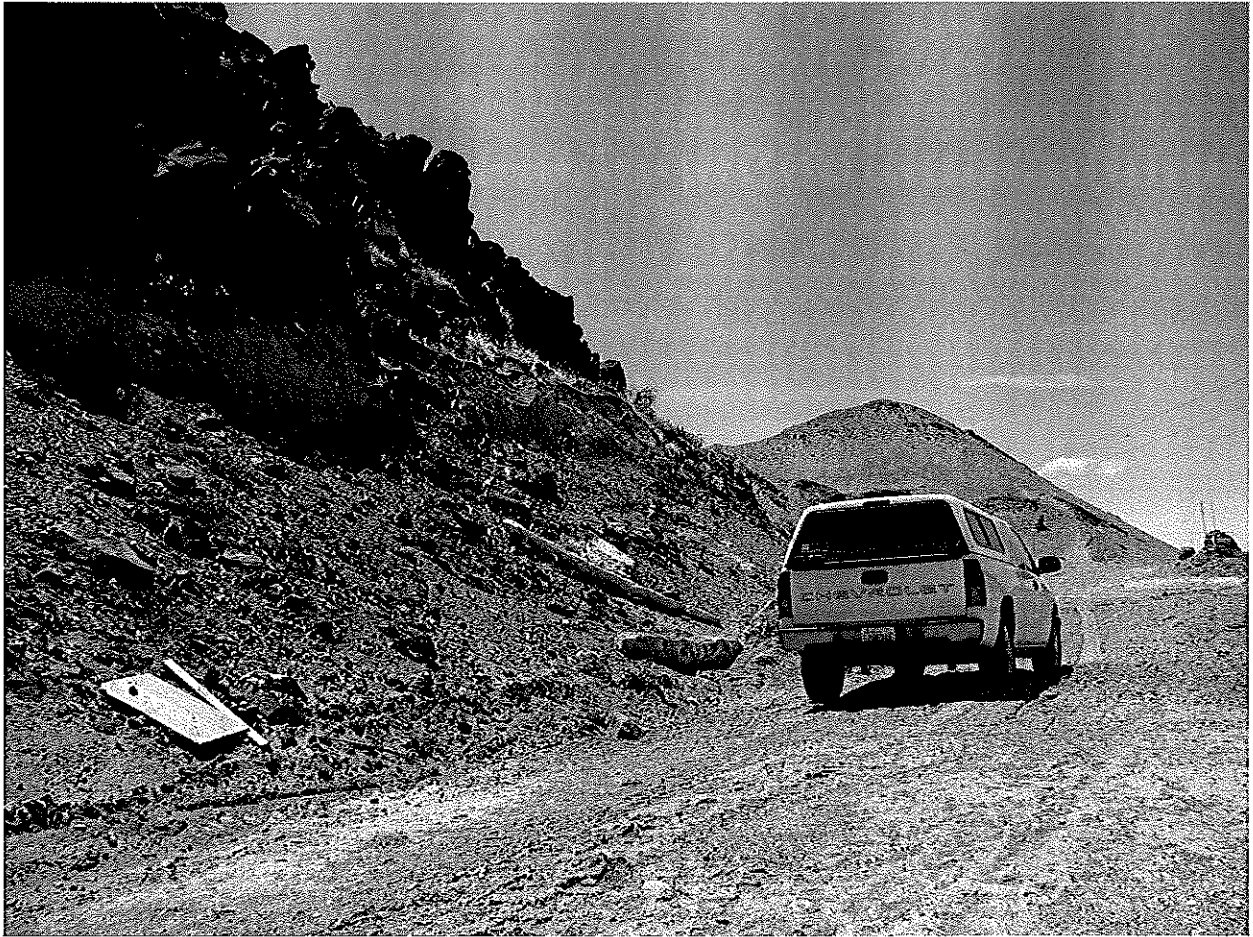
Photo # 3 After – The pickup truck indicates scale after Phase 2 excavation of the basalt outcrop bluff that forms the south wall of bowl in which aluminum waste was disposed.
