## **Interim Action Scope of Work**

Everett Smelter Cleanup Site  
Everett, Washington

**Washington Department of Ecology**

February 20, 2014

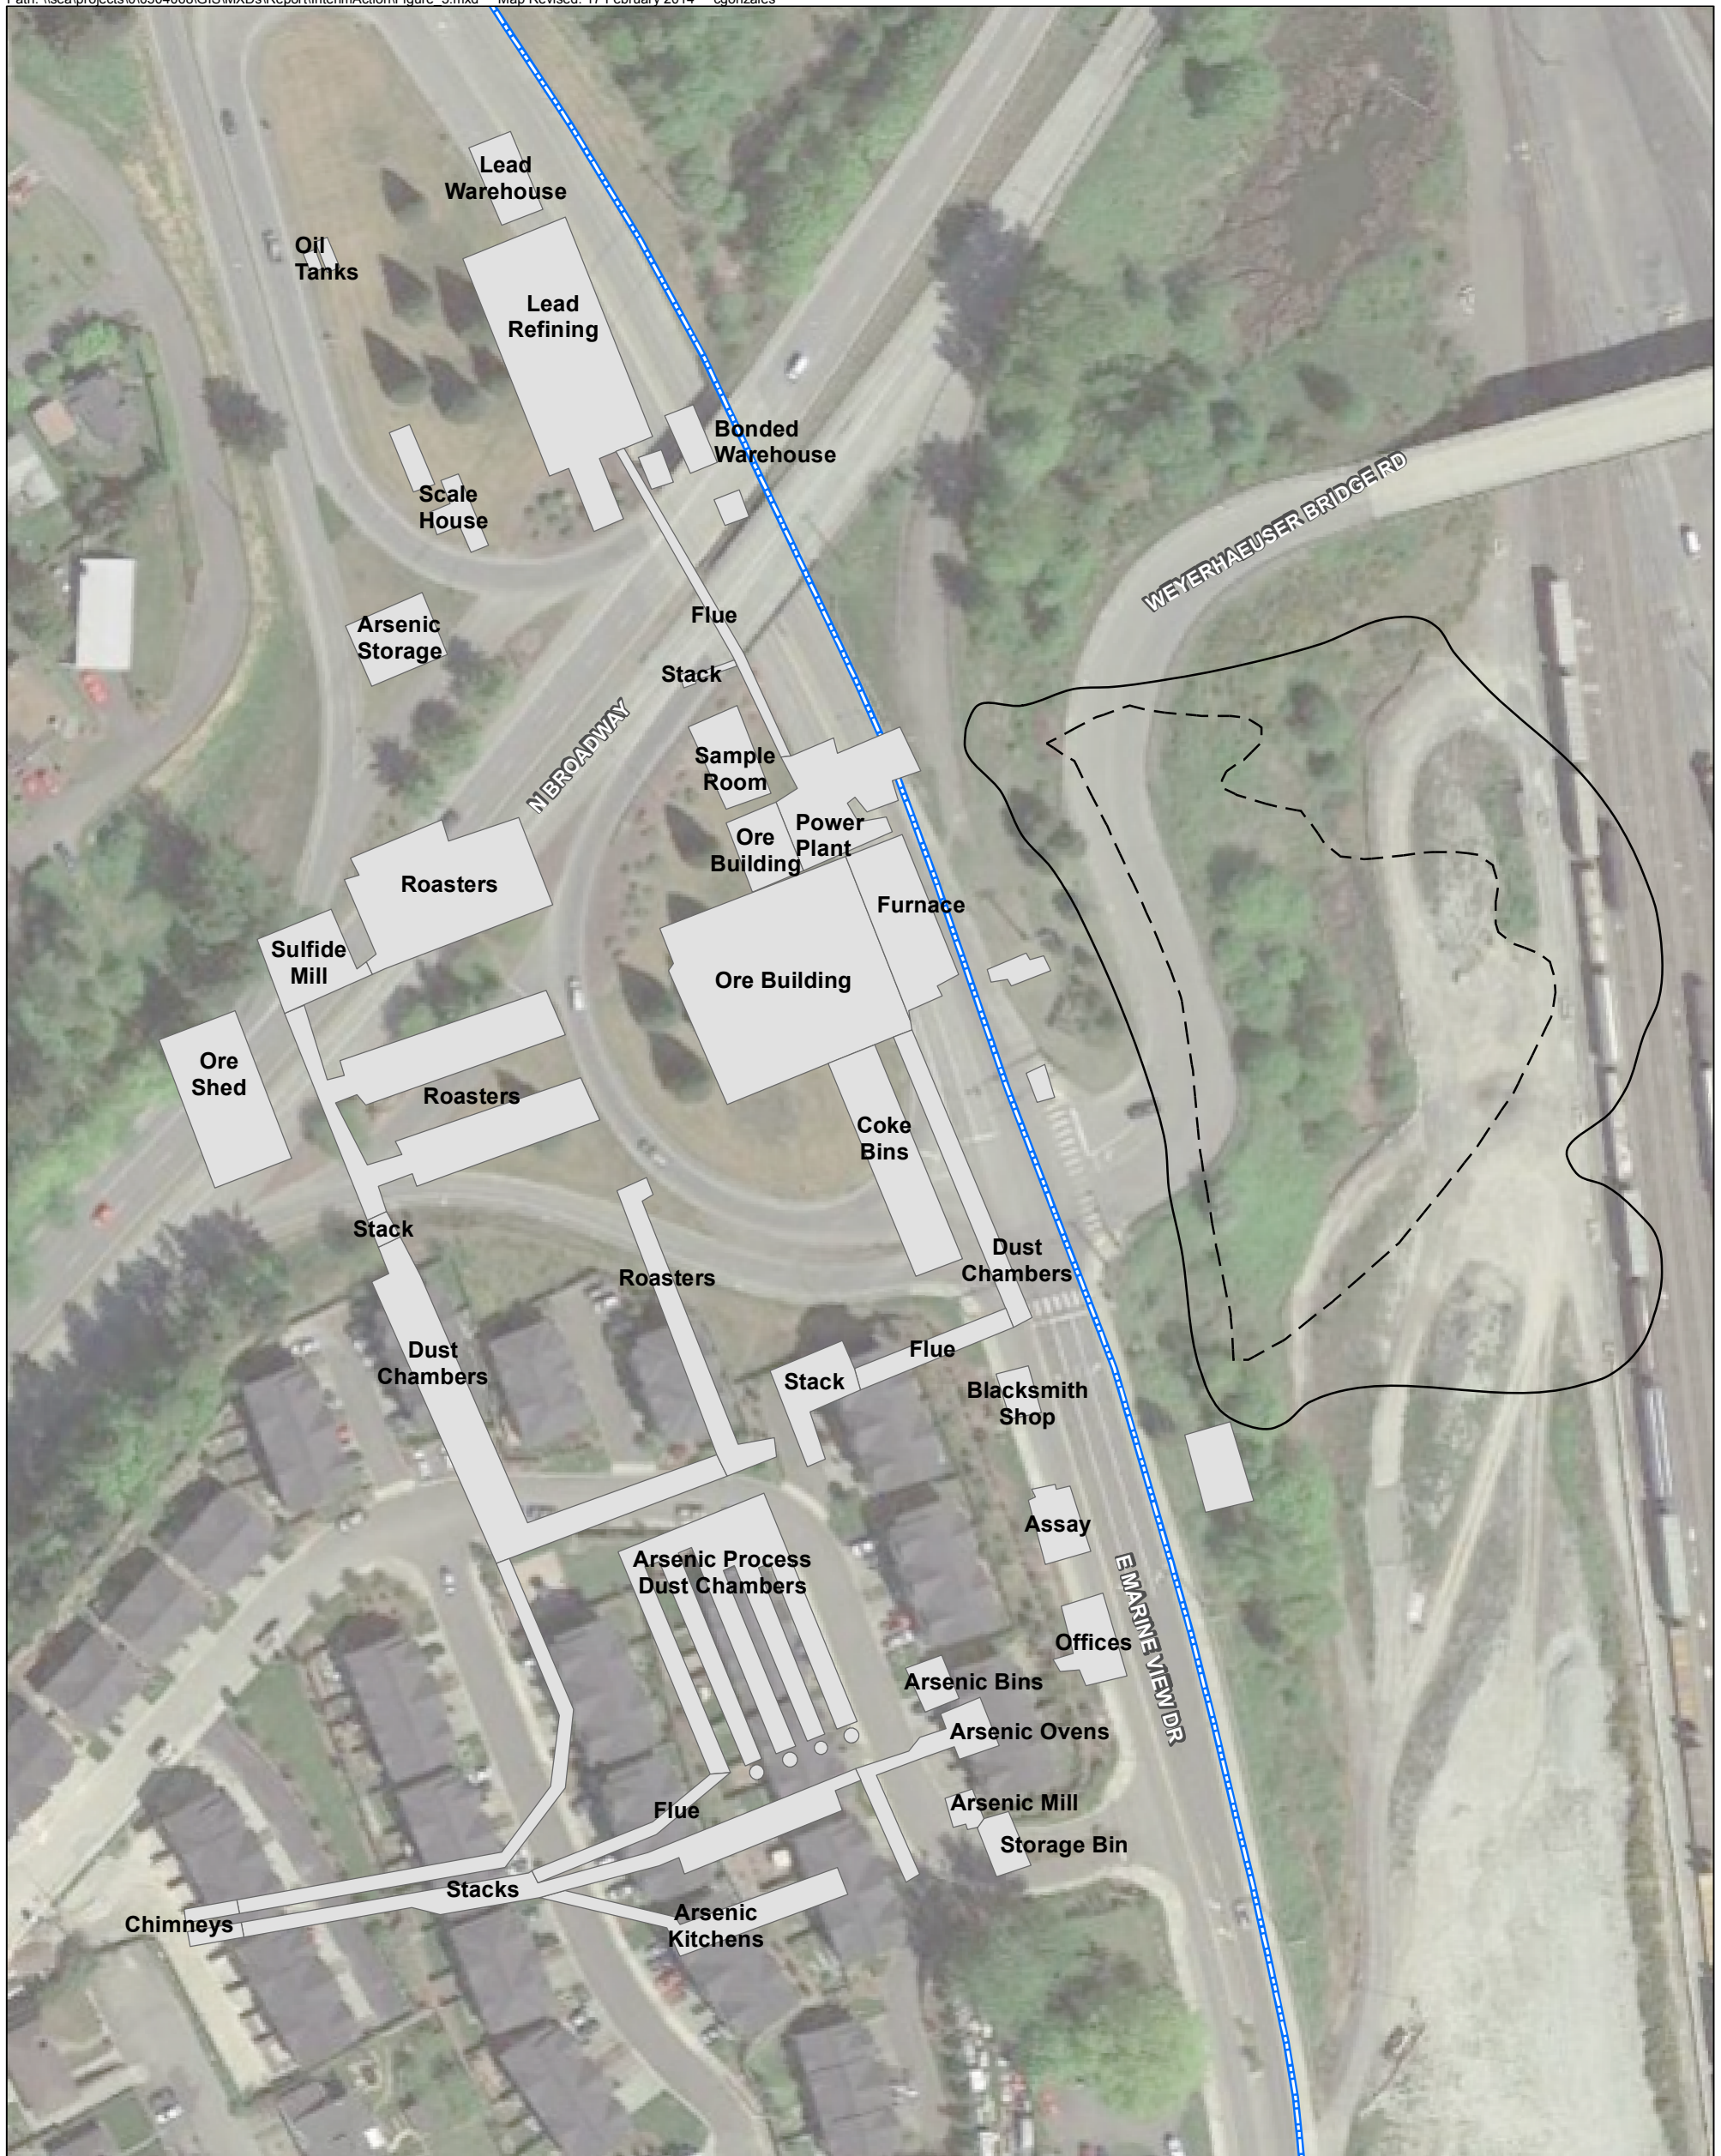
**Figure 3**

Figure 3 presents the approximate location of the former smelter structures. The former smelter had a flue that transferred emissions from the furnace to a stack along the current alignment of E. Marine View Drive. The flue made a 90 degree turn to the west near the existing southwest portion of the intersection at E. Marine View Drive and Riverside Road. Demolition of the smelter structures began in 1912. The roadway section of the current E. Marine View Drive was constructed in 1956. There are no records identified that indicate that potentially impacted soil below E. Marine View Drive was removed.

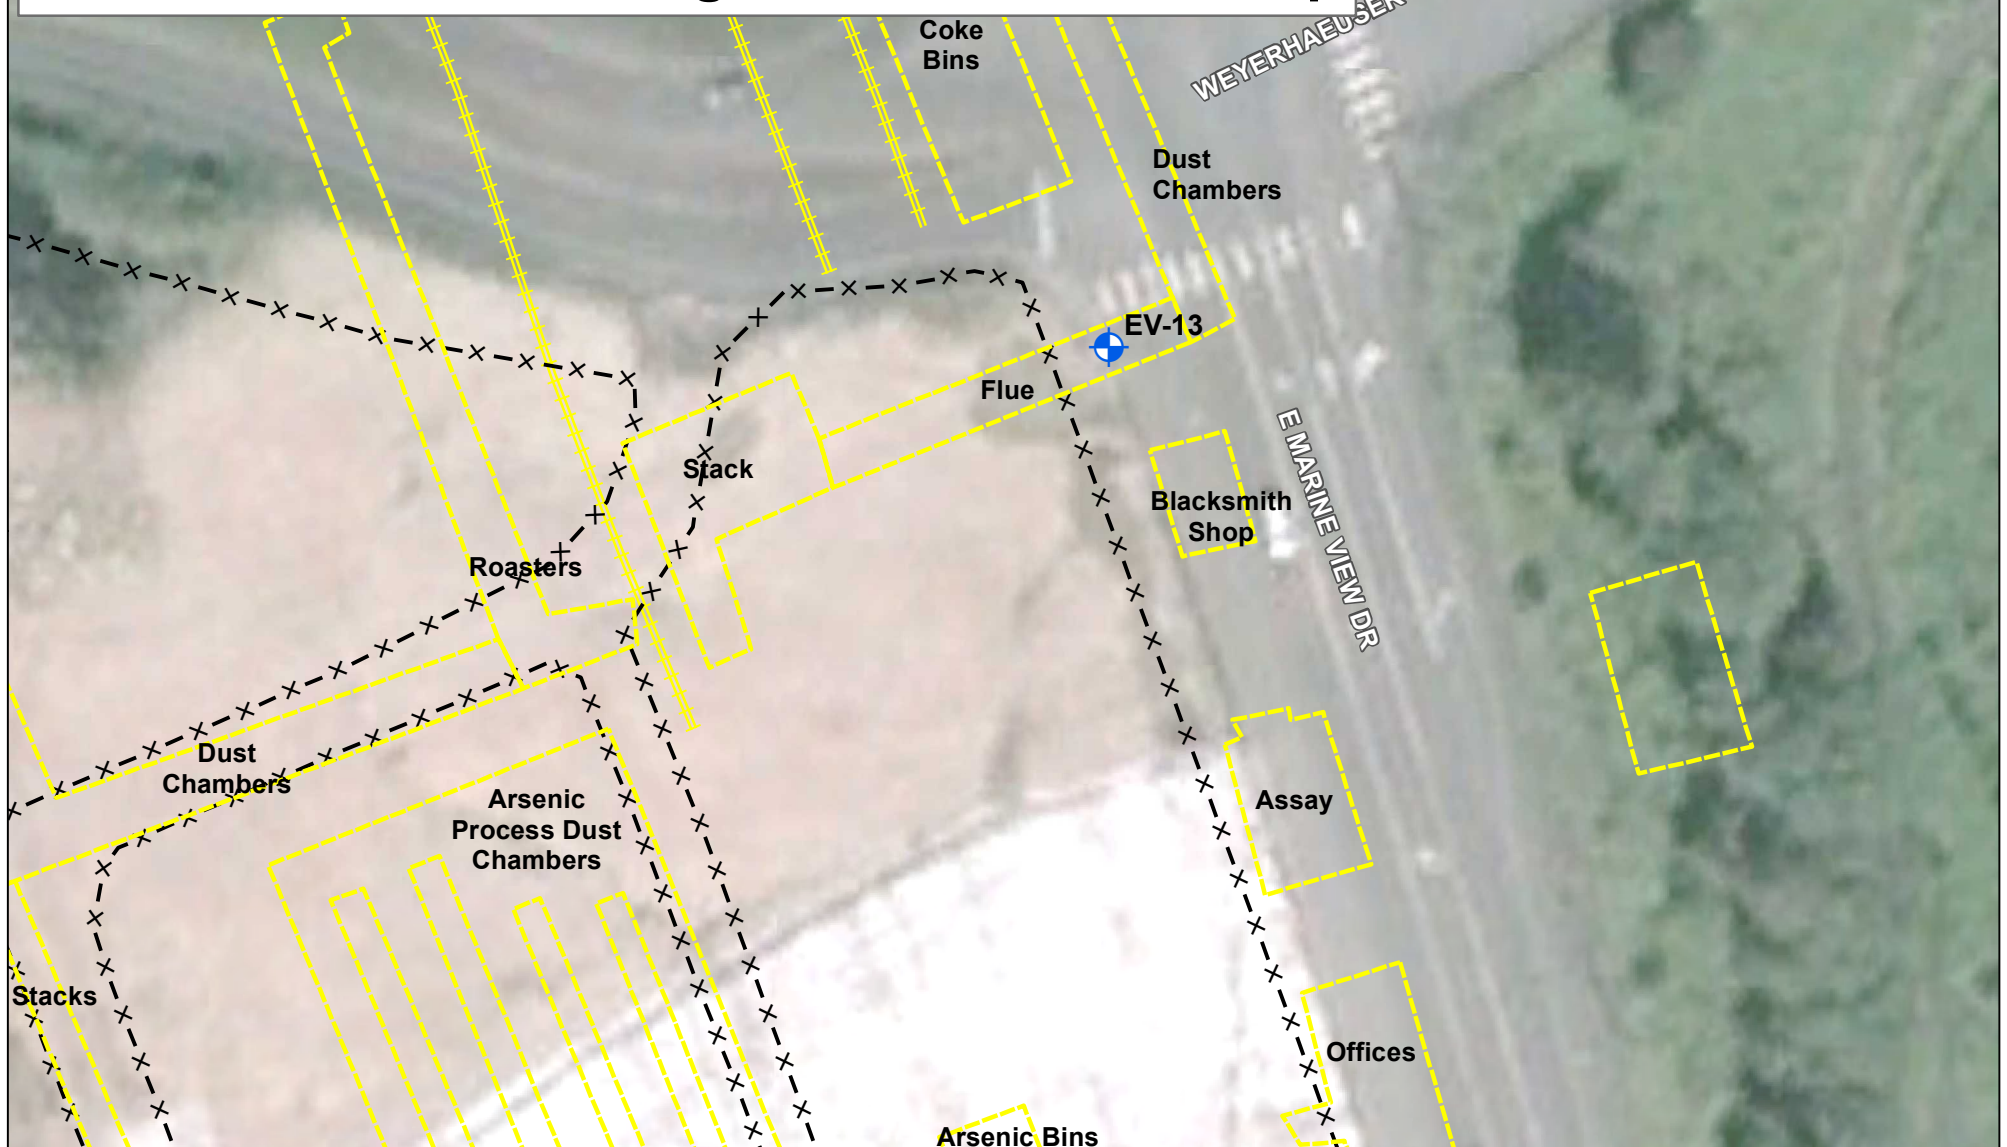
# 2005 Aerial Photo During Fenced Area Cleanup

- The aerial photo from 2005, presented in Figure 5, corresponds to the timeframe of the Fenced Area cleanup and shows the approximate excavation activities being conducted in the Fenced Area. Consistent with the Fenced Area cleanup design reports and supplemental information, the 2005 aerial photo also shows that the area near EV-13 was not excavated at that time.

- Fenced Area cleanup generally extended to or slightly beyond the former fence line as shown in Figure 5.
- Monitoring well EV-13 was installed in the roadway and is now located in the sidewalk, outside the Fenced Area and within the footprint of the historical flue structure. The concentrations of arsenic detected in soil and groundwater samples collected from EV-13 were high and consistent with the pattern of contamination associated with the flue structure and adjacent areas.

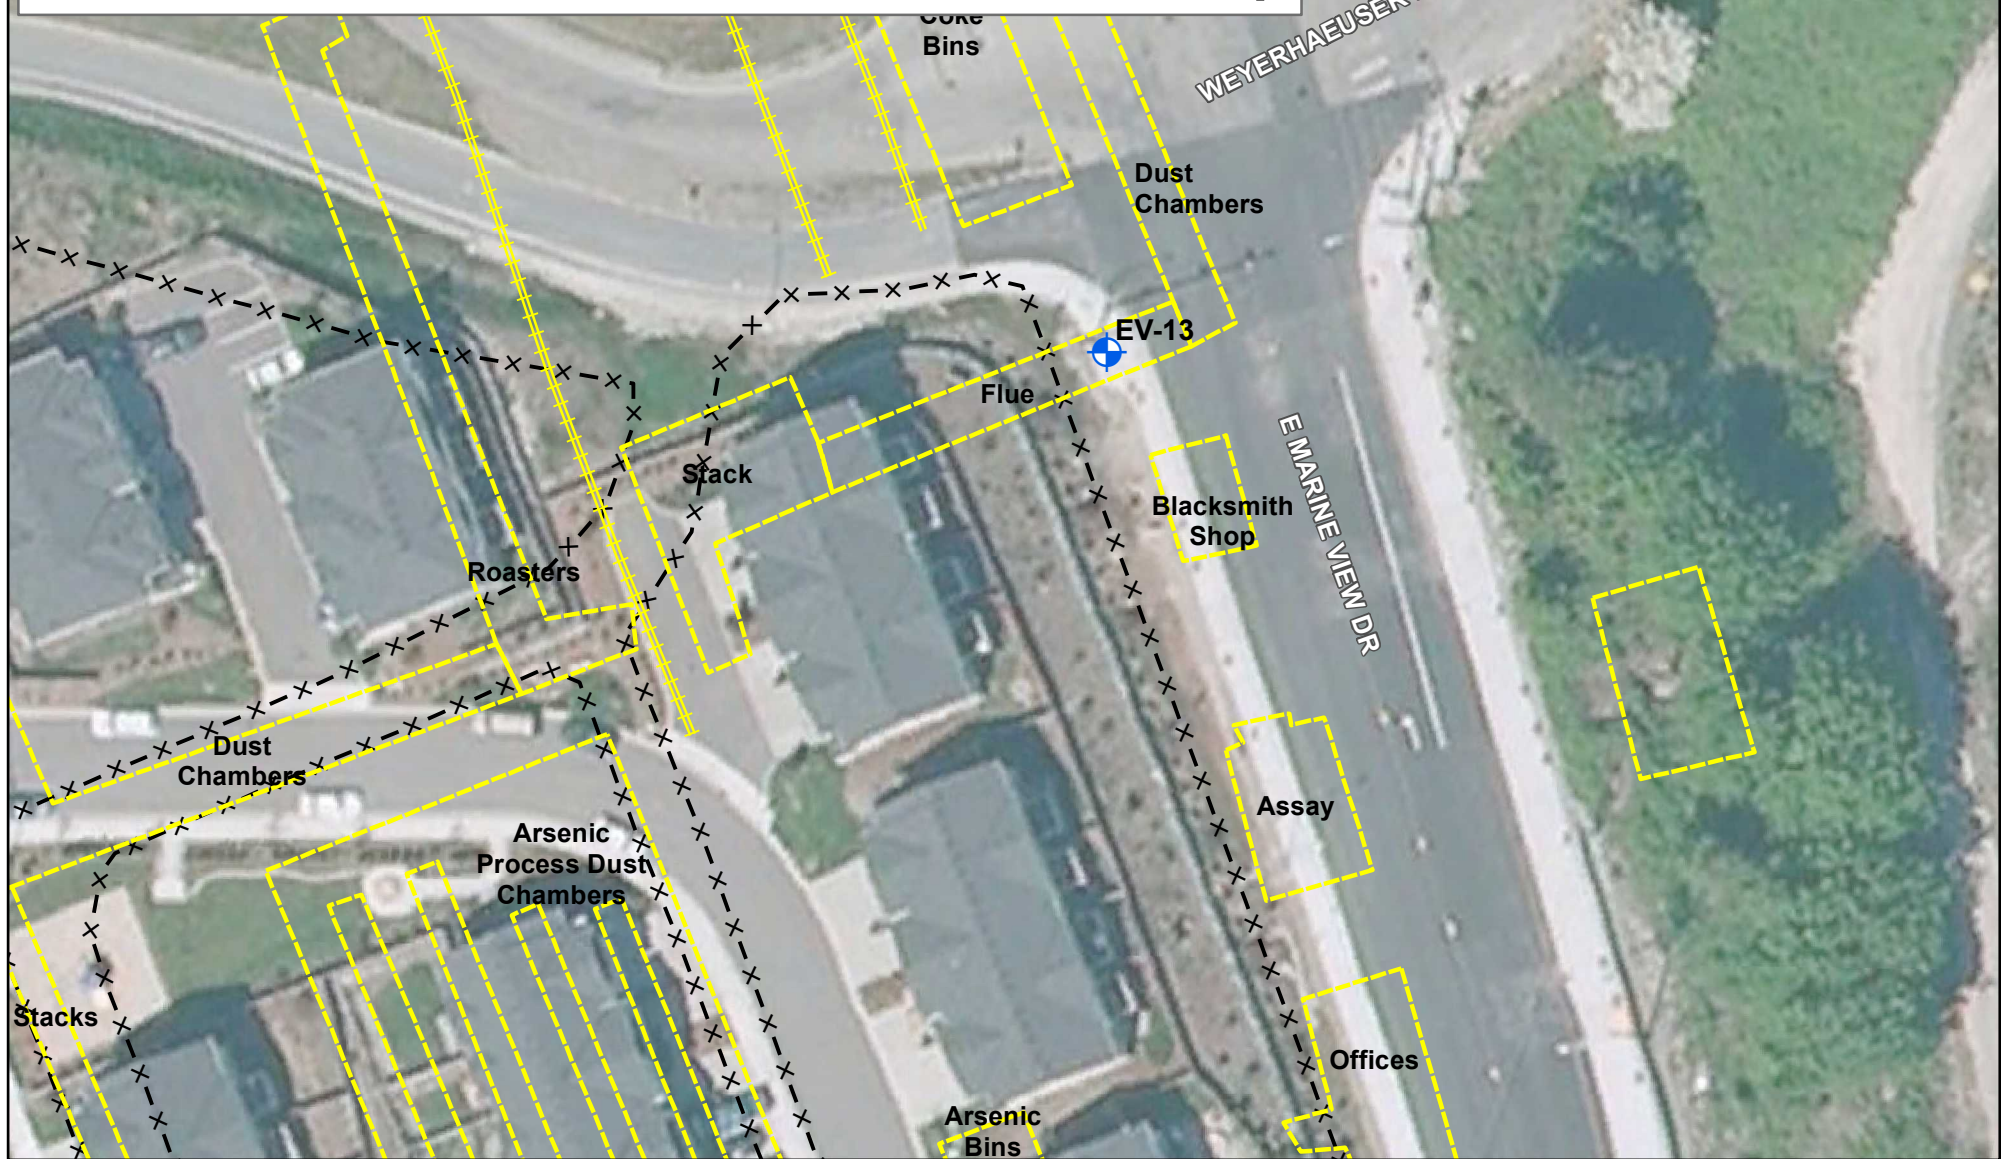
# 2009 Aerial Photo After Fenced Area Cleanup

- The 2009 aerial photograph (Figure 5) shows E. Marine View Drive ROW after a roadway improvement project was completed after Fenced Area cleanup that included a new sidewalk. Monitoring well EV-13, which was constructed in 1996 prior to the Fenced Area cleanup, is currently located in the sidewalk along E. Marine View Drive.

The continued presence of this monitoring well suggests that cleanup activities and roadway improvement construction likely did not include removal of potentially contaminated soil located in the vicinity of the monitoring well.

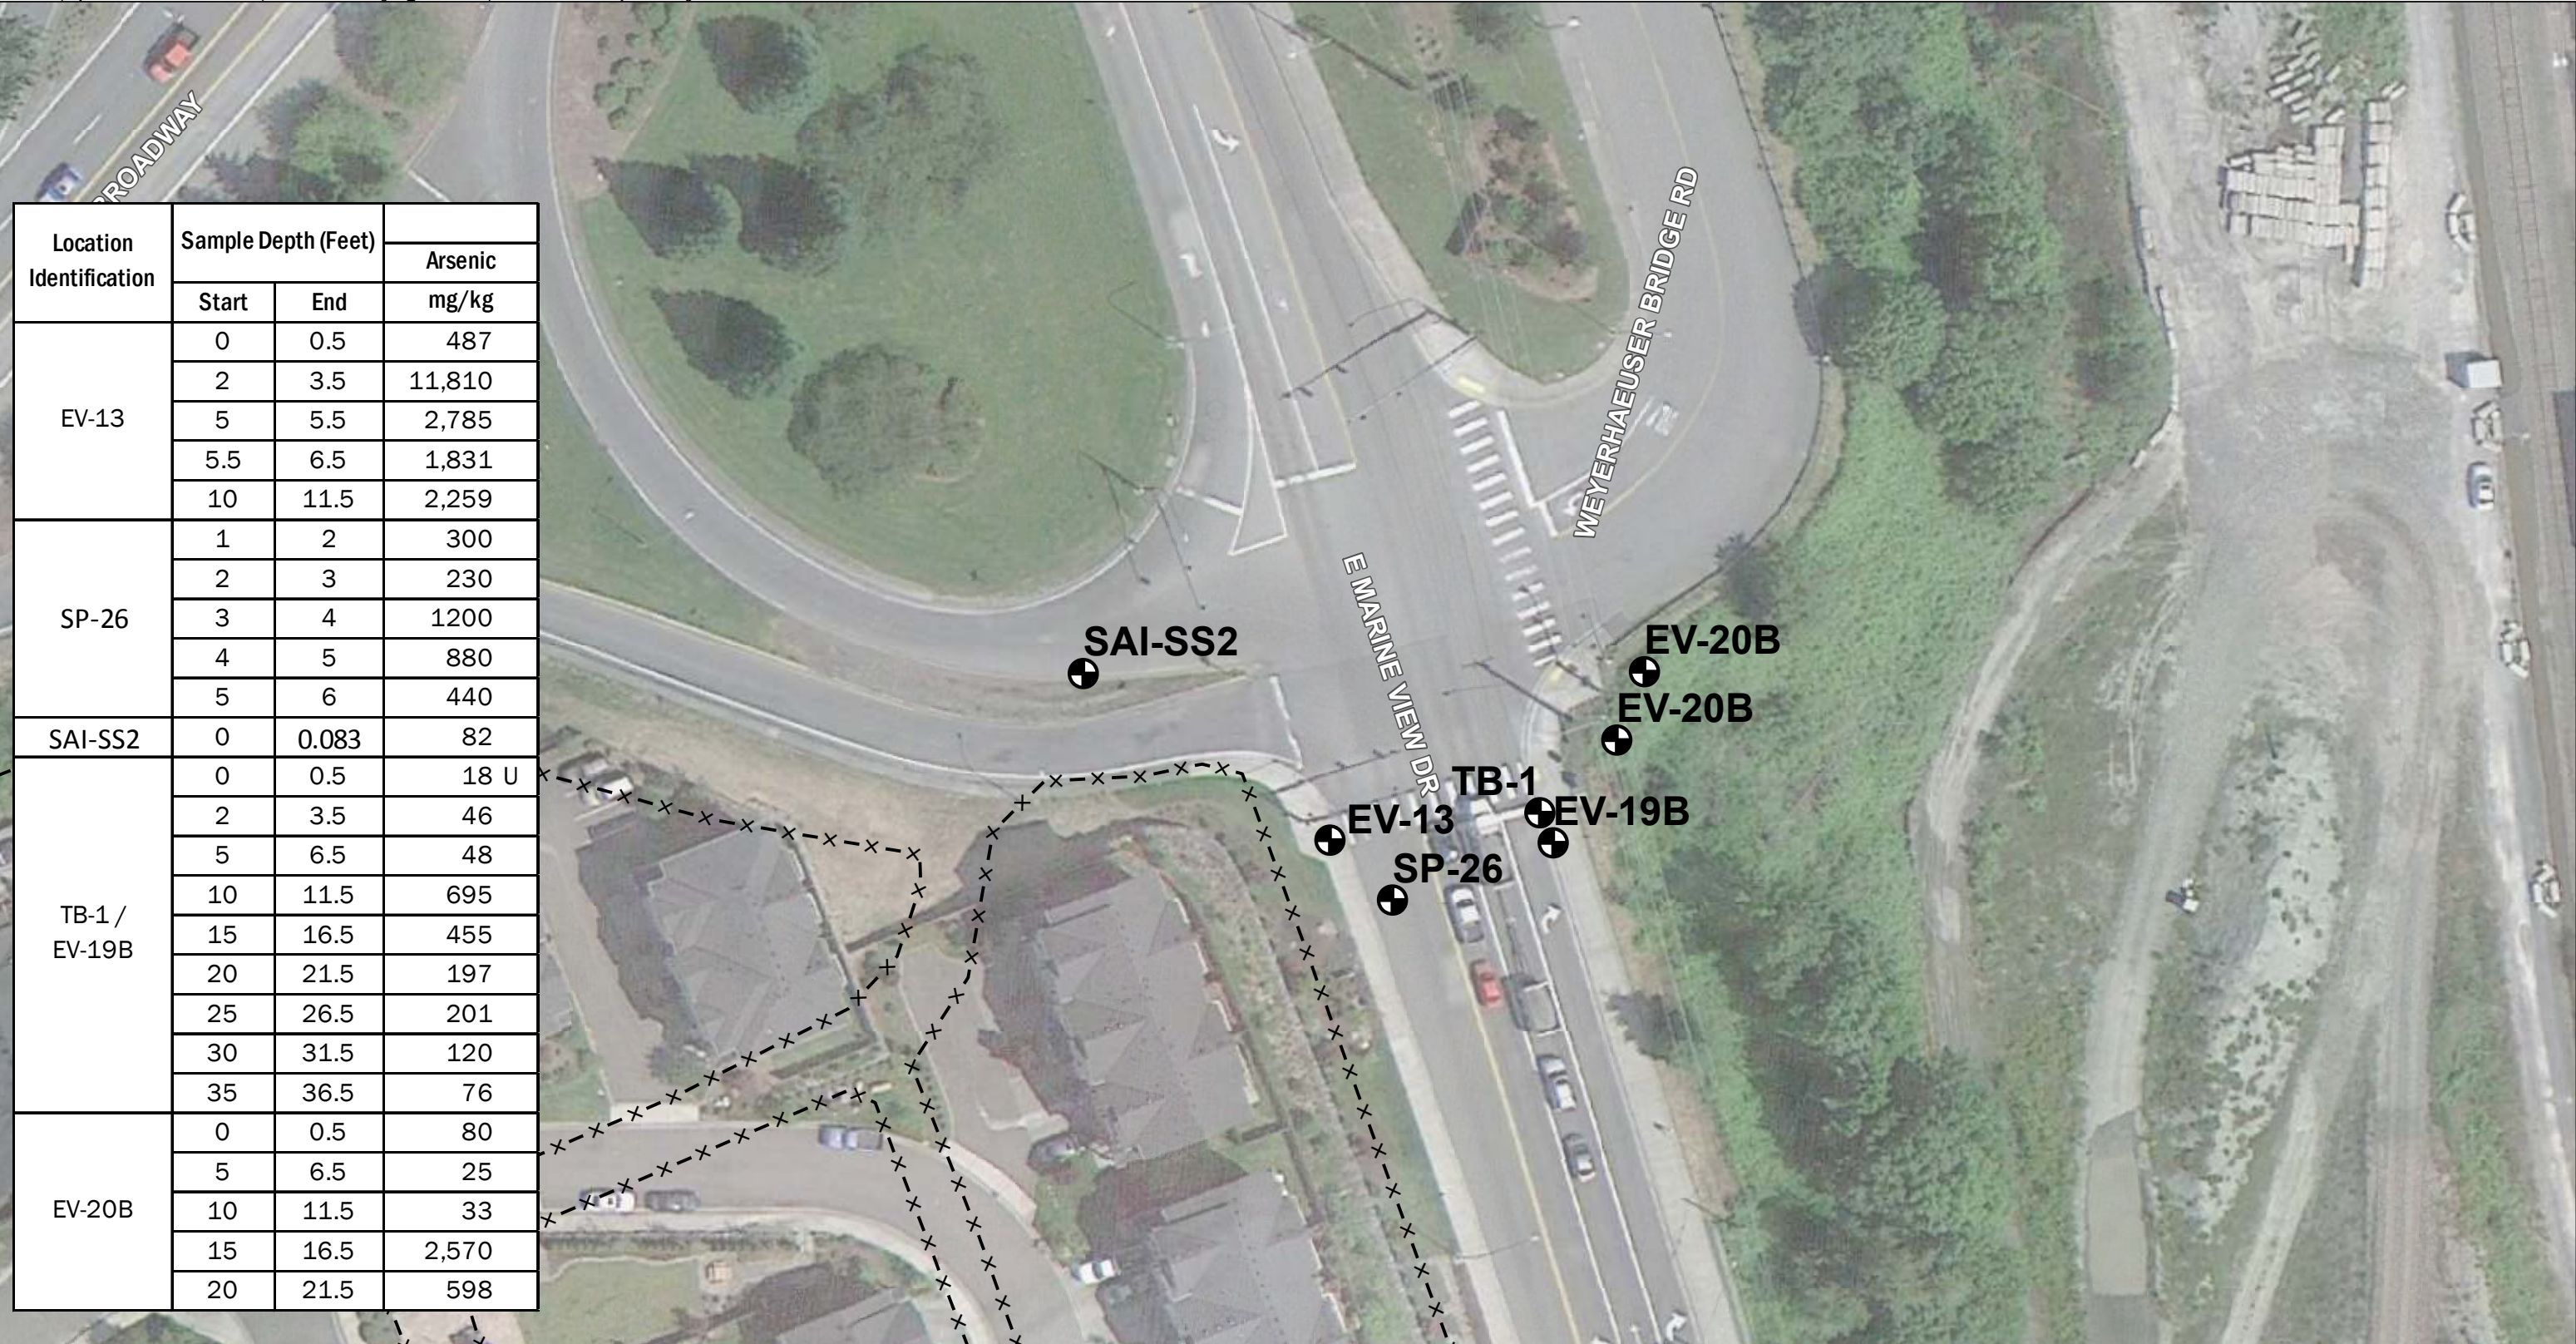
<b>Figure 6</b>

<b>Soil Analytical Data</b>	
Everett Smelter Interim Action

Recent and historical soil and groundwater data provide evidence that potential source material may be located near monitoring well EV-13. Figure 6 presents soil data in the vicinity of EV-13. Soil and groundwater data provide the following evidence that potential source material remains in this area:

- Arsenic in a soil sample collected in February 1996 from 2 feet deep during installation of monitoring well EV-13 was elevated with a concentration greater than 11,000 mg/kg.

- Soil samples to the north, south and east of EV-13 are elevated, but not to the same extent as EV-13 (see Figure 6). This suggests that a relatively narrow band of potential source material may exist and is likely located along the footprint of the former flue structure.
- Arsenic was detected at a concentration of 25,000 µg/L in groundwater collected from EV-13 in the spring of 1997. Groundwater in wells directly downgradient of EV-13, including EV-20 and BP-5 (see Figure 4), contain elevated arsenic concentrations ranging from 13,000 to over 17,000 µg/L. Concentrations of arsenic in groundwater are substantially lower in monitoring wells located to the north and south of EV-13. (This evidence also suggests that the area where the former flue structure turned to the west may be a source of arsenic to groundwater.)
