RE: **WELDCRAFT STEEL AND MARINE (GATE 2 BOATYARD) SITE  
SUPPLEMENTAL REMEDIAL INVESTIGATION WORK PLAN ADDENDUM**

**Interim Action Completion Report  
Sediment Remediation and Redevelopment Project  
Weldcraft Steel and Marine (Gate 2 Boatyard) Site  
Bellingham, Washington**

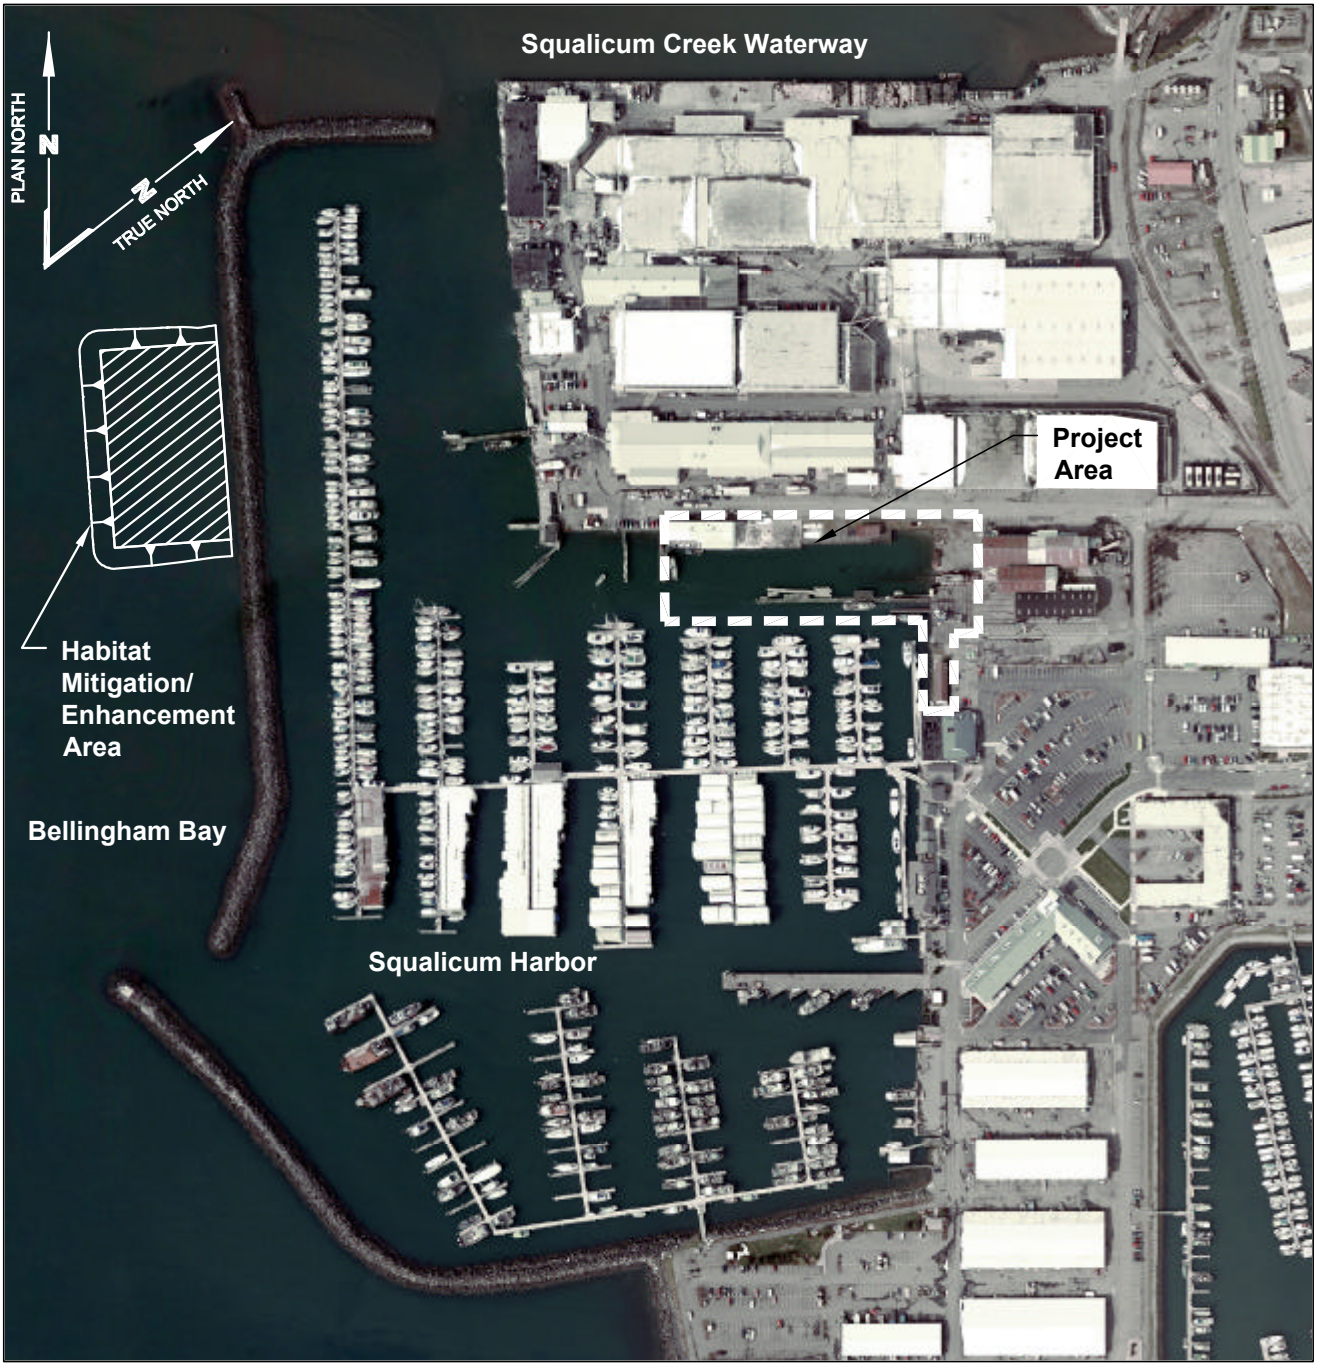
Figure  
**2**

**Project Area  
 Site Map**

This interim action completion report documents the implementation of the sediment remediation and redevelopment project at the former Weldcraft Steel and Marine (Gate 2 Boatyard) site (Site) at the Port of Bellingham (Port) in Bellingham, Washington. A Site vicinity map is shown on Figure 1, and a project area Site map with an aerial photograph taken prior to conducting the interim action is shown on Figure 2.

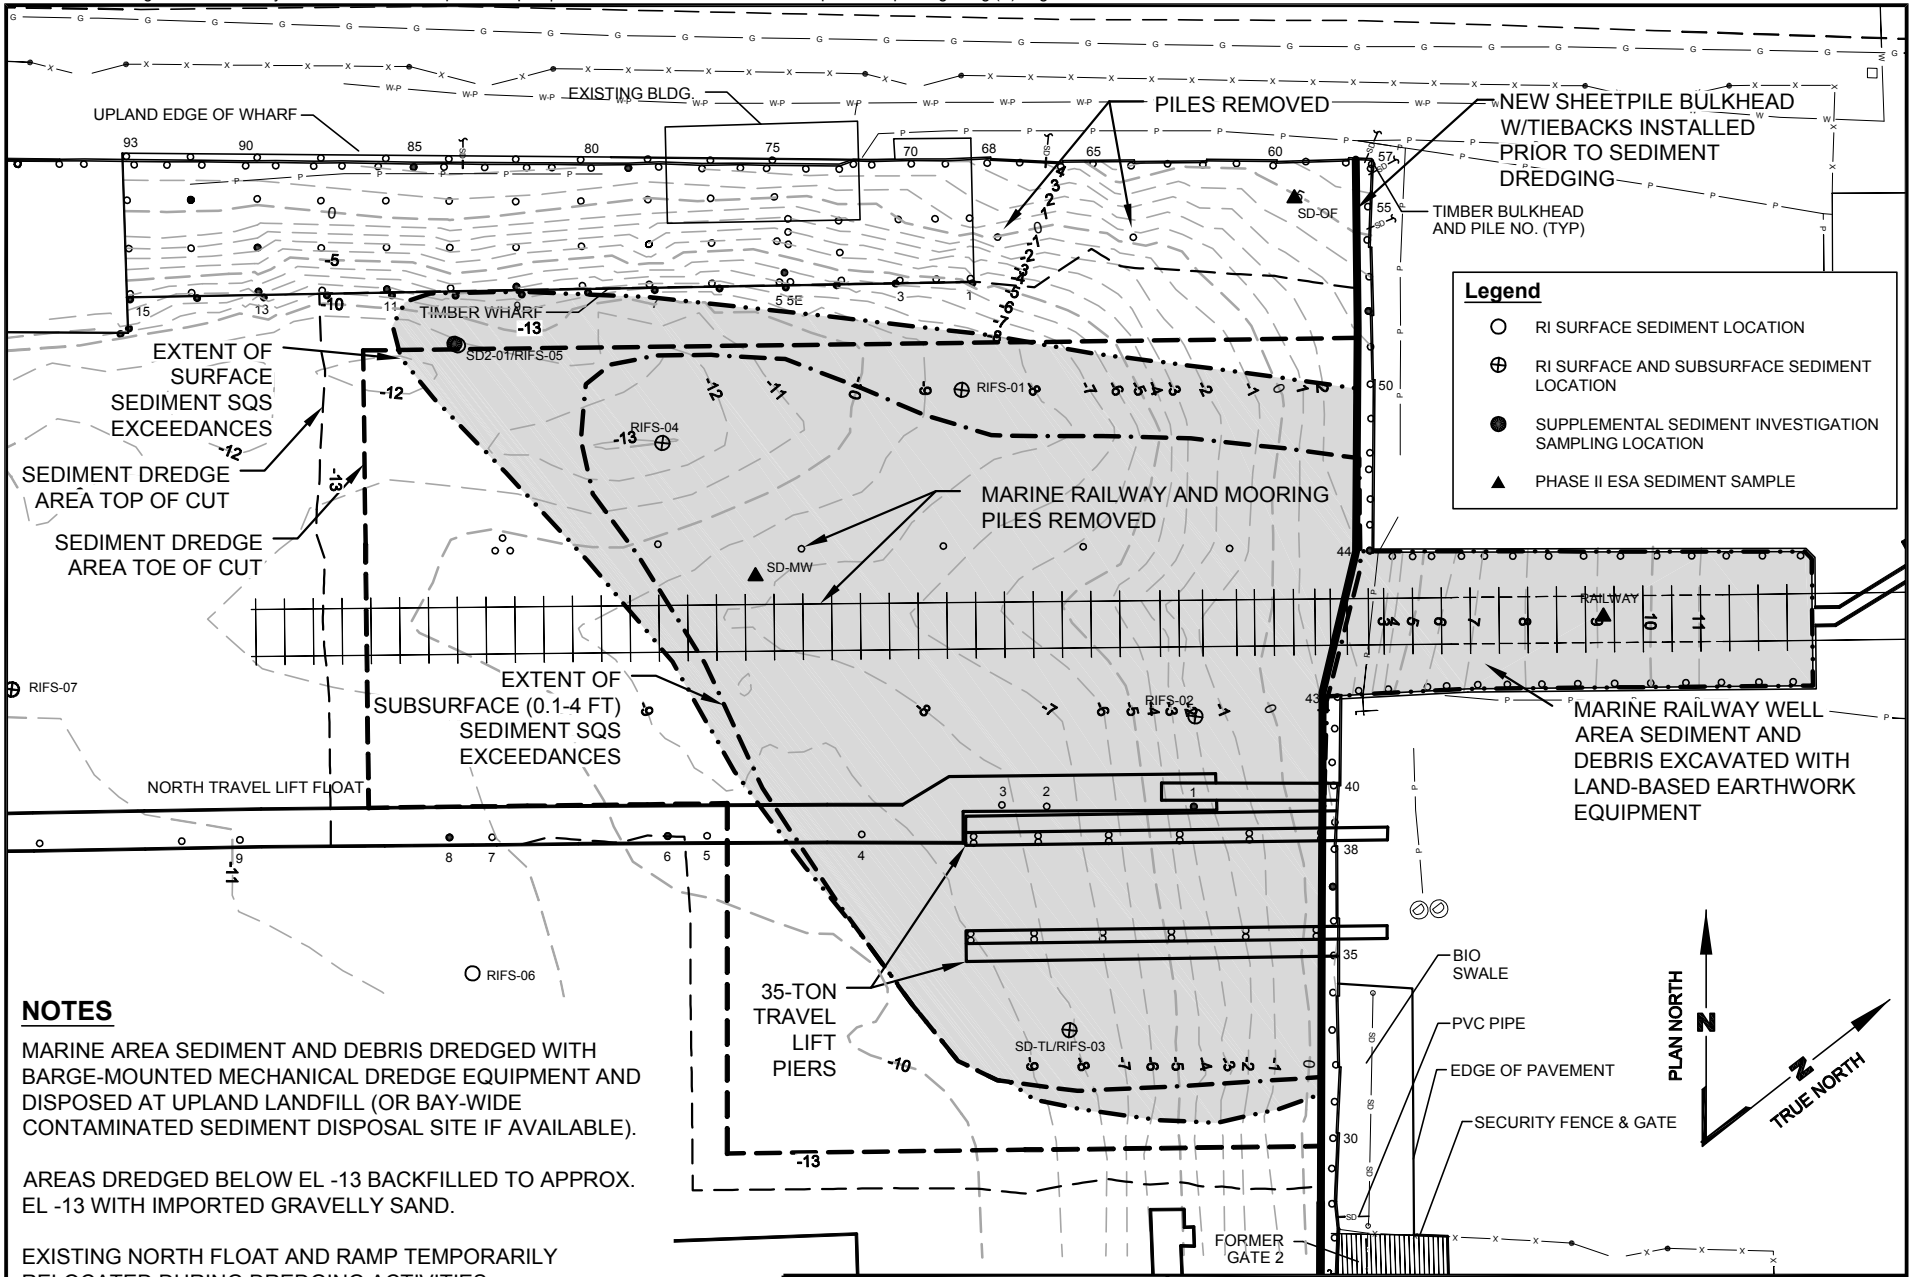
Figure  
**4**

**Sediment Dredging Areas**

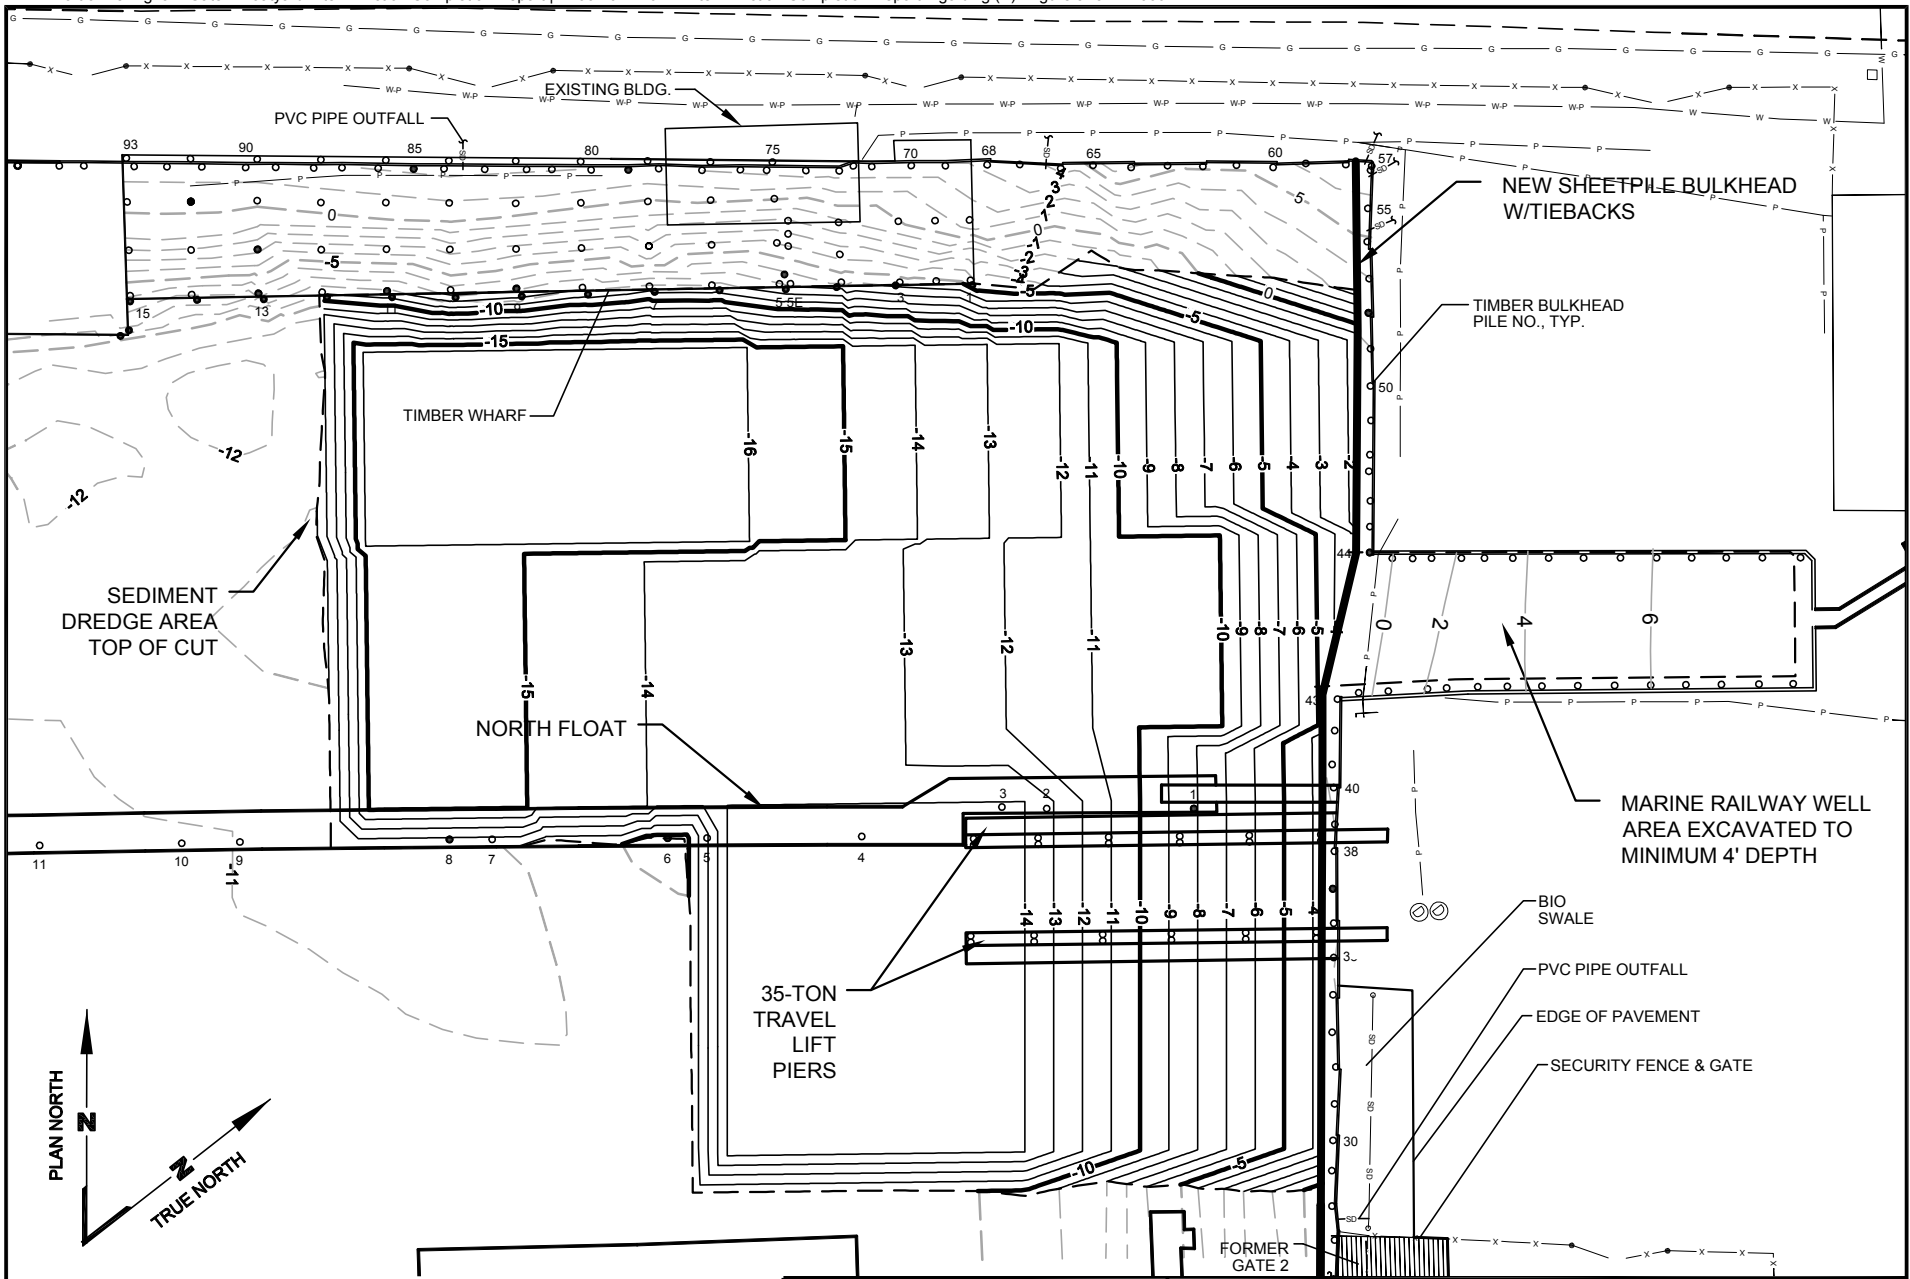
Figure  
**5**

**Design Sediment Dredging Contours**
