Historical Site Development Analysis
North Marina Ameron/Hulbert Site
Everett, Washington

The North Marina Ameron/Hulbert Site PLP Group

May 11, 2010

**HISTORICAL SITE DEVELOPMENT ANALYSIS
NORTH MARINA AMERON/HULBERT SITE
EVERETT, WASHINGTON
FOR
THE NORTH MARINA AMERON/HULBERT SITE PLP
GROUP**

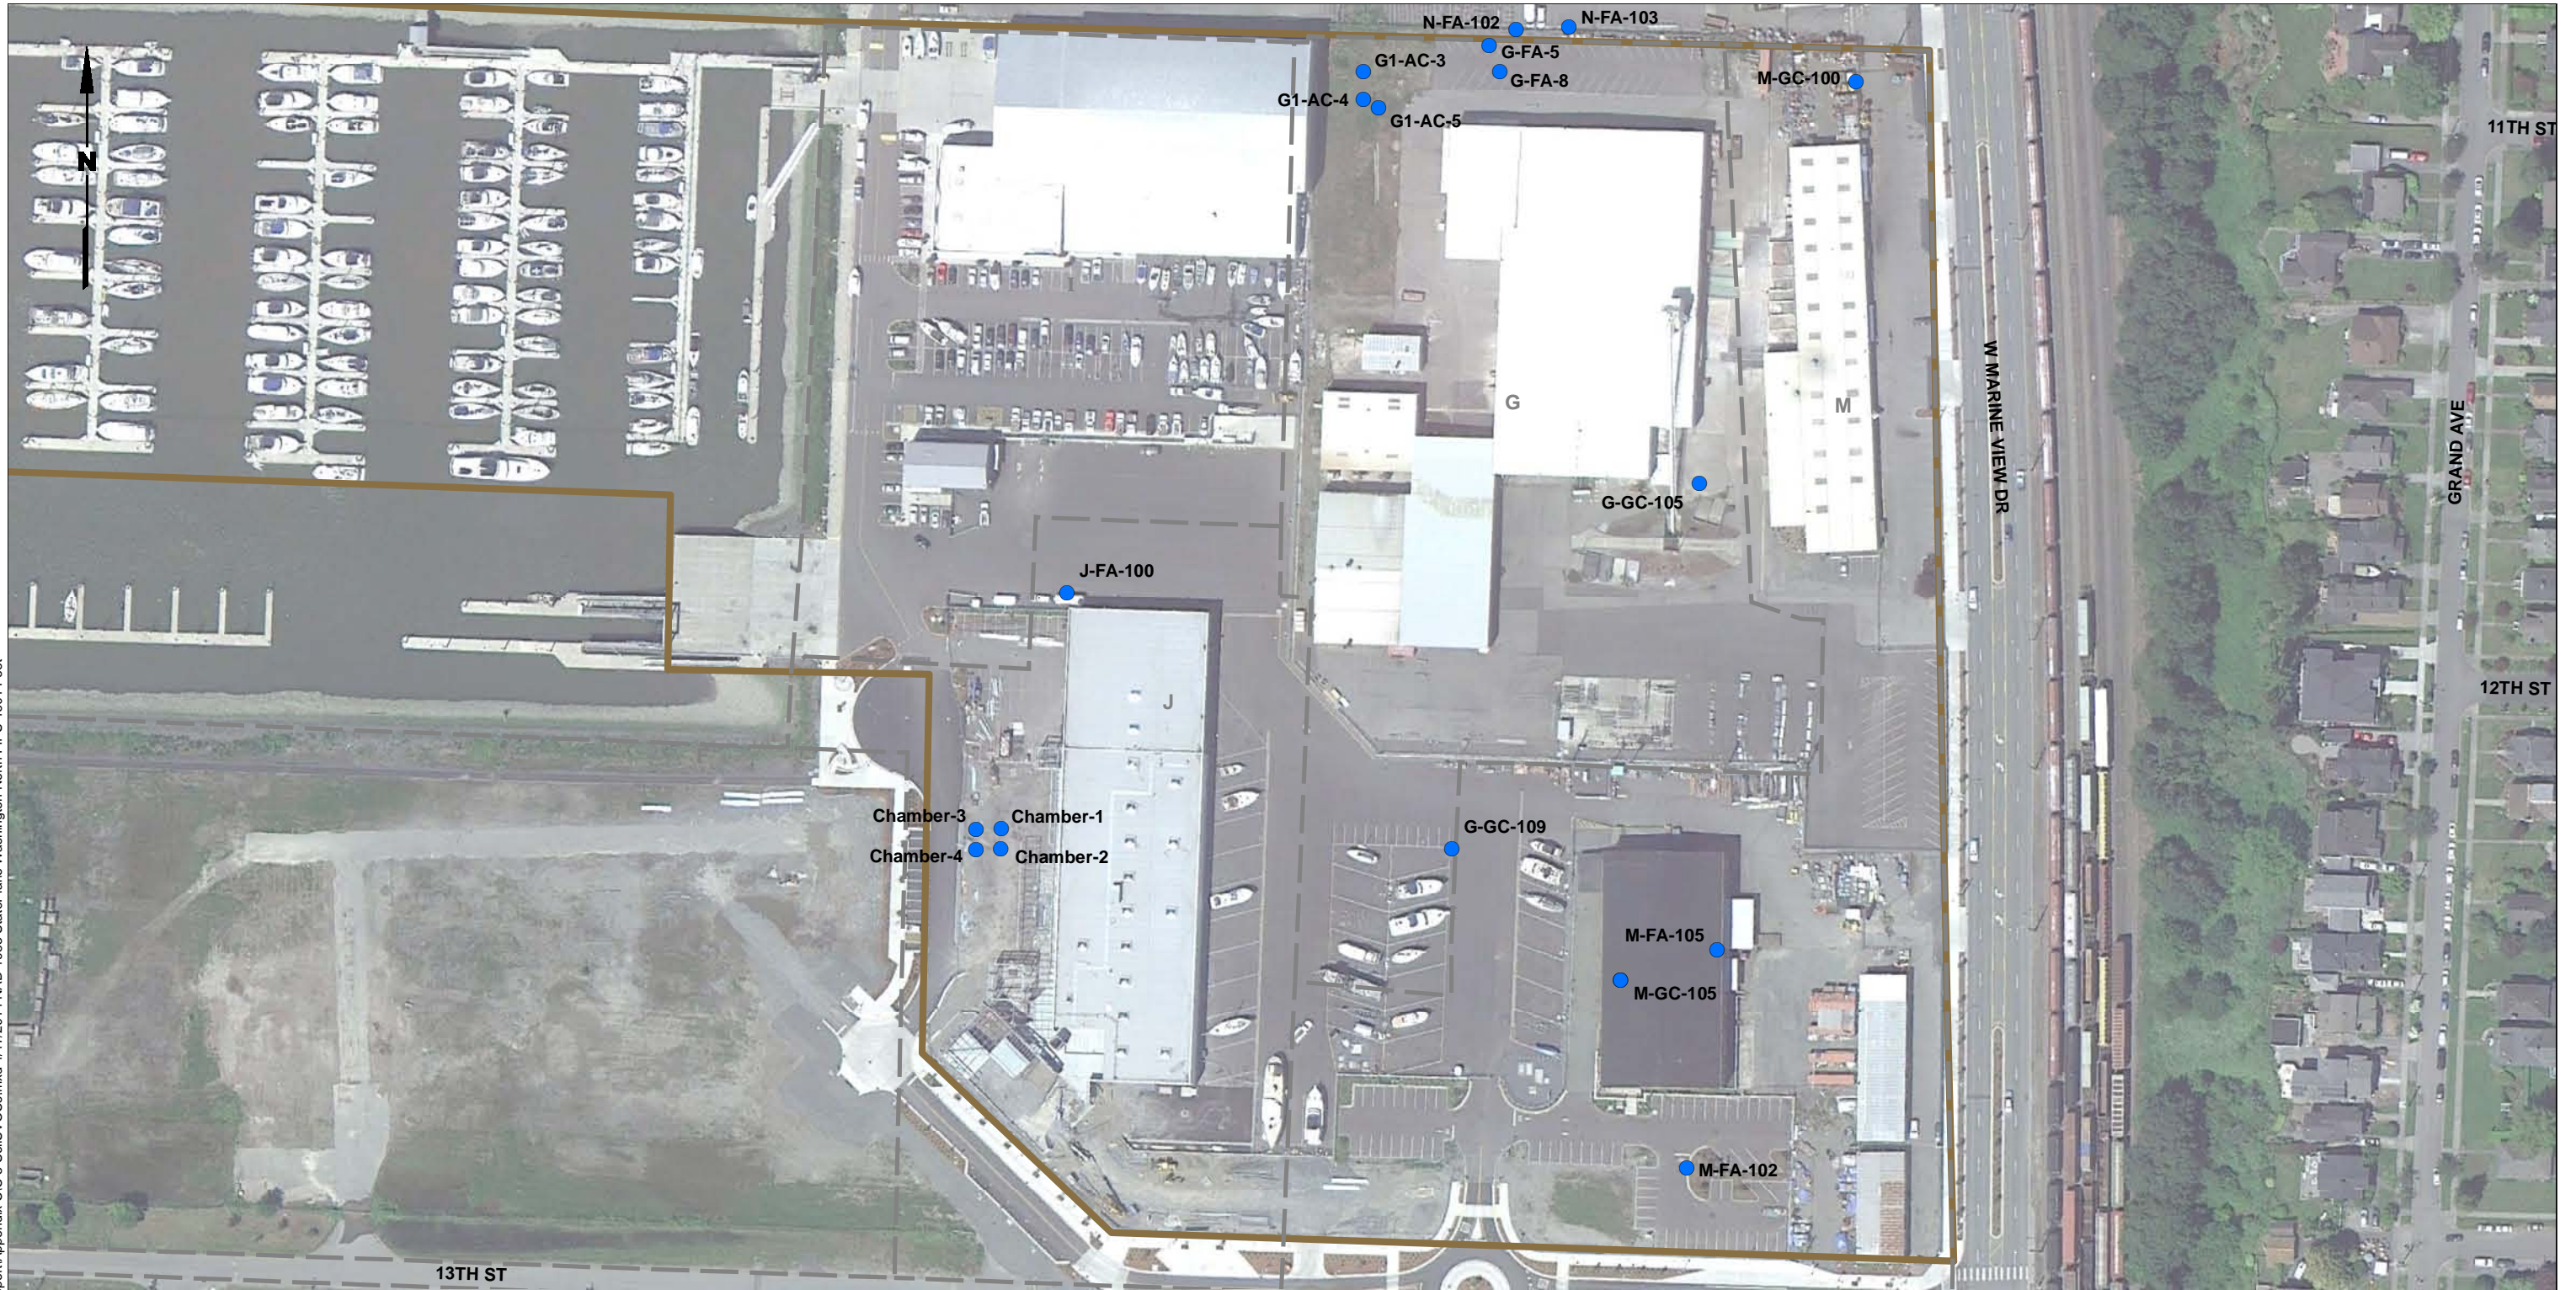
Figure
C-1

- Soil Sample Analyzed for SVOCs
- G G - Area Designation
- Approximate North Marina Ameron/Hulbert Site Boundary

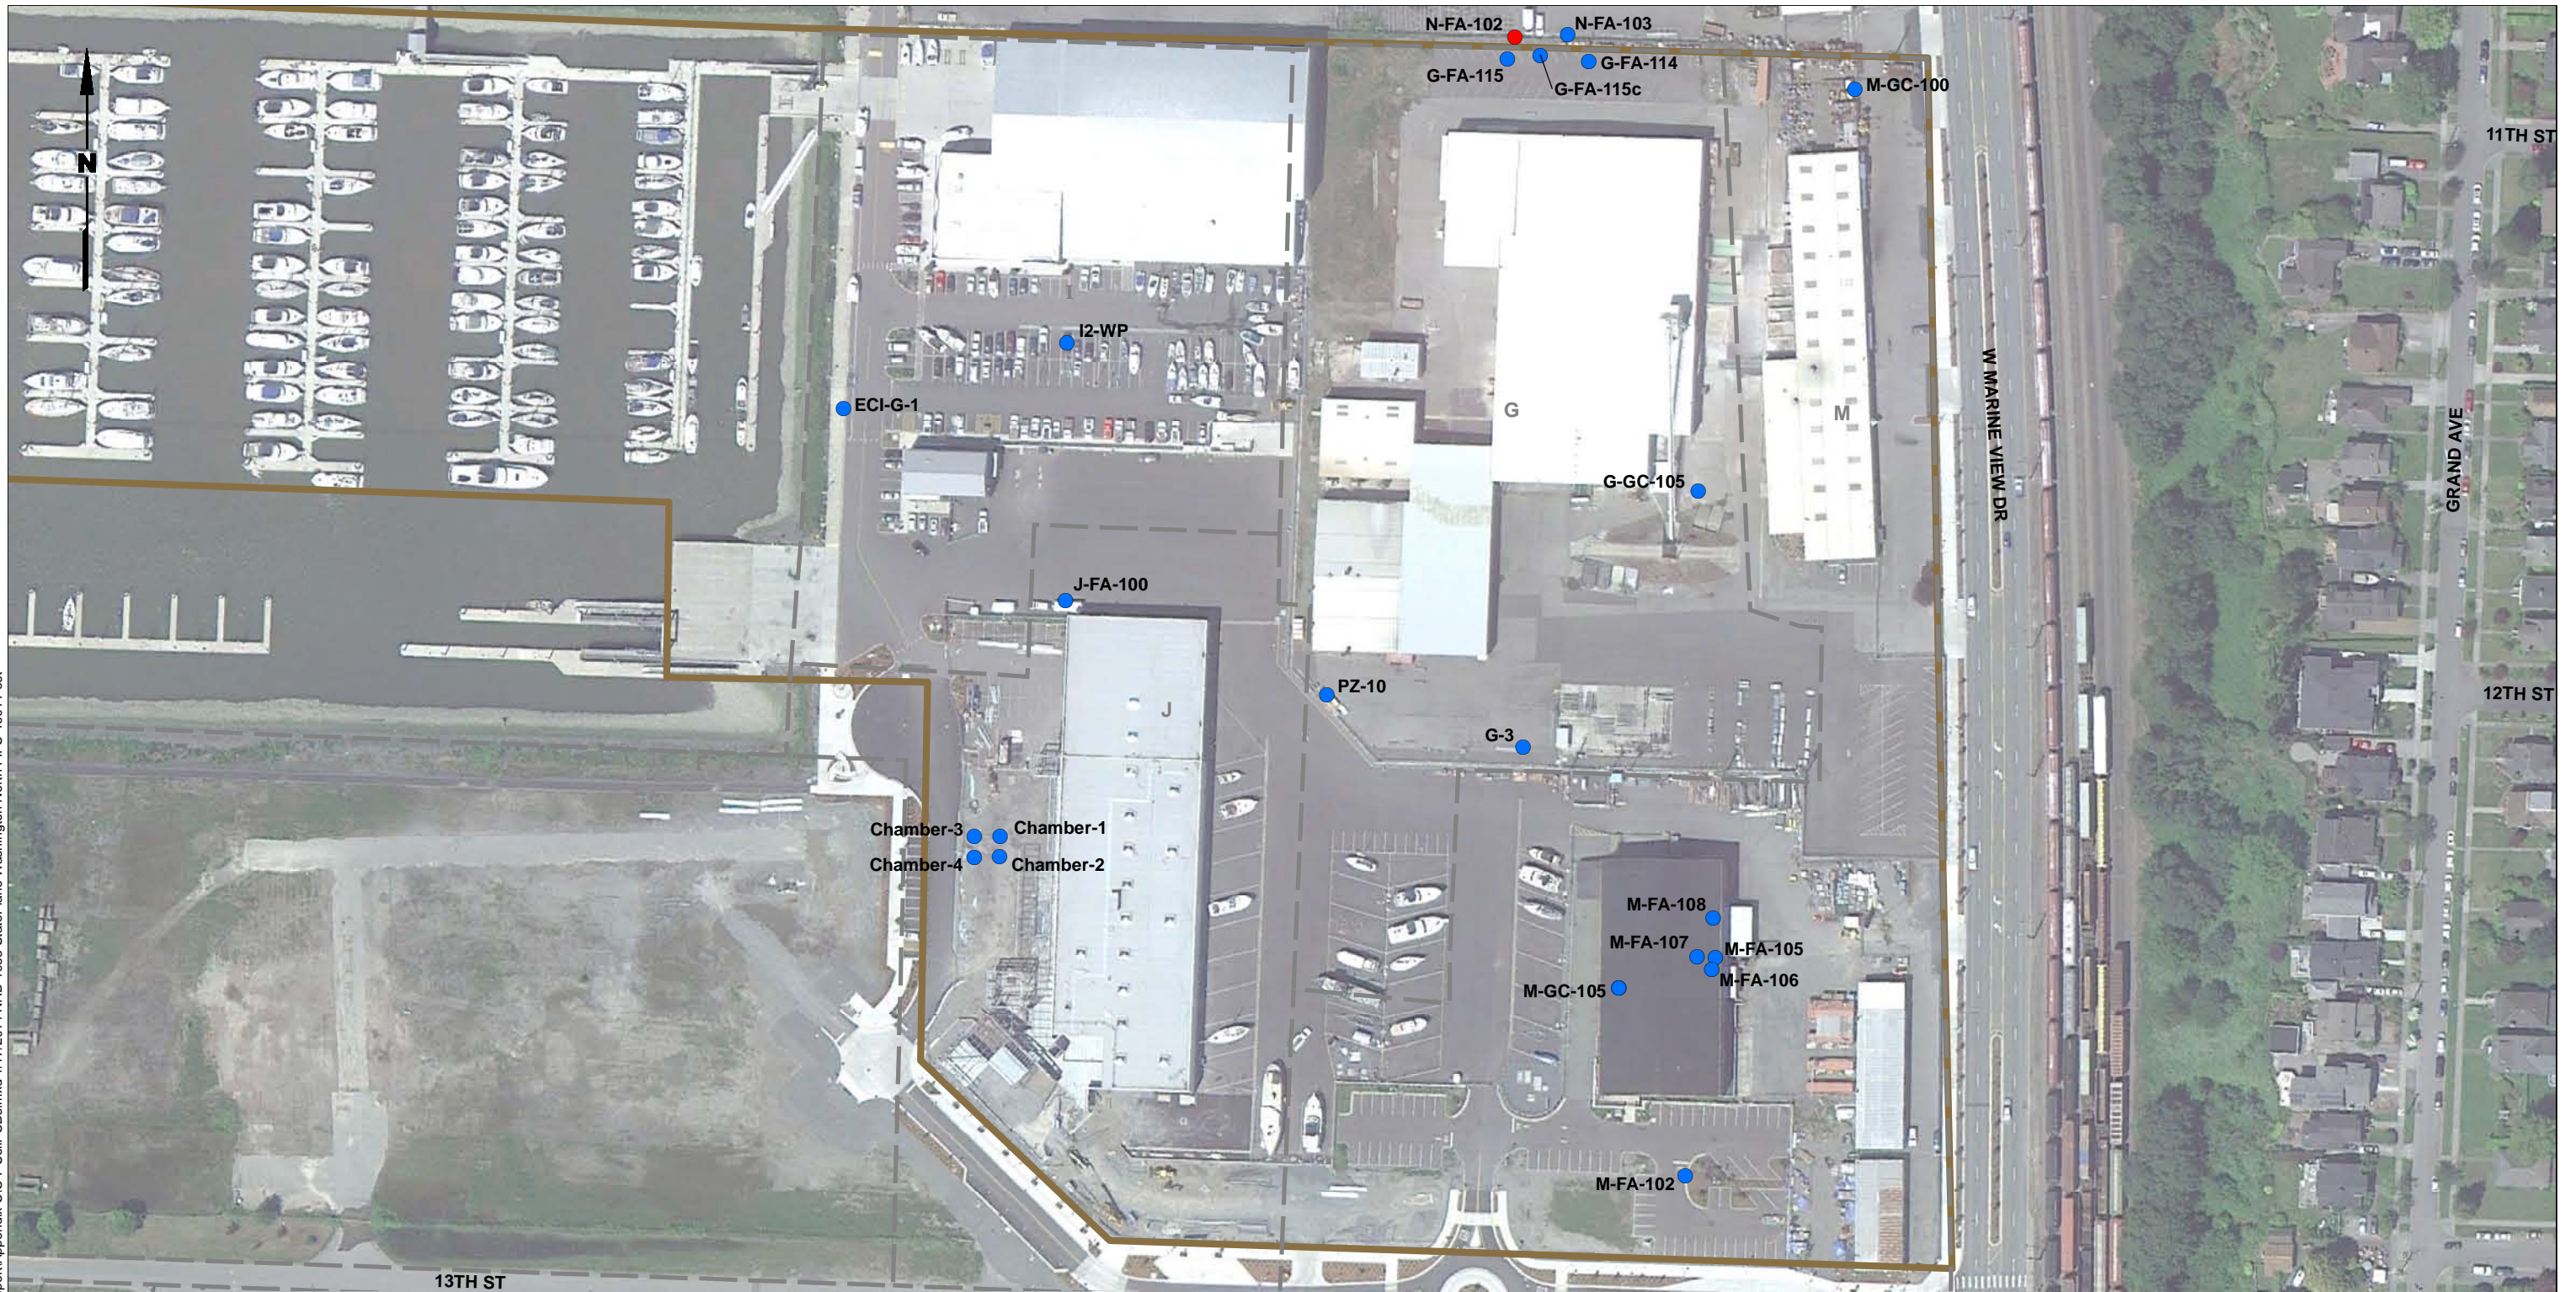
G:\Projects\147029\500\640\2012 RIFS Report\Appendix C\C-7 SoilPCBs.mxd 1/17/2014 NAD 1983 StatePlane Washington North FIPS 4601 Feet

- Soil Sample Exceeds Cleanup Screening Level for PCBs
- Soil Sample Locations Analyzed for PCBs
- G - Area Designation
- Approximate North Marina Ameron/Hulbert Site Boundary

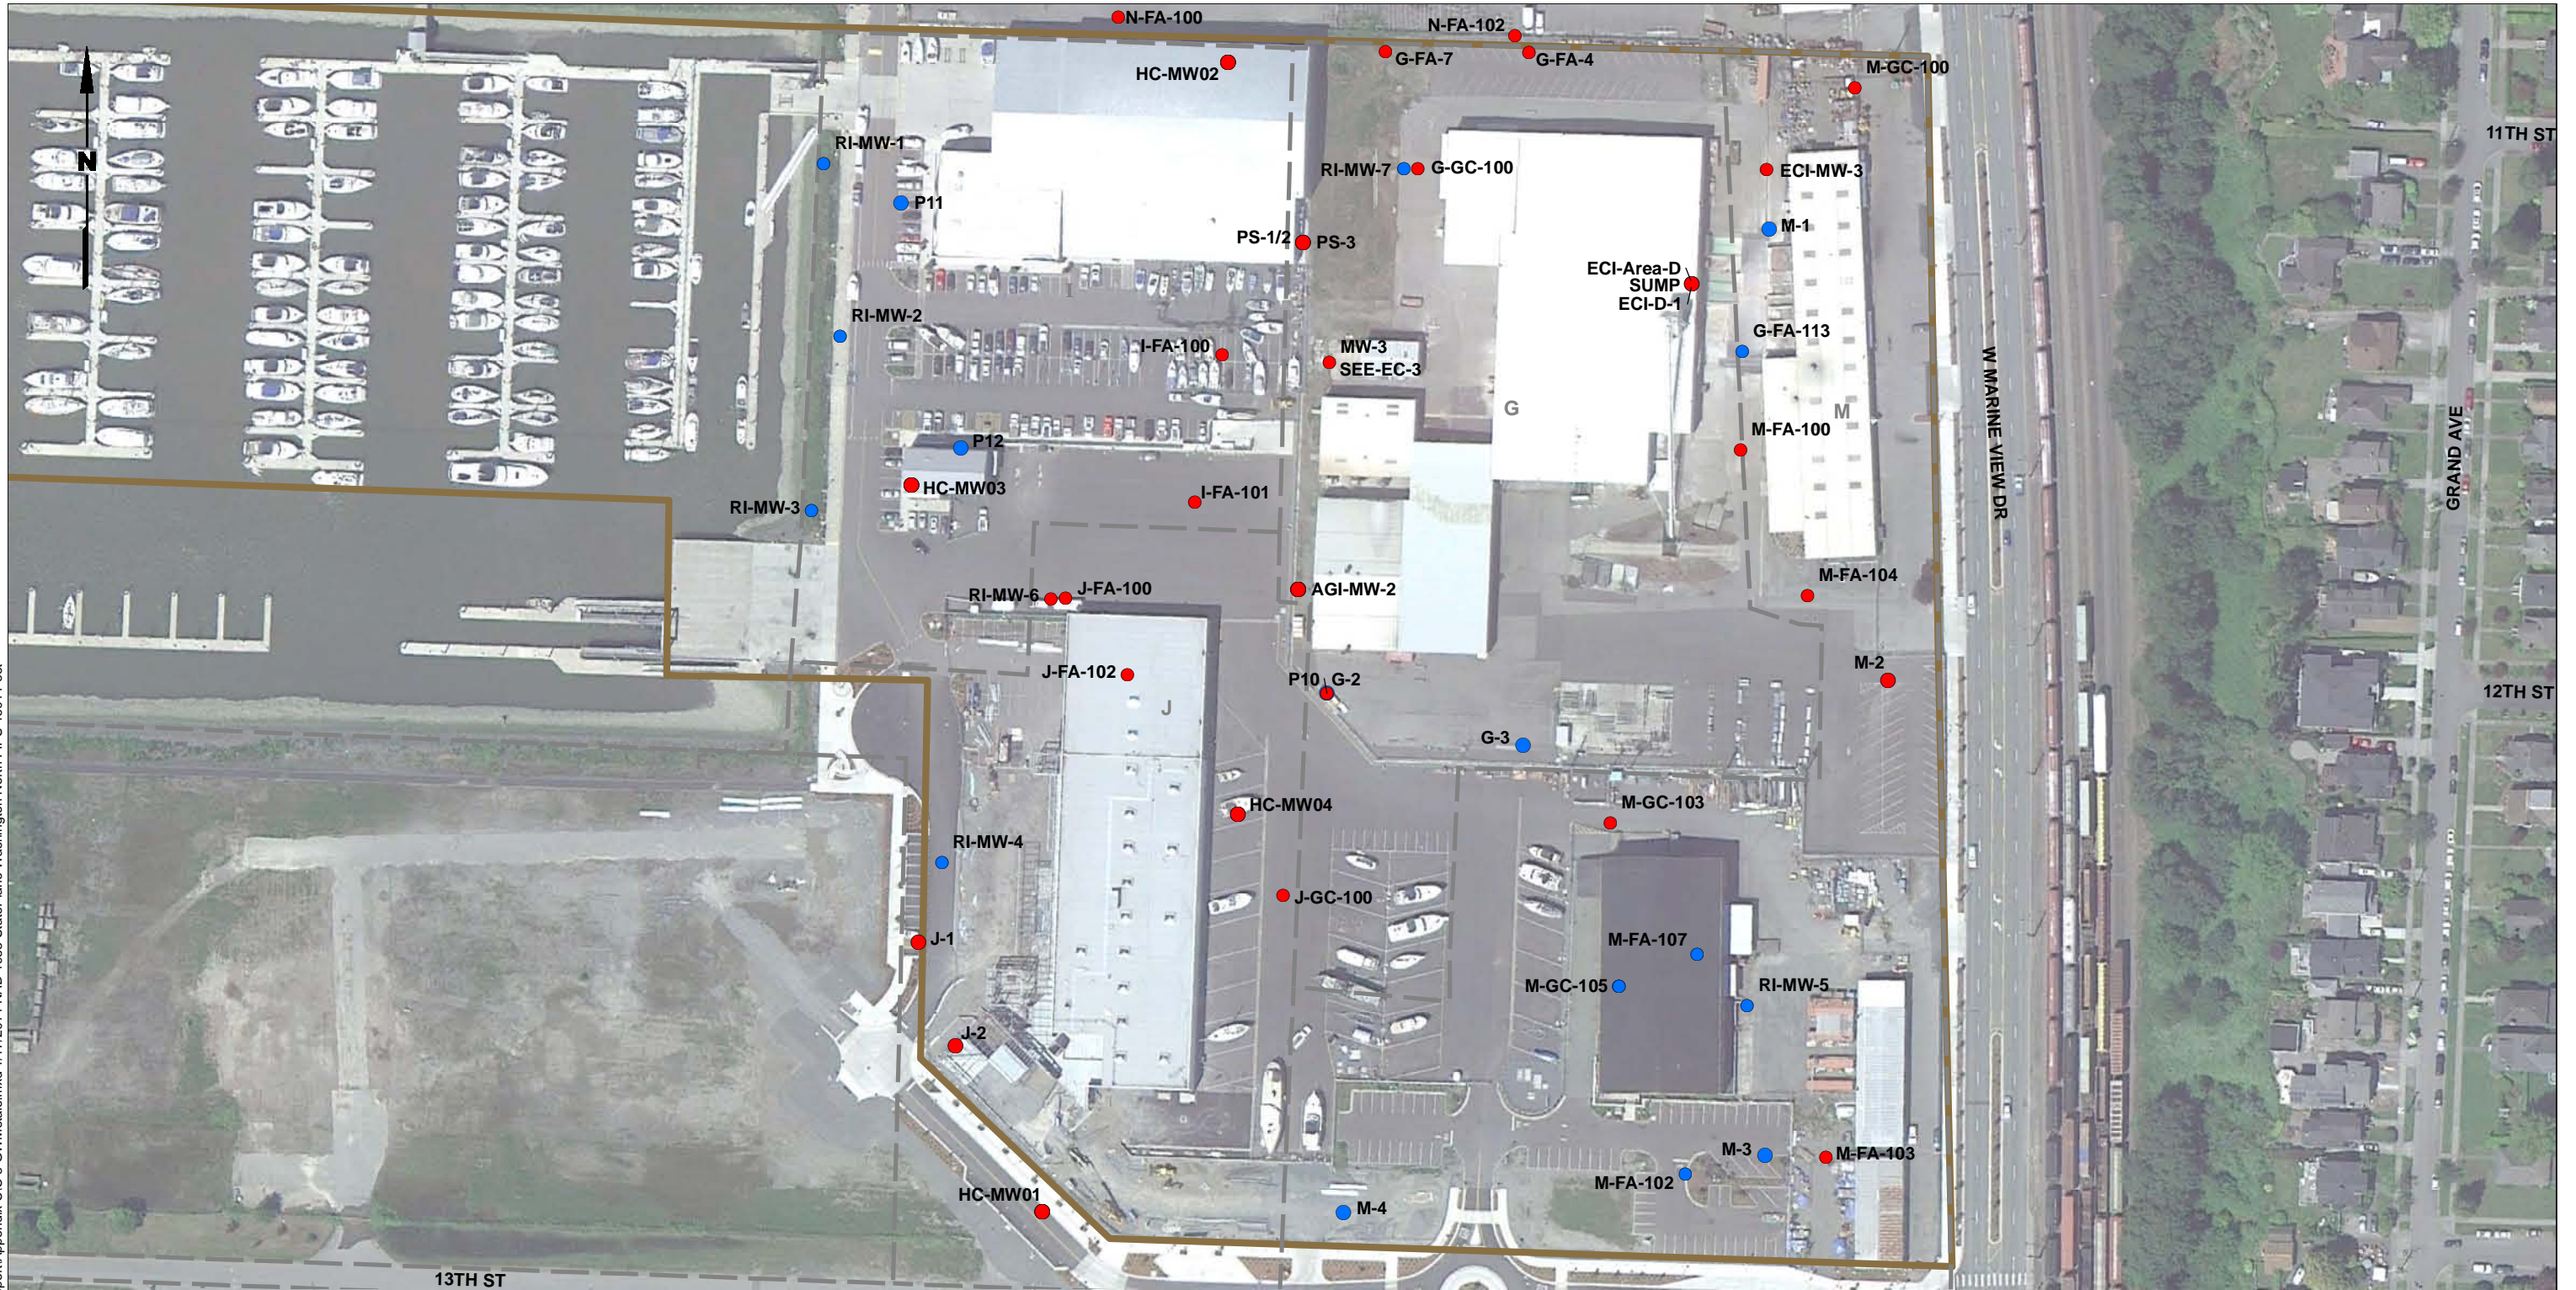
G:\Projects\147029\500\640\2012 RIFS Report\Appendix C\C-8 GWMetals.mxd 1/17/2014 NAD 1983 StatePlane Washington North FIPS 4601 Feet

- Groundwater Sample Exceeds Cleanup Screening Level for Metals
- Groundwater Sample Locations Analyzed for Metals
- G G - Area Designation
- Approximate North Marina Ameron/Hulbert Site Boundary

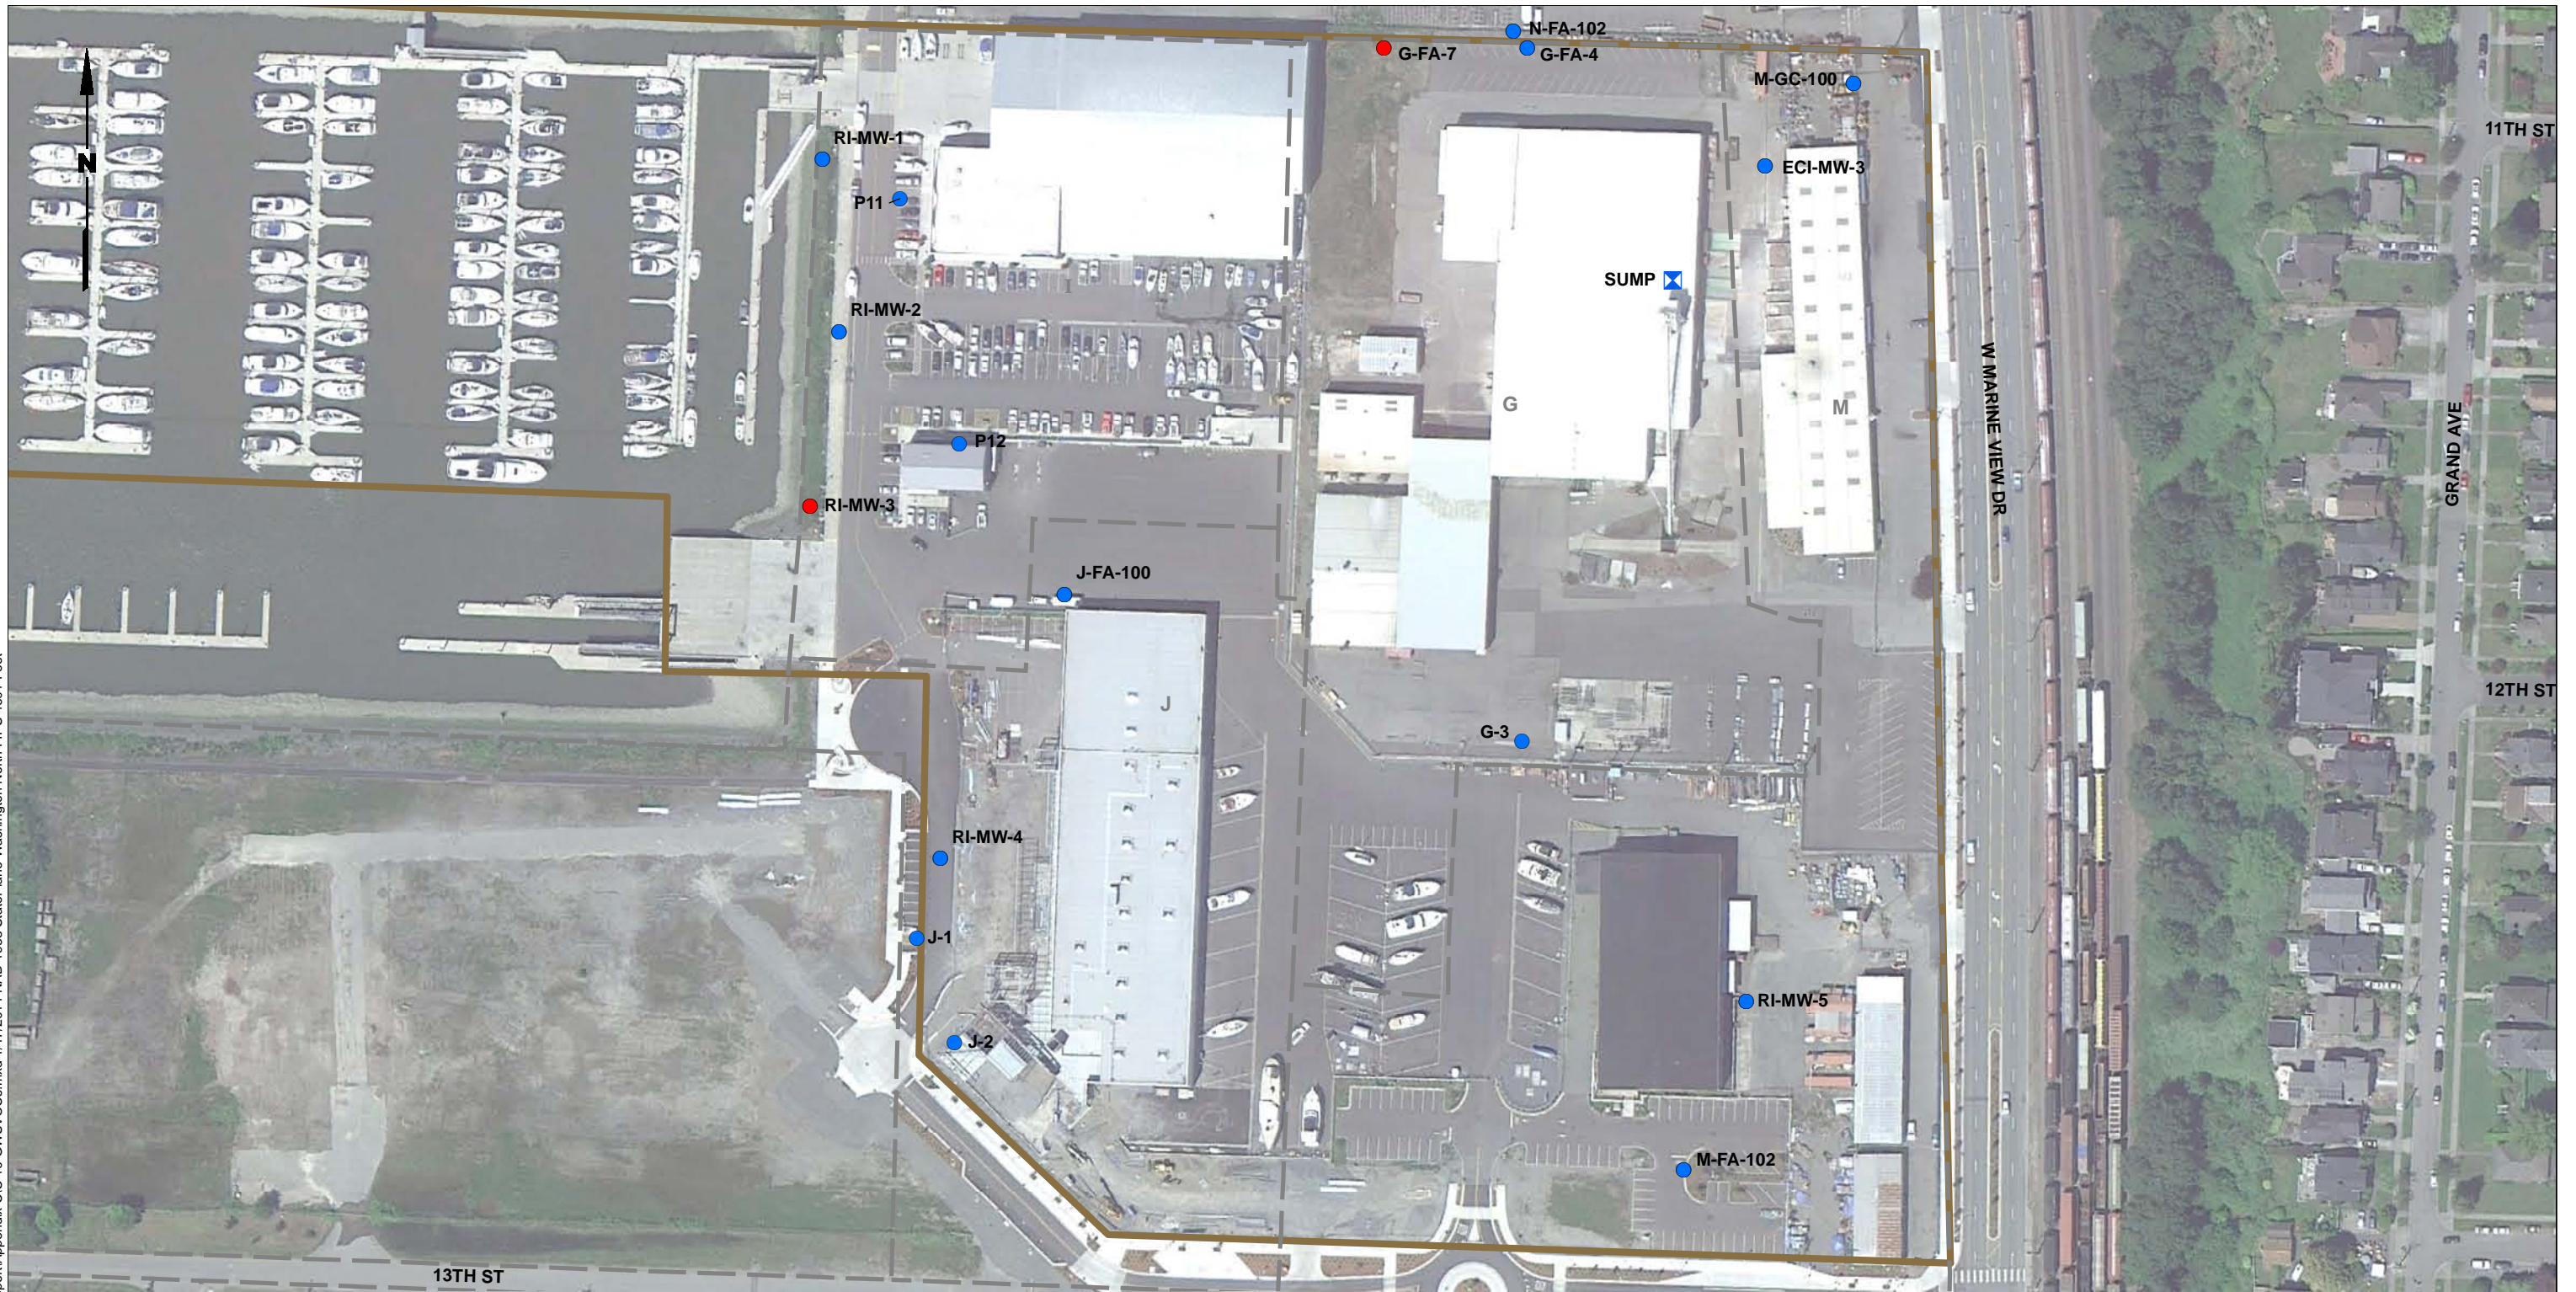
G:\Projects\147029\500640\2012 RIFS Report\Appendix C\C-10 GWSVOCs.mxd 1/17/2014 NAD 1983 StatePlane Washington North FIPS 4601 Feet

- Groundwater Sample Exceeds Cleanup Screening Level for SVOCs
- Groundwater Sample Locations Analyzed for SVOCs
- G - Area Designation
- Approximate North Marina Ameron/Hulbert Site Boundary

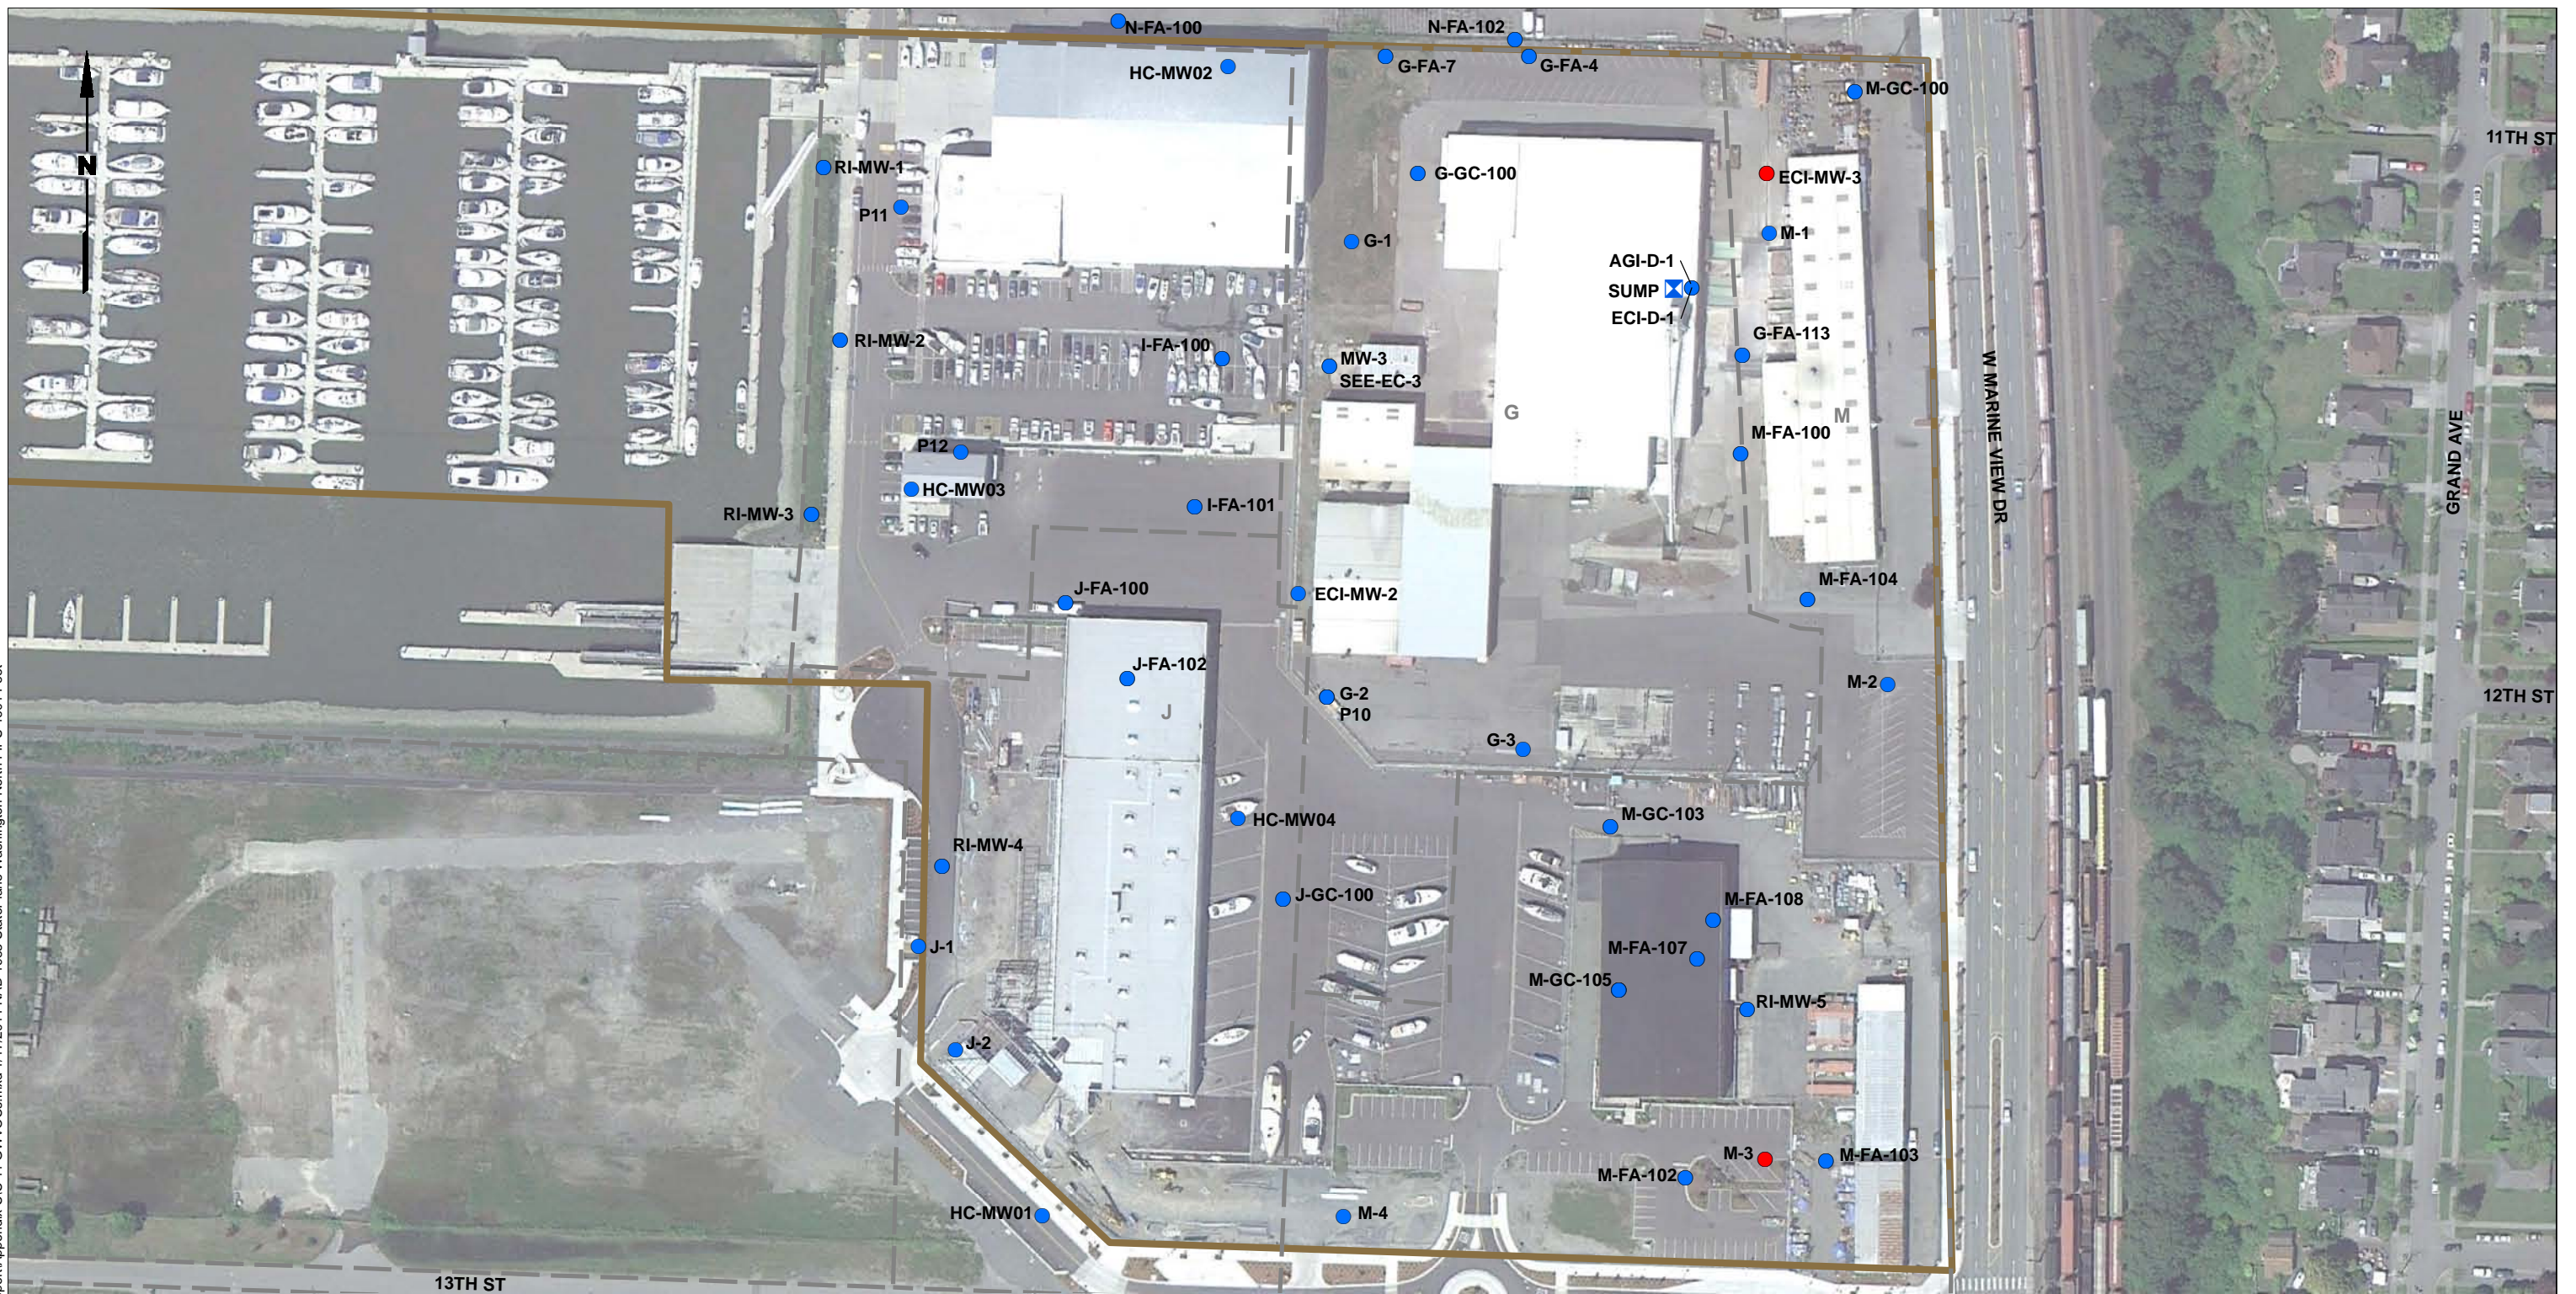
G:\Projects\147029\500\640\2012 RIFS Report\Appendix C\C-11 GWVOCs.mxd 1/17/2014 NAD 1983 StatePlane Washington North FIPS 4601 Feet

- Groundwater Sample Exceeds Cleanup Screening Level for VOCs
- Groundwater Sample Locations Analyzed for VOCs
- G G - Area Designation
- Approximate North Marina Ameron/Hulbert Site Boundary

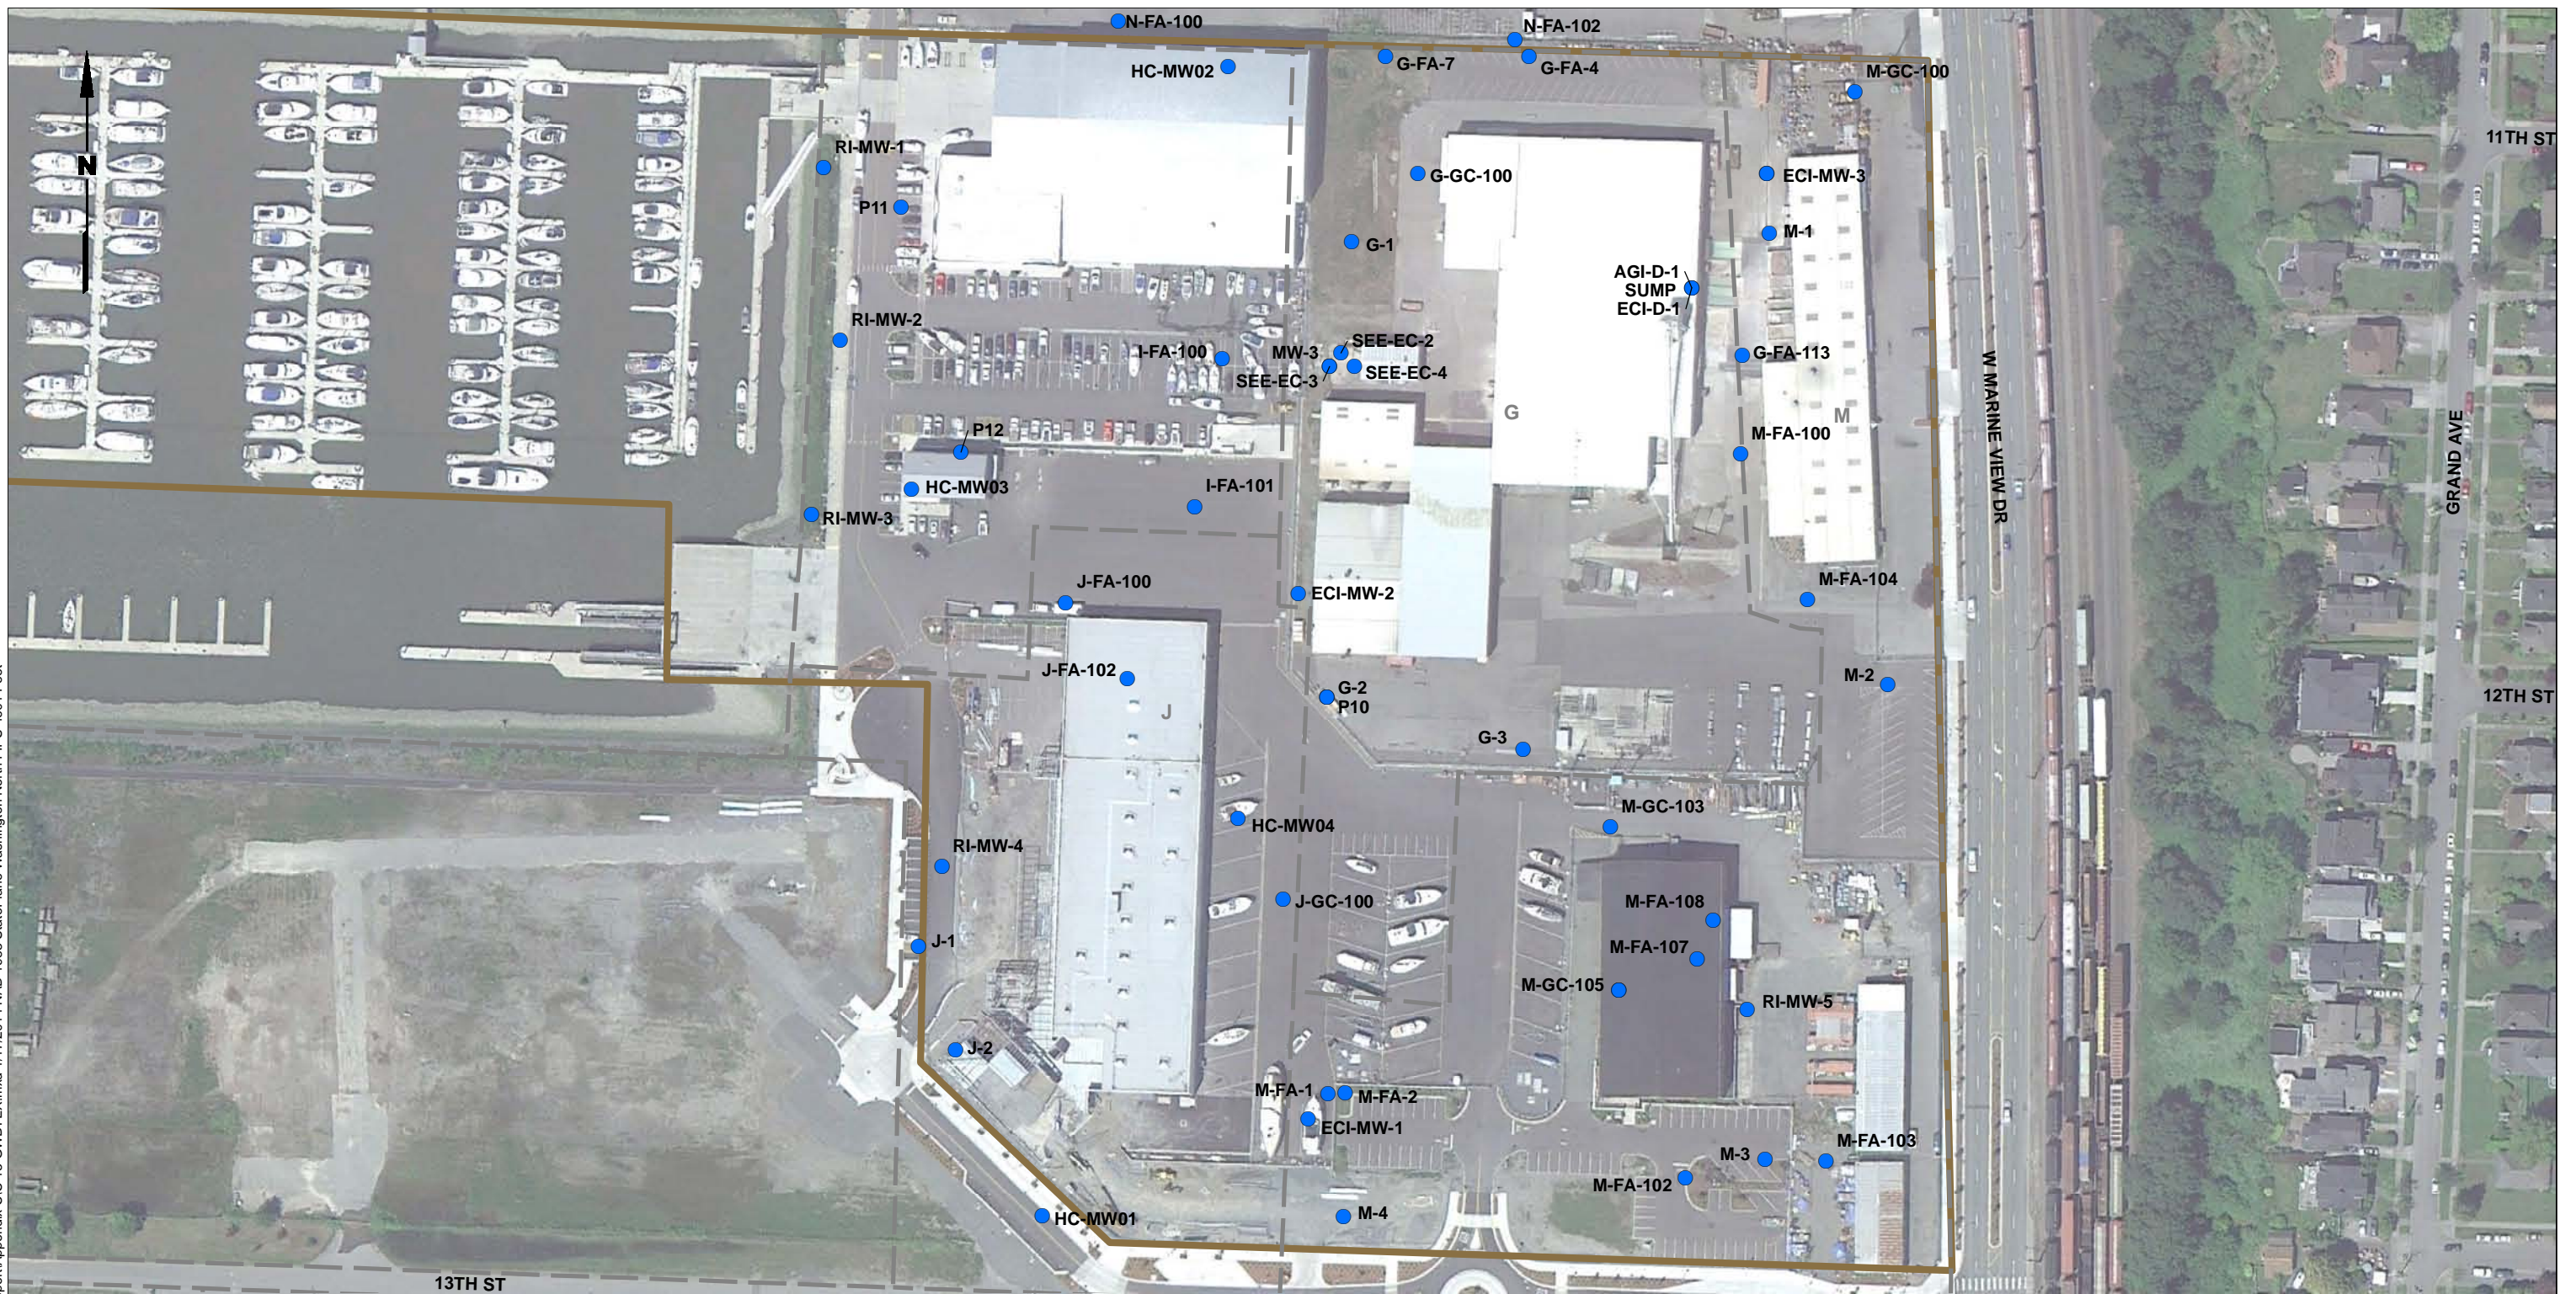
Figure
C-11

- Groundwater Sample Locations Analyzed for BTEX
- G G - Area Designation
- Approximate North Marina Ameron/Hulbert Site Boundary

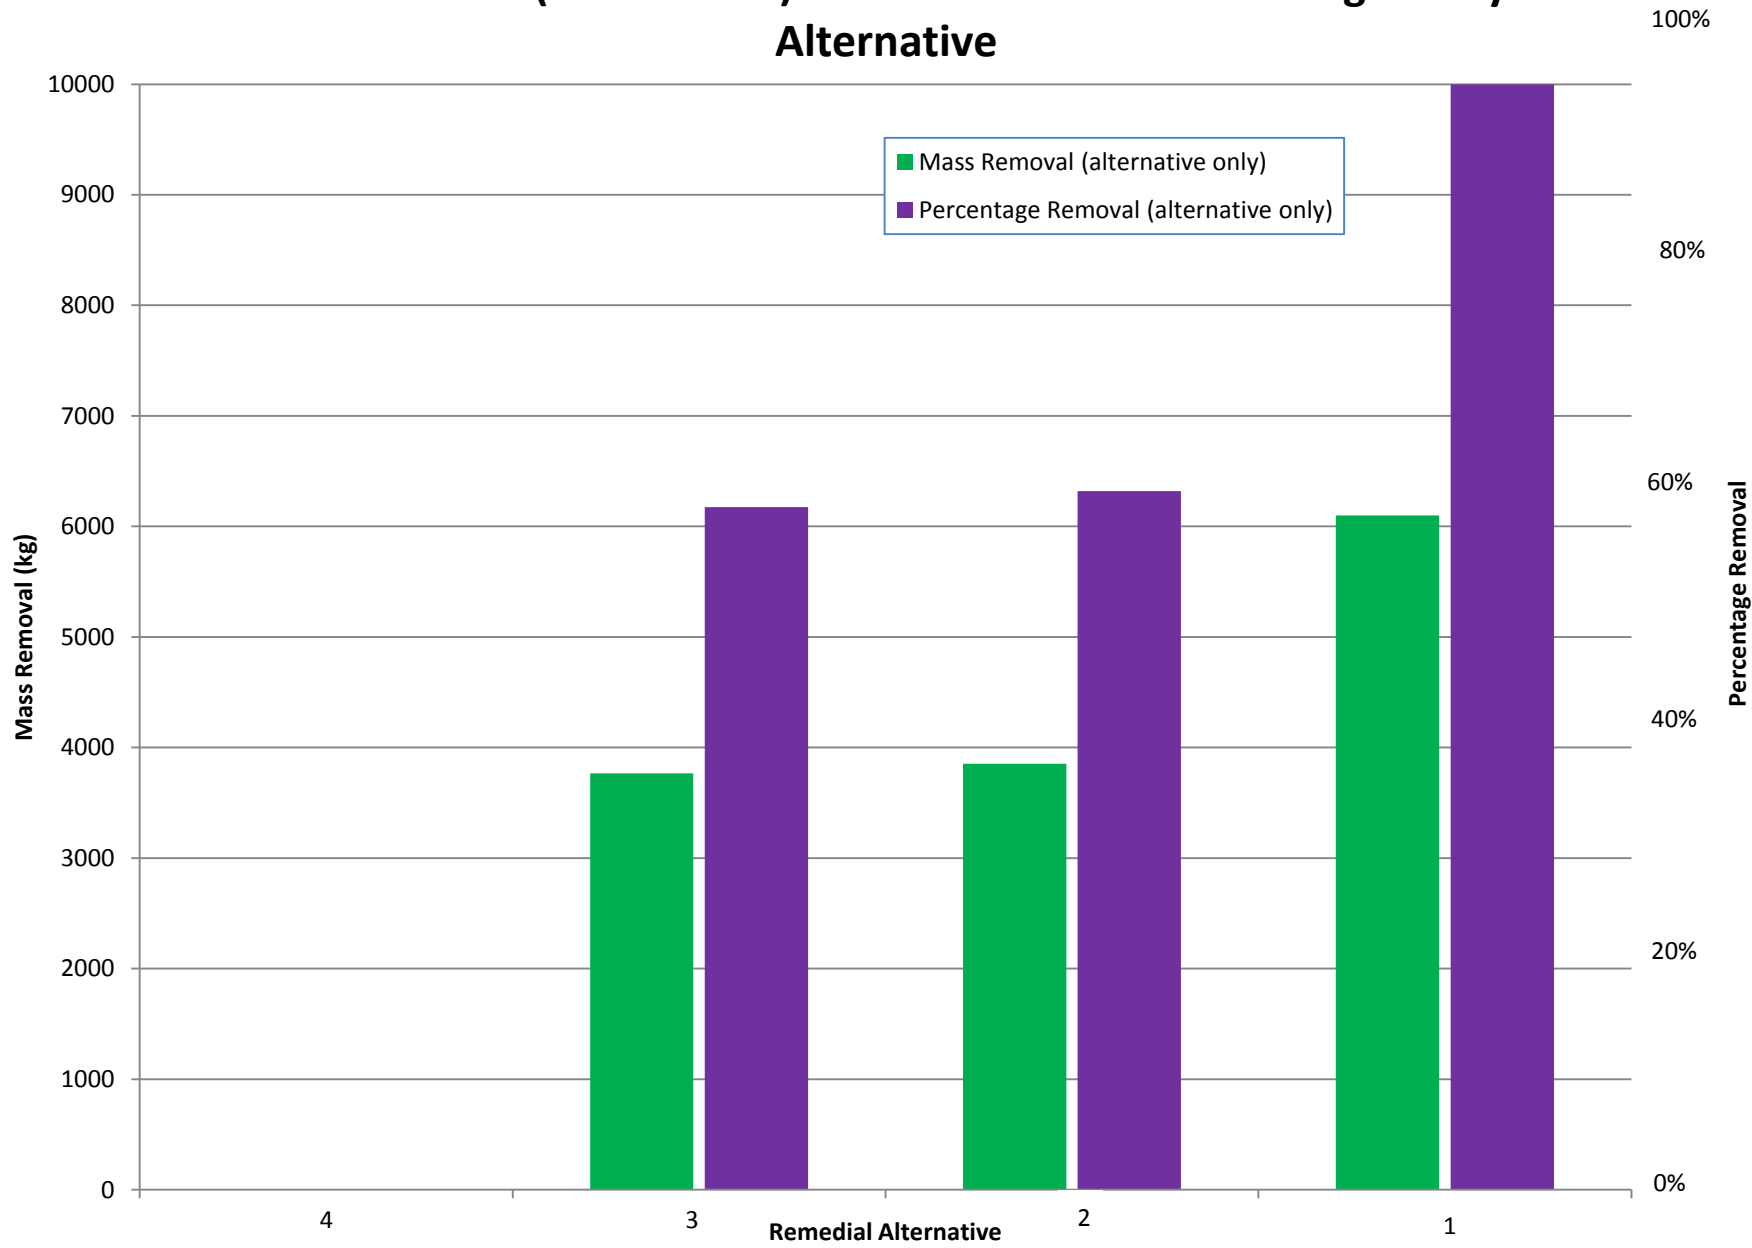
Contaminant (COC Metals) Mass Removal of Remaining Soil by Alternative
