Historical Site Development Analysis
North Marina Ameron/Hulbert Site
Everett, Washington

The North Marina Ameron/Hulbert Site PLP Group

May 11, 2010

**HISTORICAL SITE DEVELOPMENT ANALYSIS
NORTH MARINA AMERON/HULBERT SITE
EVERETT, WASHINGTON
FOR
THE NORTH MARINA AMERON/HULBERT SITE PLP
GROUP**

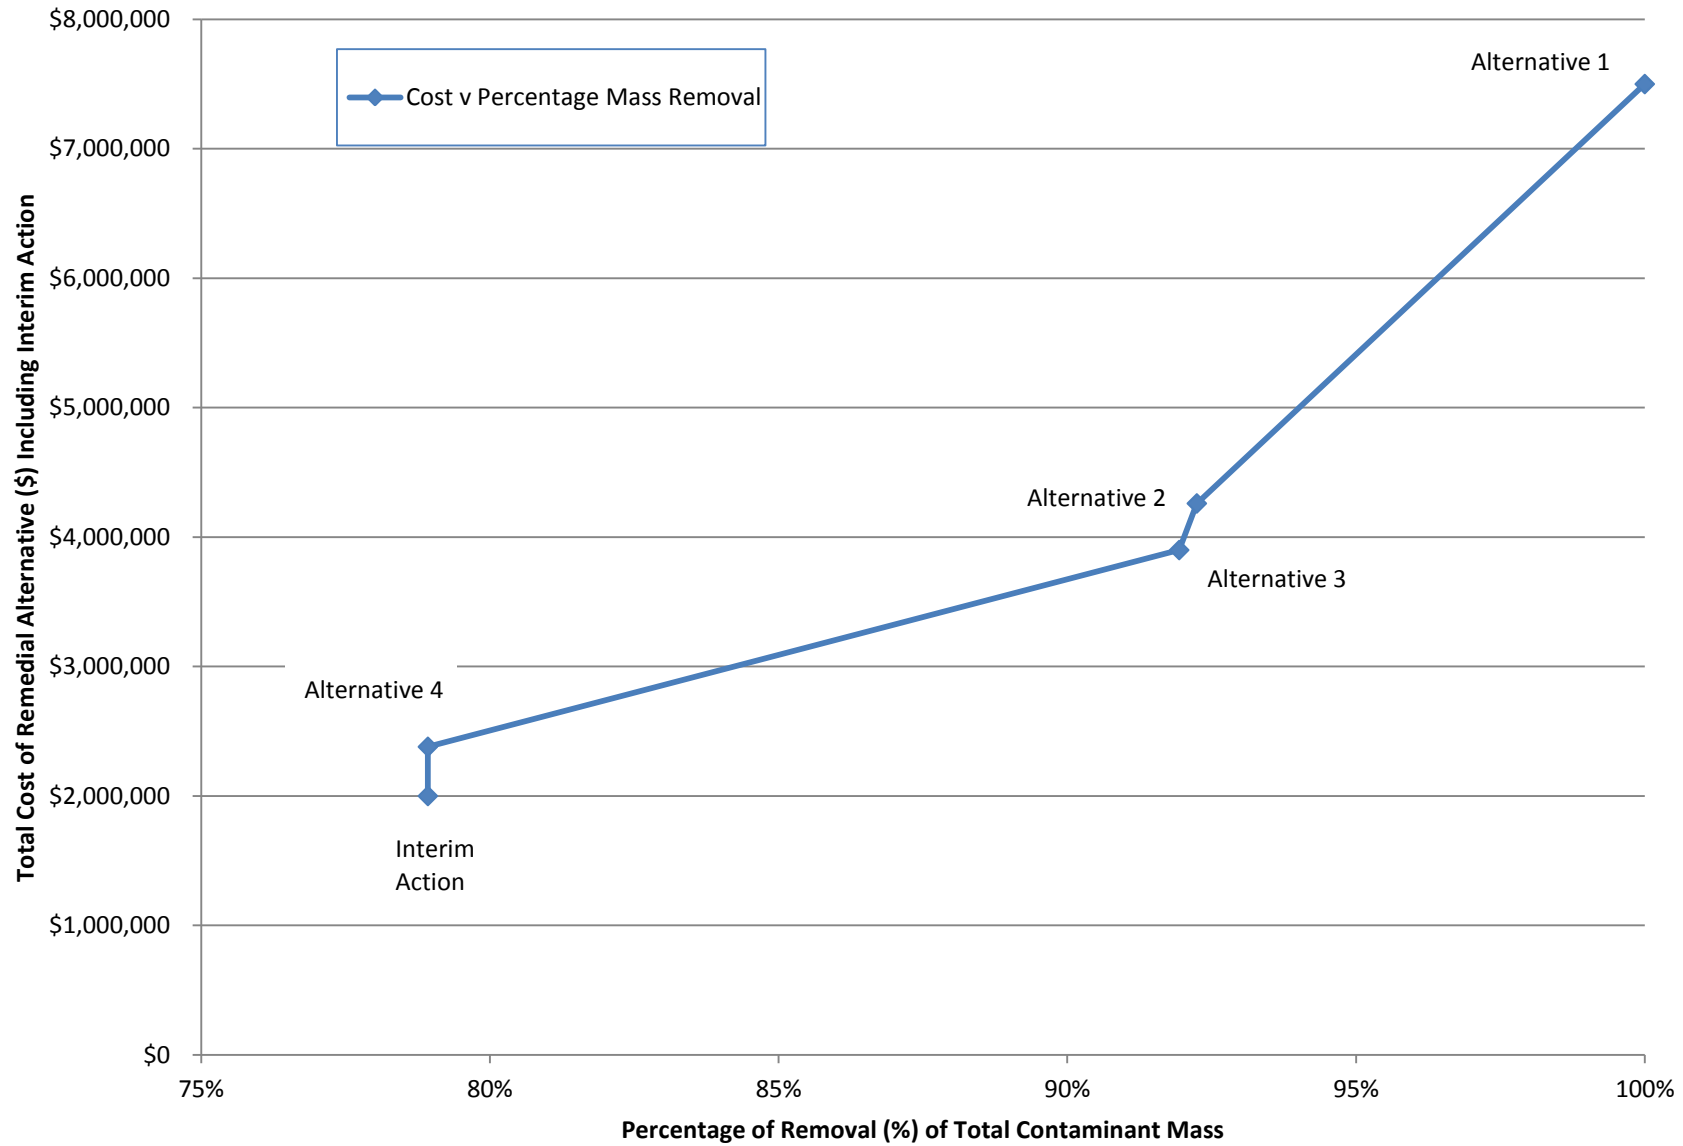
Cost of Remedial Alternatives Compared to Contaminant Mass Removal (Total Mass)
