Interim Action Completion Report

RG Haley Site
Bellingham, Washington

for
City of Bellingham

February 12, 2014

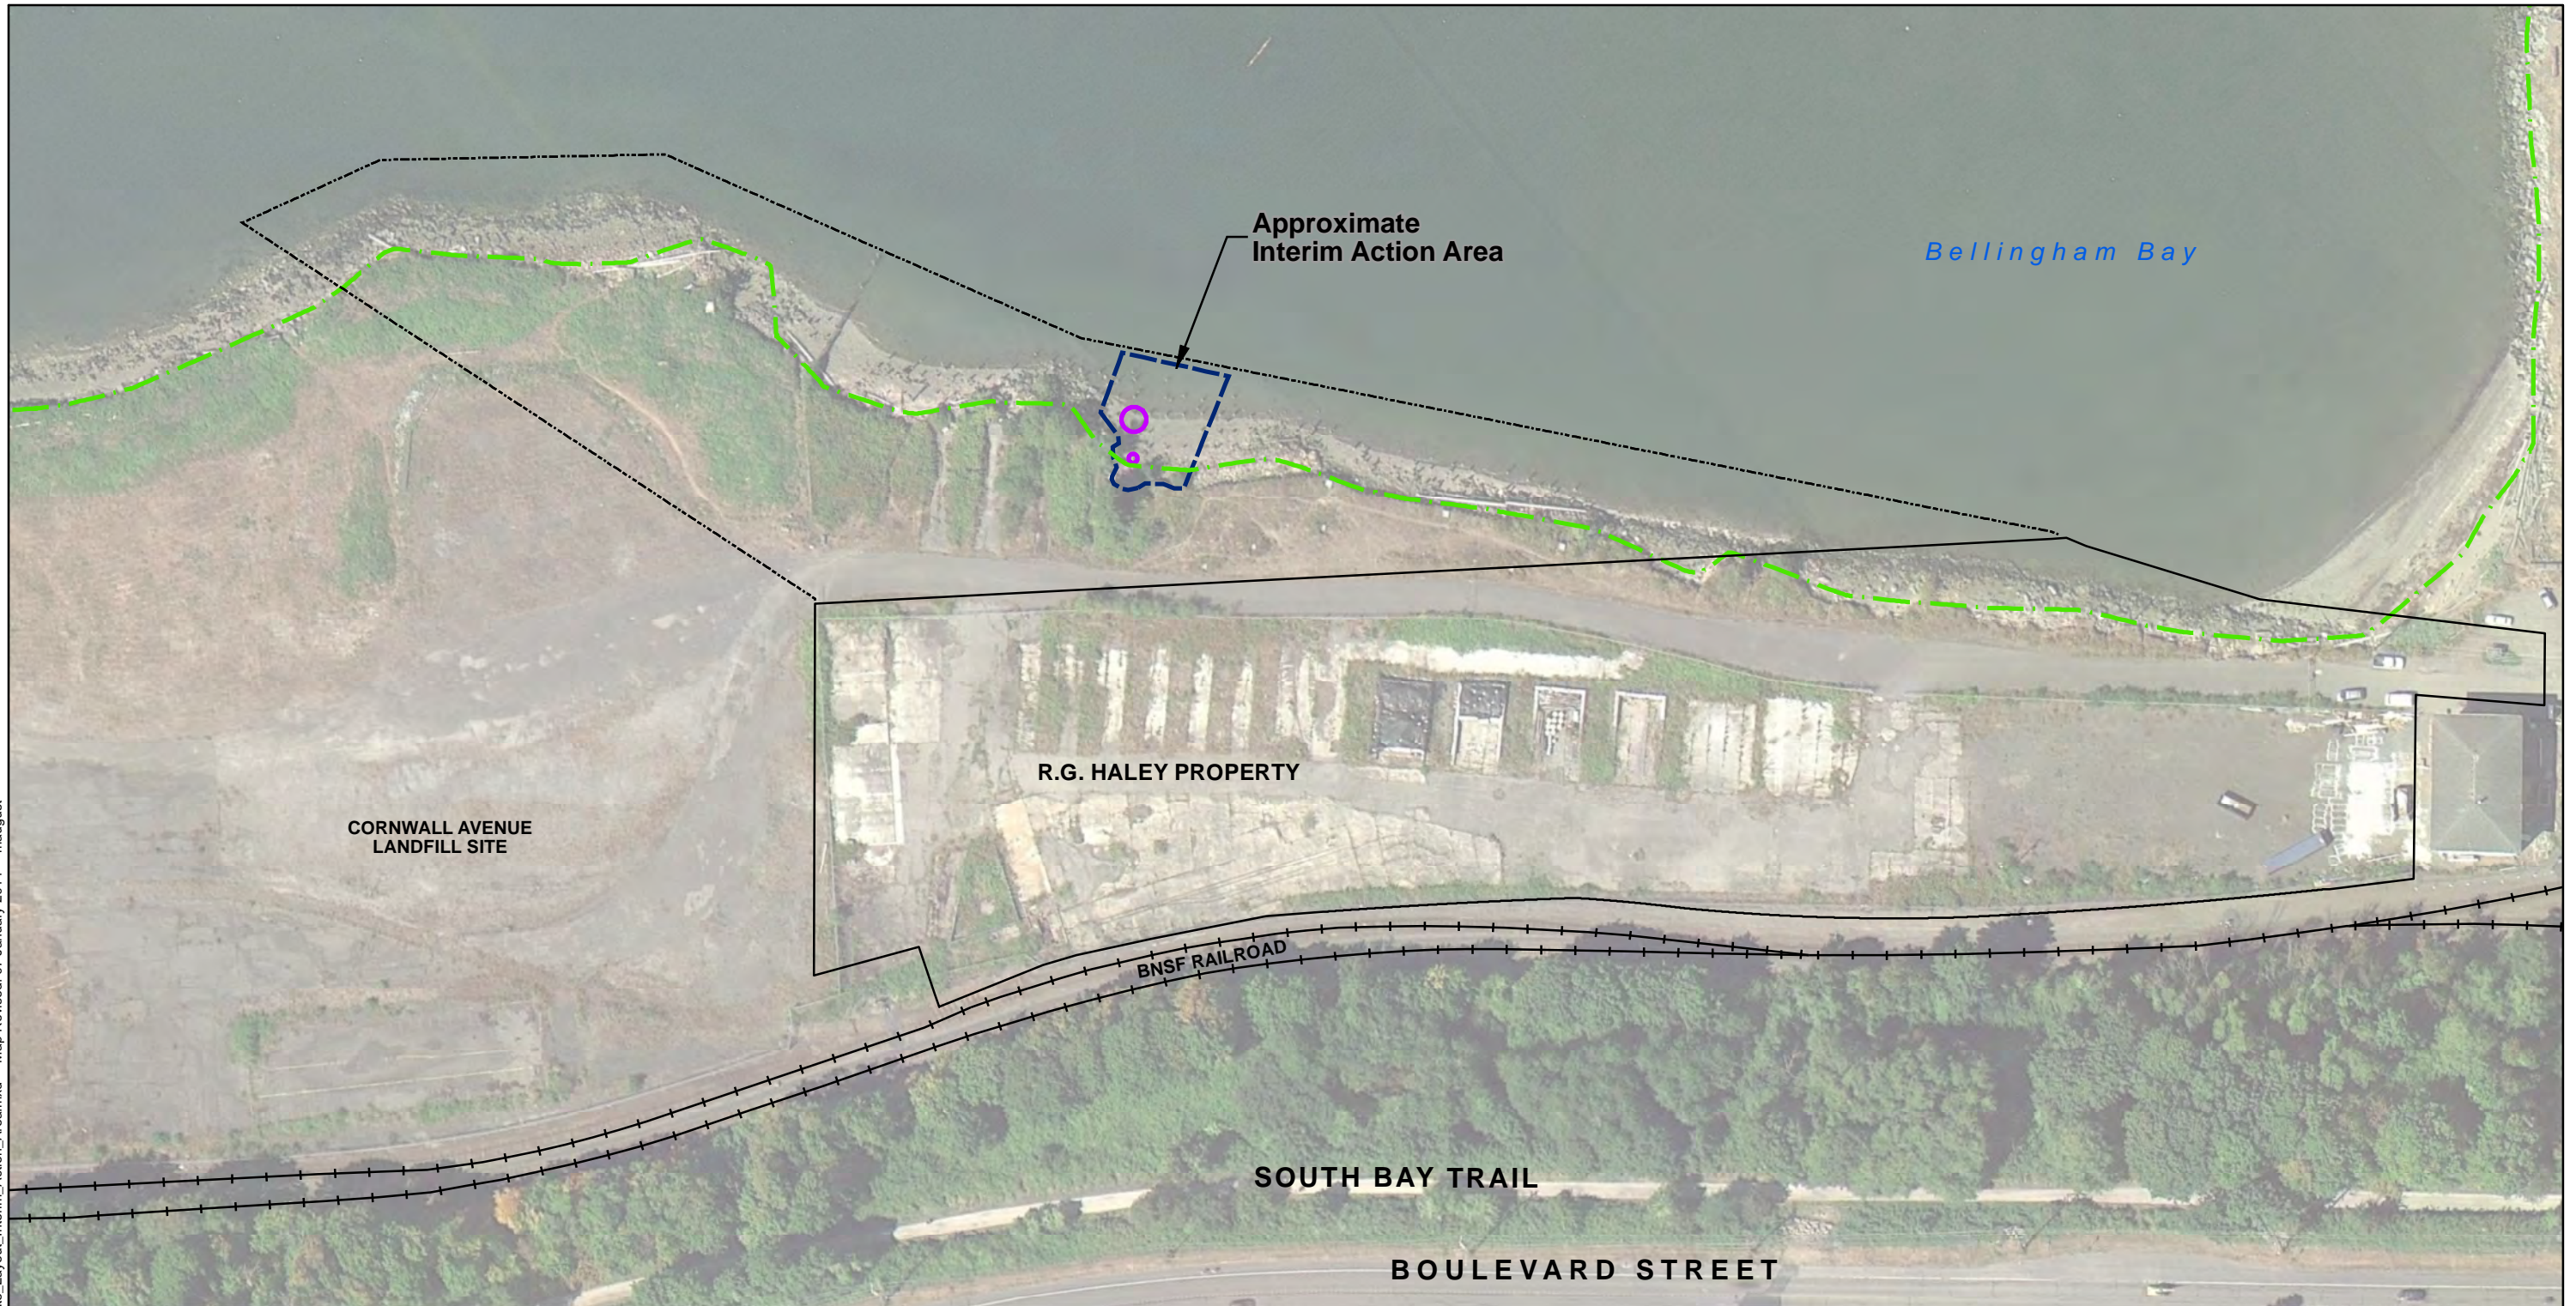
- City Owned, R.G. Haley Property
- - - - - Tideland Lease Area
- - - - - Approximate Boundary of Interim Action Area
- - - - - MHHW (8.04 ft NAVD88)
- Approximate Area with Light Nonaqueous Phase Liquid (LNAPL) Emerging from Sediment (Observed in 2012/2013 prior to Interim Action)

IA construction activities were completed as specified in the Ecology approved Interim Action Work Plan (Work Plan; GeoEngineers, 2013). The purpose of the IA is to contain light nonaqueous phase liquid (LNAPL) petroleum hydrocarbons observed to be emerging from the southern¹ portion of the Site shoreline while the City completes a Remedial Investigation and Feasibility Study (RI/FS) to select a final cleanup action for the Site including the IA area. Locations of LNAPL emergence and the IA area are shown relative to the Site on Figure 2.

Observations made on December 12, 2012 as part of City's quarterly monitoring activities indicated the presence of LNAPL sheen on surface water adjacent to the shoreline on the southern portion of the Site. A containment boom and oil-sorbent materials were deployed and maintained at the Site to contain the sheen and capture LNAPL prior to implementation of the IA. Approximate areas where LNAPL was observed to emerge from sediment are shown on Figure 2. Regular monitoring performed prior to the IA identified the intermittent occurrence of LNAPL sheen on surface water in the general areas shown on Figure 2 between December 2012 and March 2013.

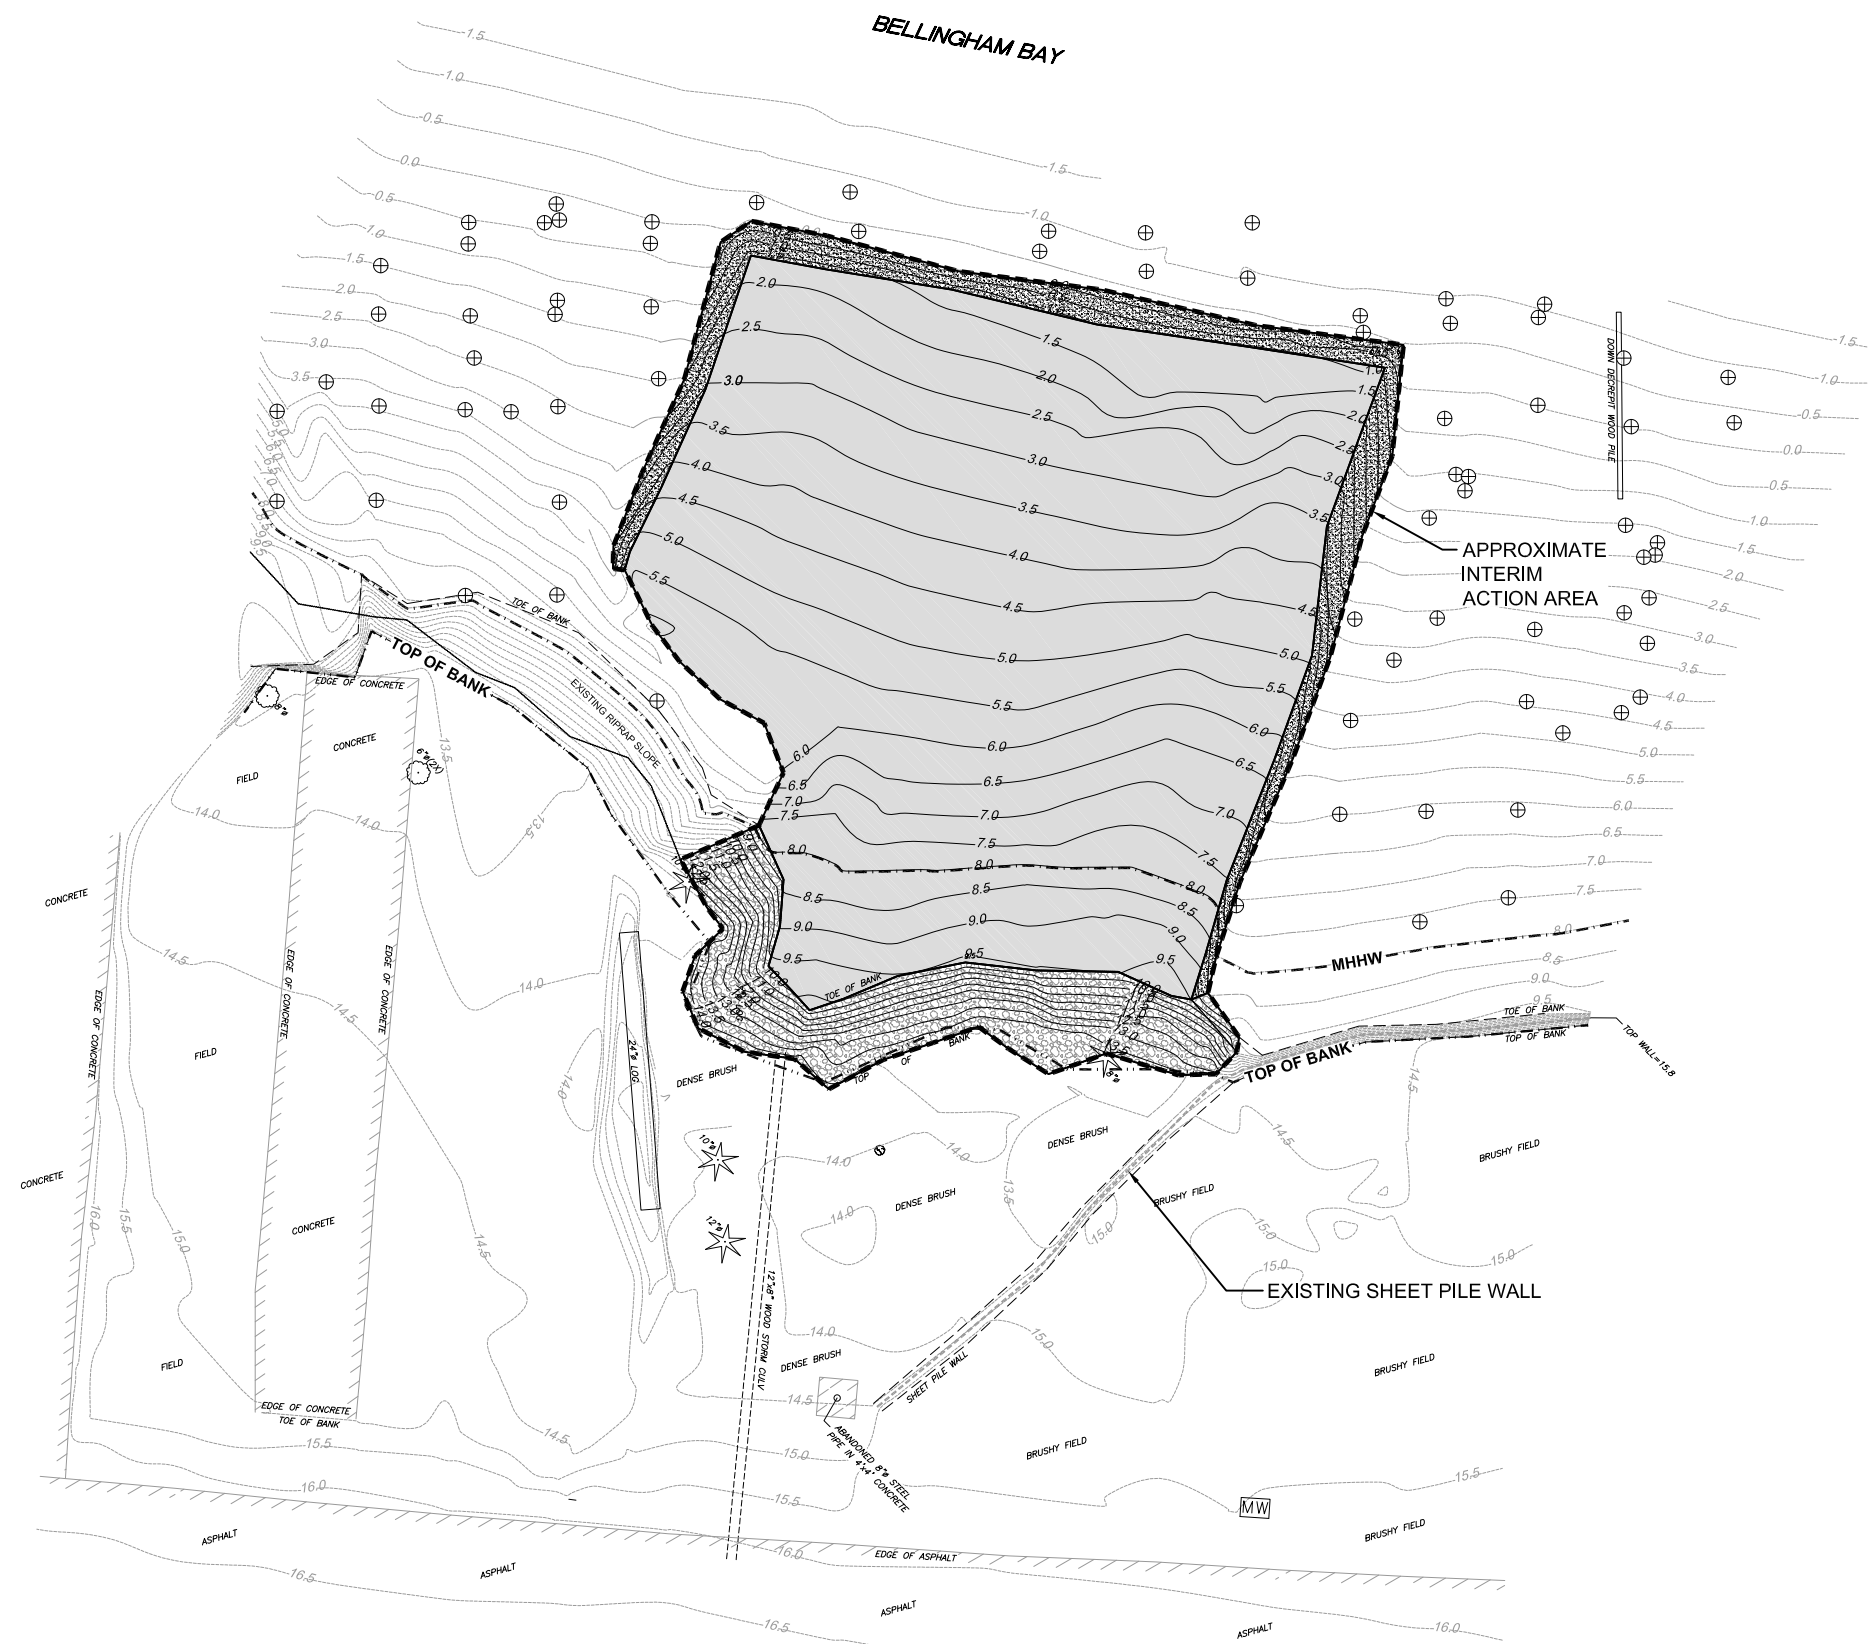
- TOP OF BANK---
- - - - -MHHW - - - - -
- 4.0
- 4.0
- APPROXIMATE INTERIM ACTION AREA
- APPROXIMATE LIMITS OF CONTAINMENT BERM (SEE FIGURE 6 FOR TYPICAL DETAIL)
- APPROXIMATE LIMITS OF SEDIMENT CAP (SEE FIGURE 6 FOR TYPICAL DETAIL)
- APPROXIMATE LIMITS OF RIPRAP (SEE FIGURE 6 FOR TYPICAL DETAIL)
- ⊕ EXISTING DERELICT WOOD PILE
- ⋆ EXISTING FIR TREE WITH DIAMETER (PROTECTED DURING CONSTRUCTION)
- ⊙ EXISTING ALDER TREE WITH DIAMETER (PROTECTED DURING CONSTRUCTION)
- MW EXISTING 4'x4' VAULT (PURPOSE UNKNOWN)

The IA sediment cap consists of approximately 6 inches of fined grained, amended cap material capable of absorbing organic contaminants overlain by approximately 12 inches of cap armor rock consisting of 4-inch to 8-inch angular rock to prevent erosion of the cap. Geotextile fabric was placed on top of the amended cap material prior to placing cap armor rock and was extended approximately 2 feet beyond the north, west and south edges of the amended cap material and beneath the cap containment berm. Containment berm rock consisting of 4-inch to 18-inch angular rock were placed to an approximate height of 18 inches to secure the edges of geotextile fabric as well as the cap armor layer. The geotextile fabric is intended to prevent the loss of fine-grained amended cap material through the interstices of the larger diameter armor and containment berm rock. The approximate limits of the IA sediment cap including limits of amended cap, cap armor and containment berm are shown on Figure 5. Typical details of the cap construction are shown on Figure 6. The as-built survey of the IA cap is provided in Appendix B.

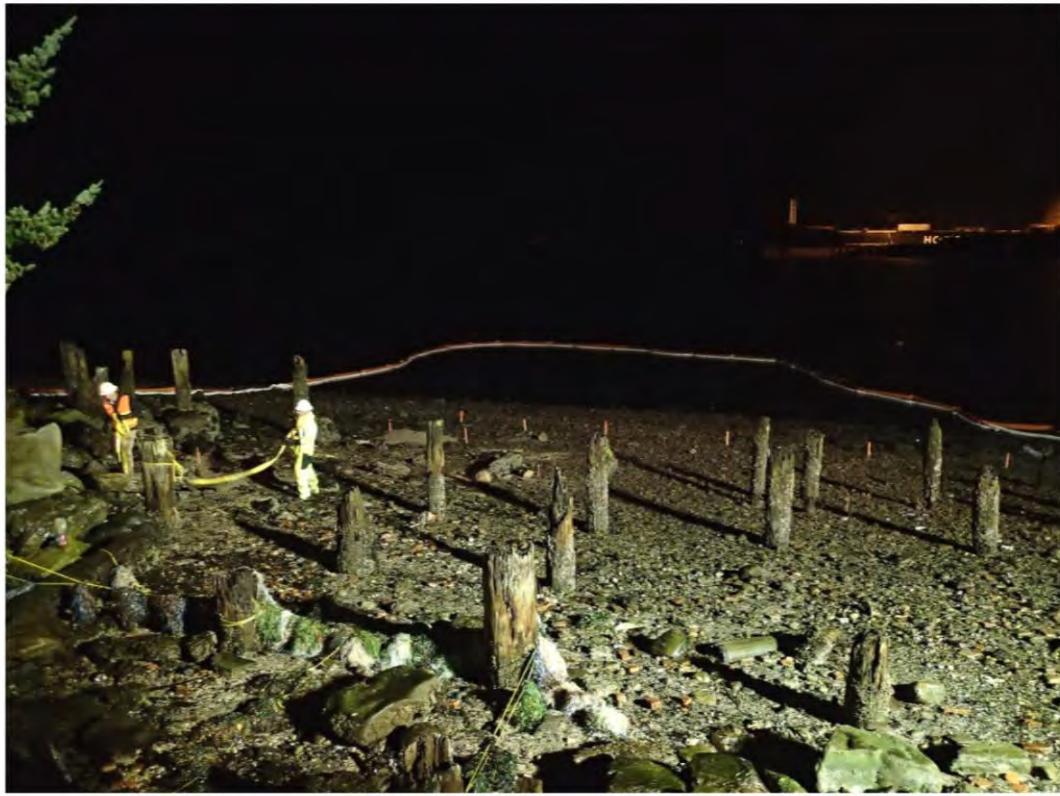
Photo 1: Pre-Construction Condition of the Interim Action Area

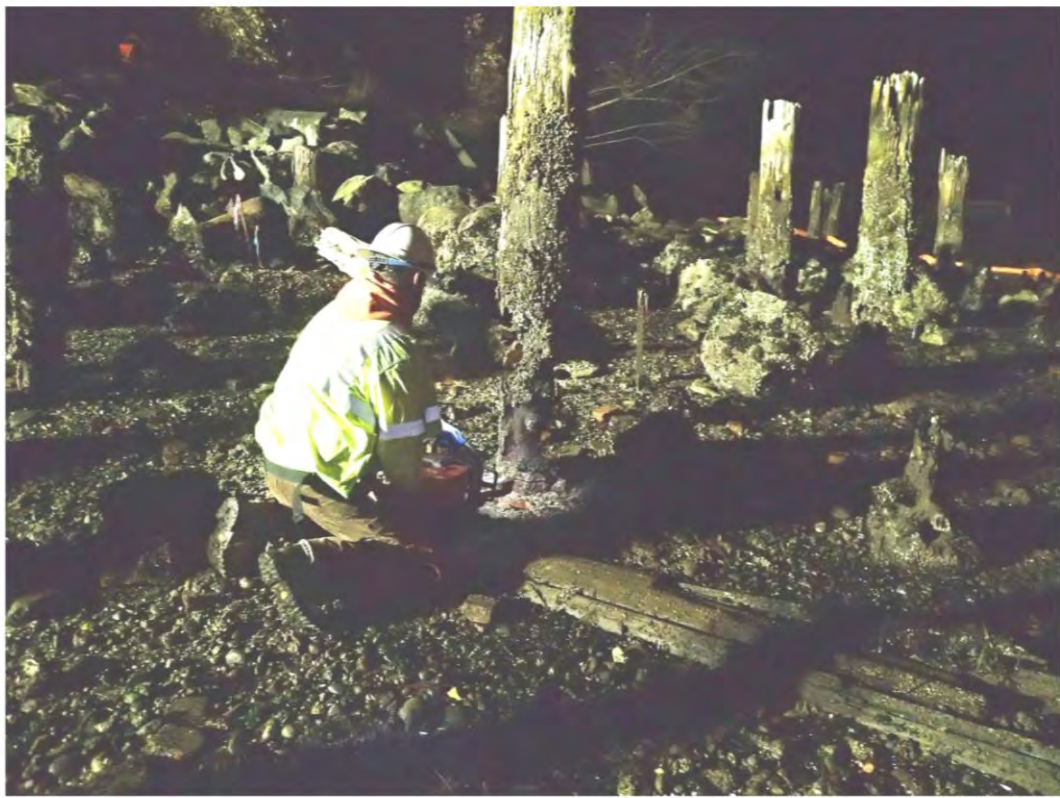
Photo 2: Saw-Cutting of derelict wood piles

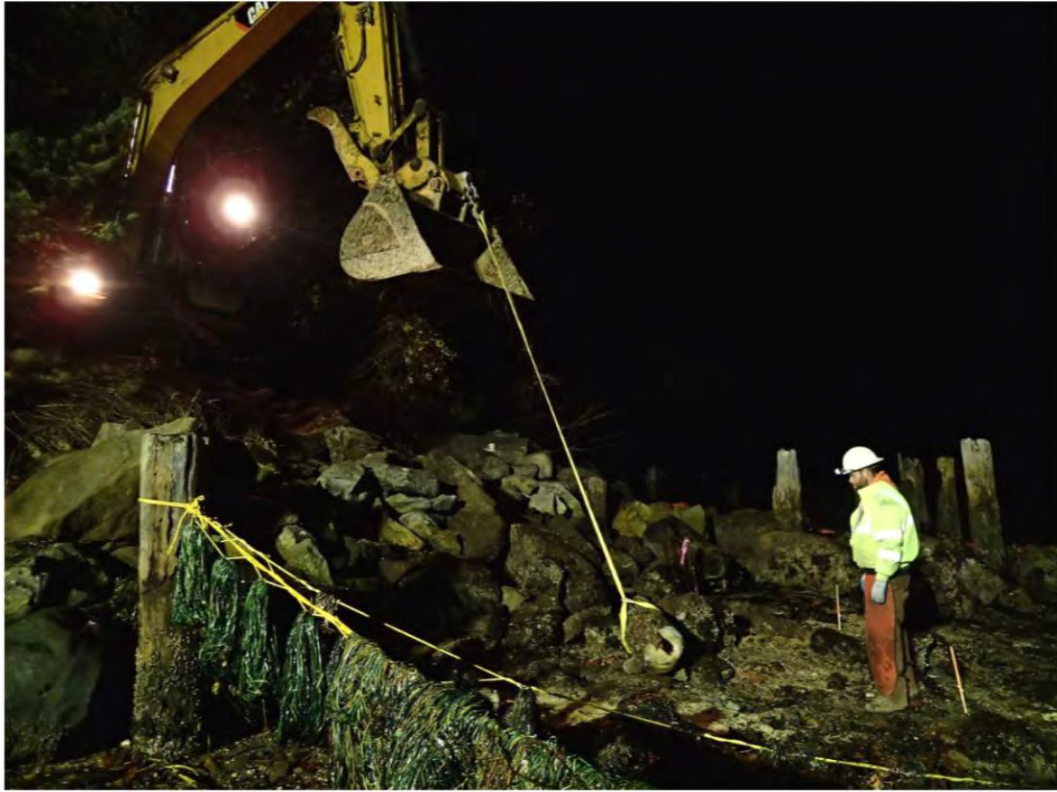
Photo 3: Removal of derelict wood piles from the Interim Action Area to prepare mudline for cap placement

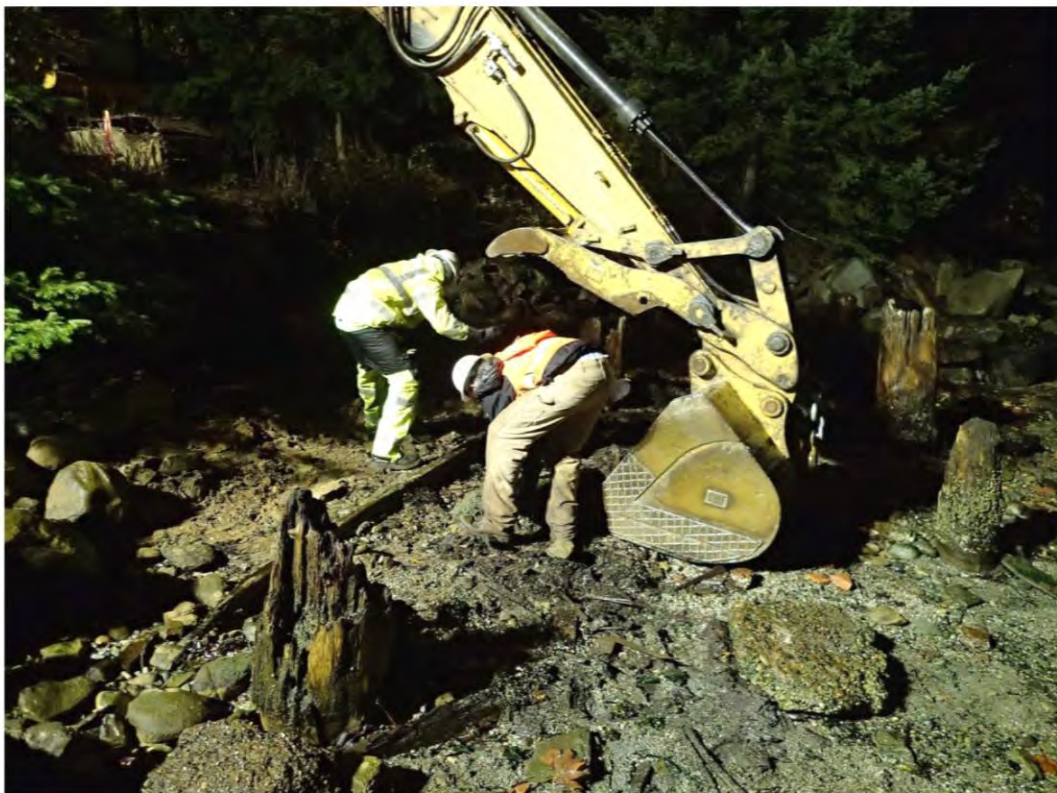
Photo 4: Removal of debris and large rocks from the Interim Action Area to prepare mudline for cap placement

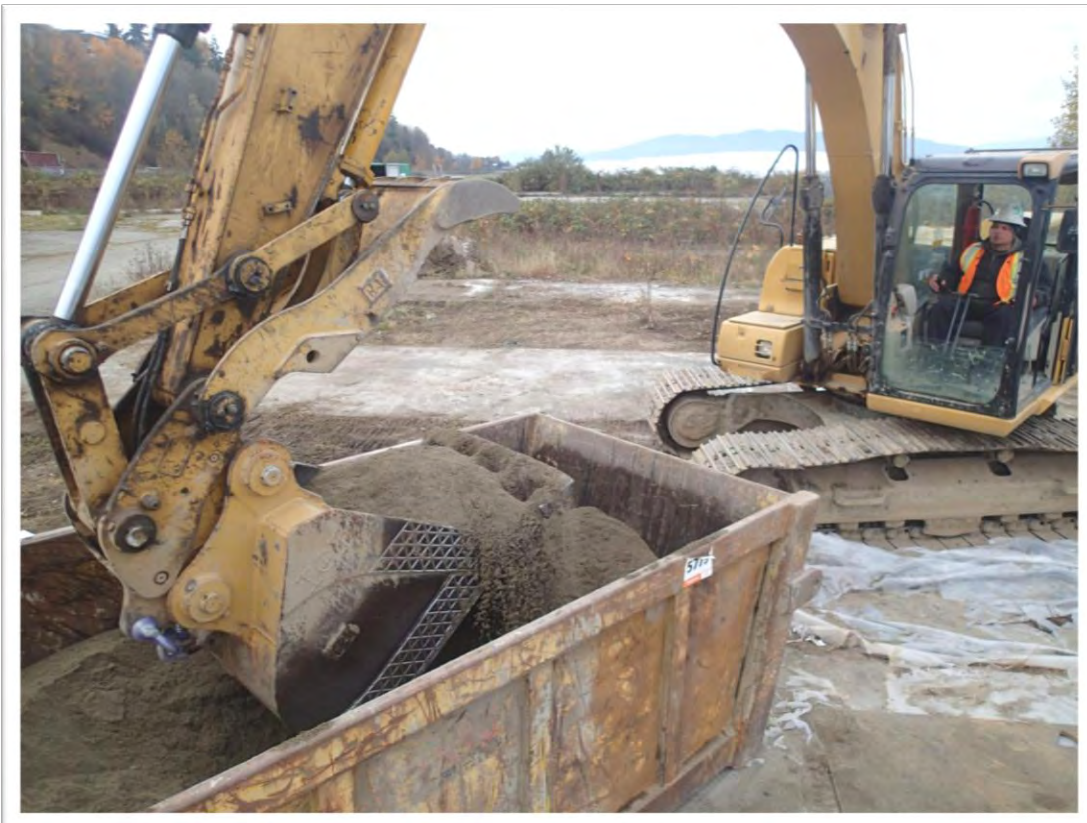
Photo 5: Mixing sand and organoclay on site to prepare amended cap (50/50 sand organoclay mix)

The amended cap material consists of sand amended with granulated organoclay. Granulated organoclay was procured by the City from a vendor (CETCO) and was supplied to the Site in 1,000 pound super sacks. The amended cap material was prepared by mixing equal volumes of organoclay and sand to achieve a 50/50 mix (i.e., 50 percent sand and 50 percent organoclay). Mixing of the sand and organoclay was performed by Interwest in the upland portion of the Site in a metal bedding box using a backhoe. Upon completion of mixing, amended cap material was transferred from the metal bedding box to the import material stockpile area (Figure 4) for temporary stockpiling prior to placement in the IA area. Prepared, amended cap material was observed by a GeoEngineers field engineer to confirm an approximate 50/50 mix. A total of approximately 84 cubic yards (42 cubic yards of sand mixed with 42 cubic yards of granulated organoclay) of amended cap material was utilized for capping the IA area.

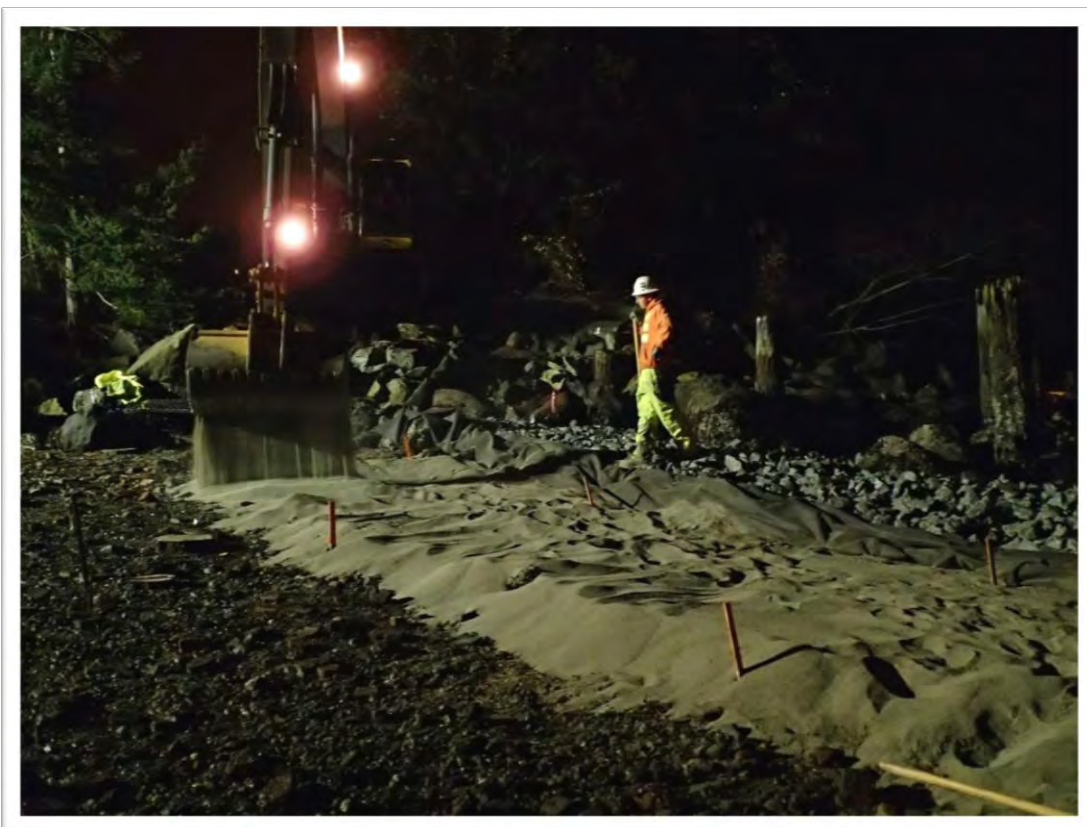
Photo 6: Placement of amended cap (50/50 sand organoclay mix) on prepared mudline

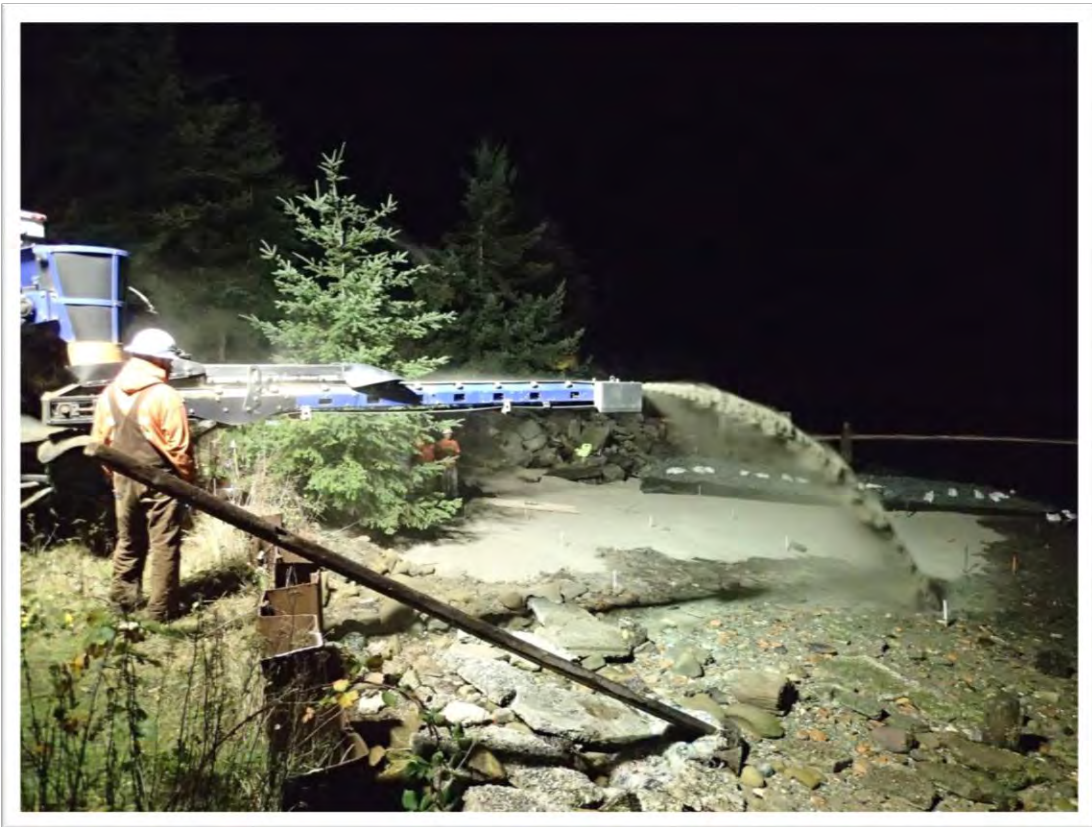
Photo 7: Placement of amended cap (50/50 sand organoclay mix) on prepared mudline

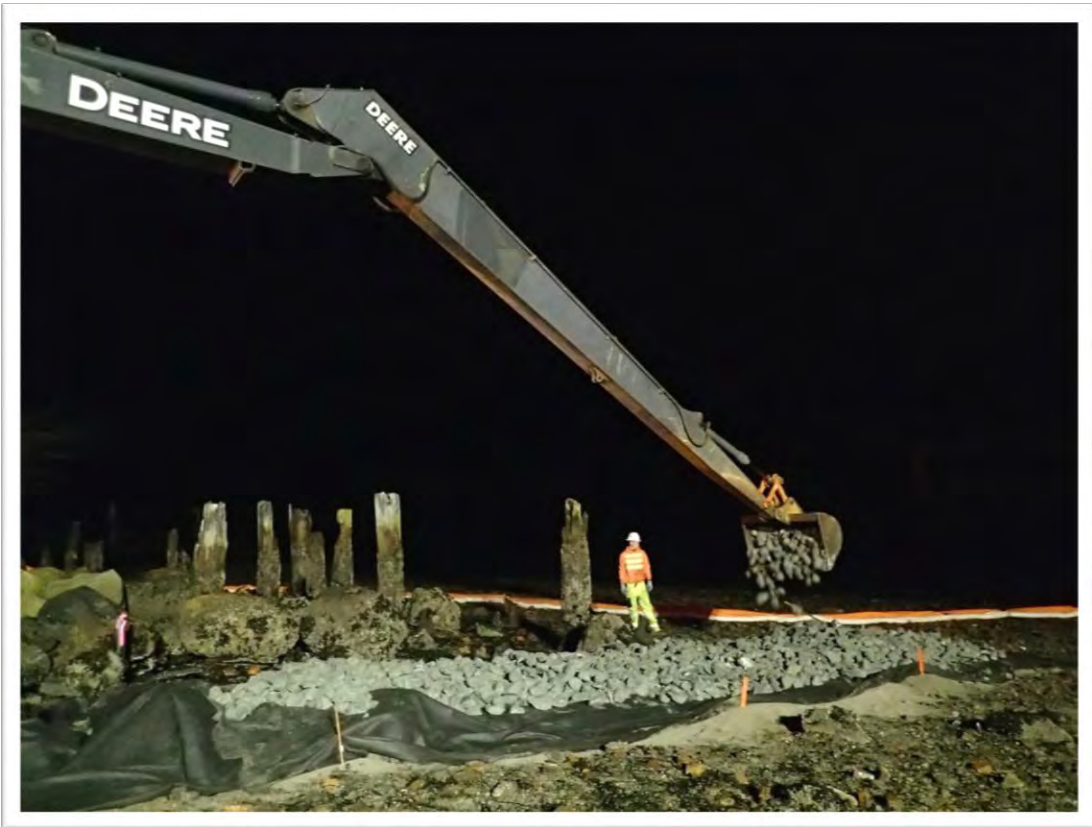
Photo 9: Placement of containment berm

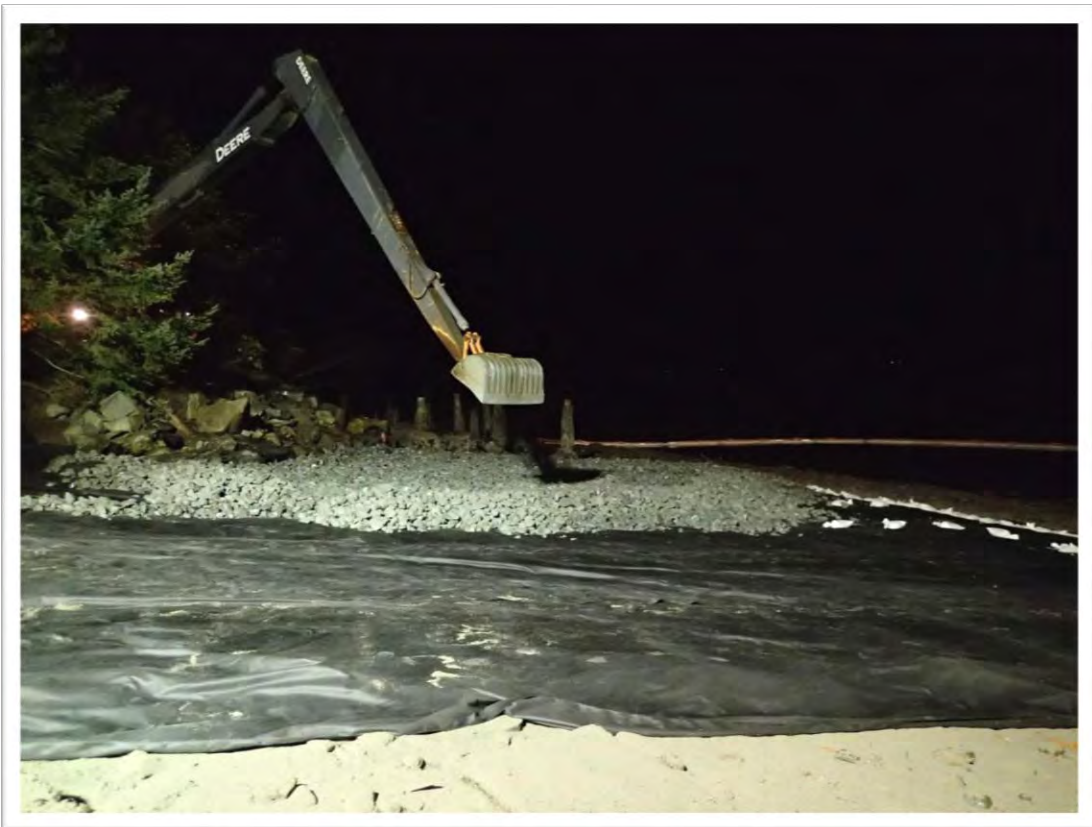
Photo 10: Placement of cap armor

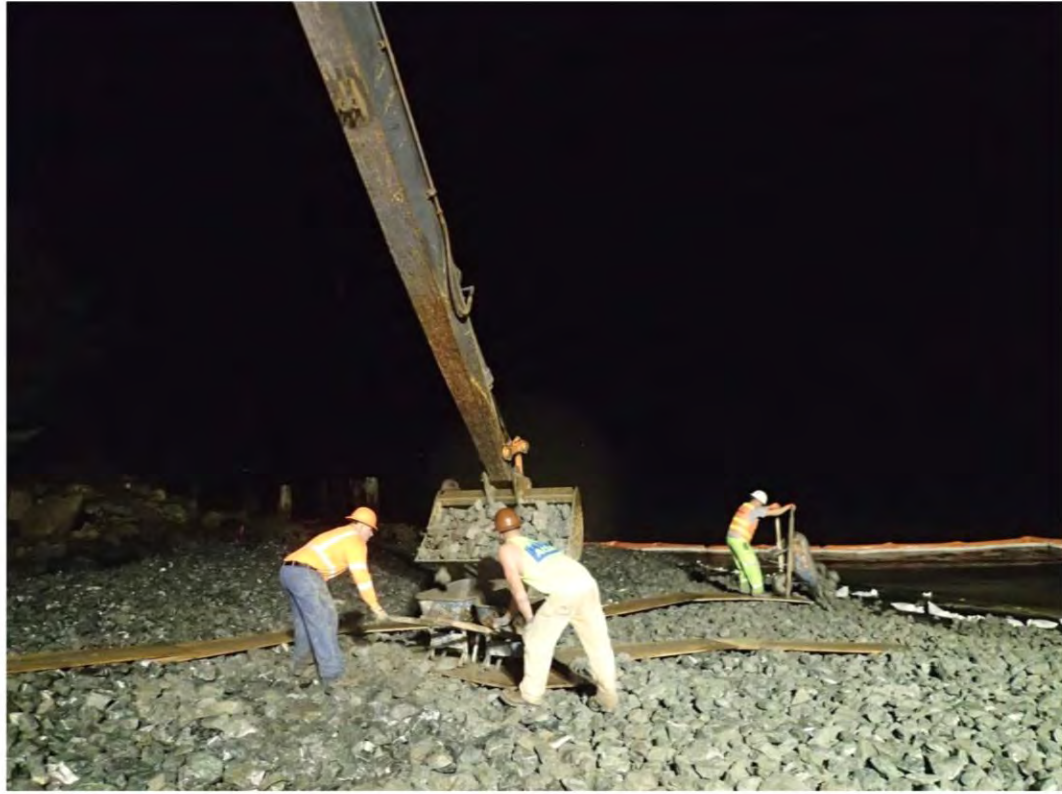
Photo 11: Placement of cap armor

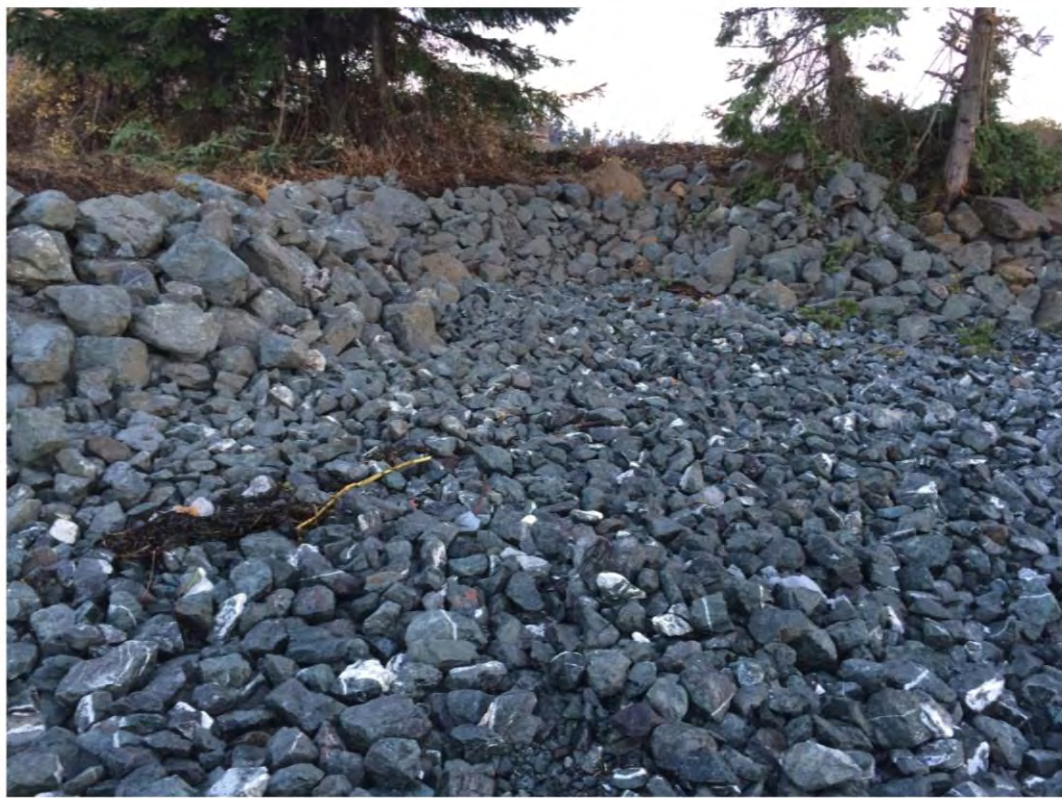
Photo 12: As-Built conditions of sediment cap and riprap placed during the Interim Action
