**LIMITED SITE CLEANUP
at the
BP-PIT STOP
Naches, Washington**

Limited Site Cleanup

Property: BP Pit Stop
Hwy 12
Naches, Washington 98937

Report Date: June 20, 1998

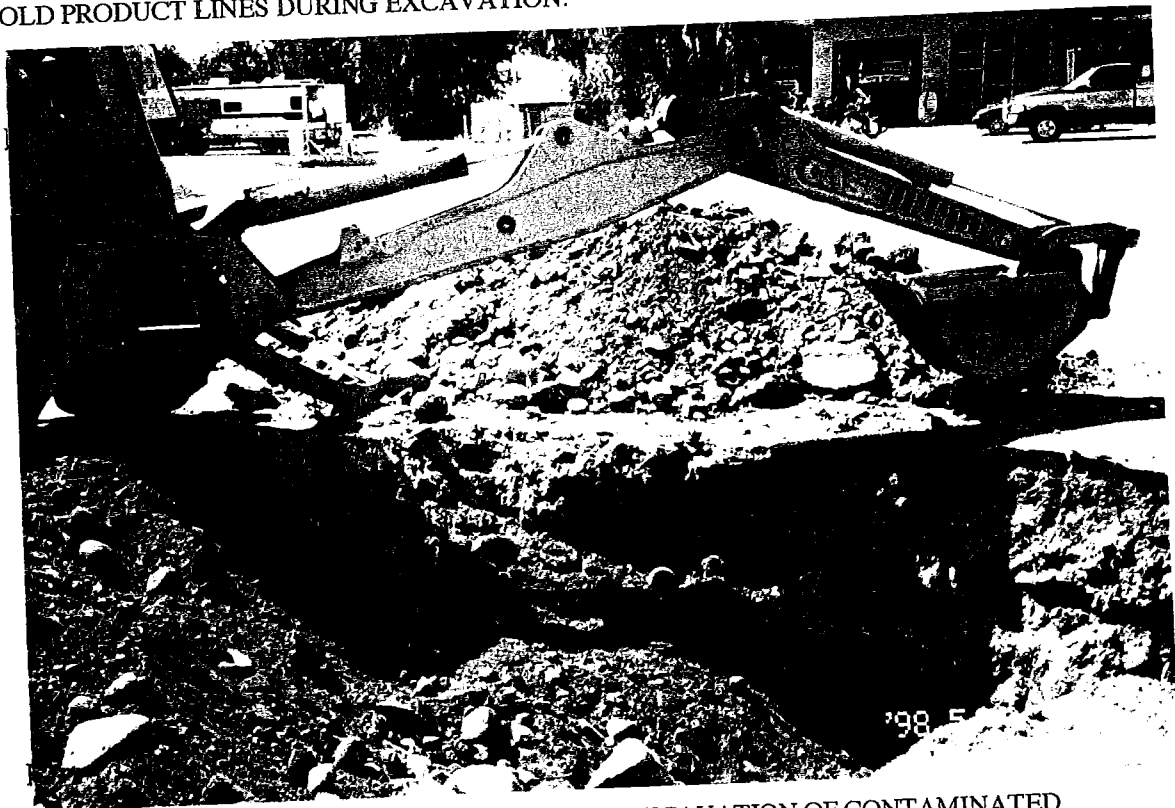
BACKFILLING WITH CLEAN MATERIAL AFTER EXCAVATION OF CONTAMINATED SOIL AT THE FORMER DISPENSER ISLAND.

The excavation was backfilled with clean material (Sample #BP-P) from the adjoining property. The remainder of the property was visual inspected on May 11, and we found no obvious evidence for suspicious spills or stains which could pose potential environmental risks, nor environmental conditions indicating the presence of hazardous conditions, were observed. Based on the information available to date, we believe that there is no risk to the environment from existing conditions at the subject site.
