**PHASE I
ENVIRONMENTAL SITE ASSESSMENT**

**MAID O'CLOVER #202
1802 EAST NOB HILL BOULEVARD
YAKIMA, WASHINGTON**

**MARCH 2004
TC NUMBER: 14064-01**

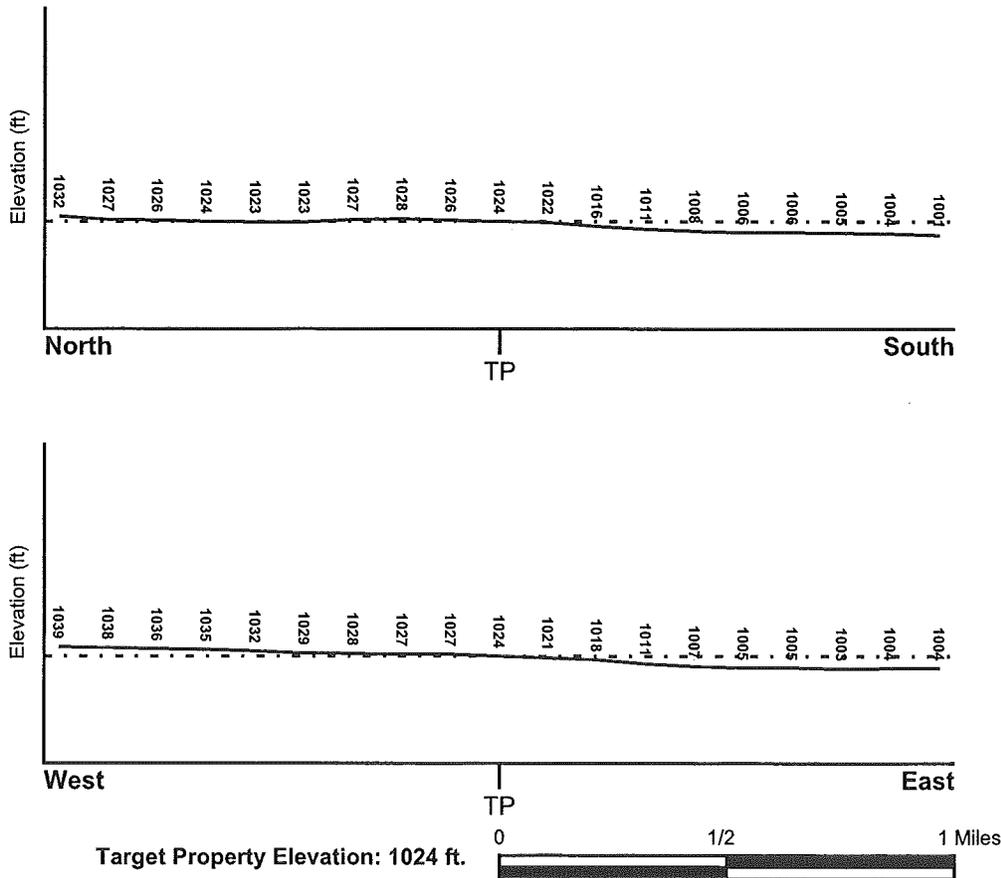
SURROUNDING TOPOGRAPHY: ELEVATION PROFILES

Source: Topography has been determined from the USGS 7.5' Digital Elevation Model and should be evaluated on a relative (not an absolute) basis. Relative elevation information between sites of close proximity should be field verified.

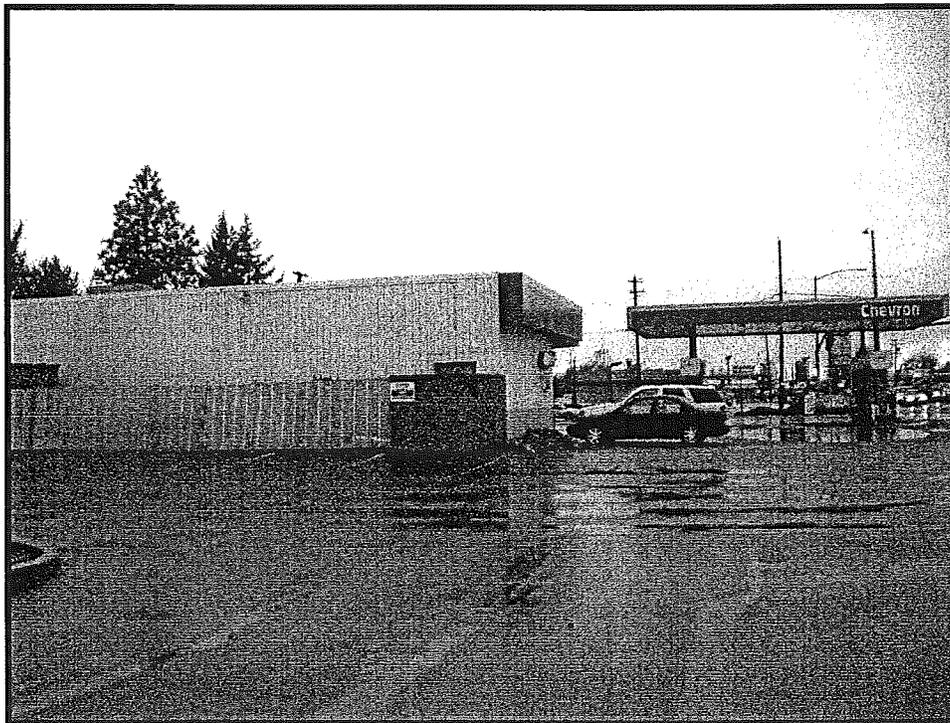
PHOTO 2: Looking north at the subject property including convenience store, pump island and fenced in area to south of store building.

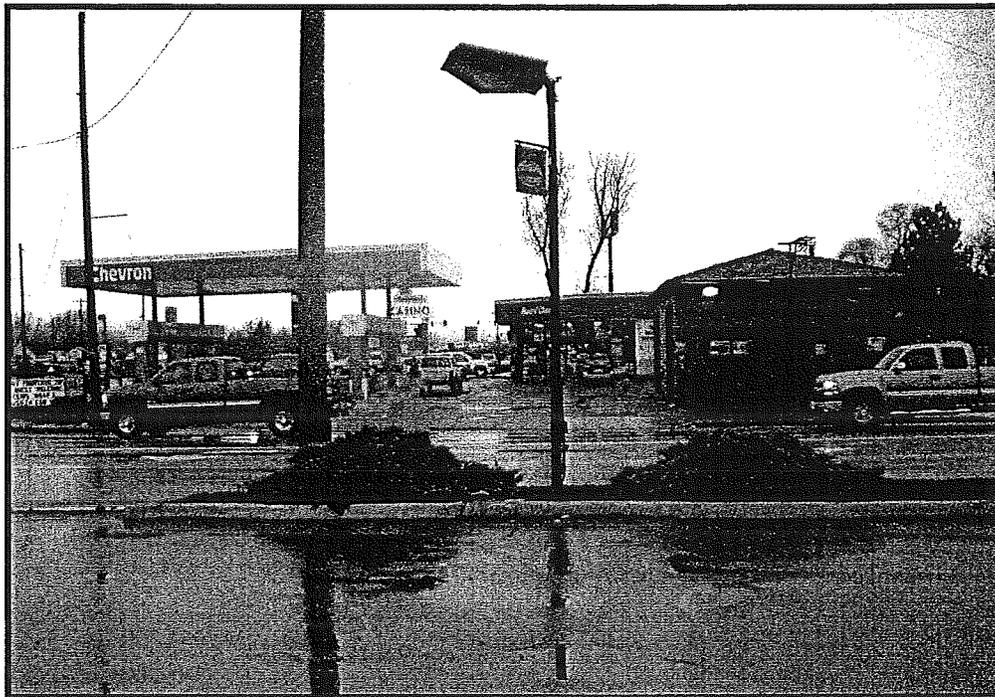
The pump islands are located on a northern-central portion of the subject property and serve diesel and three grades of gasoline. The pumps islands rest side by side under a large awning. A small fenced area was observed east of the store building. Inside the fenced area were a small wood storage shed and two air conditioning units. The three-bay car wash is situated west of the

PHOTO 6. Looking east at the subject property including covered pump islands and car wash.

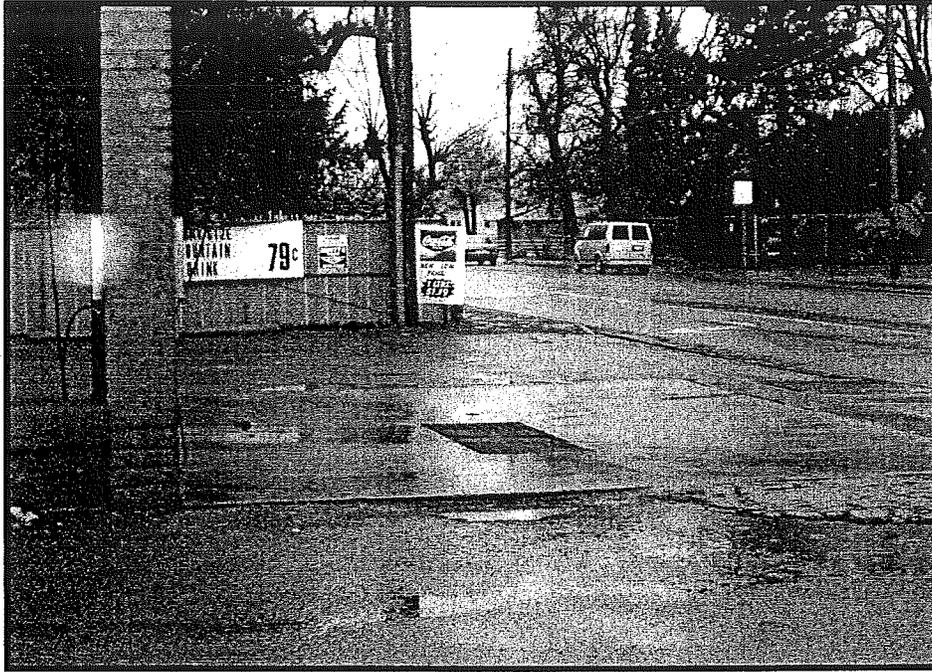
store building on a southwest portion of the property. The car wash is of concrete block construction. Car-wash water collects into drains within each bay of the car wash and later funnels to a catch basin at the northeast corner of the building. The vent pipes for the USTS were observed adjacent to the southwest corner of the site building.

PHOTO 7. Looking south along South 18th Street including water drainage catch basin located west of the car wash.

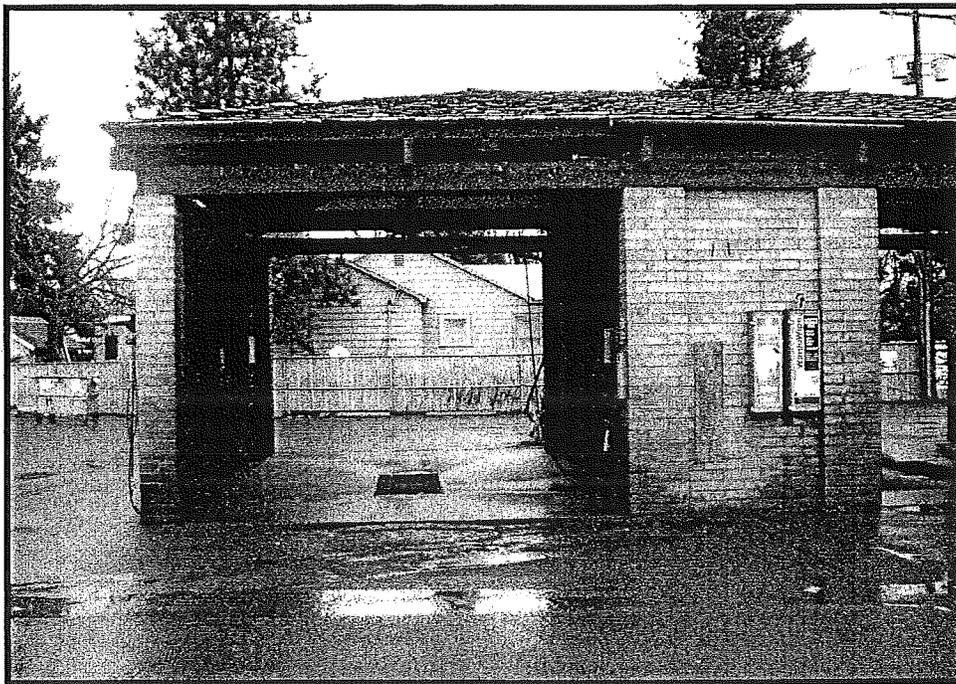
PHOTO 8. Looking south at car wash on subject property including dumpster to the left of photo and residential housing in the background.

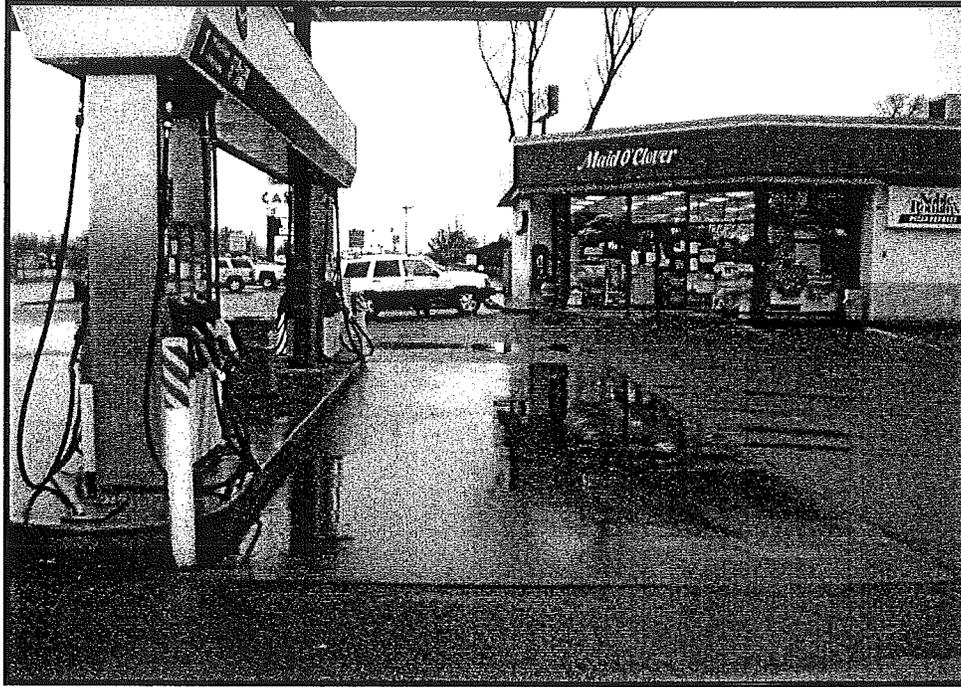
PHOTO 9. Looking south at subject property including store building and south pump island.

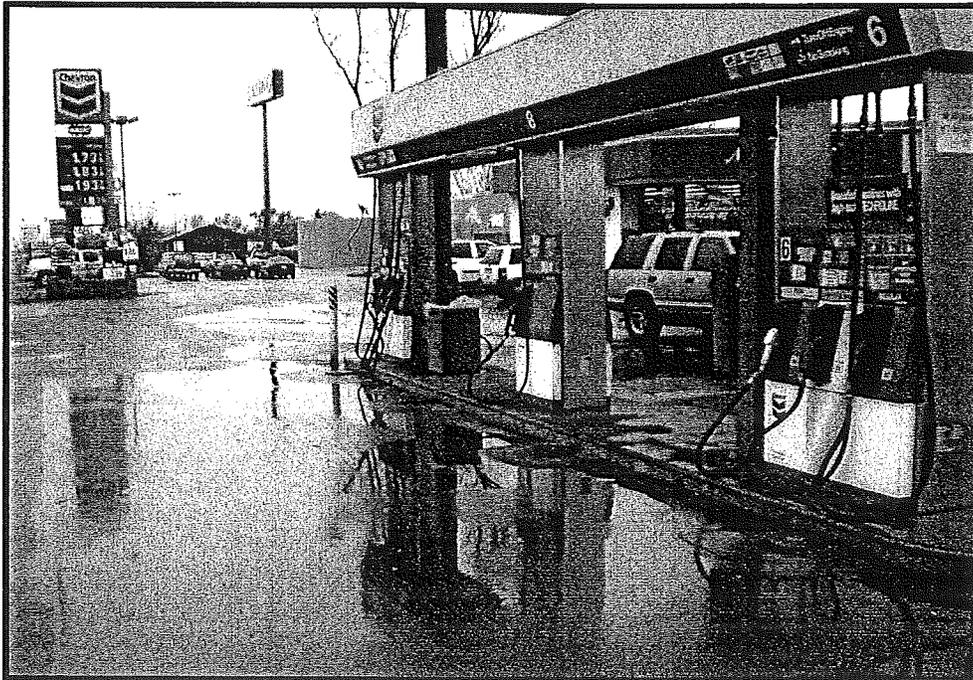
PHOTO 10. Looking south at subject property including north pump island, Chevron sign and Caribbean Casino in background.
