## UNDERGROUND STORAGE TANK Site Check/Site Assessment Checklist

Site/Business Name: Lake Goodwin Store

- ☒ Investigate suspected release due to on-site environmental contamination.  
☐ Investigate suspected release due to off-site environmental contamination.  
☐ Extend temporary closure of UST system for more than 12 months.  
☐ UST system undergoing change-in-service.  
☐ UST system permanently closed with tank removed.  
☐ Abandoned tank containing product.  
☐ Required by Ecology or delegated agency for UST system closed before 12/22/88.  
☒ Other (describe): Evaluate a gasoline spill 12-11-2013

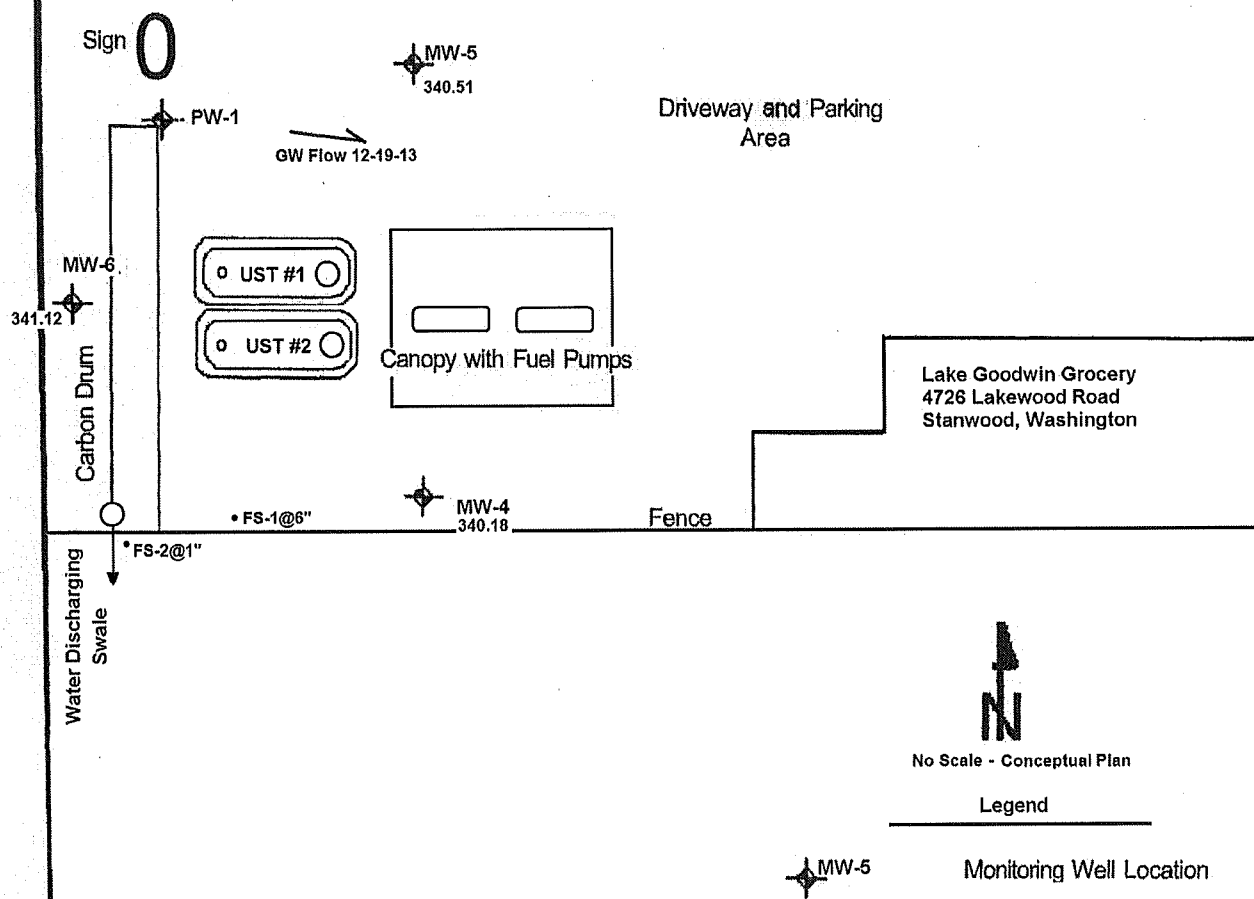
Lakewood Road

8. A sketch or sketches showing the following items is provided:		
- location and ID number for all field samples collected	X	
- groundwater samples distinguished from soil samples (if applicable)	X

- samples collected from stockpiled excavated soil	N/A	
- tank and piping locations and limits of excavation pit	X	
- adjacent structures and streets	X	
- approximate locations of any on-site and nearby utilities	X
