**Snohomish River Sediment, Seep and Outfall  
Sampling Technical Memorandum**

Everett Smelter Cleanup Site  
Lowland Area  
FSID 2744, ISIS Cleanup Site ID 4298  
Everett, Washington

**Project No. 0504-068-00**

**June 25, 2013**

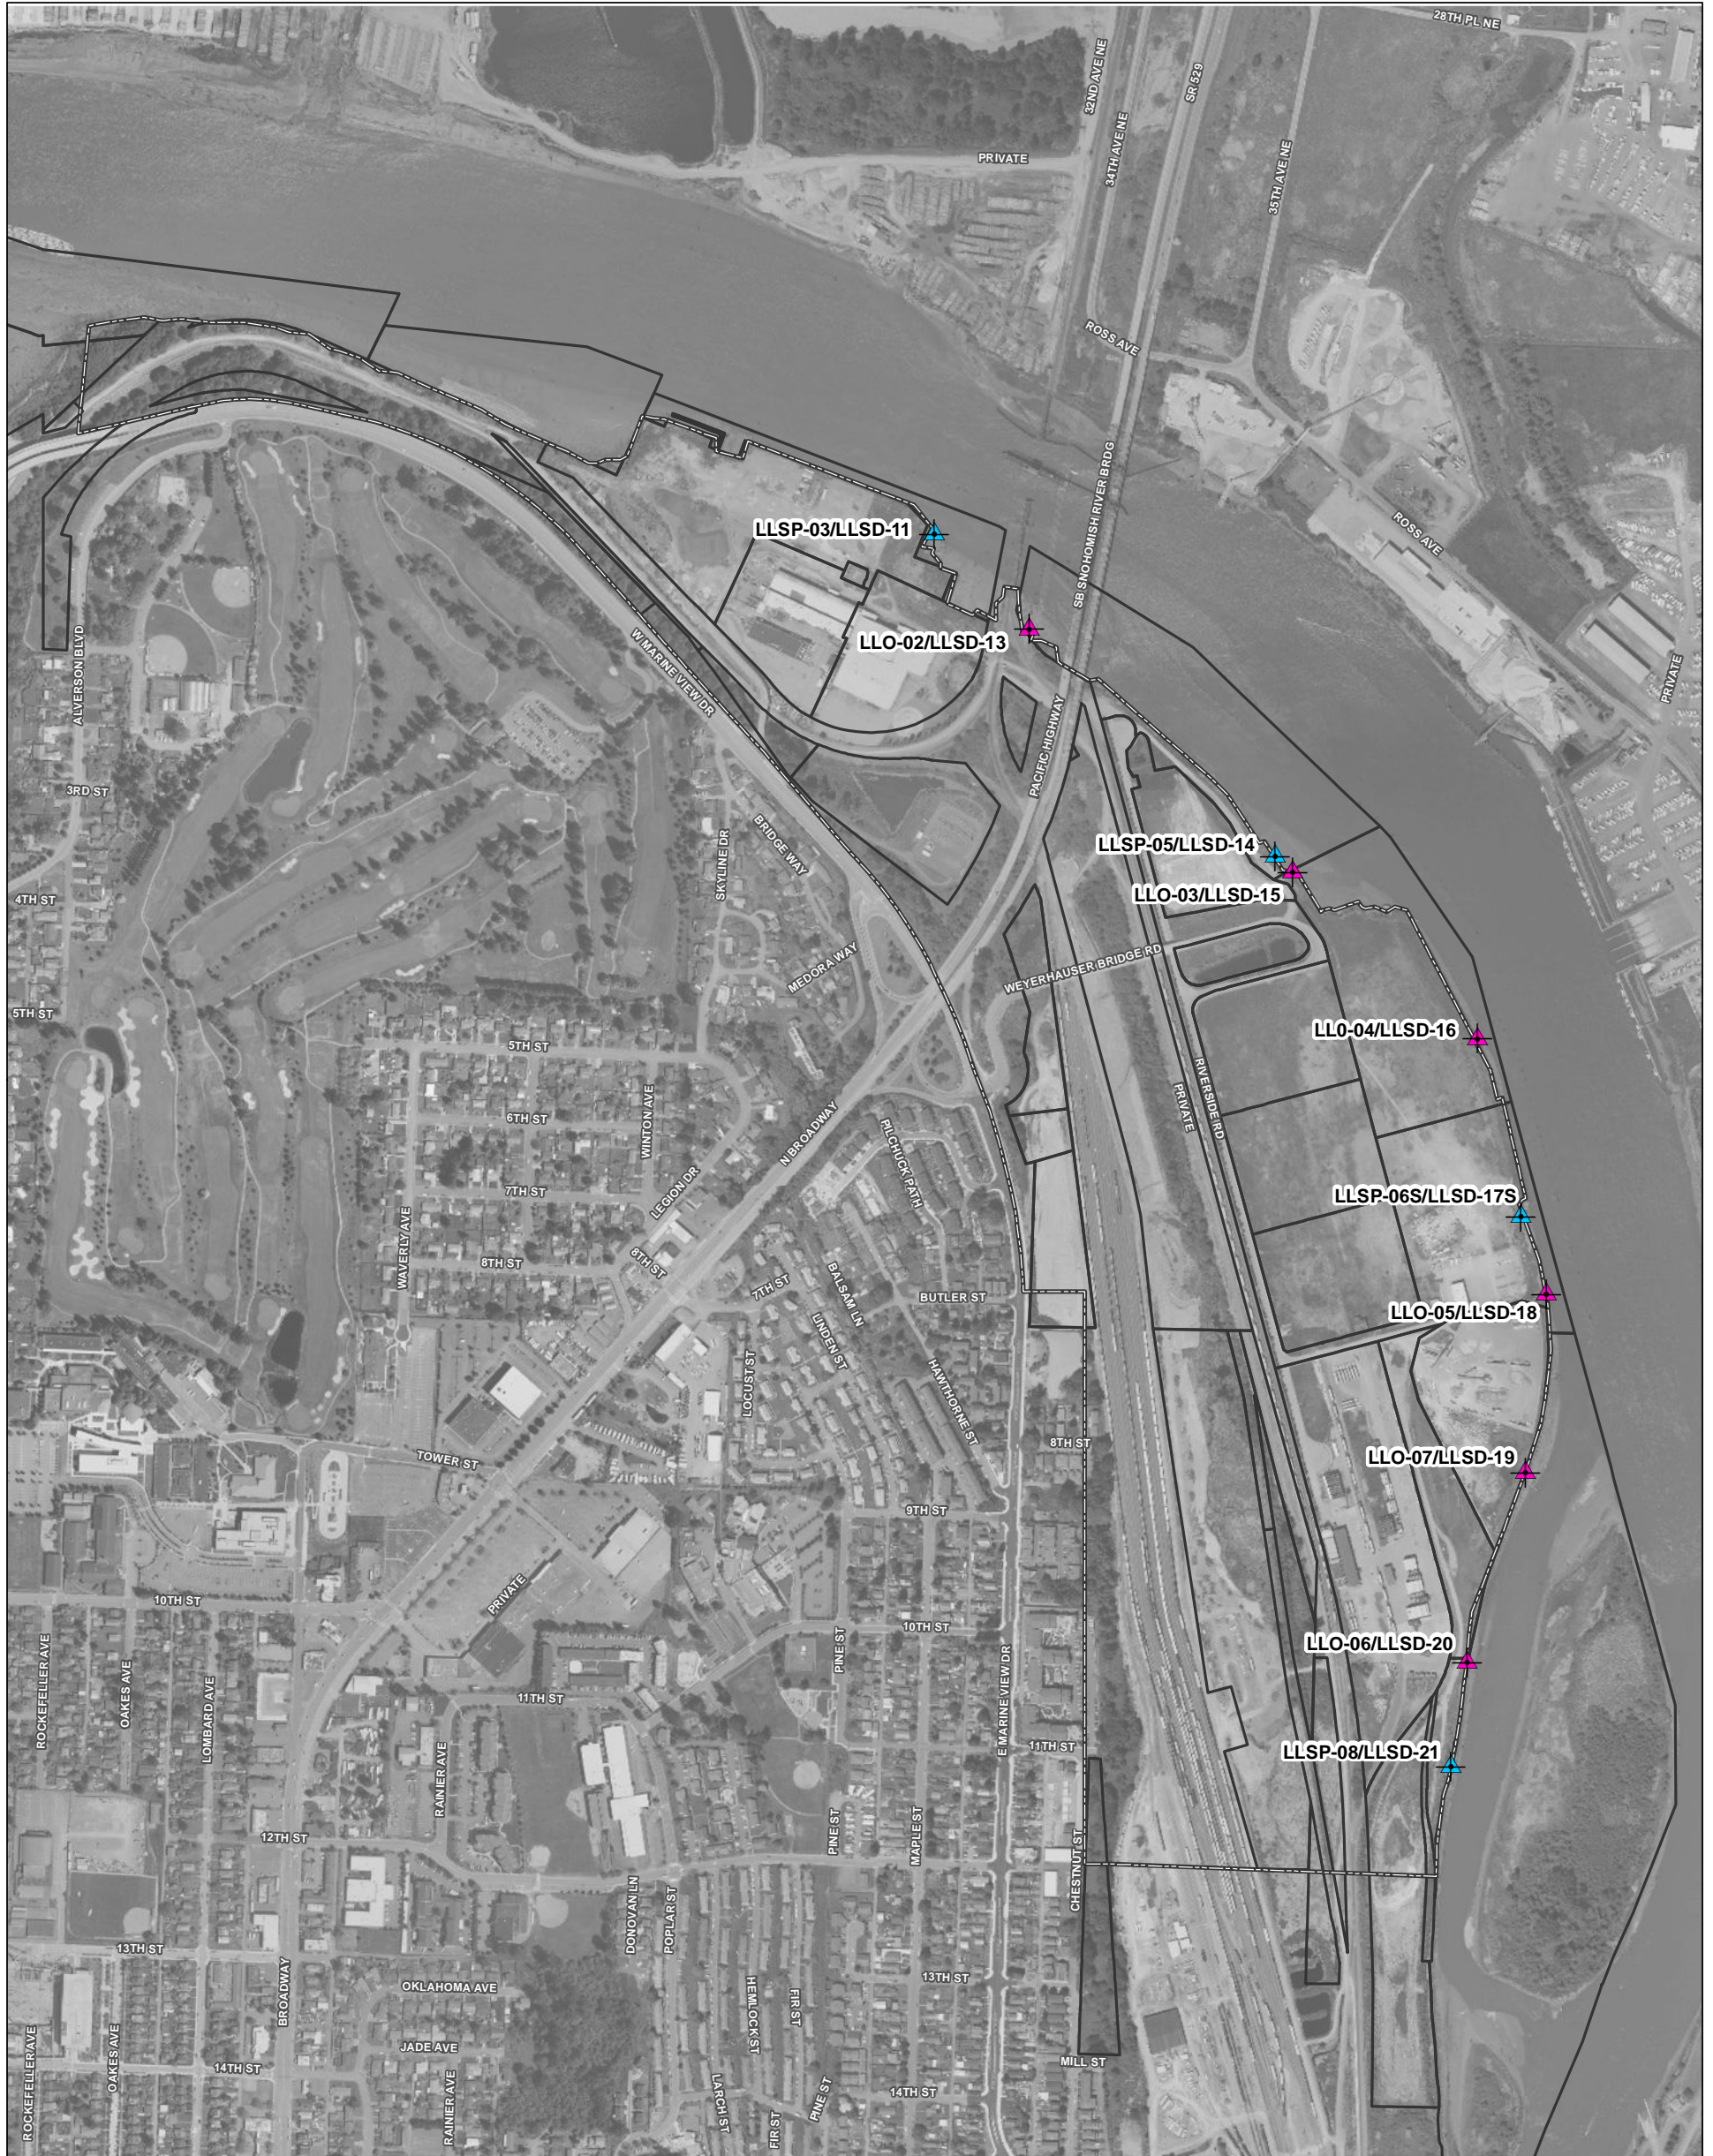
**Figure 2**

River sediment sampling occurred on April 26, 29 and 30, 2013 at 10 locations along the west bank of the Snohomish River (Figure 2). Samples were obtained using either hand sampling or mechanical sampling equipment. Hand sampling equipment was used where sediment sampling locations were exposed at low tide and accessible by foot at the time of sampling. These techniques generally included collecting sediment using a stainless steel (SS) “cookie cutter,” a SS spoon or hand auger. The mechanical sampling equipment included a modified Van Veen “power grab” deployed from a boat operated by RSS. This technique was used at locations where sediment was below tide levels at the time of sampling.

Riverbank seep and outfall water sampling occurred on April 26, 29 and 30, 2013 at the 10 locations (four seeps and six outfalls) along the west bank of the Snohomish River (Figure 2).

**Lowland Investigation Locations**
