INITIAL SOIL INVESTIGATION

HORSE HEAVEN HILLS TRAVEL PLAZA
101 MERLOT DRIVE
PROSSER, WASHINGTON

September 24, 2013

Blue Mountain Environmental and Consulting Company, Inc.
Po Box 545/125 Main St.
Waitsburg, WA 99361
509-520-6519

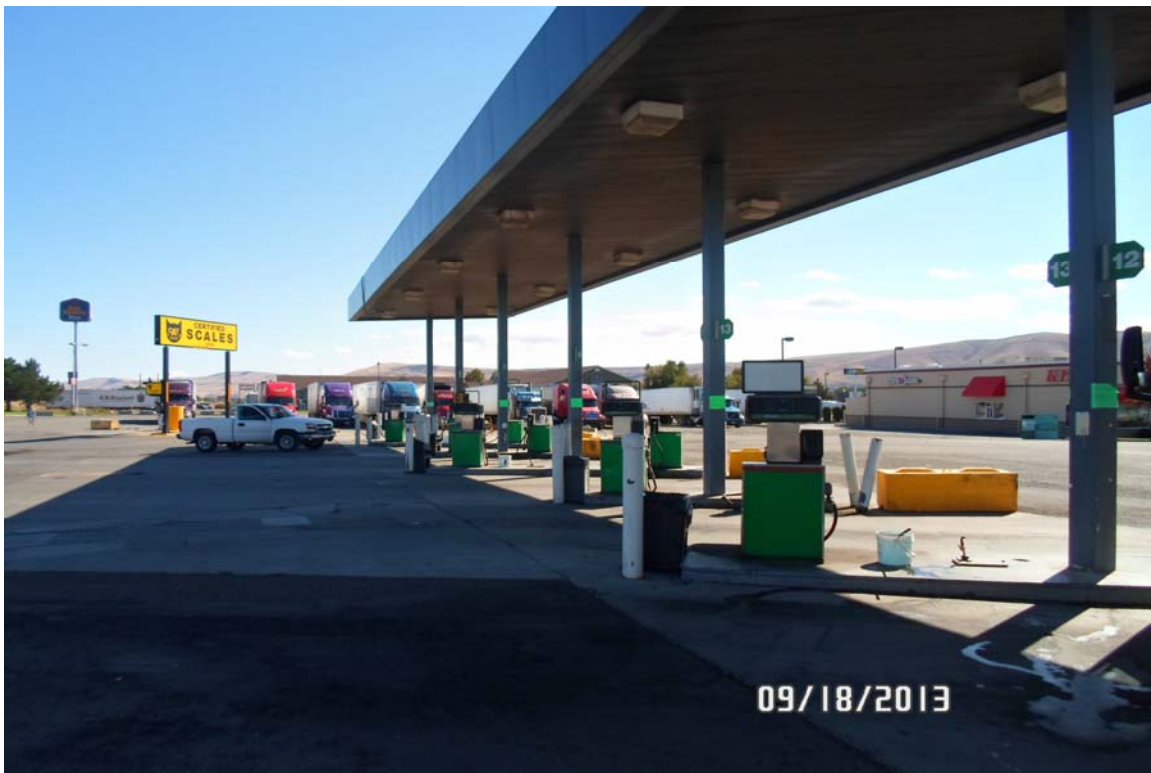
DIESEL PUMPS ISLANDS LOOKING EAST.

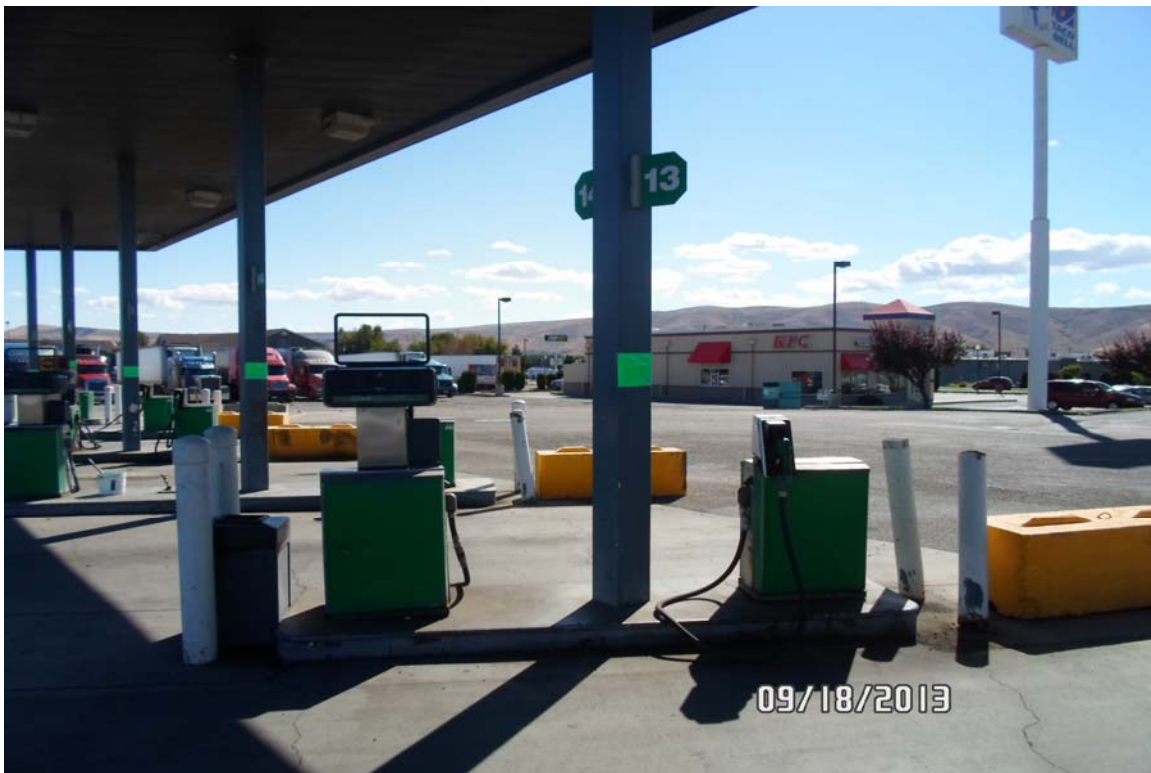
PUMPS 13 AND 14.

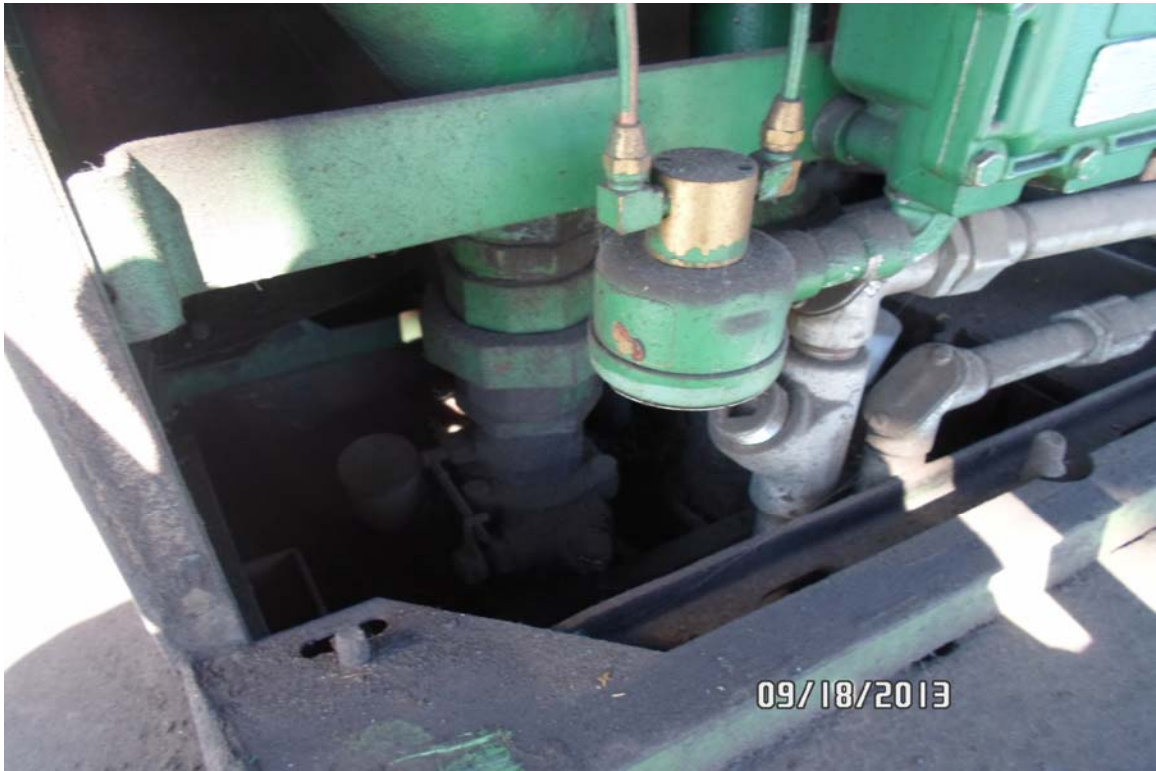
INSIDE DIESEL PUMPS.

The four samples with the highest PID readings were shipped to On Site Environmental Laboratory for analysis for diesel and lube oil by NWTPH-Dx. All four samples were well above MTCA Cleanup levels. It is the opinion of BMEC that the soil under the diesel pumps at the site has diesel contamination above MTCA cleanup levels. The current dispensers and piping should be removed and the petroleum contaminated soil (PCS) should be removed and disposed of properly, with confirmation sampling to insure that no PCS above MTCA cleanup levels remains at the site. The dispensers and piping should be replaced with new dispensers with containment, and piping according to WAC 173-360-305.

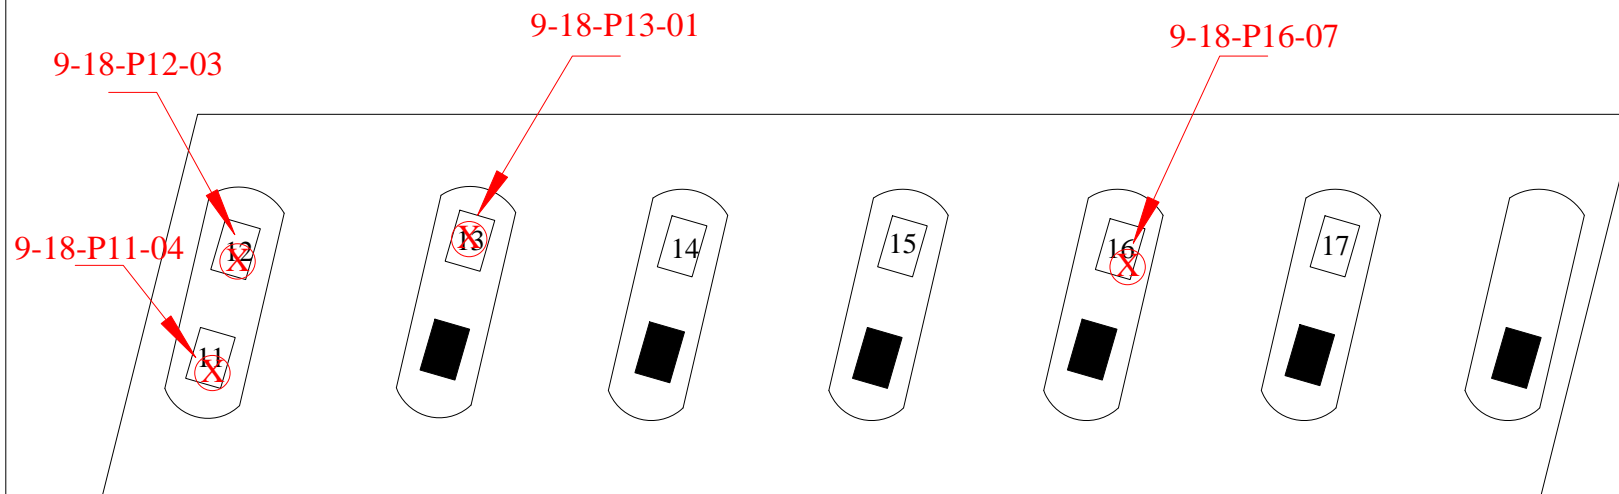
Blue Mountain Environmental Consulting Co., Inc.
E2013/0906 Horse Heaven Hills Travel Plaza,
101 Merlt Dr., Prosser, WA PH II soil sampling

Soil sampling was conducted by Mr. Meyer. Discrete grab samples were collected about 12 inches below the bottom of four separate dispensers. Each sample was placed in one four ounce, pre-cleaned glass container with Teflon lined lid. The samples were stored in a cool environment (4 degrees C) until released, with a chain-of-custody, to the laboratory. The sampling tools were decontaminated between samples, or disposed of. The field testing showed no detectable petroleum contamination. Analysis of the four discrete grab samples conducted by OnSite Environmental, Inc., in Redmond, WA, which indicated no detectable petroleum contamination:
