**PHASE I ENVIRONMENTAL SITE ASSESSMENT
OF**

**KENNEWICK PLAZA
WEST KENNEWICK AVENUE AND SOUTH ELY STREET
KENNEWICK, WASHINGTON 99336**

ATC PROJECT NO. 76.18452.0201

DECEMBER 13, 1999

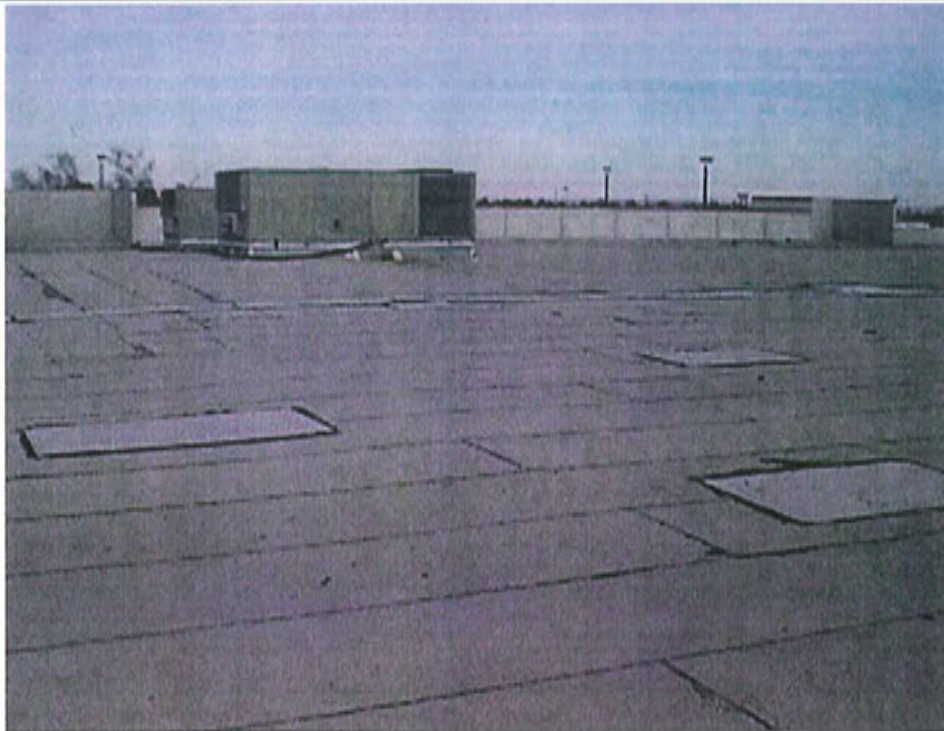
Photo 9: View looking southeast across the roof of the former Ernst store. Asbestos cement sheet material board is on the parapet wall in the background.

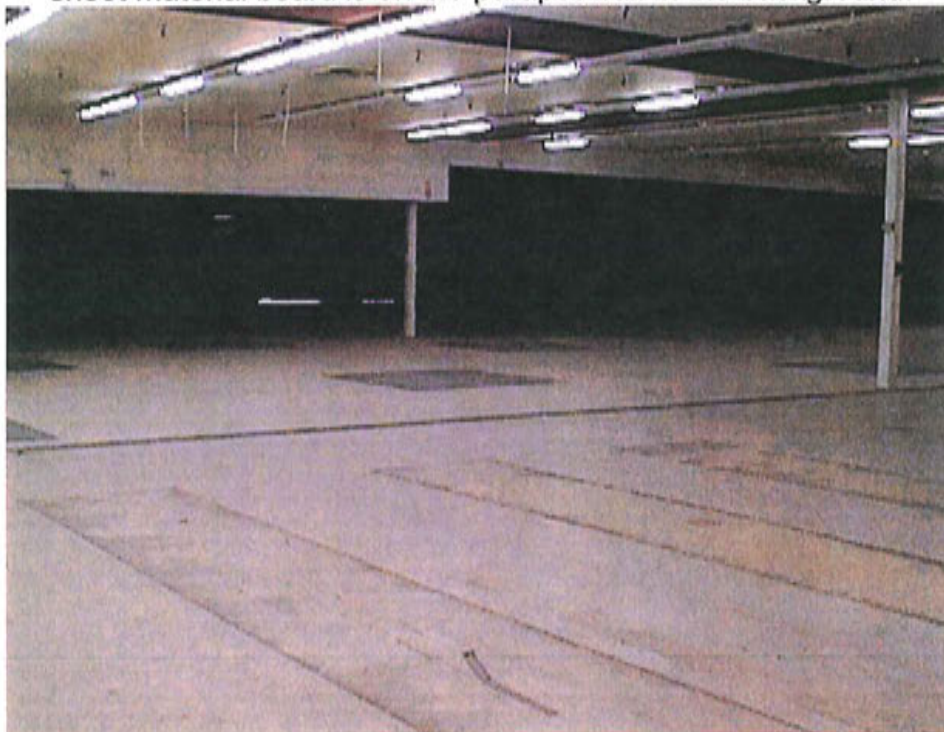
Photo 10: View of the interior of the former Ernst store. Asbestos-containing floor tile mastic is beneath the floor tiles.

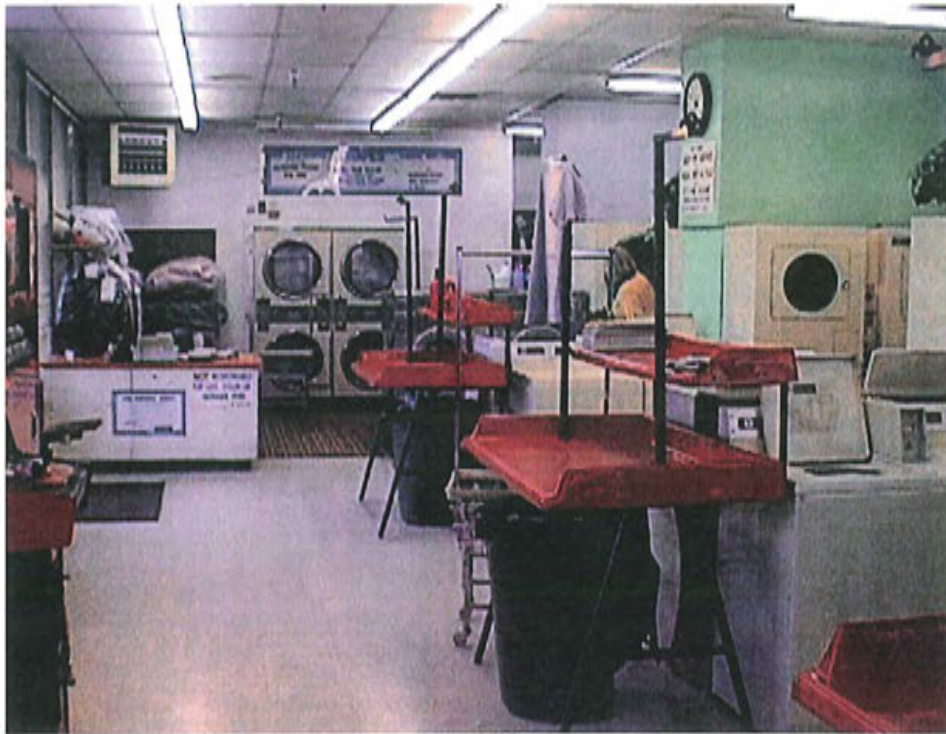
Photo 11: View of the interior of 395 Cleaners and Laundromat.
No dry cleaning was observed on site.

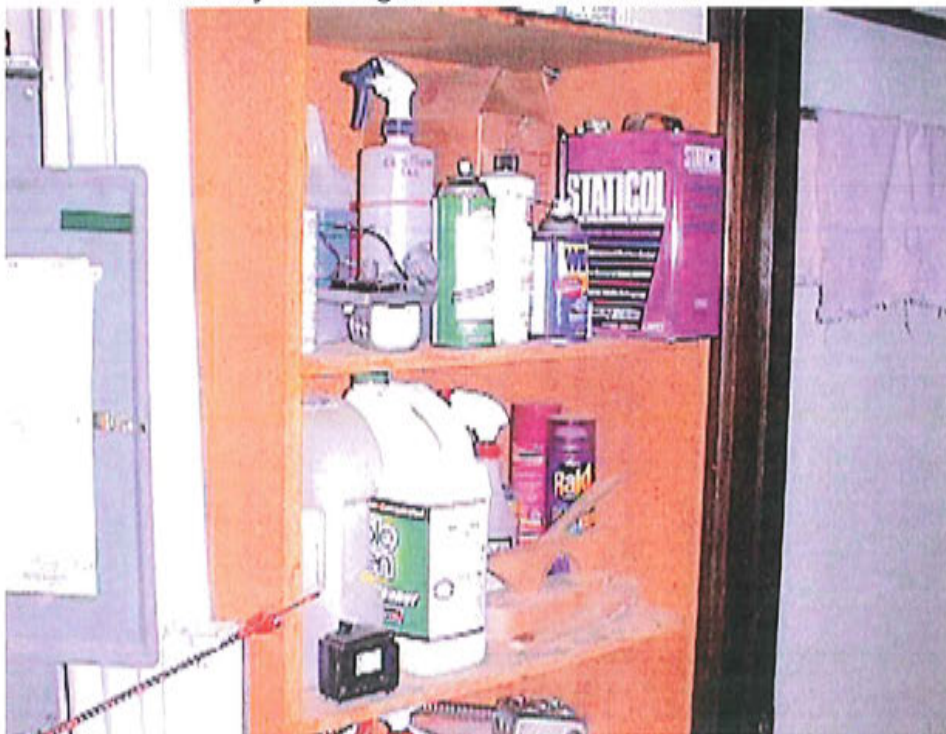
Photo 12: Cleaning and maintenance chemicals at 395 Cleaners and Laundromat.

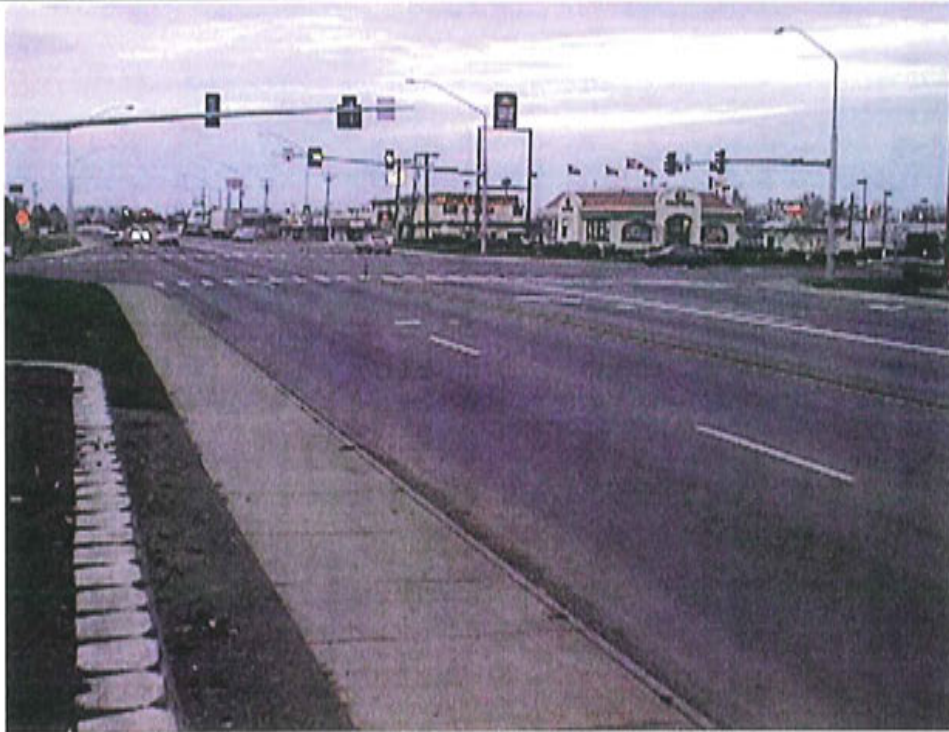
Photo 13: View looking northeast across the intersection of South Ely Street and West Kennewick Avenue. The Site is at the left. Taco Bell, a former gas station, is in the background.
