LAKE RIVER 90% REMEDIAL DESIGN REPORT

LAKE RIVER REMEDIAL ACTION
111 W DIVISION STREET
RIDGEFIELD, WASHINGTON

Prepared for
PORT OF RIDGEFIELD
March 3, 2014
Project No. 9003.01.40

Prepared by
Maul Foster & Alongi, Inc.
400 E Mill Plain Blvd., Suite 400, Vancouver WA 98660

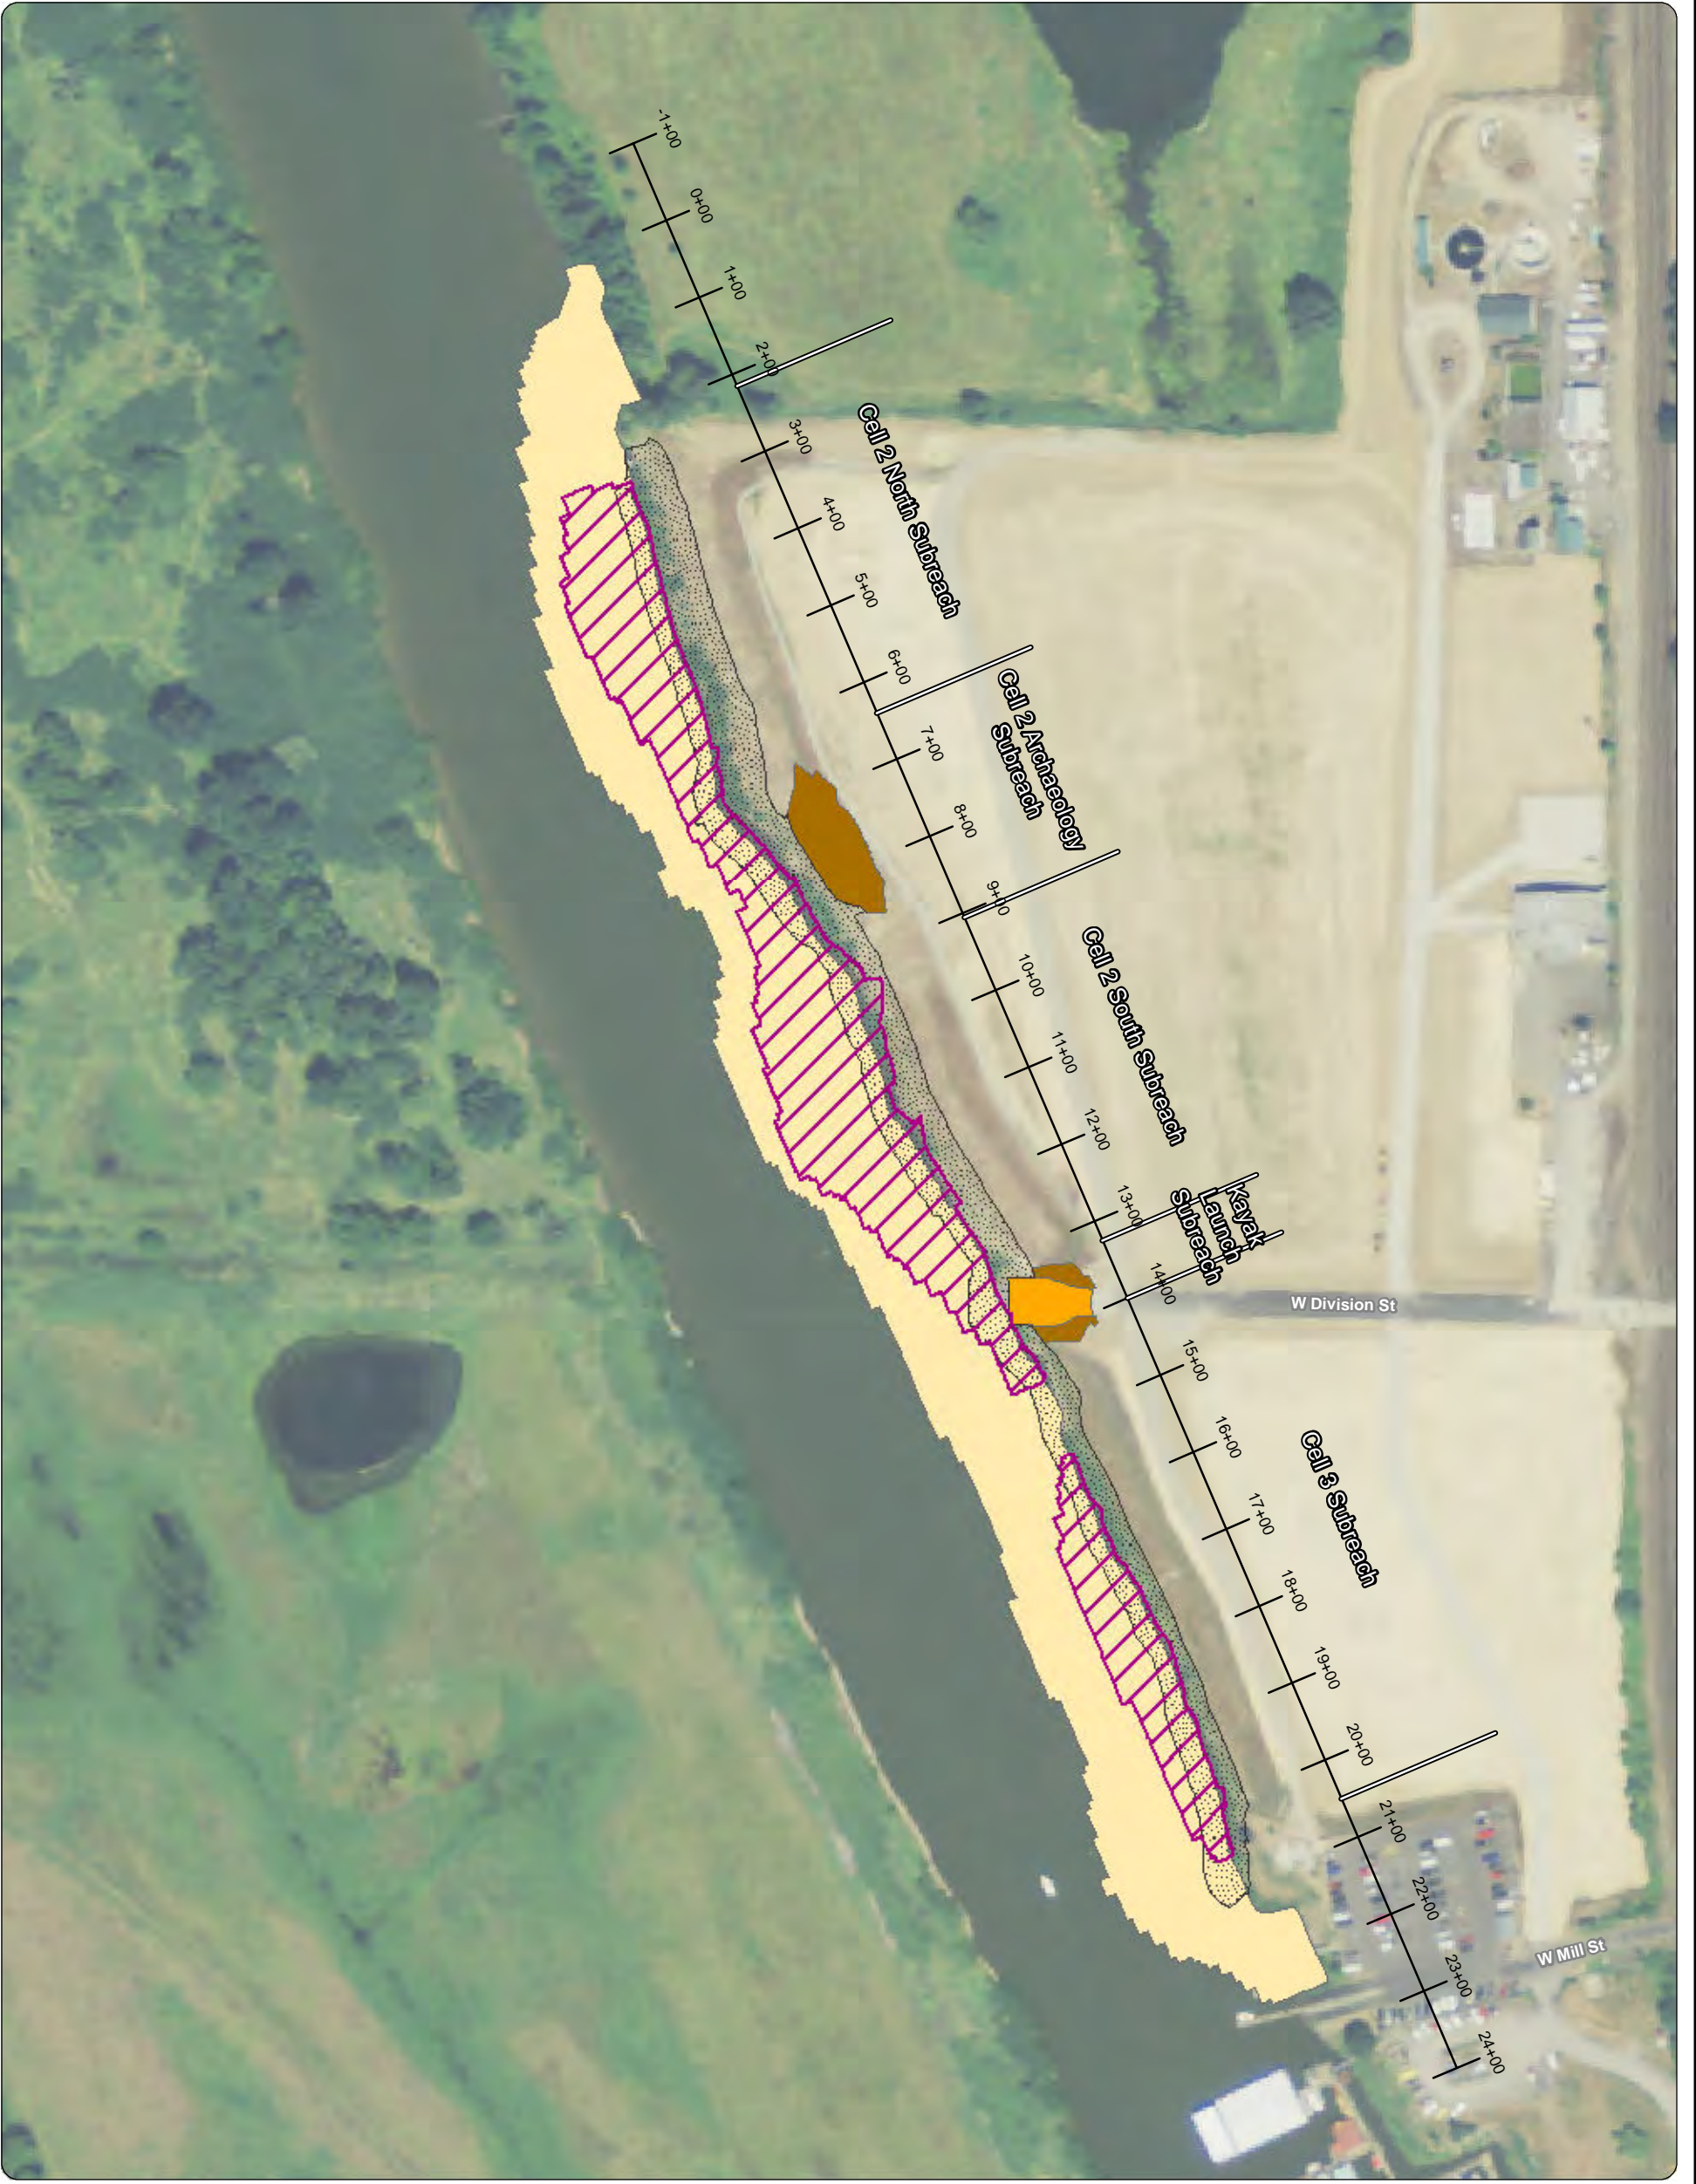
Figure 1-3
Site and Property Diagram
 Lake River Remedial Action
 Port of Ridgefield
 Ridgefield, Washington

Source: Aerial photograph (2013) obtained from the National Agriculture Imagery Program (NAIP); taxlot and road data obtained from Clark County (August 2013).

Note: ENR = enhanced natural recovery

The selected cleanup includes bank and in-water actions. The approximate project location is shown in Figure 1-3. The in-water portion of the remedy entails removal of contaminated sediment, using precision mechanical dredging followed by placement of clean sand to control residuals and enhance the natural recovery of remaining low-level concentrations in the river. Additional in-water cleanup components include the following:

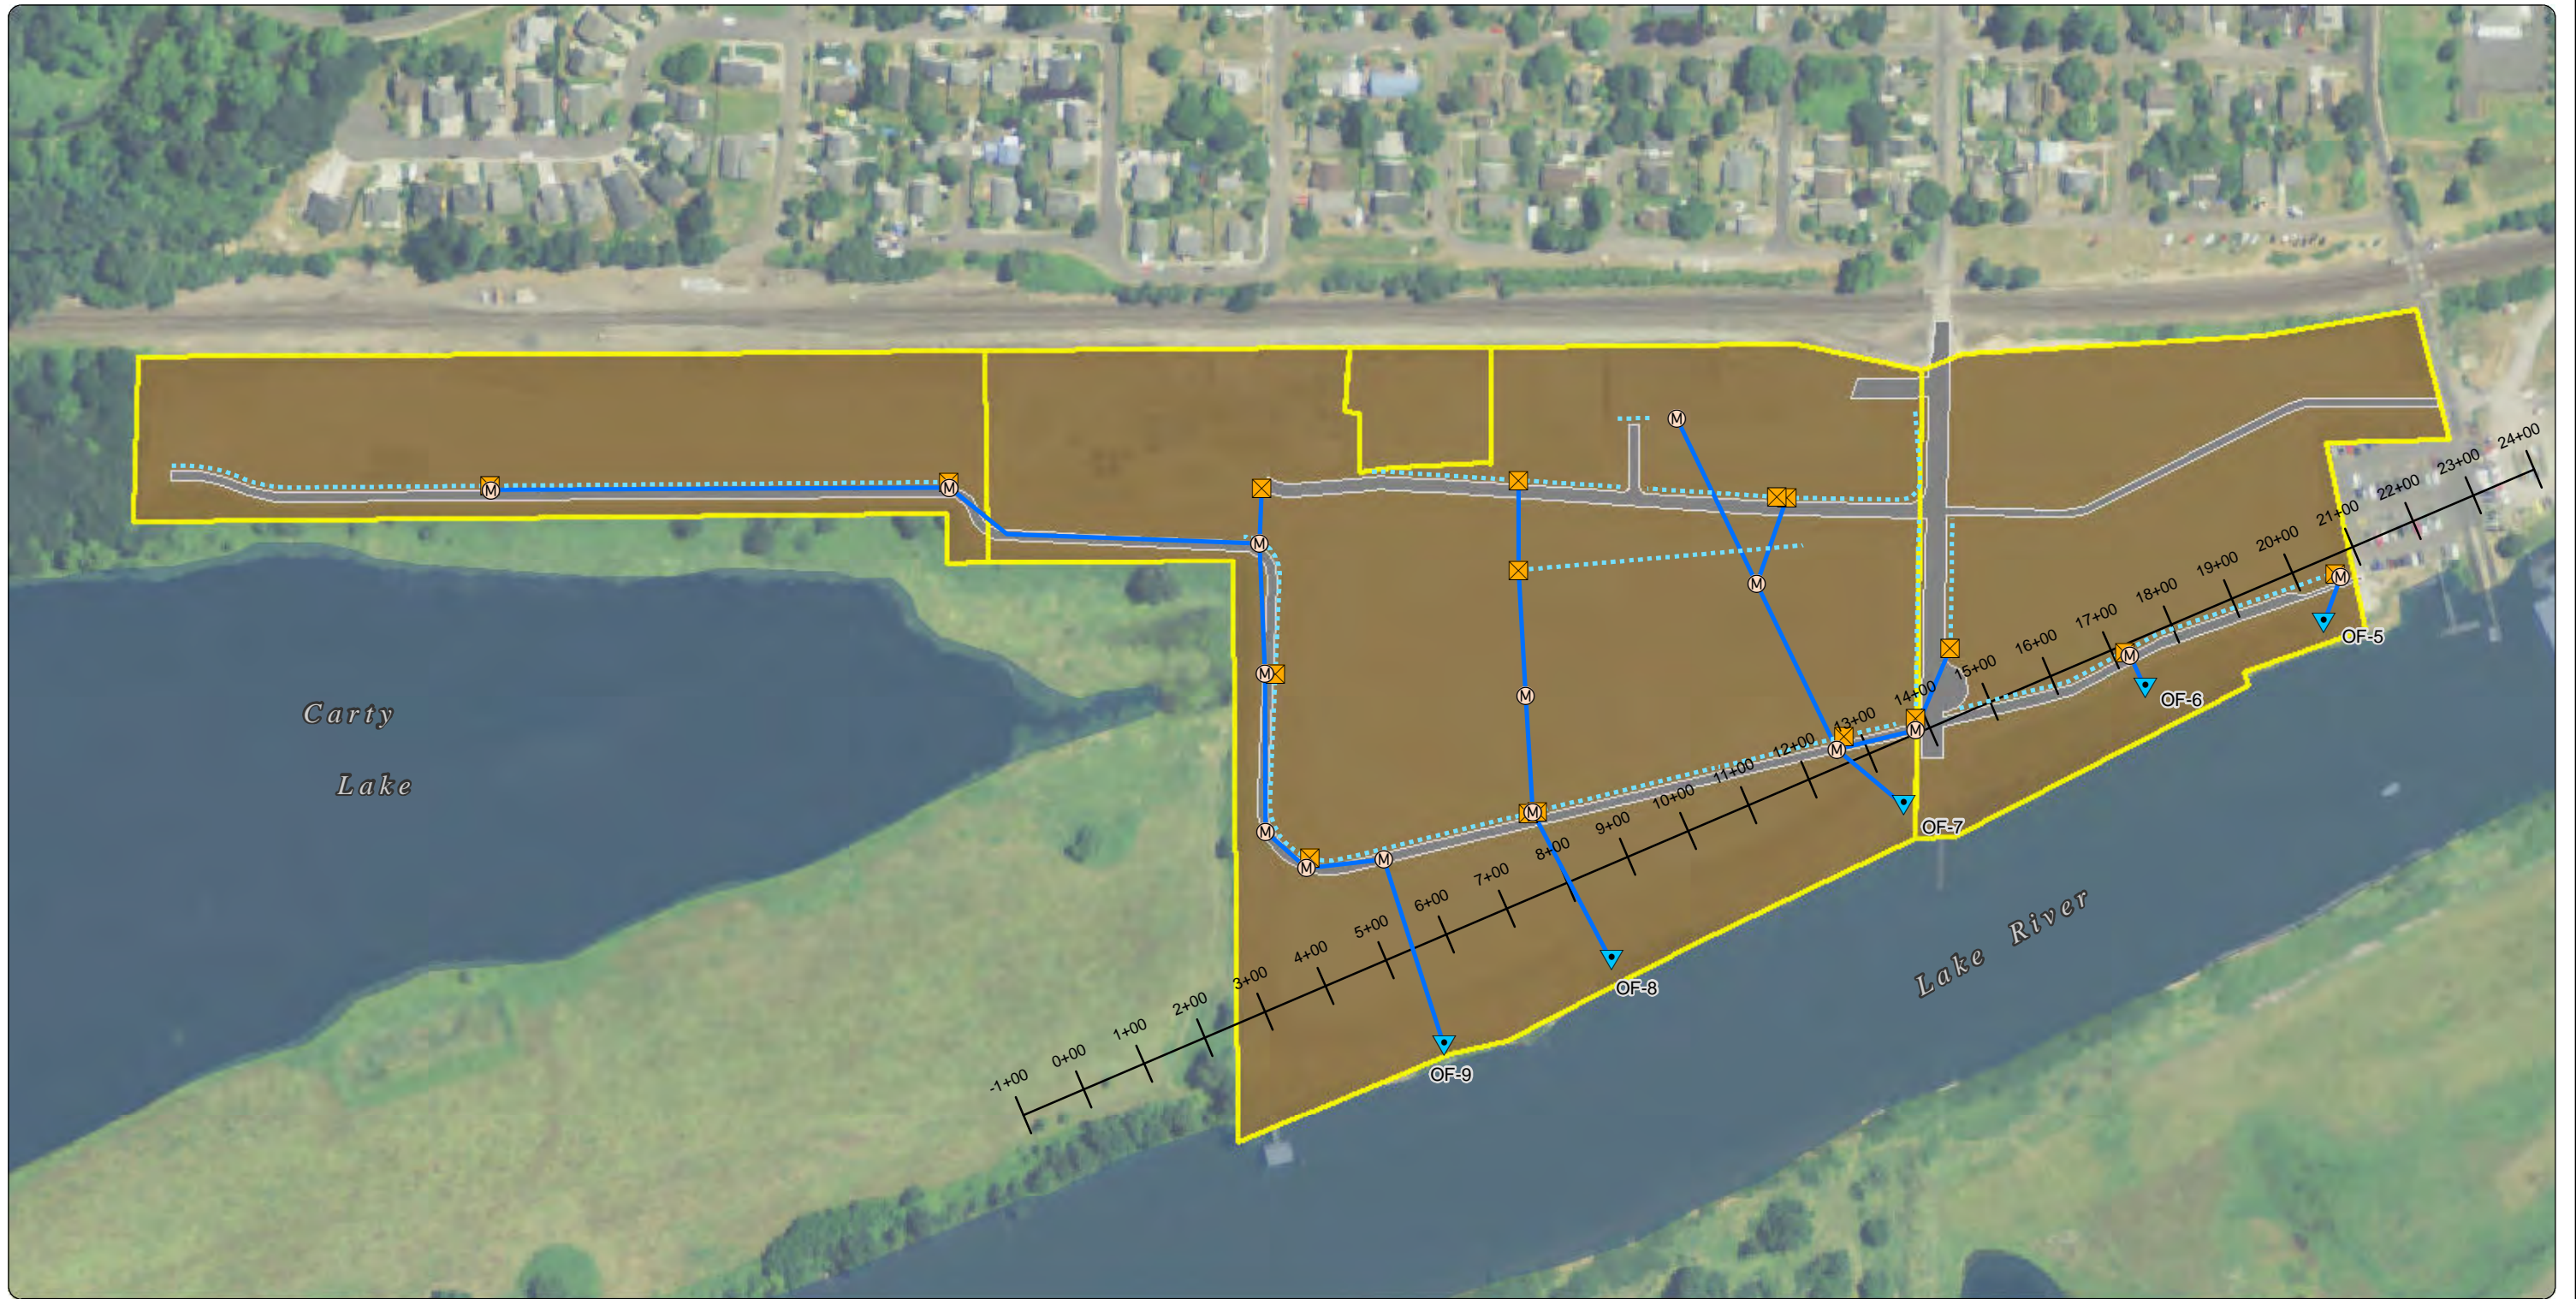
Path: X:\9003.01 Port of Ridgefield\40\Projects\06Lake River Remedial Design\Fig-3_Current Stormwater System.mxd
 Print Date: 2/20/2014
 Approved By: A. Hughes
 Produced By: Ischane
 Project: 9003.01.40

Stormwater from the LRIS either infiltrates into the ground, discharges to Lake River through five private outfalls, or discharges directly to Lake River by overland flow. The stormwater system is shown on Figure 2-3. The current stormwater system replaces the system removed as part of the upland remedial action undertaken to eliminate a source of contamination to Lake River. The outfalls are owned by the Port and serve primarily unpaved, soil-capped areas of the LRIS. The Port

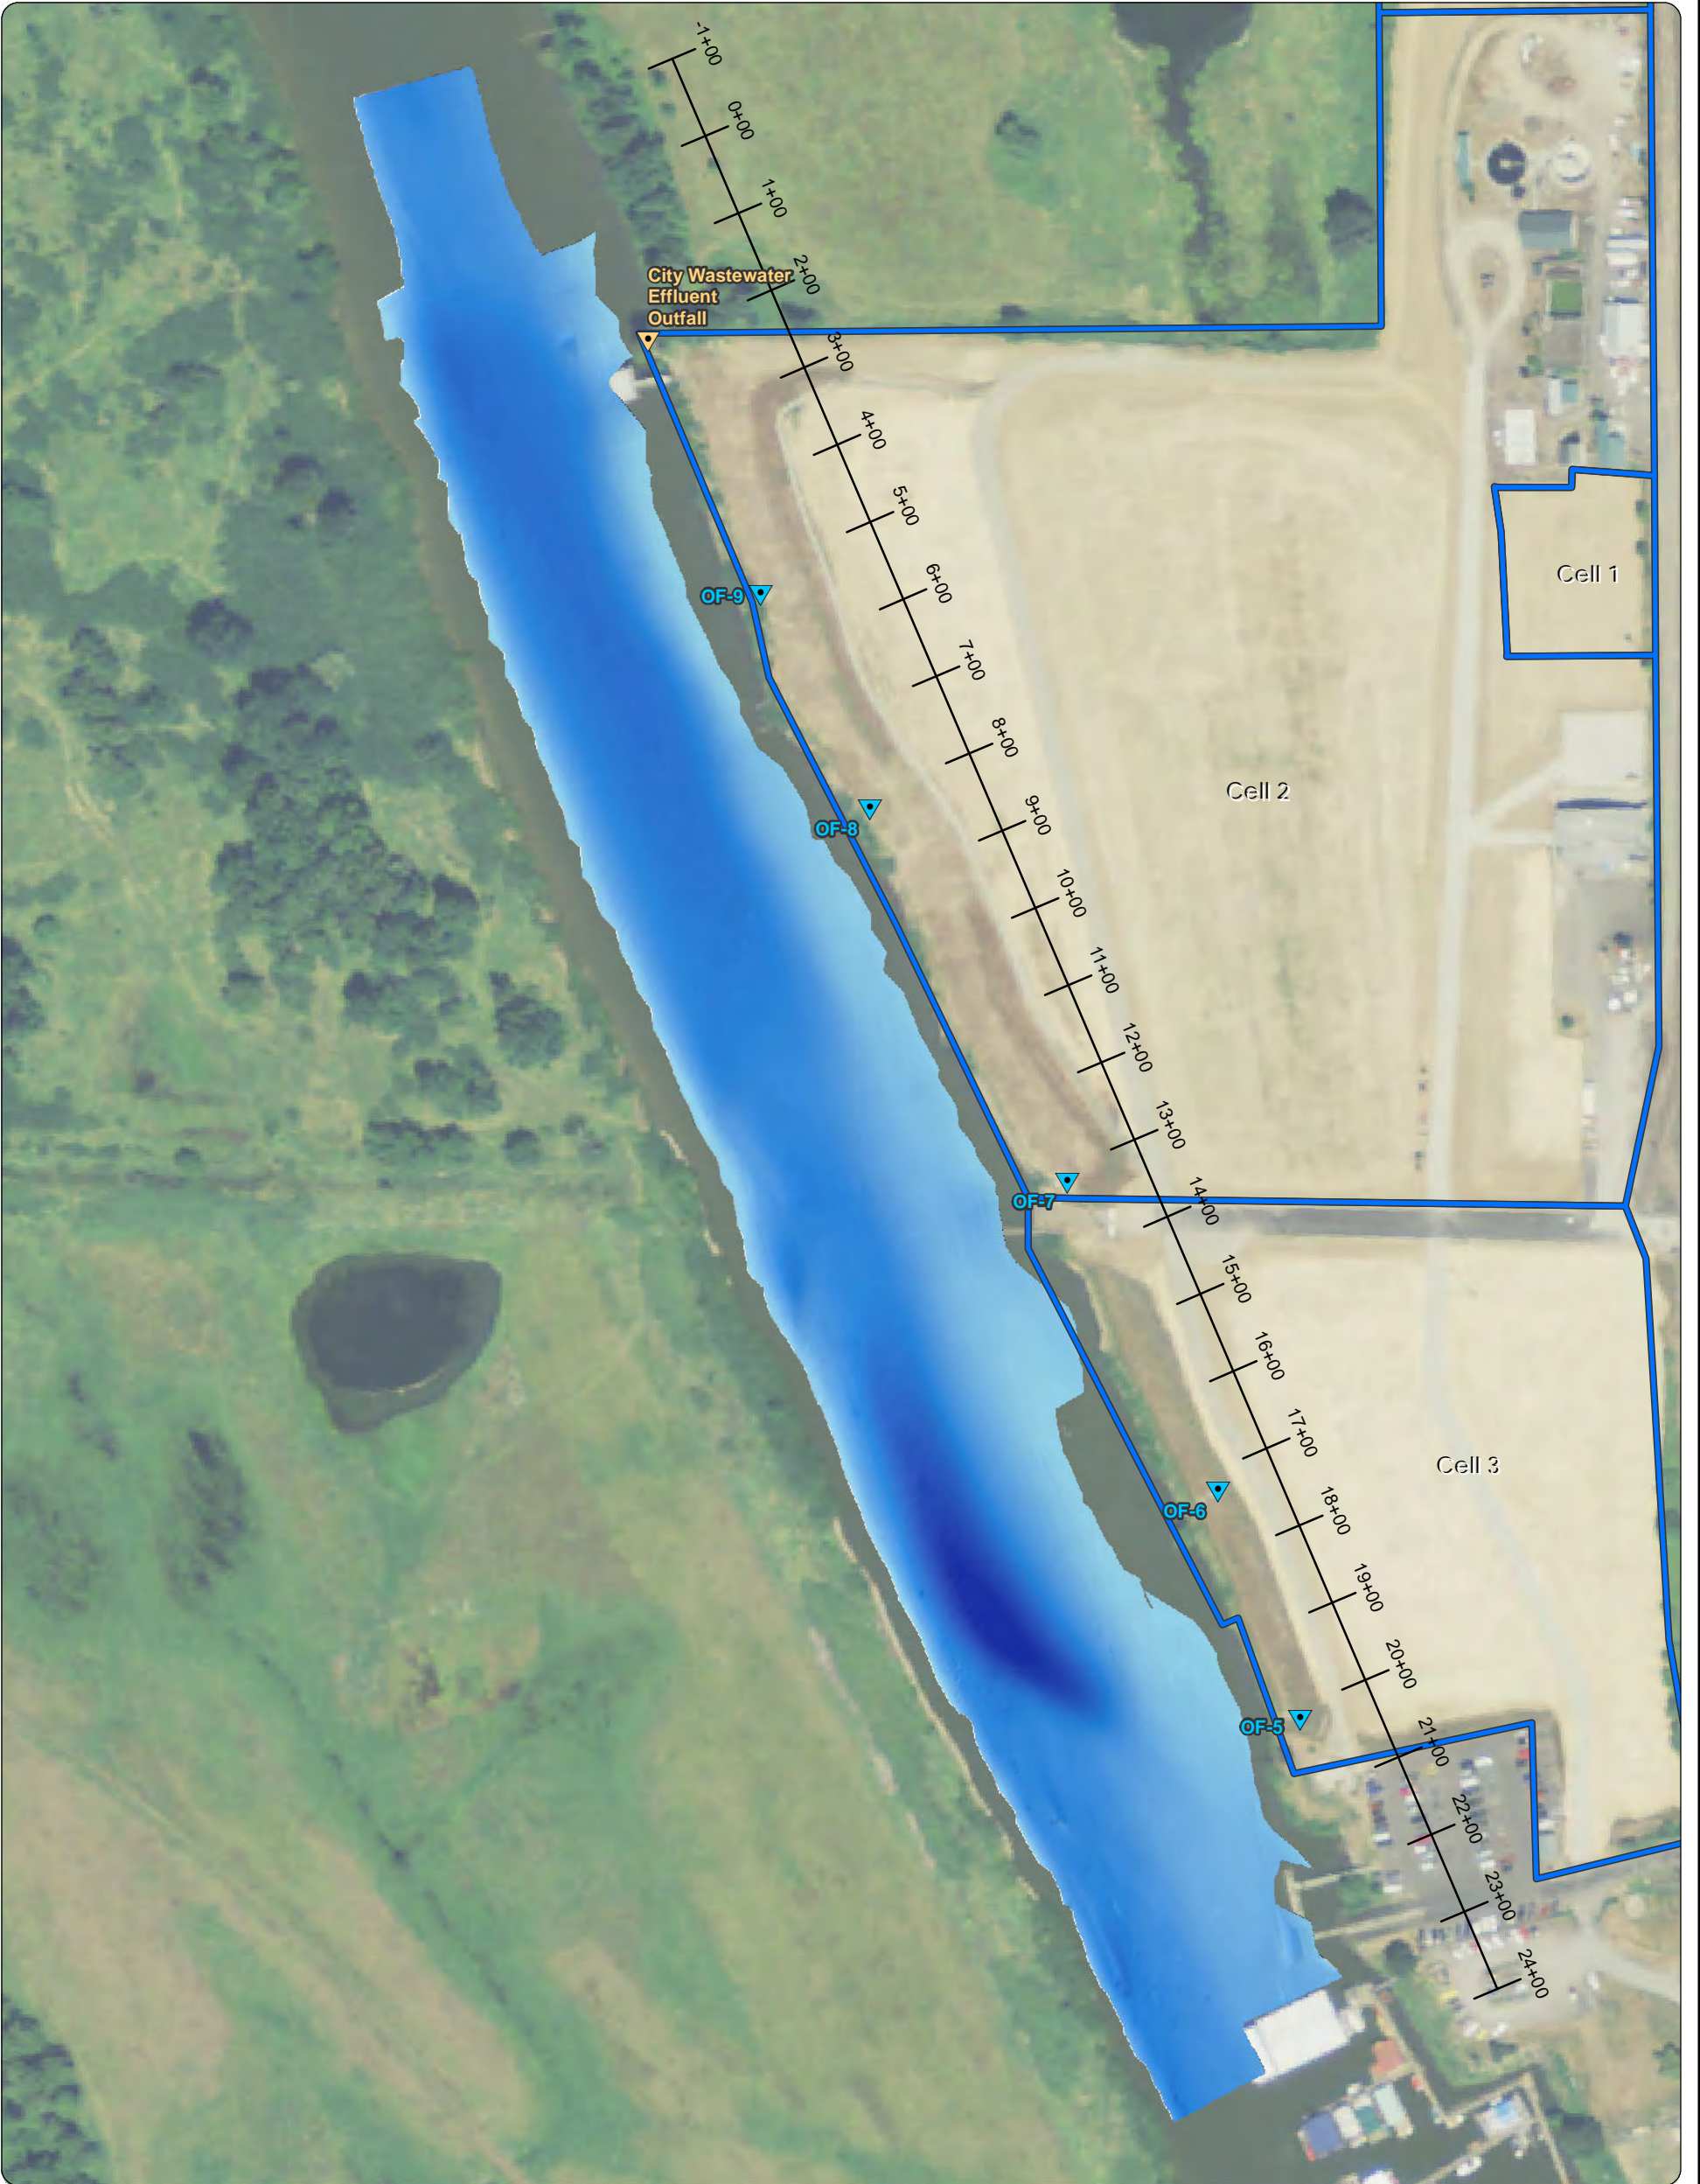
Note: Multibeam bathymetric survey was provided as a GeoTIFF from Minister-Glaeser; hillshade effect was created in ArcMap 10.1 with the Esri 9.3 Swiss Hillshade tool.

It should be noted that the multibeam sonar survey was unable to cover much of the shallow bench located near shore because of shallow water. This area was instead surveyed by Minister-Glaeser, using single-beam sonar and standard upland topographic survey methods.
